Designated Substances Survey

1009 Sheppard Ave. West, Fire Hall No. 143
Issued April 2021, by Fisher Environmental Ltd.

DESIGNATED SUBSTANCES SURVEY FOR ACCESSIBILITY UPGRADES (IBI GROUP)

**FIRE HALL 143
1009 SHEPPARD AVE. WEST
TORONTO, ONTARIO**

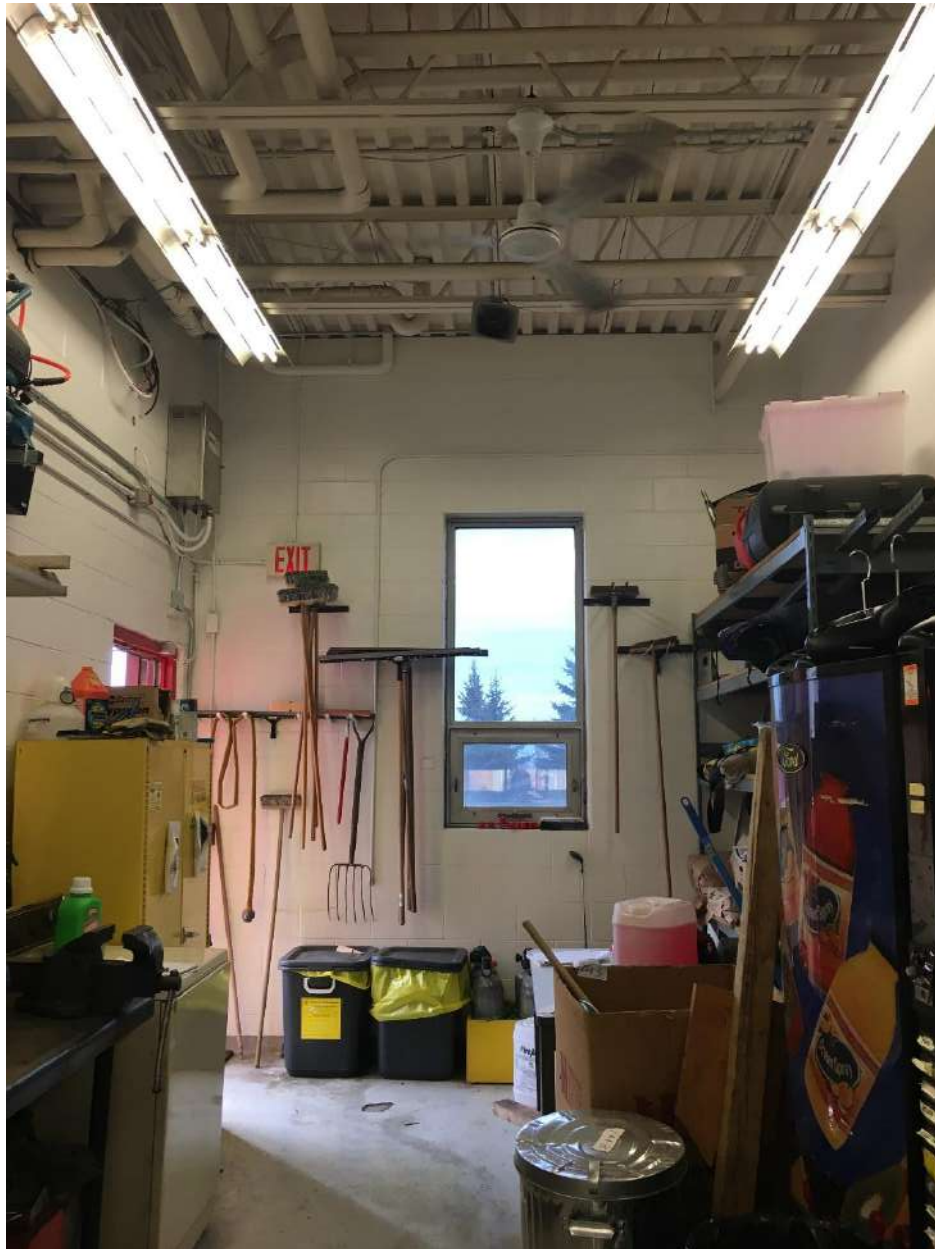
During the current survey, what appears to be asbestos-containing material (pipe fitting insulation) was identified within the specified work area (under the ceiling, above the exhaust fan). However, this material is not expected to be disturbed based on the scope of work specified. Therefore, no recommendations with regards to ACM are warranted at this time. Provide a copy of this report to contractors bidding on or performing work within the subject work areas.

Photo 1 – View of the assumed asbestos-containing pipe fitting insulation under the ceiling.
