Designated Substances Survey

1300 Sheppard Avenue West, Toronto Animal Services
Issued April 2021, by Fisher Environmental Ltd.

DESIGNATED SUBSTANCES SURVEY FOR ACCESSIBILITY UPGRADES (IBI GROUP)

**TORONTO ANIMAL SERVICES
1300 SHEPPARD AVE. WEST
TORONTO, ONTARIO**

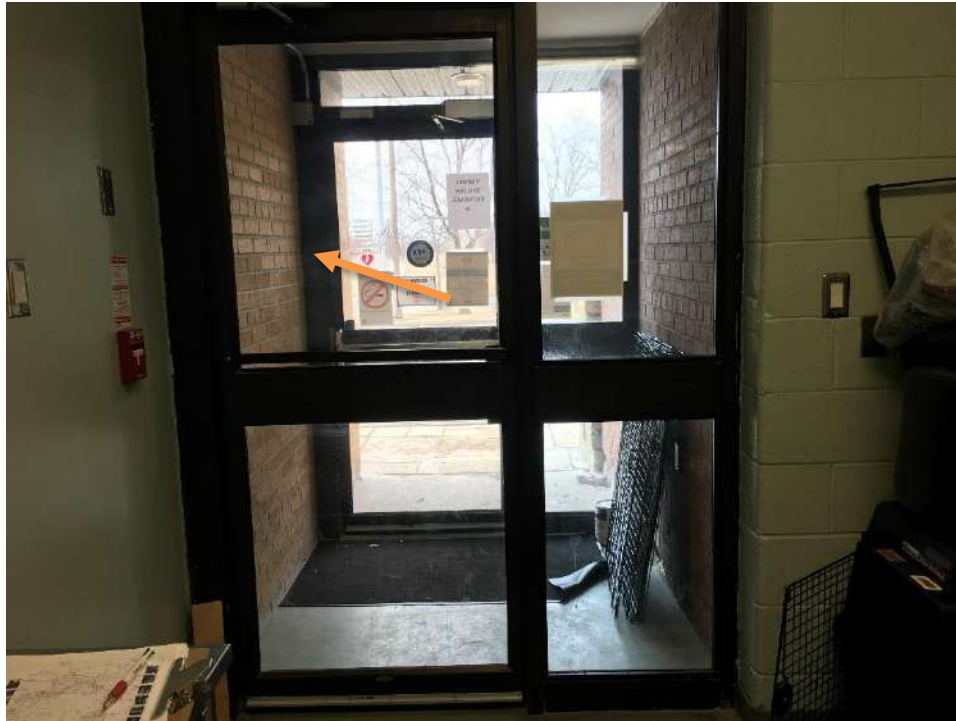
Grey caulking was observed along the joints of the block wall and the door frame of the northwest vestibule exit door. Three (3) samples of the grey caulking was collected for analysis. **The results of analysis revealed that the grey caulking contains 0.5-5% Chrysotile asbestos.**

Photo 1 – Asbestos-containing grey caulking around the exit door in the Vestibule.

Prior to demolition or any renovation activities, all asbestos-containing materials must be removed from the specified work area(s) in accordance with O. Reg. 278/05 - *Asbestos on Construction Projects and in Buildings and Repair Operations*, and be disposed of at a MOE licensed landfill in accordance with O. Reg. 558/00 (amending O. Reg. 347, *General – Waste Management*).

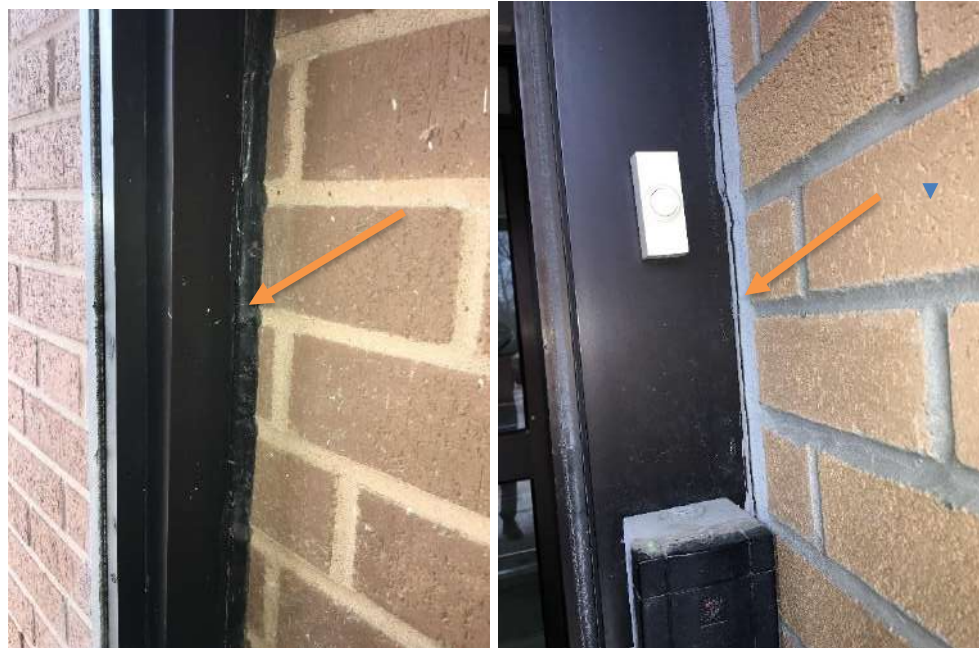
Photos 2, 3 – Asbestos-containing grey caulking - painted dark grey inside the Vestibule, and asbestos-containing grey caulking on the exterior part of the door.
