## Designated Substances Survey

4100 Keele Street, Fire Hall No. 141

# **DESIGNATED SUBSTANCES SURVEY FOR ACCESSIBILITY UPGRADES (IBI GROUP)**

**FIRE HALL 141  
4100 KEELE STREET  
TORONTO, ONTARIO**

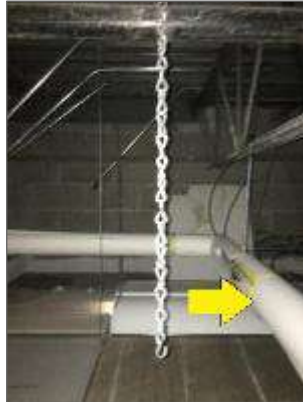
All pipes observed are either uninsulated or insulated with fibreglass.

Photo 1: Pipe insulated with fibreglass above the ceiling tiles in the Corridor (Location 1-02).

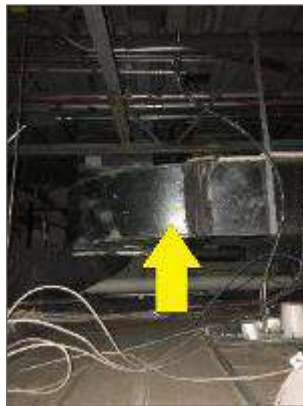
Ducts are either uninsulated or insulated with fibreglass and jacketed with foil.

Photo 2: Uninsulated duct above the ceiling tiles in the Office Area (Location 1-04).

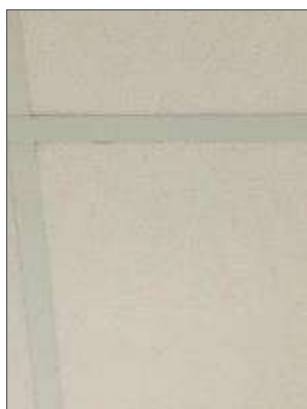
Photo 3: Non-asbestos ACT01 in the Corridor (Location 1-17).

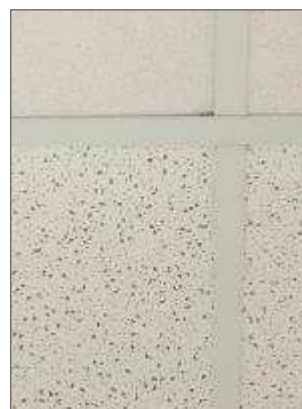
Photo 4: Non-asbestos ACT03 in the Office (Location 1-05).
