Designated Substances Survey

4330 Dufferin Street

Toronto Emergency Services Headquarters

Issued April 2021, by Fisher Environmental Ltd.

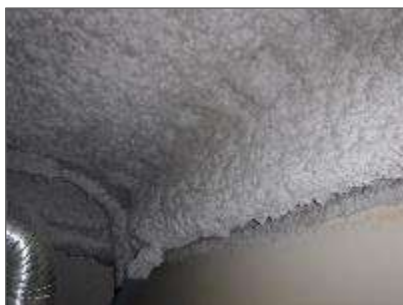
Photo 1: Non-asbestos fireproofing present above acoustic ceiling tile in the Automotive Parts room (Location 1-032).

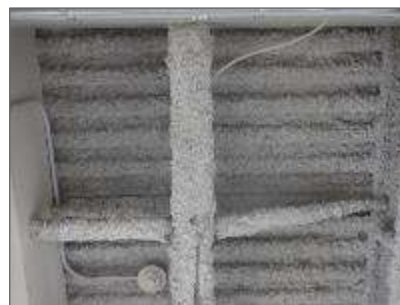
Photo 2: Non-asbestos fireproofing present in Elevator Mechanical Room (Location 1-050).

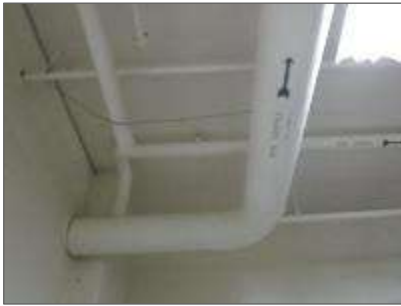
Photo 3: Hot water supply pipe insulated with fibreglass present in the Basement Document Storage room (Location B-013).

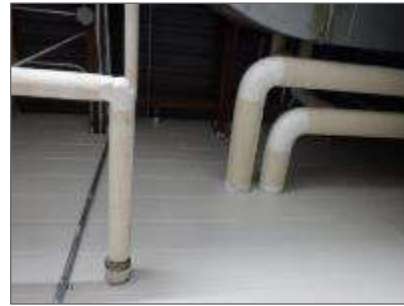
Photo 4: Pipes insulated fibreglass present in the Rooftop Mechanical Room (Location 4-001).

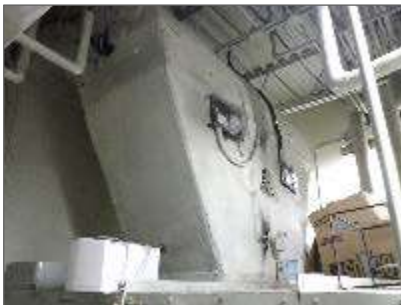
Photo 5: Duct insulated with fibreglass and jacketed in canvas present in Mechanical Room (Location 1-106).

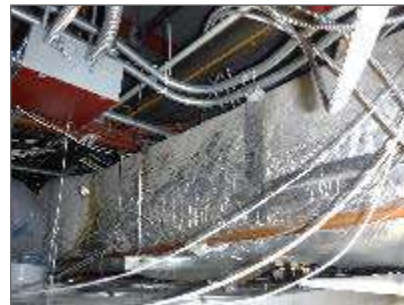
Photo 6: Duct insulated with fibreglass and jacketed in foil present in Corridor (Location 2-140).

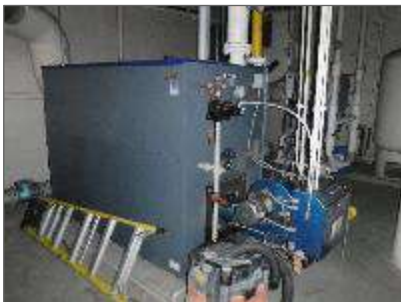
Mechanical equipment is insulated with fibreglass.

Photo 7: Boiler present in Boiler Room (Location B-014).

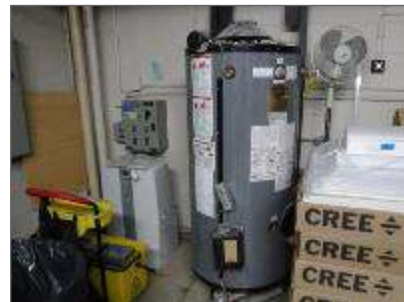
Photo 8: Hot water tank present in Boiler Room (Location B-014).

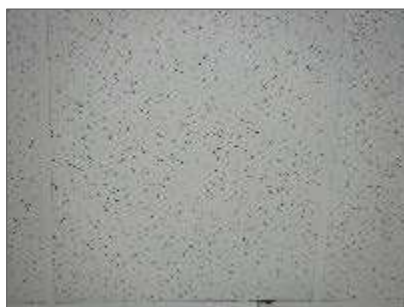
ACT10 was not accessible to the surveyor, due to its extensive height, and therefore could not be sampled. ACT10 is assumed to contain asbestos unless sampling proves otherwise. Ceiling tiles are considered to be potentially friable and are in good condition.

Photo 9: Assumed asbestos-containing ACT10.

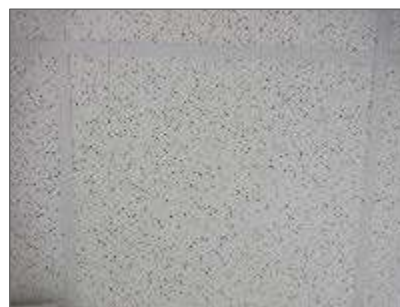
ACT19, ACT20 and ACT21 are presumed to be non-asbestos based on the date of manufacture determined from the date stamp applied to the top of the tiles. The tiles were manufactured after asbestos was stopped being used in acoustic ceiling tiles.

Photo 10: Non-asbestos ACT20.

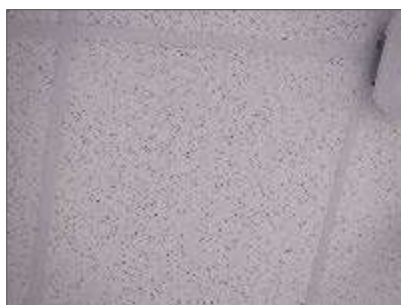
Photo 11: Non-asbestos ACT21.

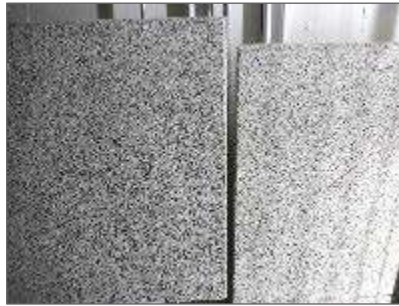
Tectum tiles are present as a ceiling finish in the Storage Cages (Location B-002). The tiles were previously sampled and determined not to contain asbestos (samples 11850-A-01-11A-C).

Photo 12: Non-asbestos Tectum tiles in Storage Cages (Location B-002).

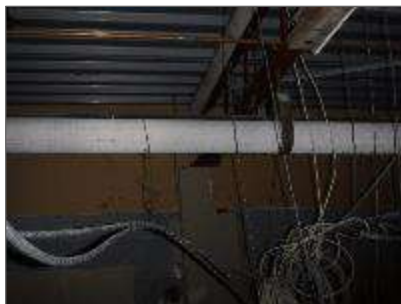
Transite pipe is present as rain water leaders in the building. Transite is assumed to contain asbestos based on visual observation. Transite is non-friable.

Photo 13: Transite pipe present above acoustic ceiling tile in Office (Location 2-088).

Refer to the Survey Form in Appendix IV for location, quantity and condition of assumed asbestos-containing Transite.

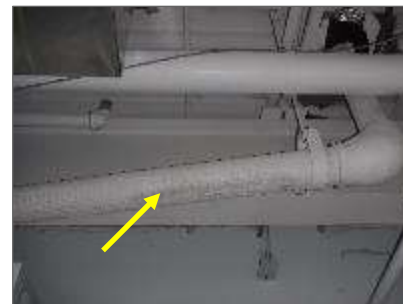
Photo 14: Transite pipe present Men's/Women's Change Room (Location 2-145).

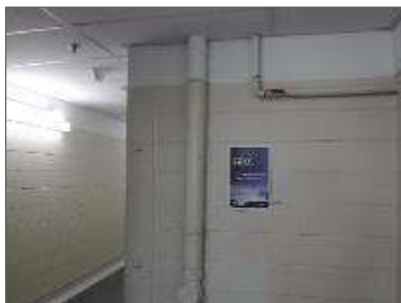
Photo 15: Transite pipe present in Corridor (Location 1-098).

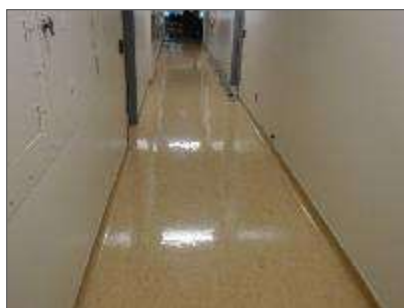
Photo 16: Non-asbestos VSF02.

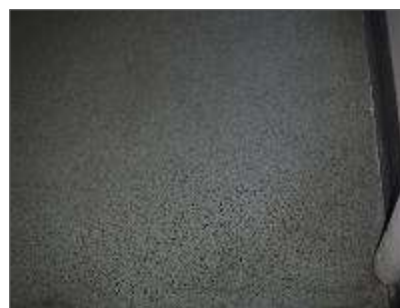
Photo 17: Non-asbestos VSF03.

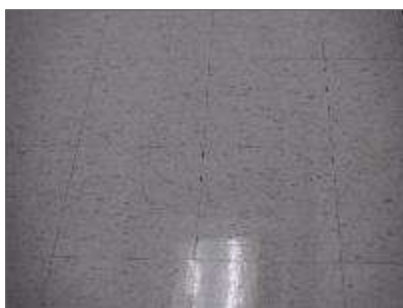
Photo 18: Non-asbestos VFT01.

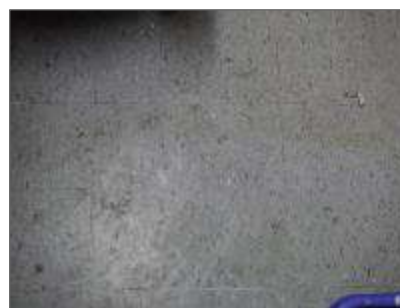
Photo 19: Non-asbestos VFT02.

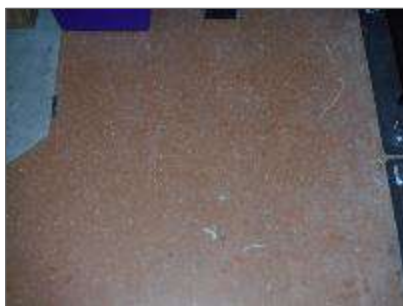
Photo 20: Non-asbestos VFT03.

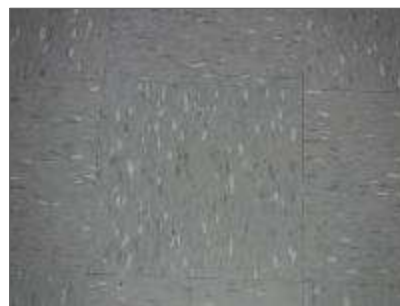
Photo 21: Non-asbestos VFT04.
