## Designated Substances Survey

**DESIGNATED SUBSTANCES  
SURVEY FOR ACCESSIBILITY  
UPGRADES (IBI GROUP)**

**PARKING STRUCTURE  
4330 DUFFERIN STREET  
TORONTO, ONTARIO**

Project No. FE-P 21-11073

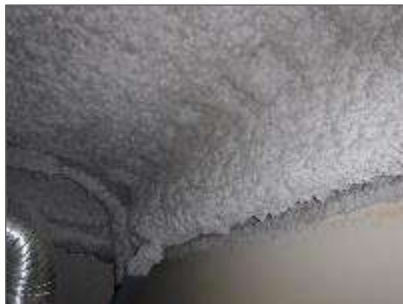
Non-asbestos fireproofing and overspray is present on the structure at various locations in the building (samples 11850-A-01-01A-G and 2018-A0001A-C).

Photo 1: Non-asbestos fireproofing present above acoustic ceiling tile in the Automotive Parts room (Location 1-032).

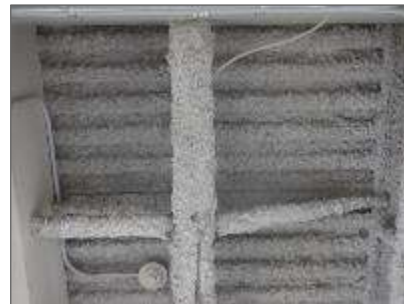
Photo 2: Non-asbestos fireproofing present in Elevator Mechanical Room (Location 1-050).

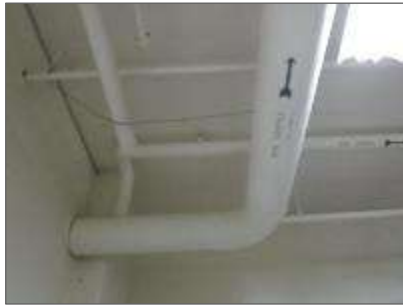
All pipes observed are either uninsulated or insulated with fibreglass.

Photo 3: Hot water supply pipe insulated with fibreglass present in the Basement Document Storage room (Location B-013).

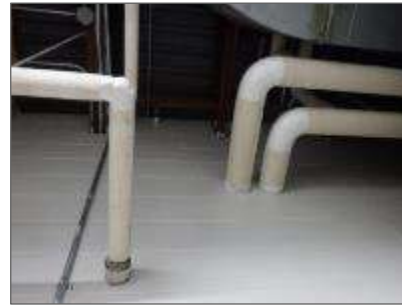
Photo 4: Pipes insulated fibreglass present in the Rooftop Mechanical Room (Location 4-001).

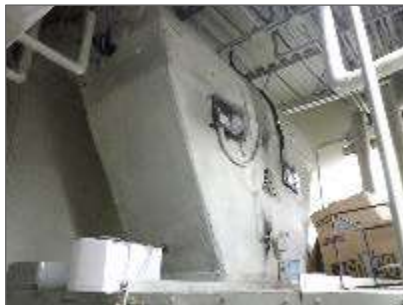
Ducts are either uninsulated or insulated with fibreglass and jacketed with either canvas or foil.

Photo 5: Duct insulated with fibreglass and jacketed in canvas present in Mechanical Room (Location 1-106).

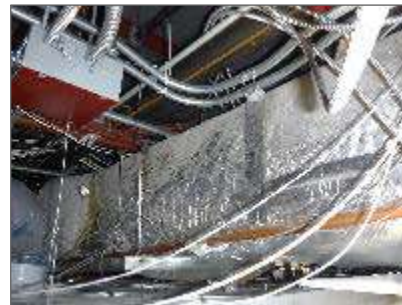
Photo 6: Duct insulated with fibreglass and jacketed in foil present in Corridor (Location 2-140).

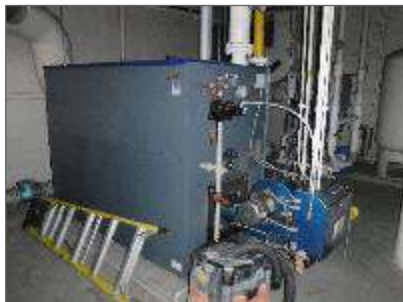
Mechanical equipment is insulated with fibreglass.

Photo 7: Boiler present in Boiler Room (Location B-014).

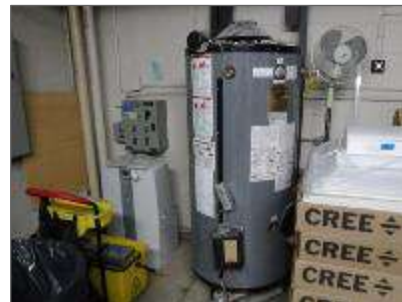
Photo 8: Hot water tank present in Boiler Room (Location B-014).

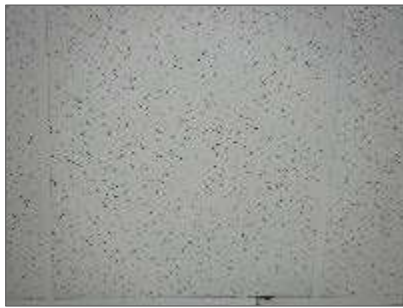
ACT10 was not accessible to the surveyor, due to its extensive height, and therefore could not be sampled. ACT10 is assumed to contain asbestos unless sampling proves otherwise. Ceiling tiles are considered to be potentially friable and are in good condition.

Photo 9: Assumed asbestos-containing ACT10.

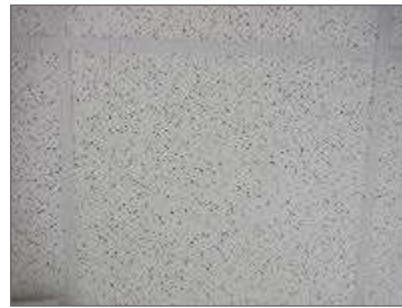
ACT19, ACT20 and ACT21 are presumed to be non-asbestos based on the date of manufacture determined from the date stamp applied to the top of the tiles. The tiles were manufactured after asbestos was stopped being used in acoustic ceiling tiles.

Photo 10: Non-asbestos ACT20.

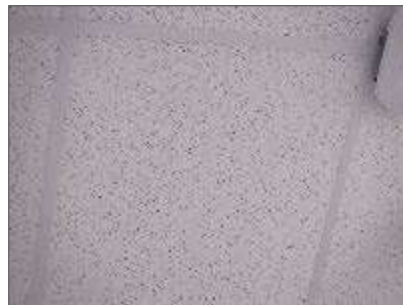
Photo 11: Non-asbestos ACT21.

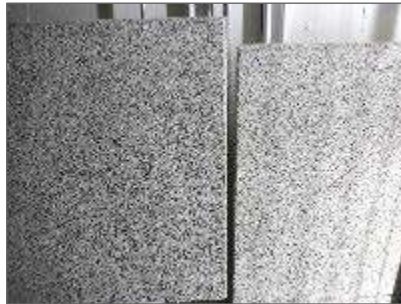
Tectum tiles are present as a ceiling finish in the Storage Cages (Location B-002). The tiles were previously sampled and determined not to contain asbestos (samples 11850-A-01-11A-C).

Photo 12: Non-asbestos Tectum tiles in Storage Cages (Location B-002).

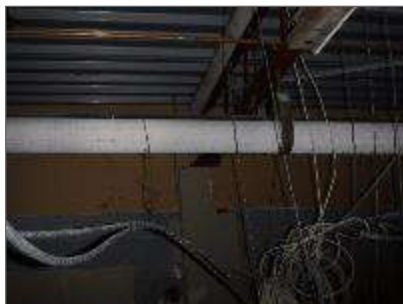
Transite pipe is present as rain water leaders in the building. Transite is assumed to contain asbestos based on visual observation. Transite is non-friable.

Photo 13: Transite pipe present above acoustic ceiling tile in Office (Location 2-088).

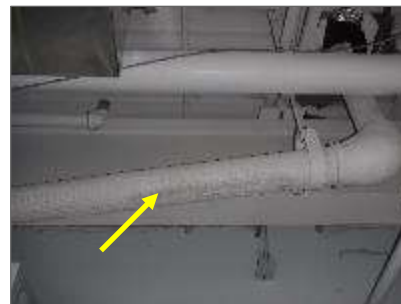
Photo 14: Transite pipe present Men's/Women's Change Room (Location 2-145).

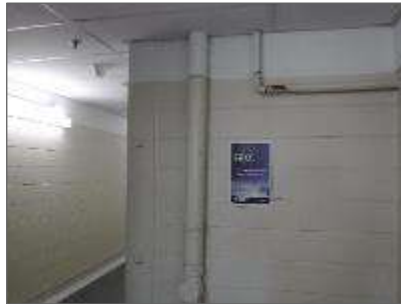
Photo 15: Transite pipe present in Corridor (Location 1-098).

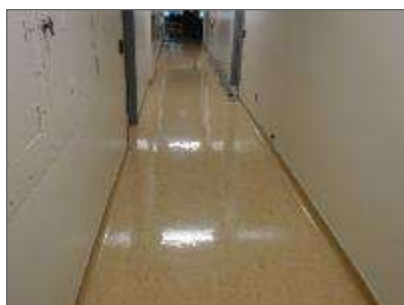
Photo 16: Non-asbestos VSF02.

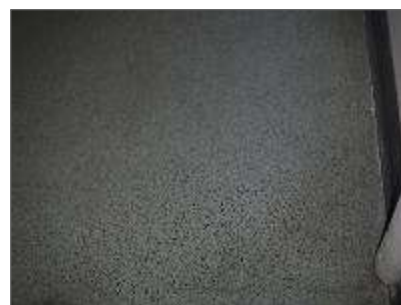
Photo 17: Non-asbestos VSF03.

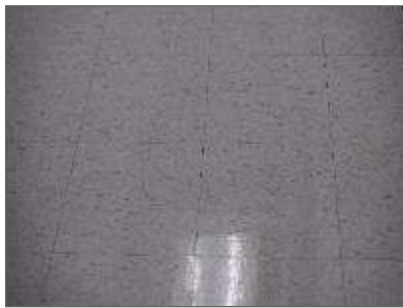
Photo 18: Non-asbestos VFT01.

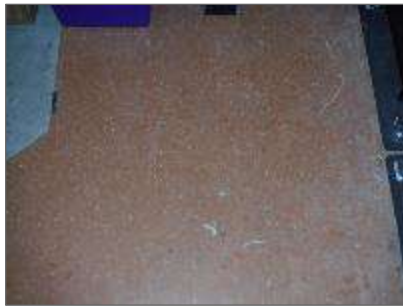
Photo 20: Non-asbestos VFT03.

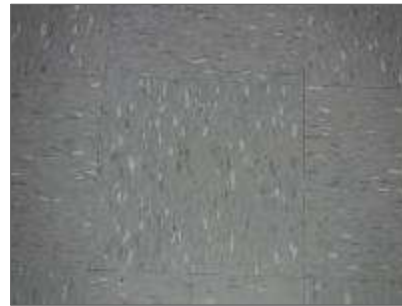
Photo 21: Non-asbestos VFT04.
