Designated Substances Survey

5700 Bathurst Street, Fire Hall No. 112

**DESIGNATED SUBSTANCES
SURVEY FOR ACCESSIBILITY
UPGRADES (IBI GROUP)**

**FIRE HALL 112
& EMS STATION 16
5700 BATHURST STREET
TORONTO, ONTARIO**

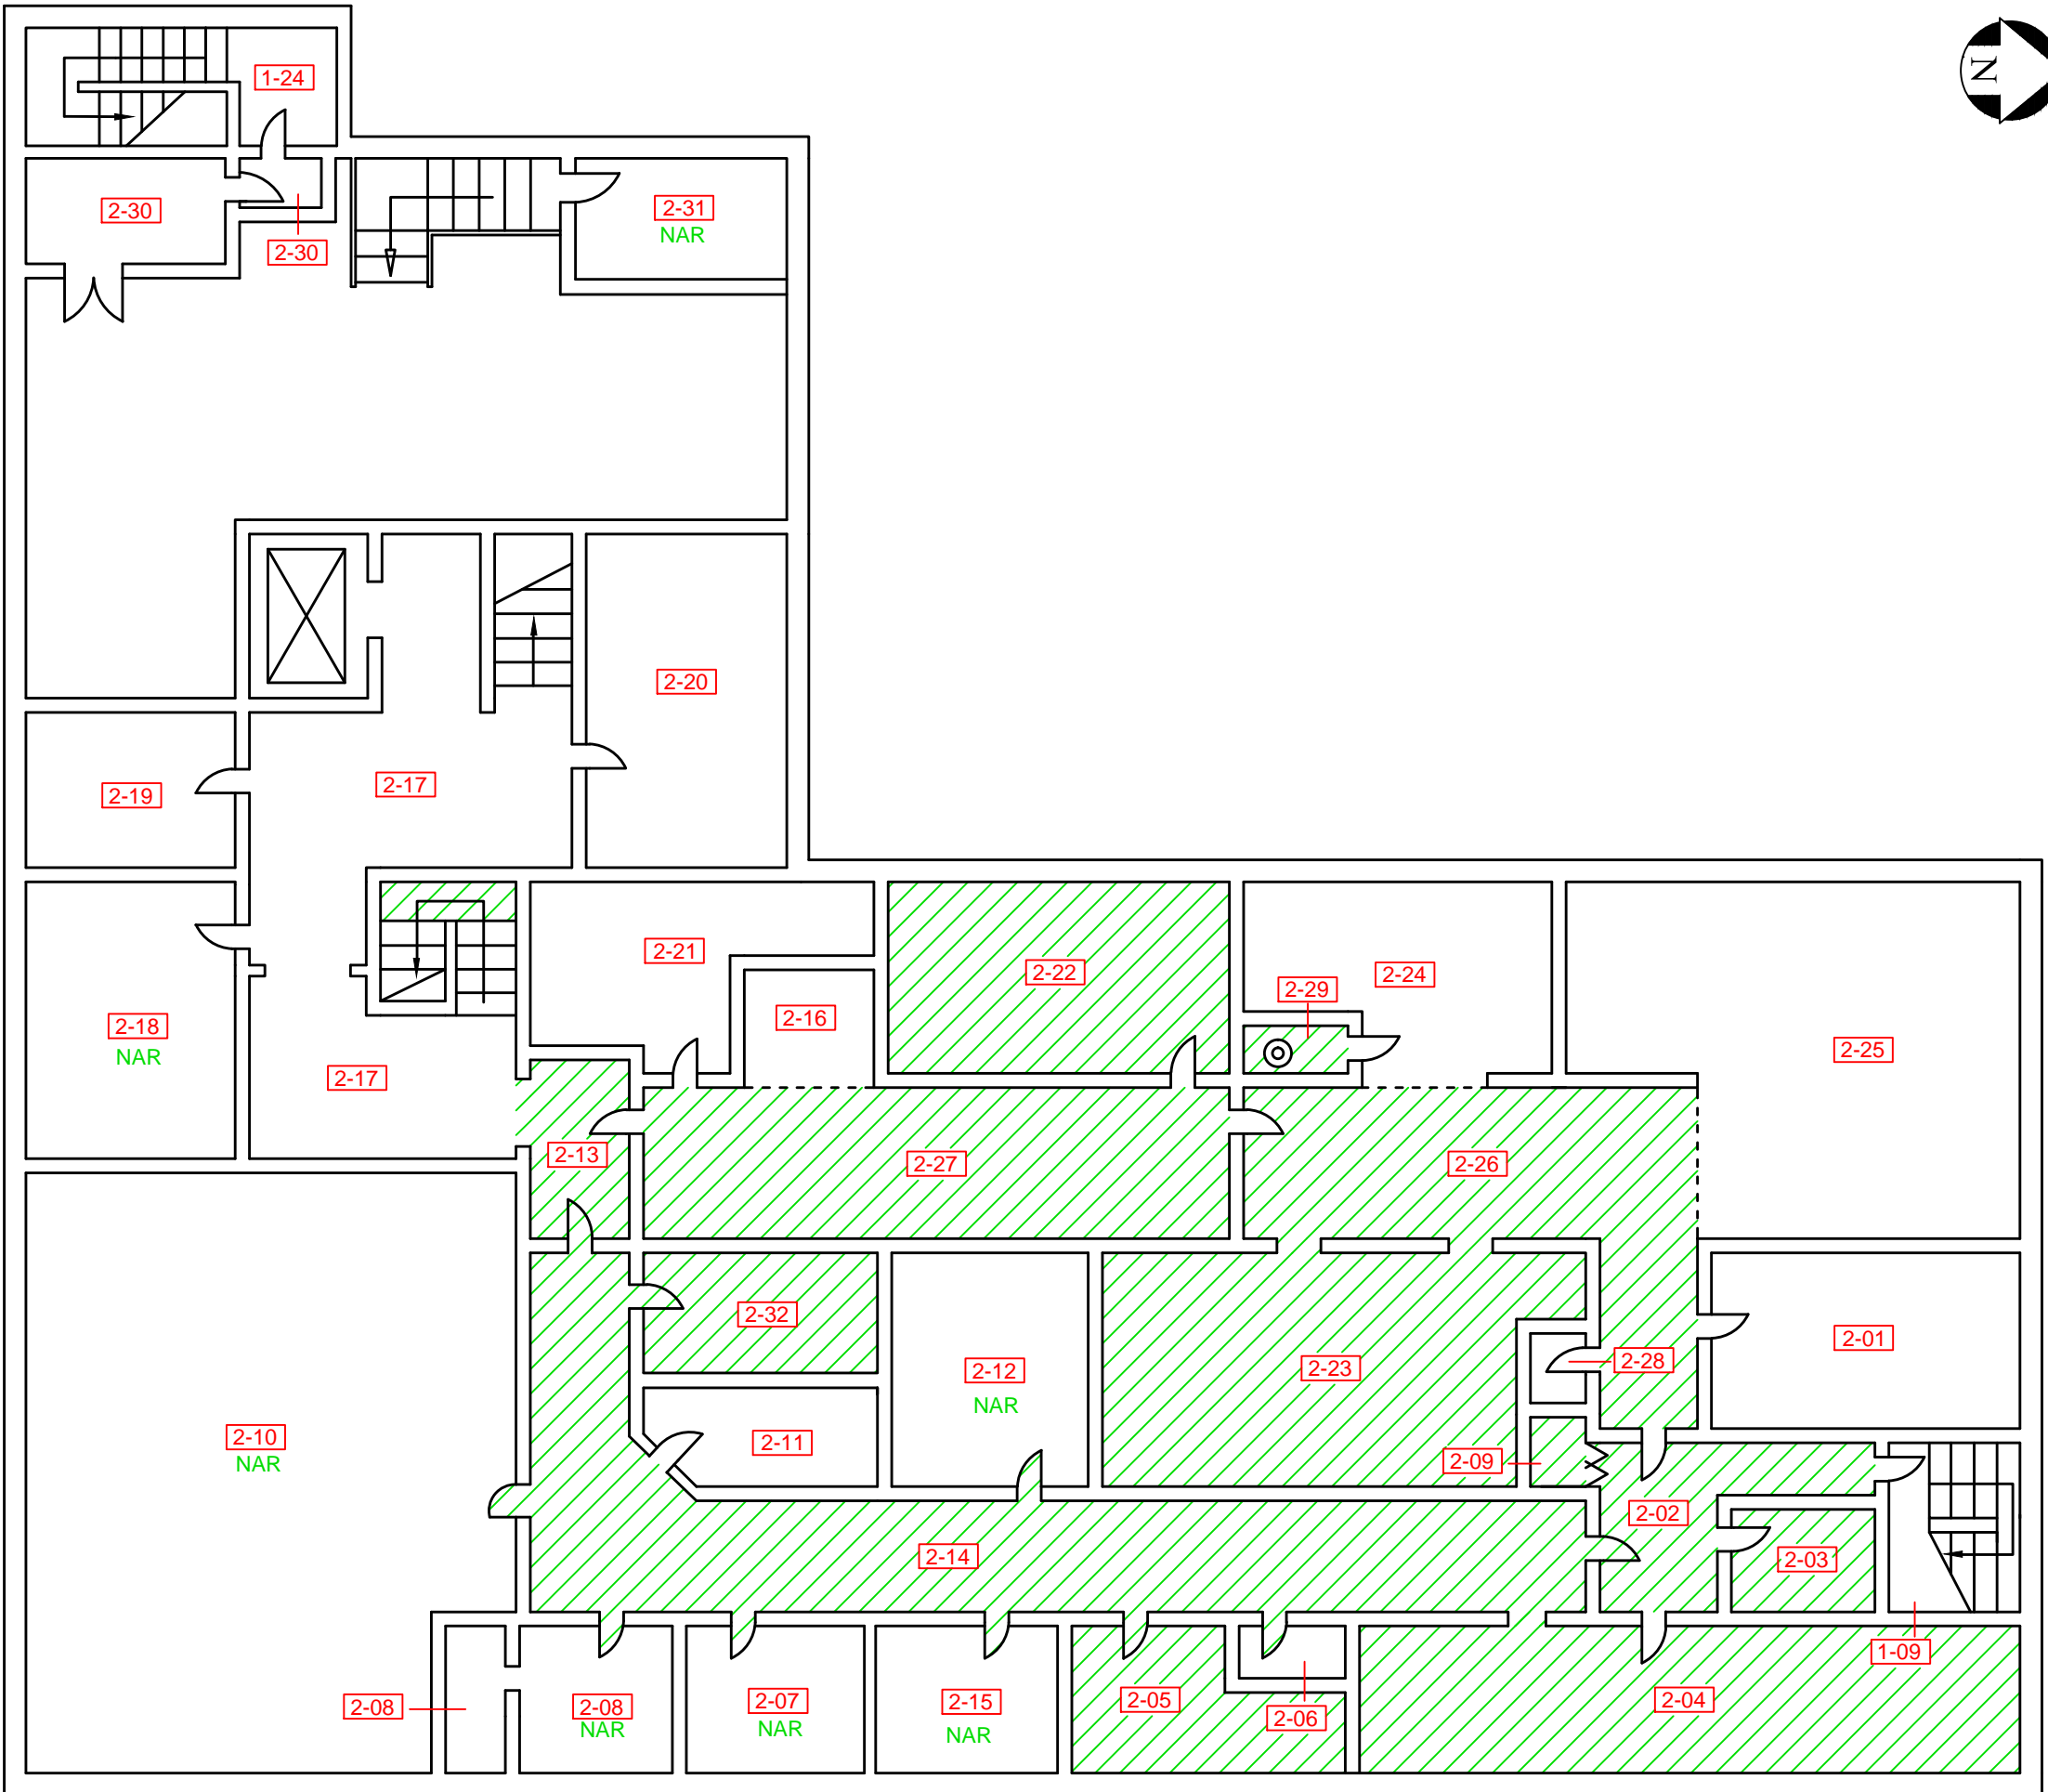
Second Floor Plan Asbestos-Containing Material Locations

The previous report confirmed that Vinyl Floor Tile 3 (12" x 12", Light Beige and Brown Streaks) was sampled for analysis. The results of analysis revealed that Vinyl Floor Tile 3, which was observed in the second-floor office area, **contains 0.5 - 5% Chrysotile asbestos.**

Prior to demolition or any renovation activities, all asbestos-containing materials must be removed from the specified work area(s) in accordance with O. Reg. 278/05 - *Asbestos on Construction Projects and in Buildings and Repair Operations*, and be disposed of at a MOE licensed landfill in accordance with O. Reg. 558/00 (amending O. Reg. 347, *General – Waste Management*).
