Designated Substances Survey

1026 Finch Yard, Building B

DESIGNATED SUBSTANCES SURVEY FOR ACCESSIBILITY UPGRADES (IBI GROUP)

**FINCH YARD, BUILDING B
1026 FINCH AVENUE WEST
TORONTO, ONTARIO**

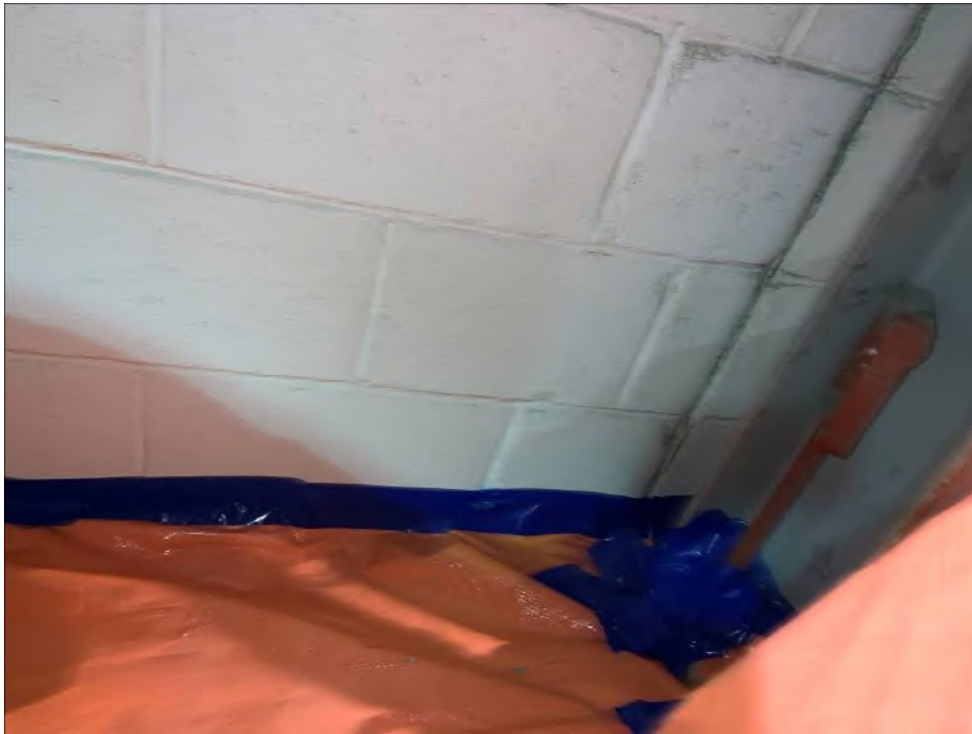
Photo 1: Example of the work area preparation for Type 1 removal.

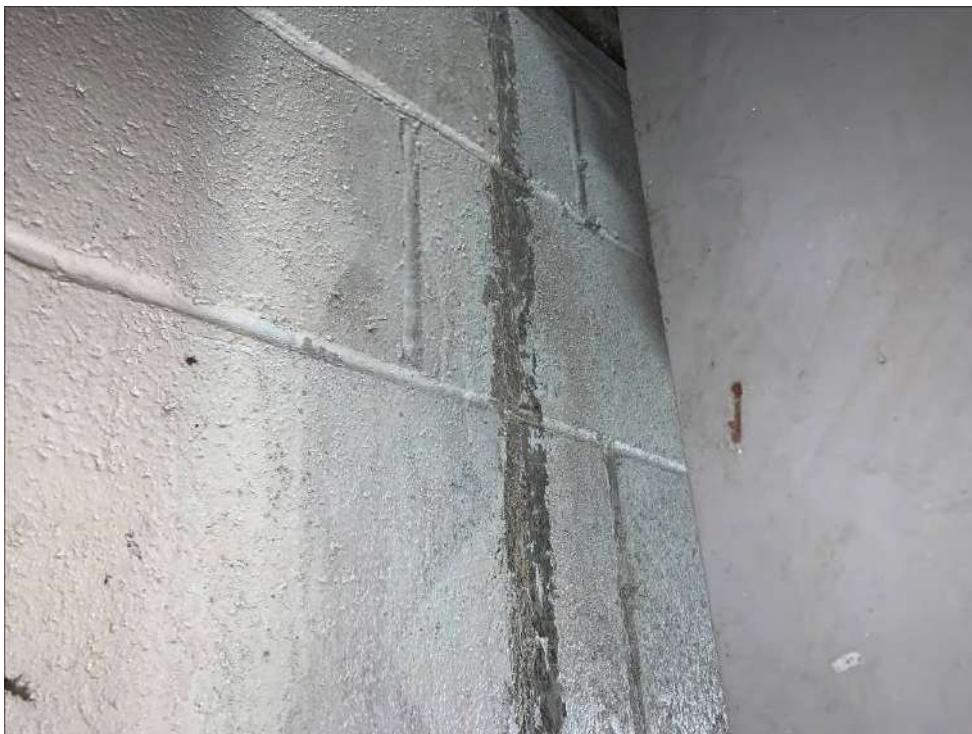
Photo 2: Post abatement view of the plain surface of the wall where from the asbestos-containing caulking was removed.

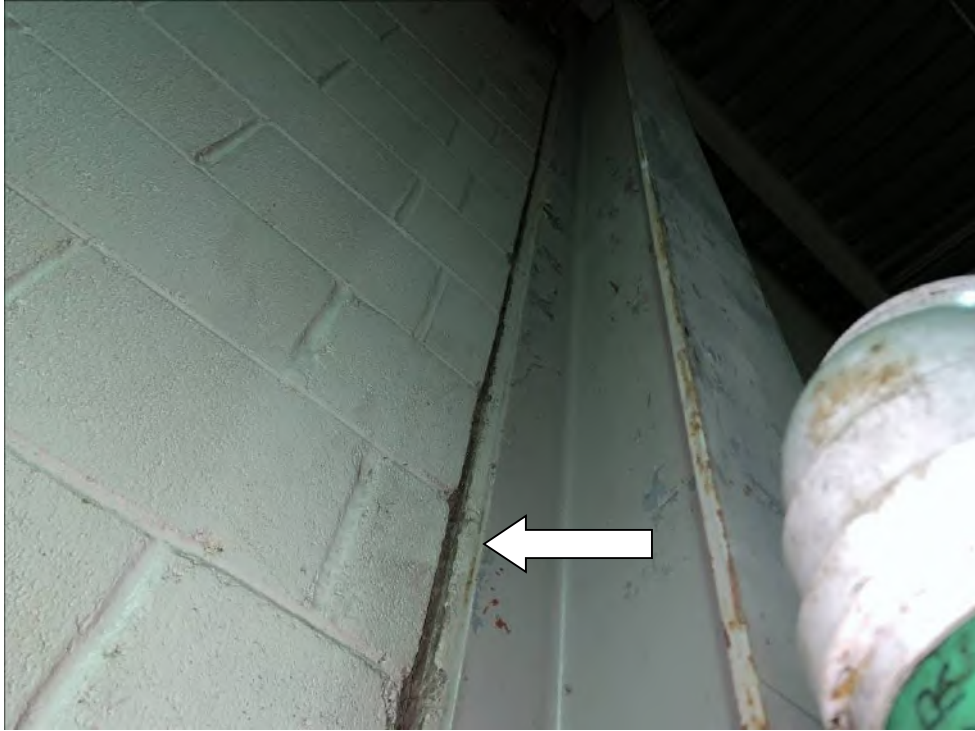
Photo 3: Example of the post abatement view of the wall joint behind the metal column.

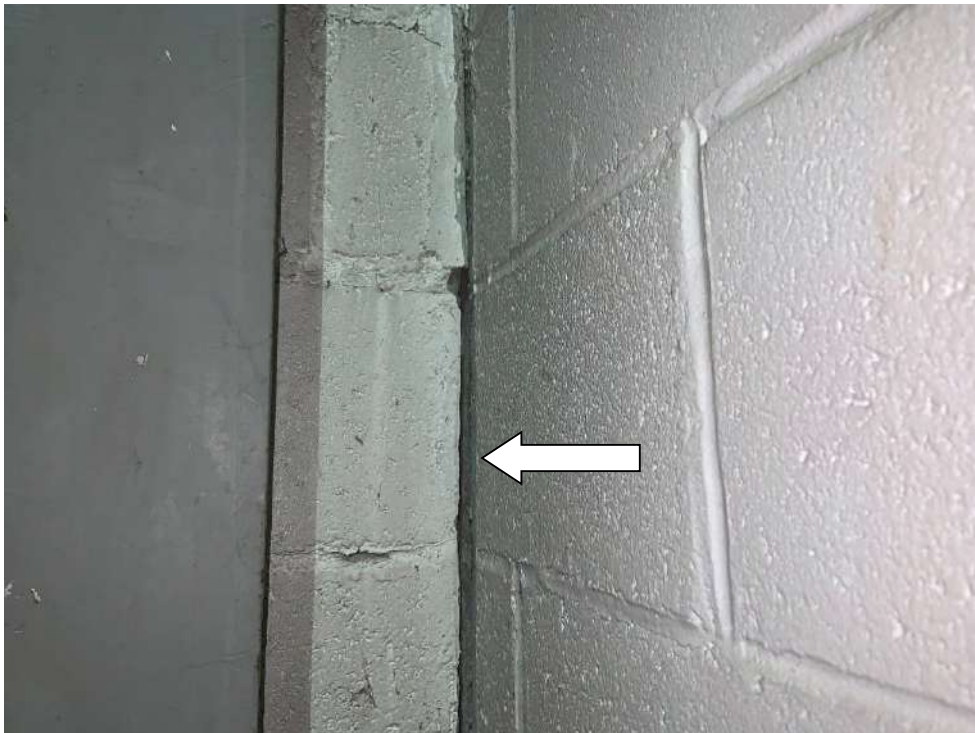
Photo 4: Post abatement view of the wall joint along the east wall at the Site.

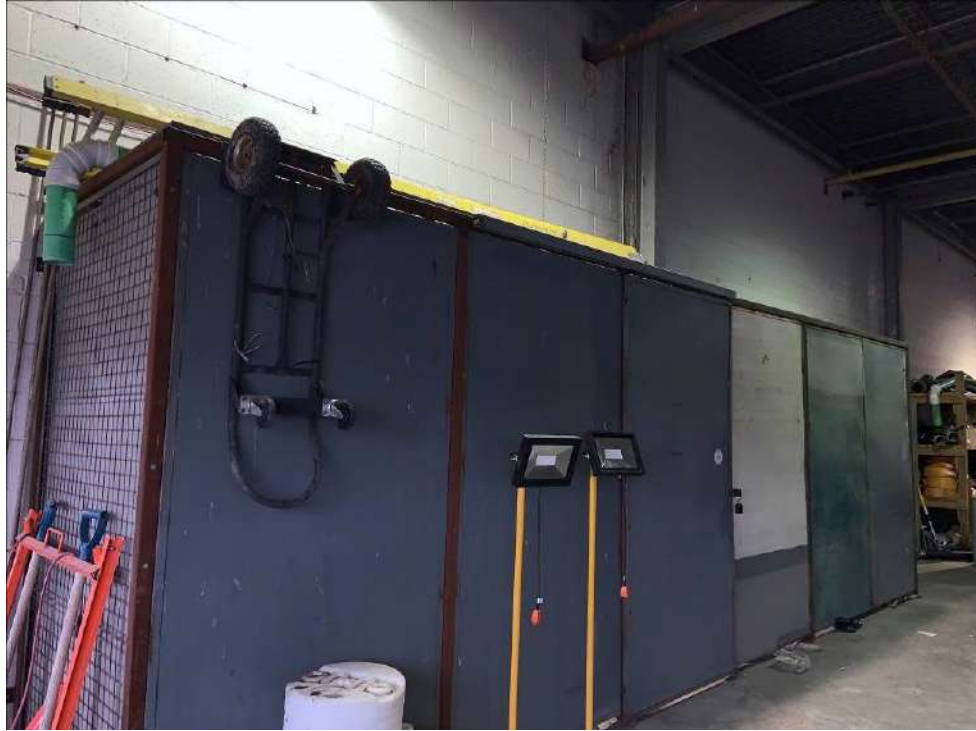
Please note that the asbestos-containing caulking on the wall behind the cabinets was not accessible during the abatement work. The cabinets were not a movable condition by the abatement contractor. During the site meeting with the City of Toronto and the abatement contractor representatives on November 19, 2020, it was decided that Furcon will remove all the caulking which are accessible. The asbestos-containing caulking behind the cabinets will remain and be excluded from the abatement scope of works.

Photo 5: View of the area (behind the cabinets) which were not accessible for removal of the asbestos-containing caulking.

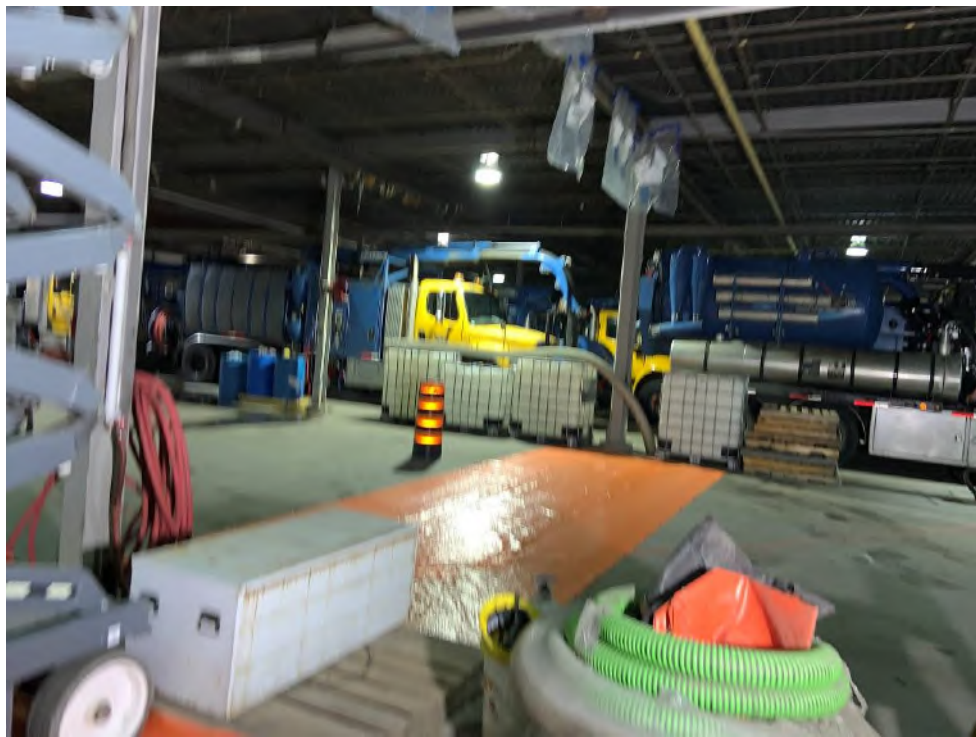
Photo 6: View of the Type 2 Glove Bag work area preparation to remove asbestos-containing parging cement from the fittings.

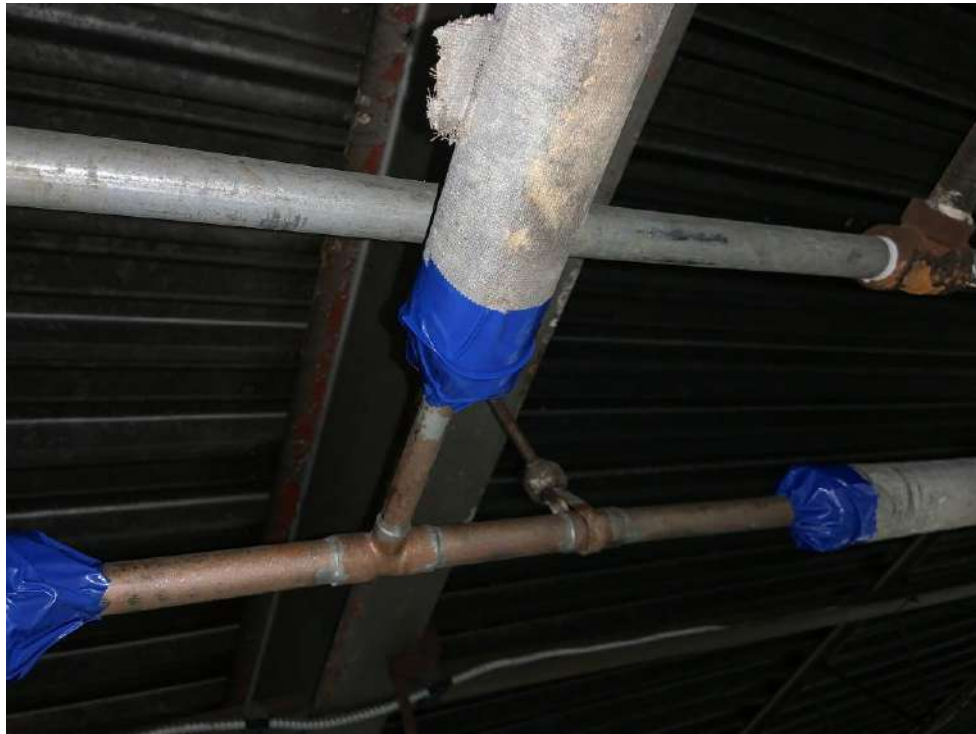
Photo 7: Post abatement view of a fitting and a hanger at the Site.

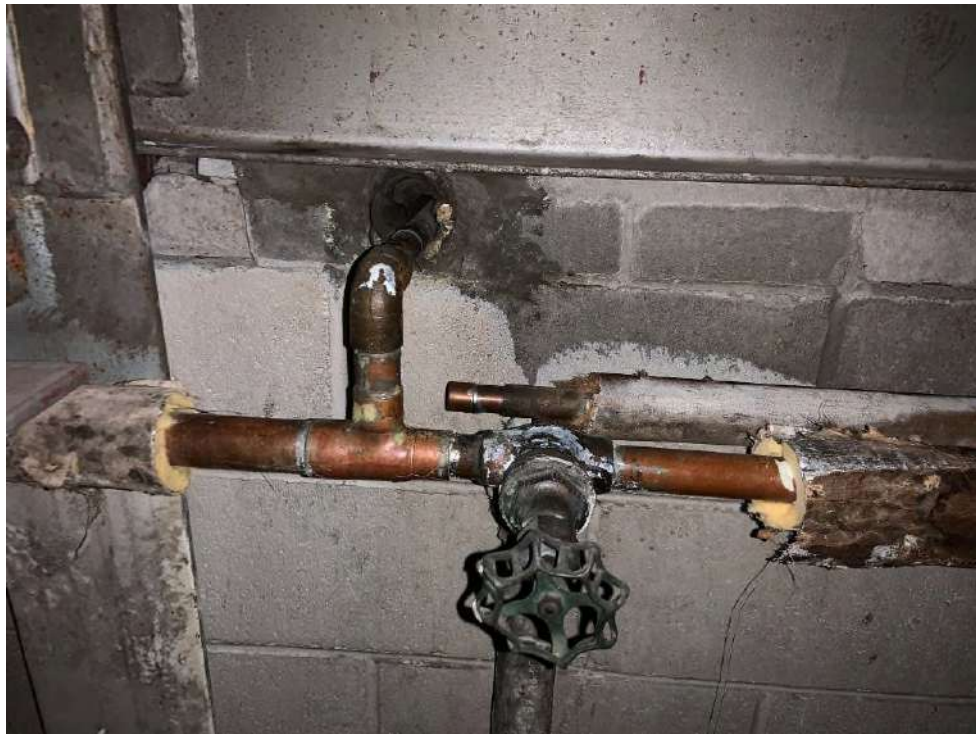
Photo 8: Another post abatement view of the fittings.

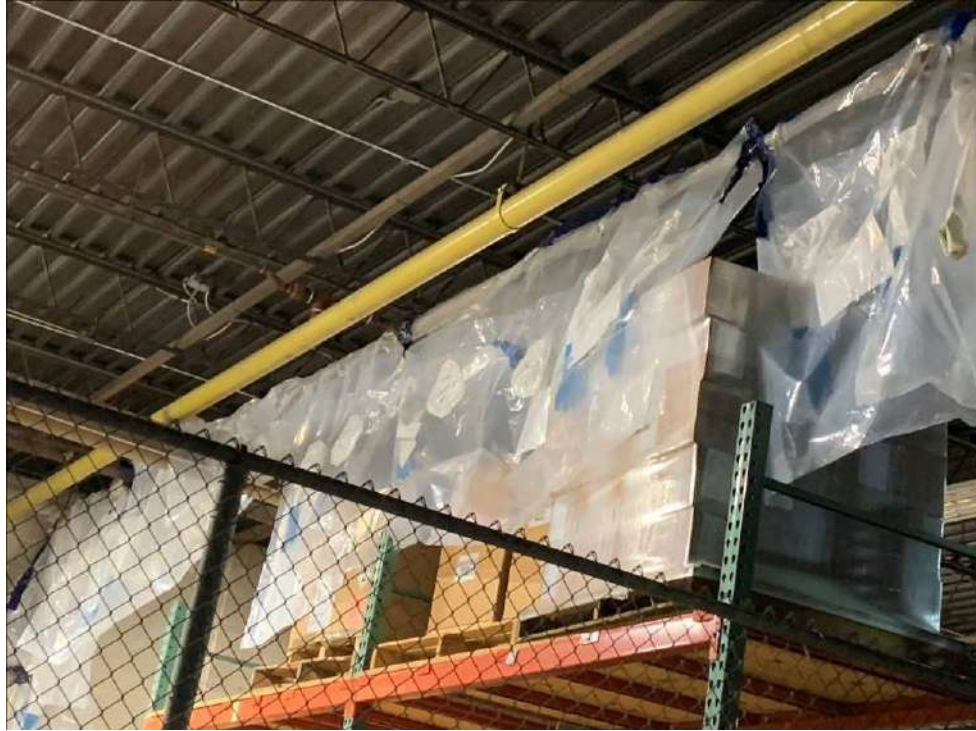
Photo 9: View of the Glove Bag settings for removal of the asbestos-containing air-cell on a pipe straight.

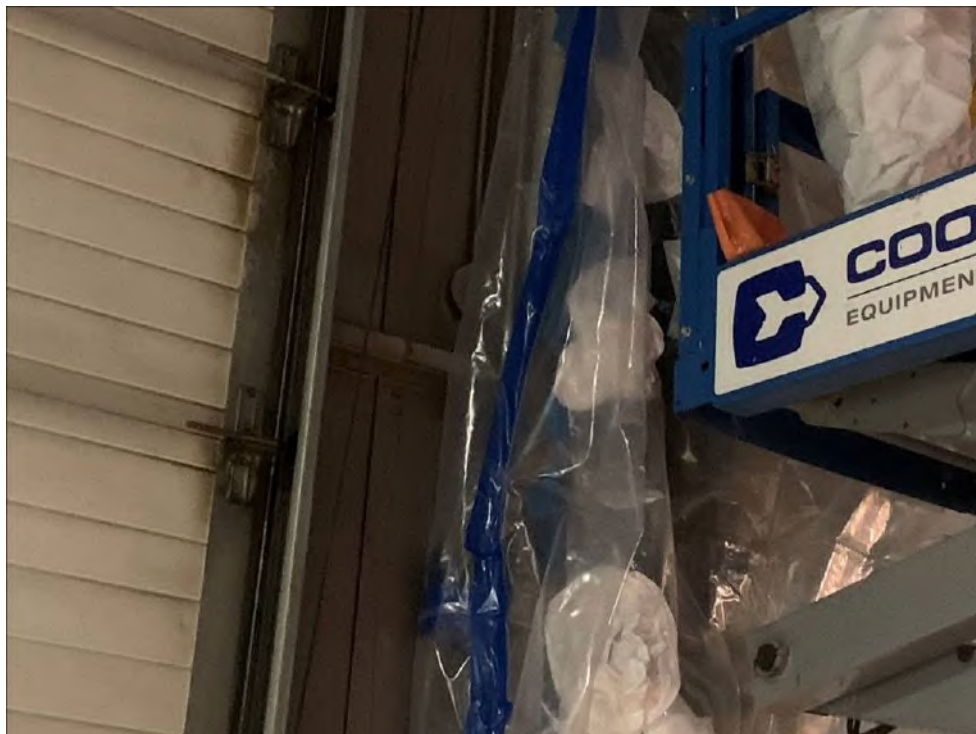
Photo 10: Another view of the Glove Bag settings for removal of the asbestos-containing air-cell from a vertical pipe straight.

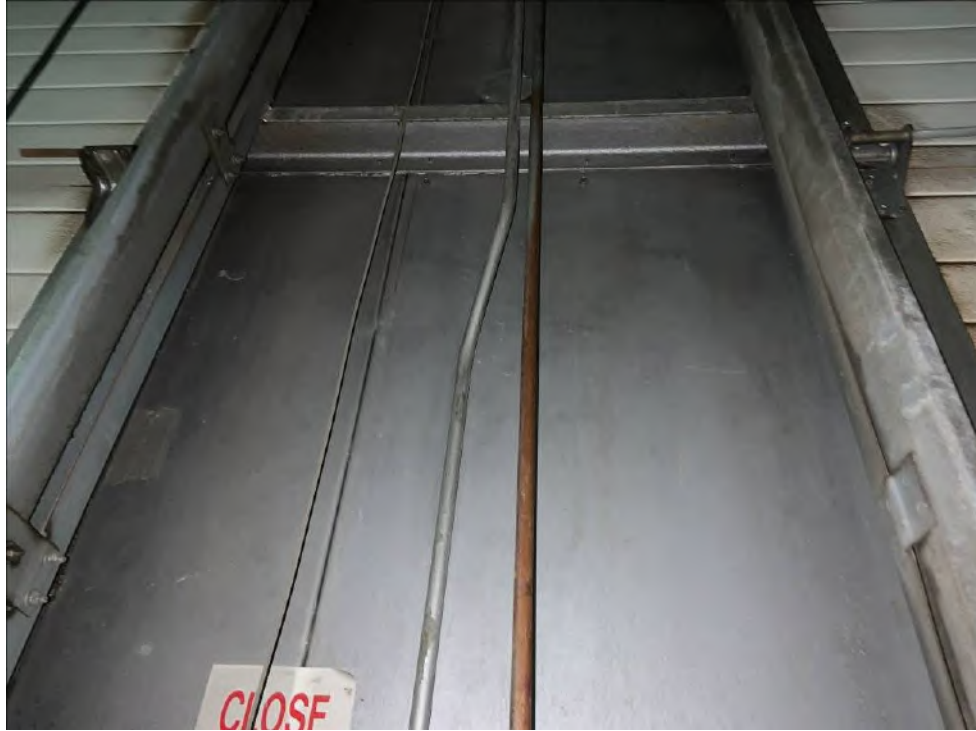
Photo 11: Post abatement view of a vertical pipe straight at the Site.

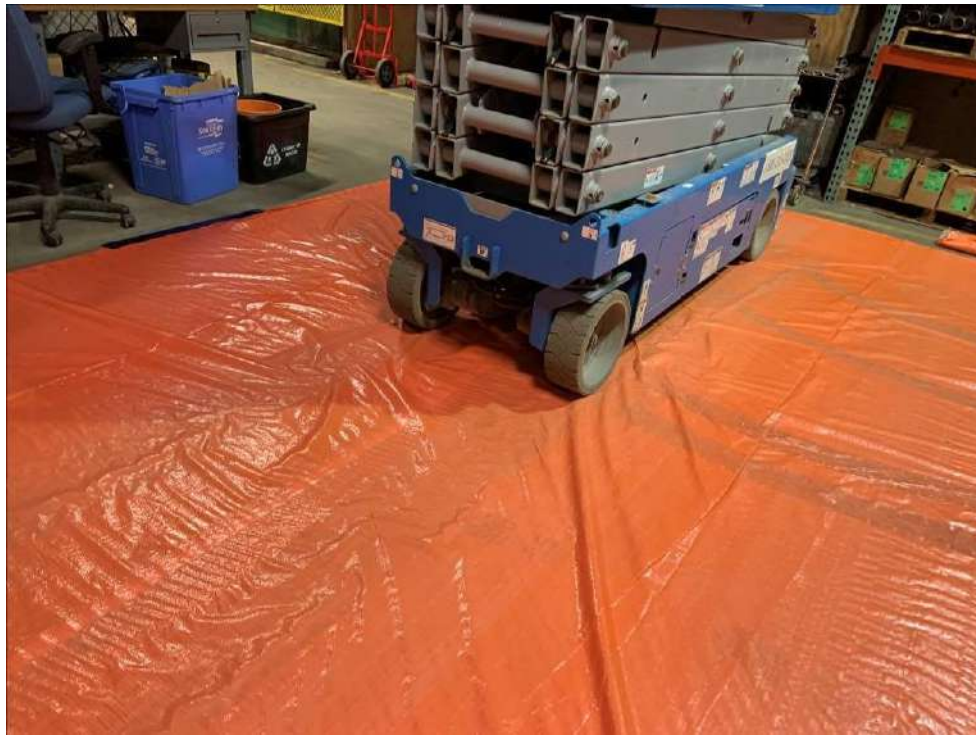
Photo 12: Example view of the Type 2a work area preparation to remove lead-containing paint from the beam.

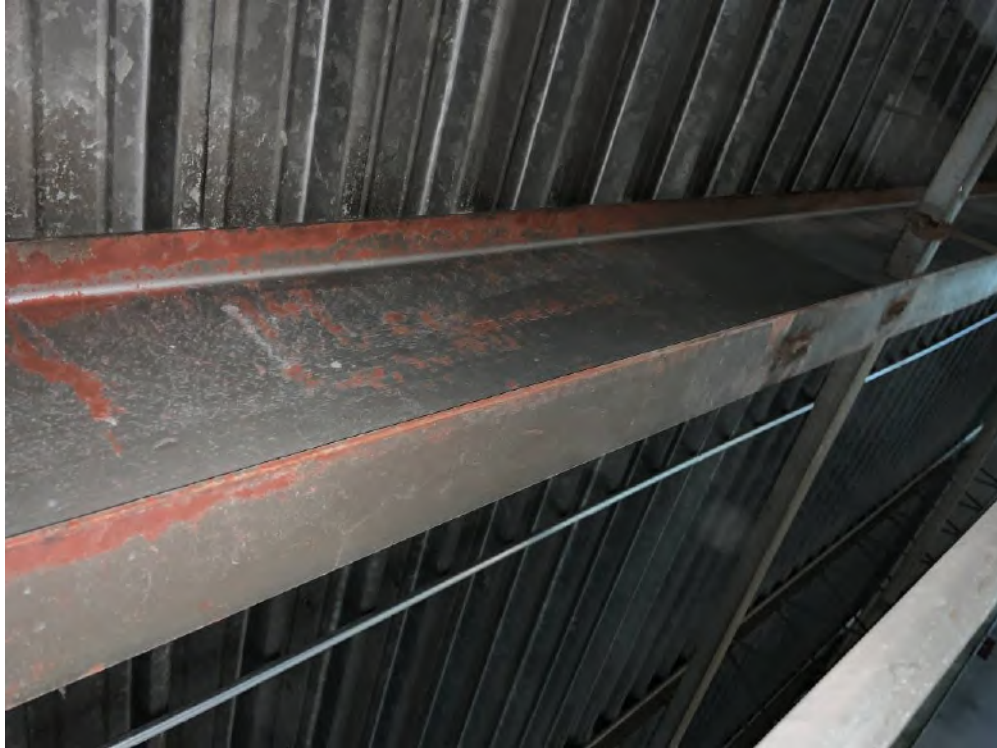
Photo 13: Example of the post abatement view of a metal beam after removal of the lead-containing flaking and loose paint.

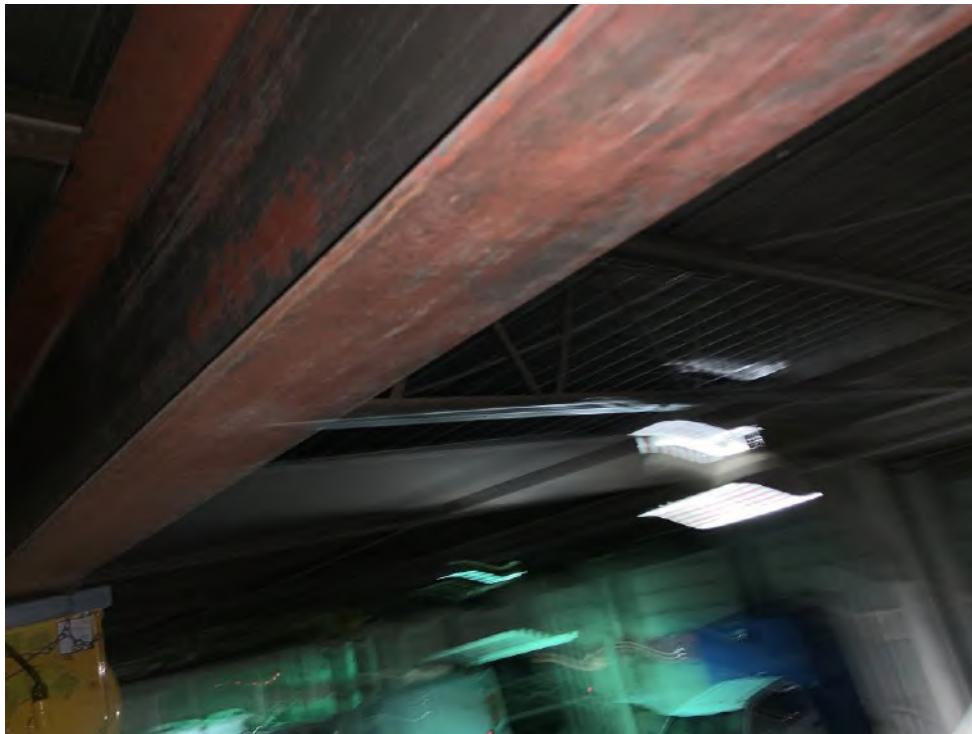
Photo 14: Another post abatement view of a metal beam after removal of the lead-containing flaking and loose paint.

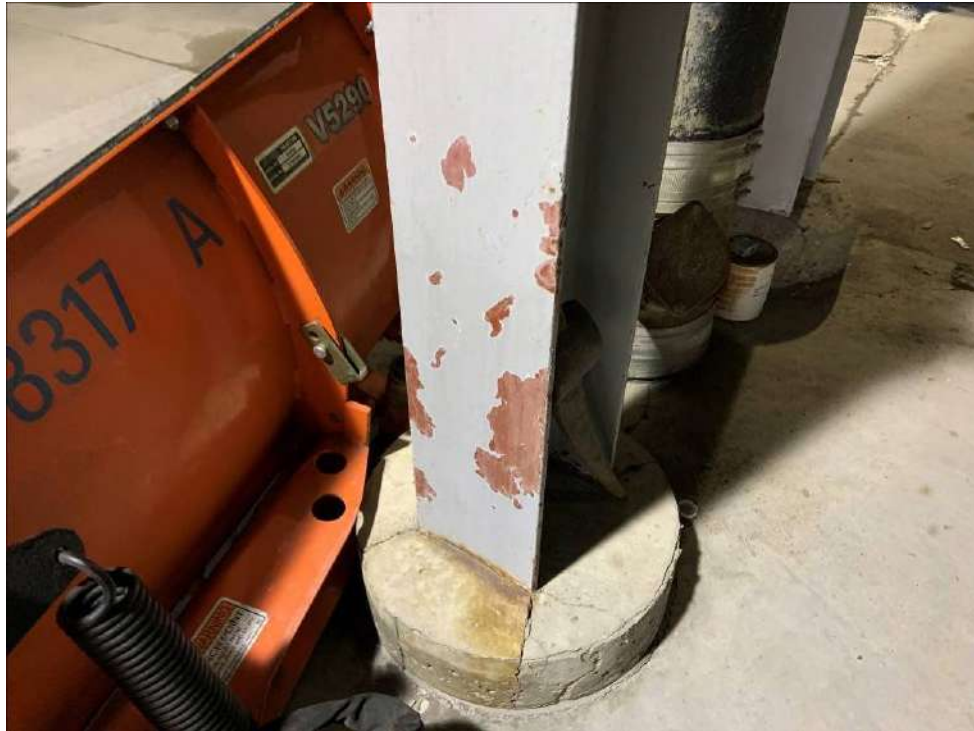
Photo 15: Post abatement view of a metal column after removal of the lead-containing flaking and loose paint.

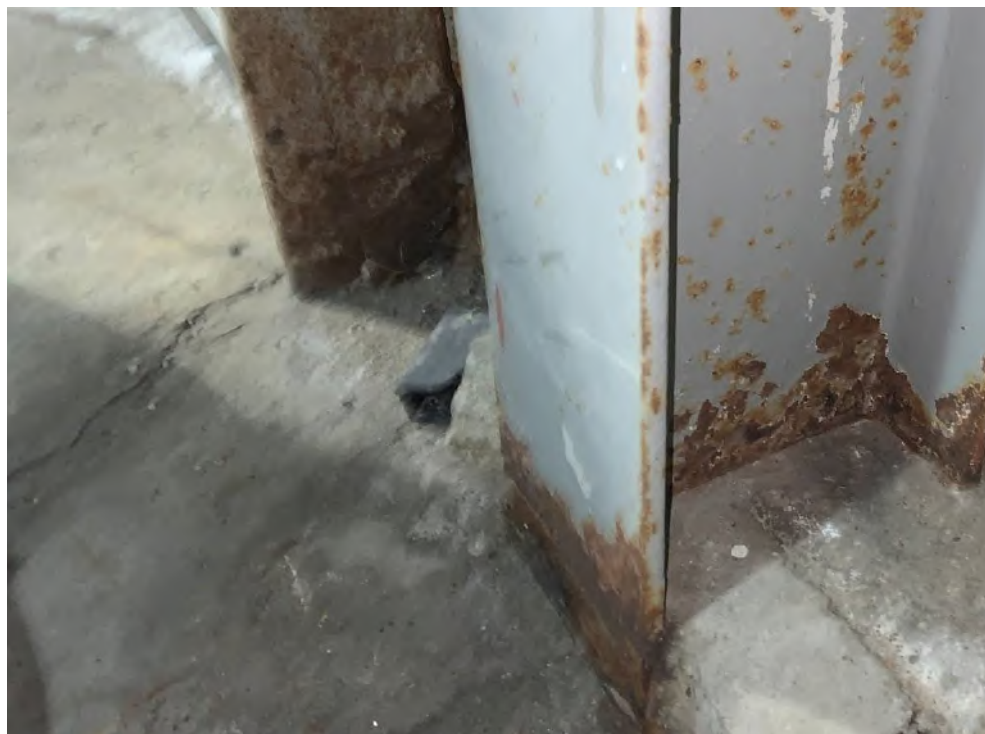
Photo 16: Another post abatement view of a metal column after removal of the lead-containing flaking and loose paint.

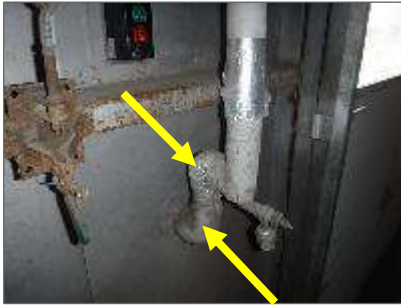
Asbestos-containing parging cement is present on pipe fittings in the following locations and quantities:

Photo 1: Asbestos-containing parging cement on an elbow in the Garage.

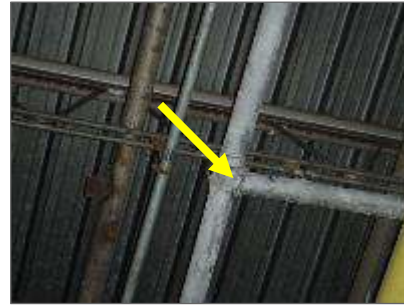
Photo 2: Asbestos-containing parging cement on a tee in the Garage.

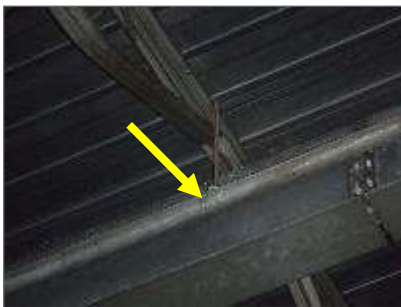
Photo 3: Asbestos-containing parging cement on a hanger in the Garage.

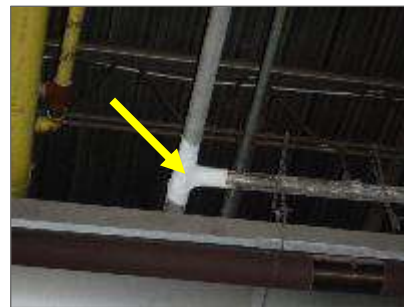
Photo 4: Repaired asbestos-containing parging cement on a tee in the Garage.

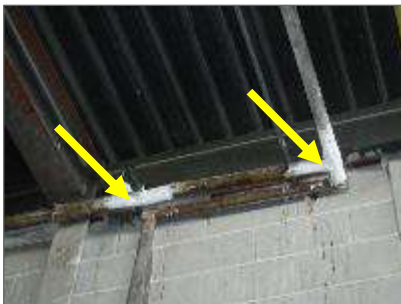
Photo 5: Repaired asbestos-containing parging cement fittings in the Garage.

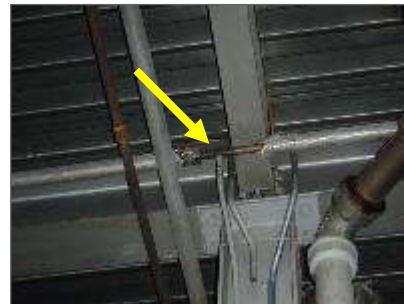
Photo 6: Previously removed fitting in the Garage.

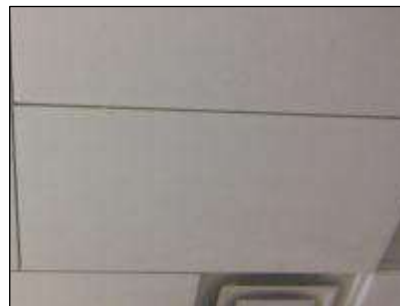
Photo 8: Non-asbestos ACT02 (photographed during 2014 assessment).

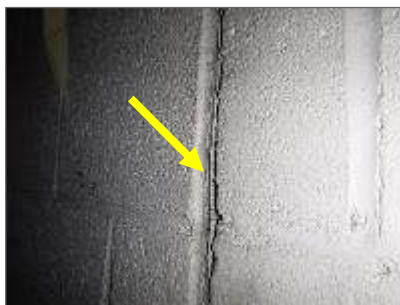
White caulking (Photo 9), containing chrysotile asbestos, is present at expansion joints in the block walls (previous samples 2013-A004A-C), in the 1-27 Garage, 1-28 Garage, 1-29 Garage, 1-30 Garage, 1-31 Garage, 1-32 Garage, 1-33 Garage and 1-34 Garage. Caulking is non-friable and is in good condition.

Photo 9: Asbestos-containing white caulking in Location 1-34 Garage.

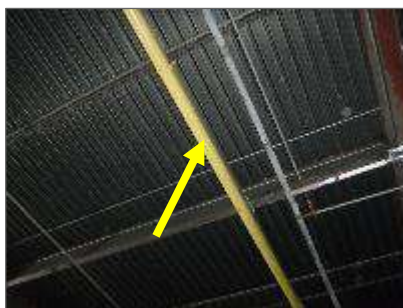
Photo 10: Yellow paint on a pipe in the Garage.

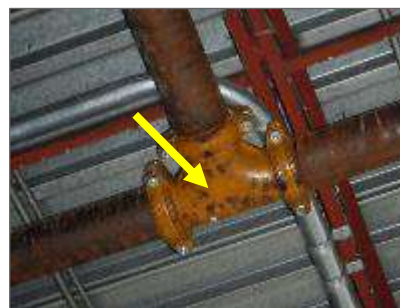
Photo 11: Orange paint in the Garage.

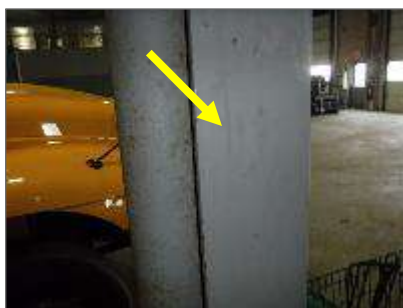
Photo 12: Grey/red paint in the Garage.

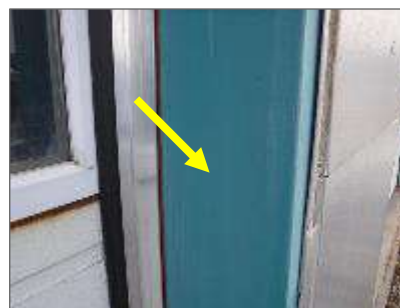
Photo 13: Teal paint on exterior steel.

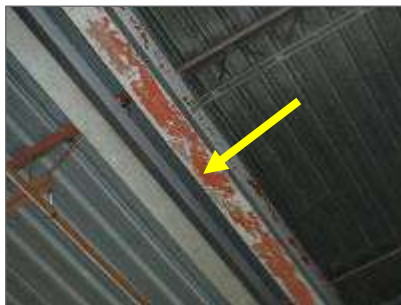
Approximately 850 square feet of grey/red paint (previous sample L009) was flaking/peeling from structural beams in the Garage (Photo 14). Please refer to the Survey Forms in Appendix IV for specific locations, quantities and conditions.

Photo 14: Flaking/peeling grey/red paint on structural beams in the Garage.

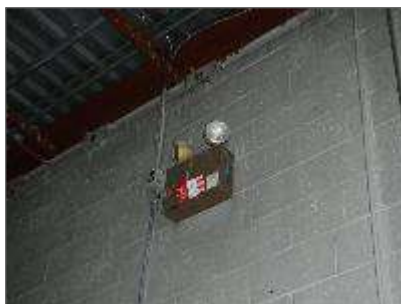
Photo 15: Emergency lighting in the Garage.

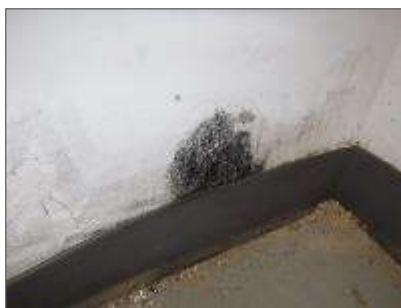
Approximately 2 square feet of visible mould growth and water staining was observed on a drywall wall in the 1-73 Vestibule.

Photo 16: Visible mould growth on drywall in the 1-73 Vestibule.
