Designated Substances Survey

1026 Finch Yard, Building D

DESIGNATED SUBSTANCES SURVEY FOR ACCESSIBILITY UPGRADES (IBI GROUP)

**FINCH YARD, BUILDING D
1026 FINCH AVENUE WEST
TORONTO, ONTARIO**

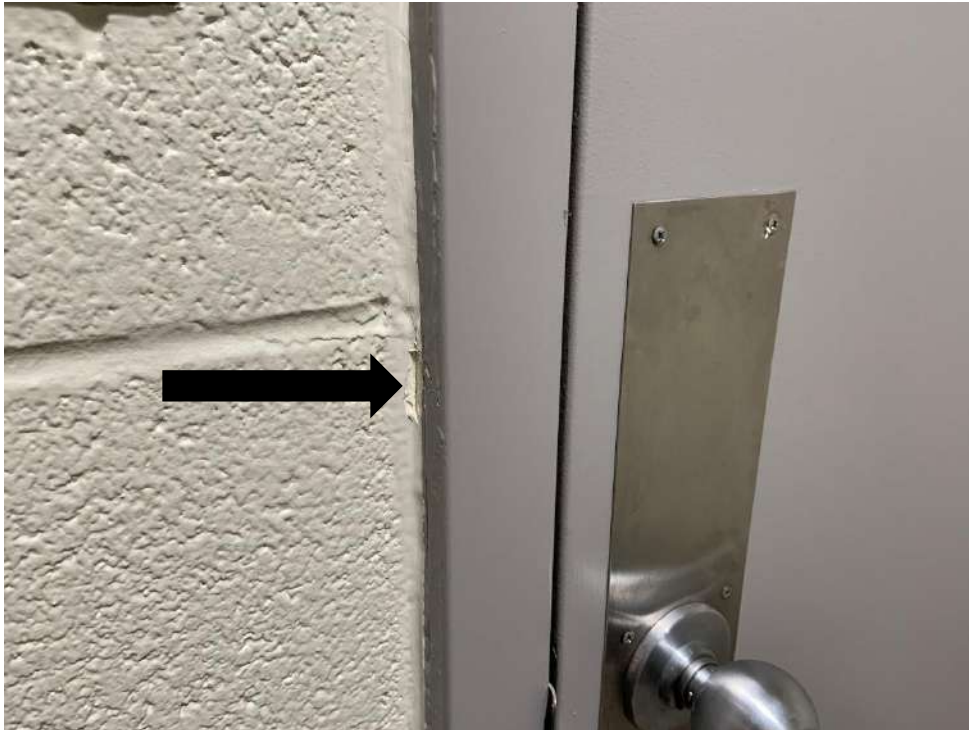
Cream caulking was observed along the joints of the block walls and the door frames at multiple locations. Three (3) samples of the cream caulking were collected for analysis. The results of analysis revealed that the cream caulking contains 0.5-5% Chrysotile asbestos.

Photo 1 – View of the asbestos-containing cream caulking along the joint of a brick wall and a door frame.

- Provide a copy of this report to contractors bidding on or performing work within the subject work areas;
- Remove the asbestos-containing cream caulking along the joints of the block walls and the door frames using Type 1 abatement procedures, as outlined in O. Reg. 278/05.
