Designated Substance and Hazardous Materials Survey

Select Areas of Former Bladen Wing & Academic Resources Building, University of Toronto Scarborough, Toronto, Ontario

Golder Associates Ltd.

August 2021

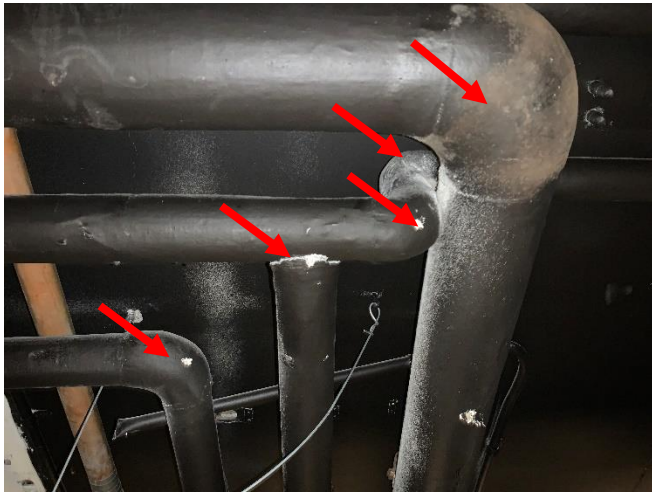
PHOTO 1

Parging cement in good condition is present on pipe fittings (i.e., elbows, tees, valves, and hangers) of various pipe systems within the assessed area. This material was previously identified to contain **chrysotile** asbestos, and was noted at the following locations:

- Approximately 30 fittings throughout the ceiling space (above the lay-in ceiling tiles) in AC290;
- Approximately 8 pipe fittings on radiator lines in AC284A;
- Approximately 8 fittings in the southwest corner of the ceiling space (above the lay-in ceiling tiles) in AC200;

Typical view of asbestos containing parging cement on pipe fittings (see arrows) present in the ceiling space of ARC290.

- Friable parging cement on pipe fittings in the areas observed were noted to be in good condition and can be managed in place. If the parging cement on pipe fittings are to be disturbed during renovation activities, the parging should be removed following Type 2 full enclosure, Type 2 Glove Bag or Type 3 asbestos work procedures as prescribed under O. Reg. 278/05.

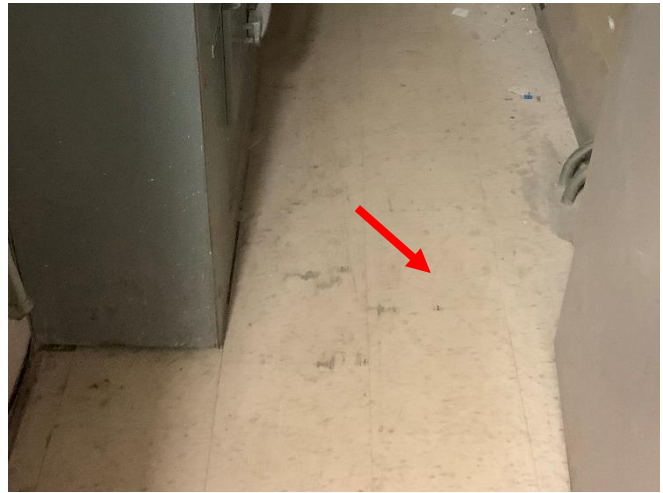
PHOTO 2

View of asbestos containing 12"x12" beige vinyl floor tiles with brown flecks (see arrow) present in AC284A.

- Beige 12"x12" vinyl floor tiles with brown flecks observed in AC284A were noted to be in good condition and can be managed in place. If the floor tiles are to be disturbed during renovation activities, the floor tiles should be removed following Type 1 asbestos work procedures, provided only hand-powered tools and continual misting with amended water are utilized, as prescribed under O. Reg. 278/05.

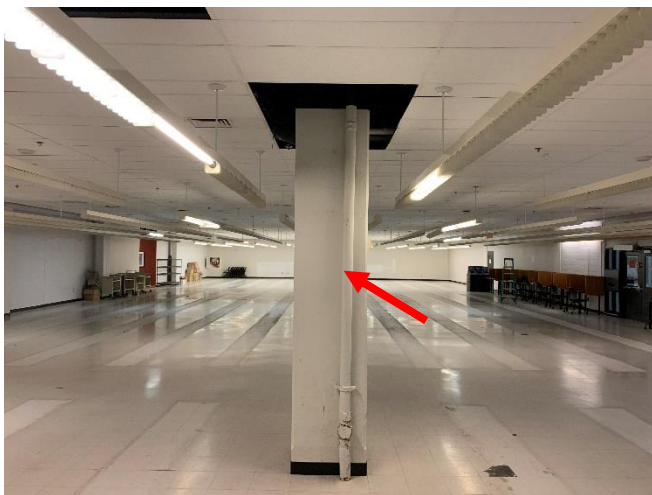
PHOTO 3

- White paint (Sample LS-01) collected from vertical pipes and columns in AC290 was found to contain **0.019% lead** by weight;
- Black paint (Sample LS-07) collected from drywall walls and metal faces on heaters in AC390M was found to contain **0.049% lead** by weight

View of lead containing white paint (see arrow) present on vertical pipes, columns and walls in AC290.

The potential for worker exposure to lead dust and fumes is dependent on how the materials are to be disturbed. The Ministry of Labour (MOL) Guideline - Lead on Construction Projects (updated April 2011) should be consulted prior to completing any lead disturbance with the objective of evaluating the need for health and safety precautions such as engineering controls, safe work and hygiene practices, personal protective equipment, and training.

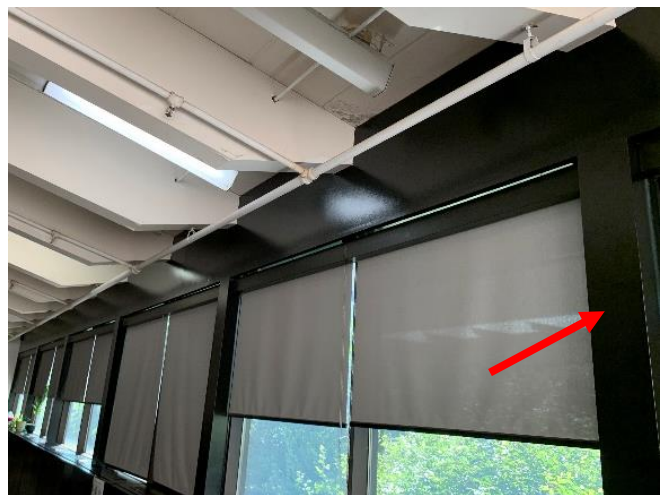
PHOTO 4

- Joint compound (Samples DJC-05a to c) associated with perimeter drywall wall finishes enclosing the windows in AC390A, AC390B, and AC390M was identified to contain **chrysotile asbestos**. As such, all drywall finishes in these areas should be considered to have asbestos containing joint compound. All finishes present in these areas were in good condition; and
- 12"x12" beige vinyl floor tiles with brown flecks (Samples VFT-01a) present in AC284A was identified to contain **chrysotile** asbestos. Approximately 60 ft² of the asbestos containing vinyl floor tile was observed to be in good condition. Mastic beneath this style of vinyl floor tile is non-asbestos (VFT-01A-C).

View of both the lead containing black paint and drywall finishes (see arrow) with associated asbestos containing joint compound present in AC390M.

- Joint compound associated with drywall perimeter wall finishes enclosing windows in AC390(A, B, and M) were observed to be in good condition and can be managed in place. If the drywall finishes in this area are to be disturbed during renovation activities, the drywall finishes should be removed prior to renovation disturbance following Type 2 asbestos work procedures as prescribed under O. Reg. 278/05.

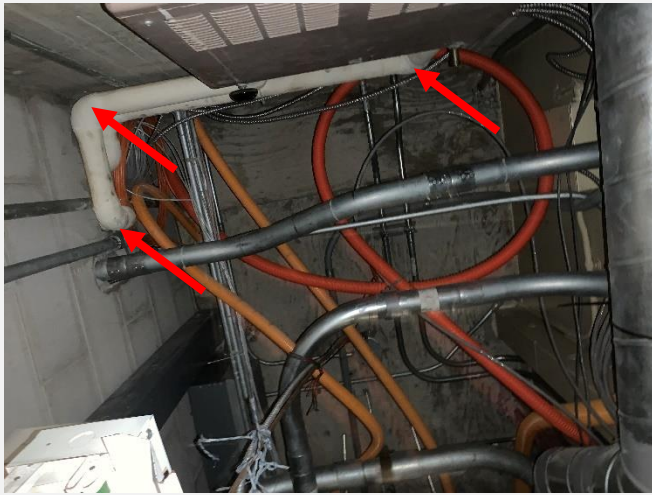
PHOTO 5

View of parging cement on pipe fittings (see arrows) present in AC284A.

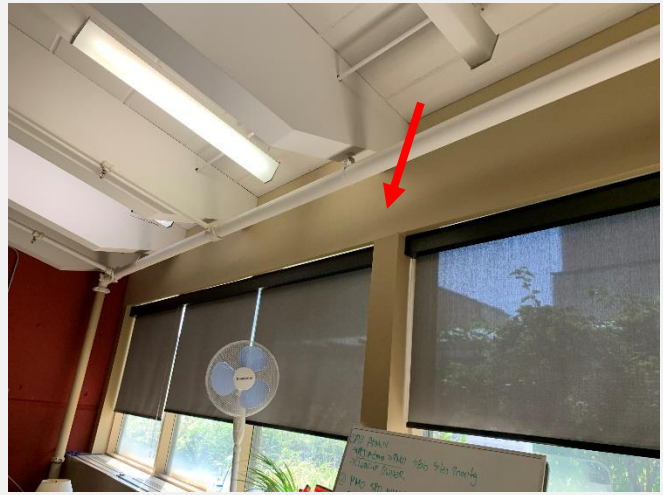
PHOTO 6

View of the drywall finishes (see arrow) with associated asbestos containing joint compound present in AC390B.

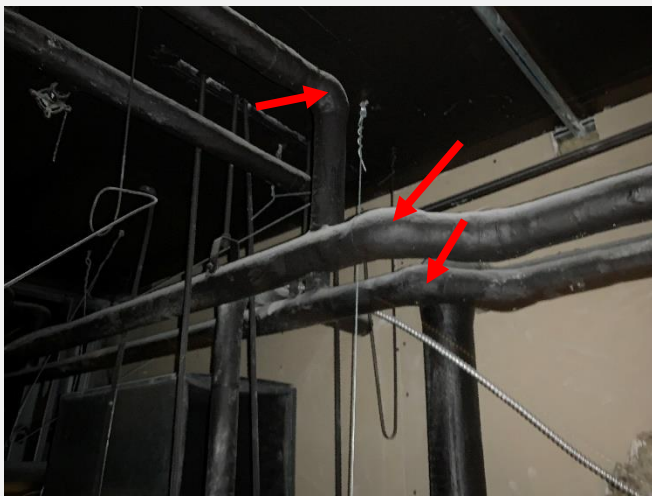
PHOTO 7

Typical view of asbestos containing parging cement on pipe fittings (see arrows) present above the lay-in ceiling tiles in AC205

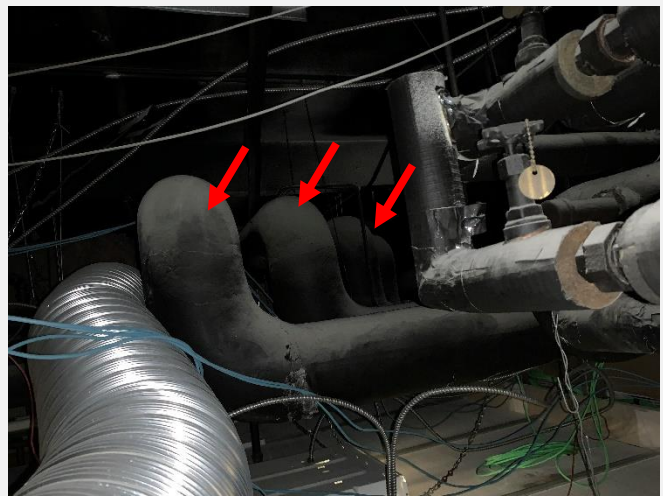
PHOTO 8

Typical view of asbestos containing parging cement on pipe fittings (see arrows) present above the lay-in ceiling tiles in AC205A
