ARBORIST REPORT

VAUGHAN FIRE STATION 7-12 9541 WESTON ROAD

MARCH 2022

LGL FILE TA9196

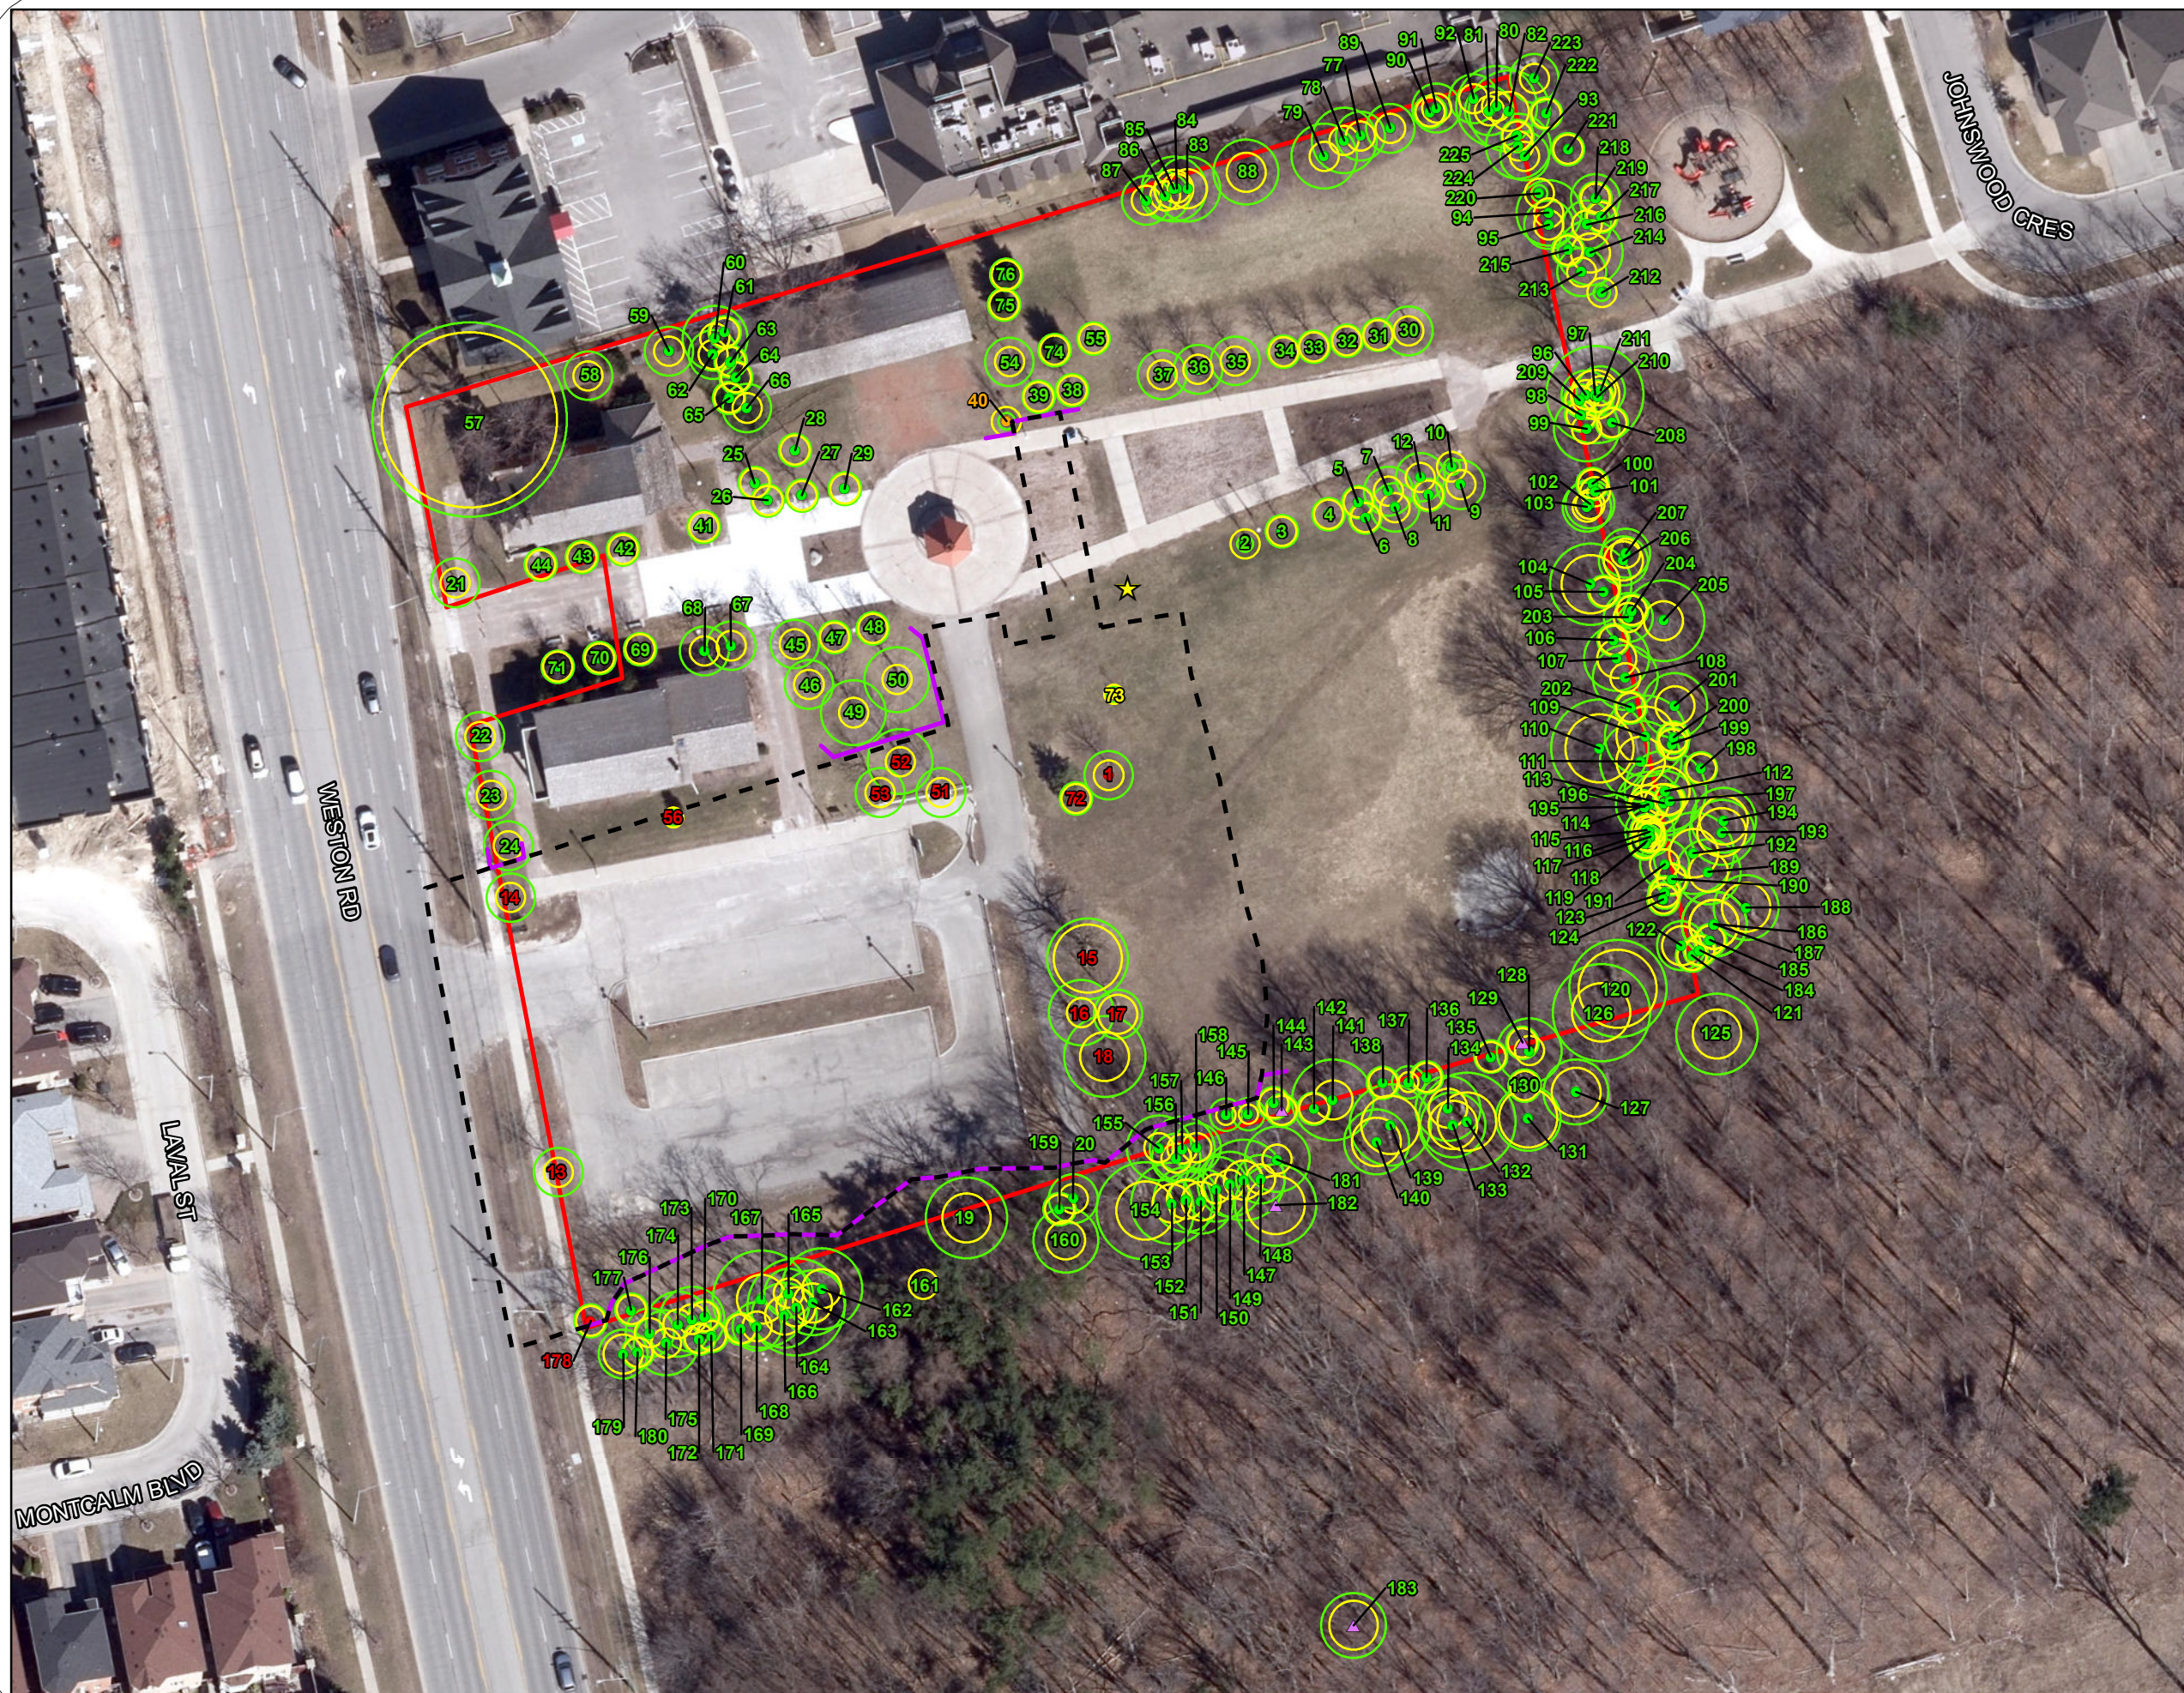
9541 Weston Road
TREE RESOURCES

A total of 225 trees were identified and assessed during the tree inventory. Trees within the study area range in size from 1 to 180 cm DBH and range from good to poor condition. Trees surveyed include planted amenity trees within the subject property, and naturally occurring trees bordering the property. A detailed summary of all trees surveyed are presented in the **Appendix A Tree Inventory** and the locations of each tree (by identifier number) are presented in **Figure 2**.

Kentucky coffee tree is regulated as Threatened under the *Ontario Endangered Species Act*, 2007 and was noted within the property. Three (3) Kentucky coffee trees were planted as amenity trees (LGL Tree #28, 54, 55). Ministry of Natural Resources and Forestry (MNR) has advised that amenity and streetscape Kentucky coffee trees are not regulated under the *Endangered Species Act*, 2007, due to their non-native origin.

Four (4) butternut (*Juglans cinerea*) were identified within and adjacent to the study area (LGL Tree #129, 143, 182, 183). Butternut is regulated as Endangered under the *Ontario Endangered Species Act*, 2007. The butternut trees were identified on the southern edge of the property and within the adjacent Vellore Tract Woodlot. In general, all butternut trees had signs of canker (sooty marks and open wounds) and evidence of crown dieback. One butternut tree (LGL Tree #143) was determined to be dead. Butternut locations are depicted in **Figure 2**. Consultation with the MNR should be undertaken given that works are proposed to occur within the 50 m butternut habitat protection zone and a Butternut Health Assessment will be required during the growing season.

A memorial tree was identified on the subject property (LGL Tree #73). The tree is a small pear tree (*Pyrus sp.*) with a diameter of 5 cm. Since the proposed development will impact this tree, it is recommended that it be relocated to another suitable location within the property, outside of the limits of disturbance. A proposed relocation site has

been included in **Figure 2**. It is recommended that the City of Vaughan Parks, Forestry and Horticulture Operations department be consulted before relocation.

As noted in **Section 4.0**, trees identified for removal includes trees within the proposed disturbance limits and those trees outside of the disturbance limits where the amount of critical root zone that will be removed will likely cause significant and irreversible decline of the health of the tree. As such, a total 13 trees have been identified for removal as a result of the proposed development. Of the 13 trees to be removed, 10 trees measure 20 cm DBH and greater. Trees identified for removal are listed in **Appendix A** and presented in **Figure 2**.

Impacted trees are those that are identified for retention, but encroachment into the minimum tree protection zone (TPZ) will occur. A total of 1 tree has been identified as impacted as a result of the proposed works. Trees identified as injured and the reason for the injury are listed in **Appendix A** and are presented in **Figure 2**.

A total of 211 trees have been identified for retention and listed in **Appendix A** and presented in **Figure 2**.

- Tree protection fencing must be installed as per the approved Tree Preservation Plan. The contract administrator must review and approve the fencing prior to the commencement of any grading work and the fencing will be maintained until all construction is complete;

- Tree protection fencing must be installed in accordance with York Region specifications and as per the locations outline on **Figure 2**;
- Heavy machinery should not to be operated within the TPZ (including overhead swinging of machine arms);
