September 9th, 2024

Our File: T245720

RE: Ground Penetrating Radar investigation at Toronto Western Hospital, 339 Bathurst St. in Toronto, Ontario

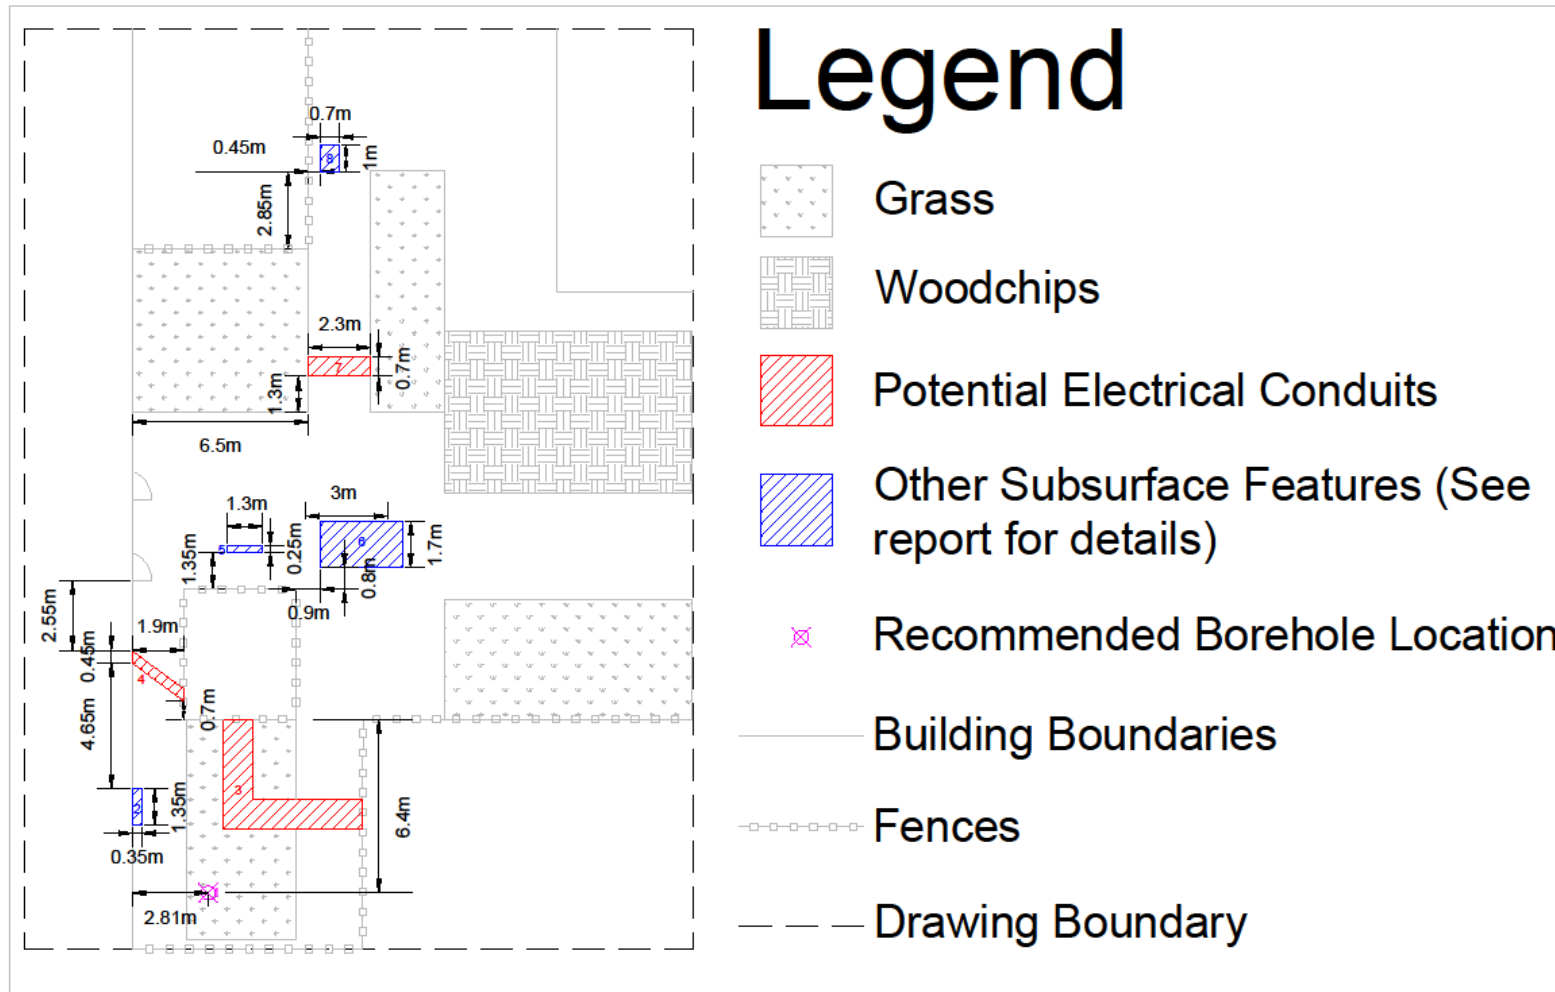
Figure 2: Drawing showing the locations of anomalies/ROIs relative to the surrounding buildings and fences

The area contained eight (8) regions of interest (ROIs). Each one is numbered and displayed within the attached drawing as shown in Figure 2. Based upon the image provided by the client (Figure 11), it does not appear that the anomalies overlap with the proposed borehole locations.

The client requested that a new borehole location be proposed in place of the southernmost borehole location that cannot be accessed due to construction activities on the property. This location is **ROI 1** and has been marked in the attached drawing with a magenta X, surrounded by a circle and on-site with a yellow X, surrounded by a circle. Access to this location is limited due to a large transformer/power installation surrounded by a chain link fence acting as an obstruction. See Figure 10 for a reference photo. The next best location within the proposed survey area/addition footprint is very close to where a borehole has already been proposed, so it was not marked.

ROI 3 was found to be a large power conduit under what appeared to be a removable concrete cover. This was confirmed to contain power with the RD7100. Sample images were not taken nor was this marked on-site due to its conspicuousness on-surface. However, it has been marked in the attached drawing in red for reference when on-site. It is recommended not to drill in this location.

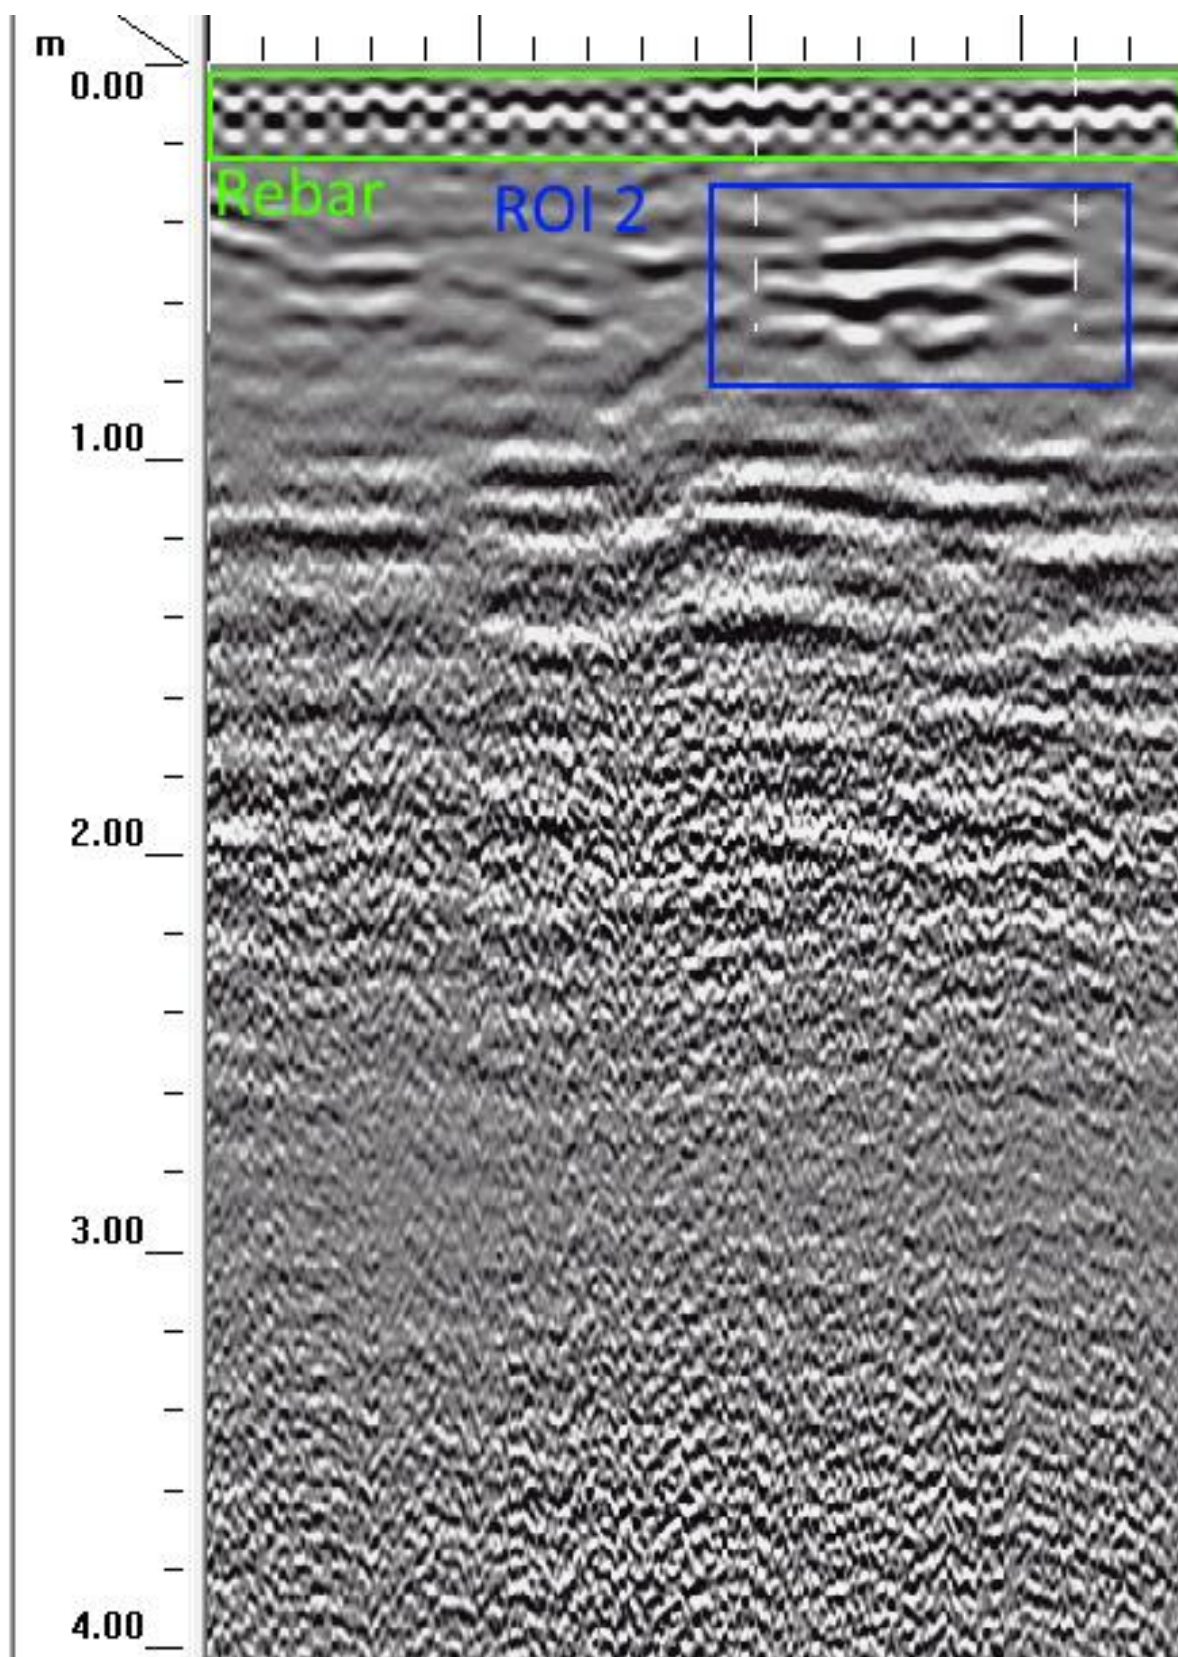
ROI 2 was found in the southwest of the survey area and was characterized by a flat, moderate strength reflector with hyperbolic ‘tails’ on each of its ends (Figure 4). It was found at a depth of ~0.52m. This indicates a non-metallic, buried object but its nature could not be determined in more detail based upon the surrounding features so it has been marked in blue. It is recommended not to drill in this location.

Figure 4: ROI 2(blue) beneath rebar near-surface (green)

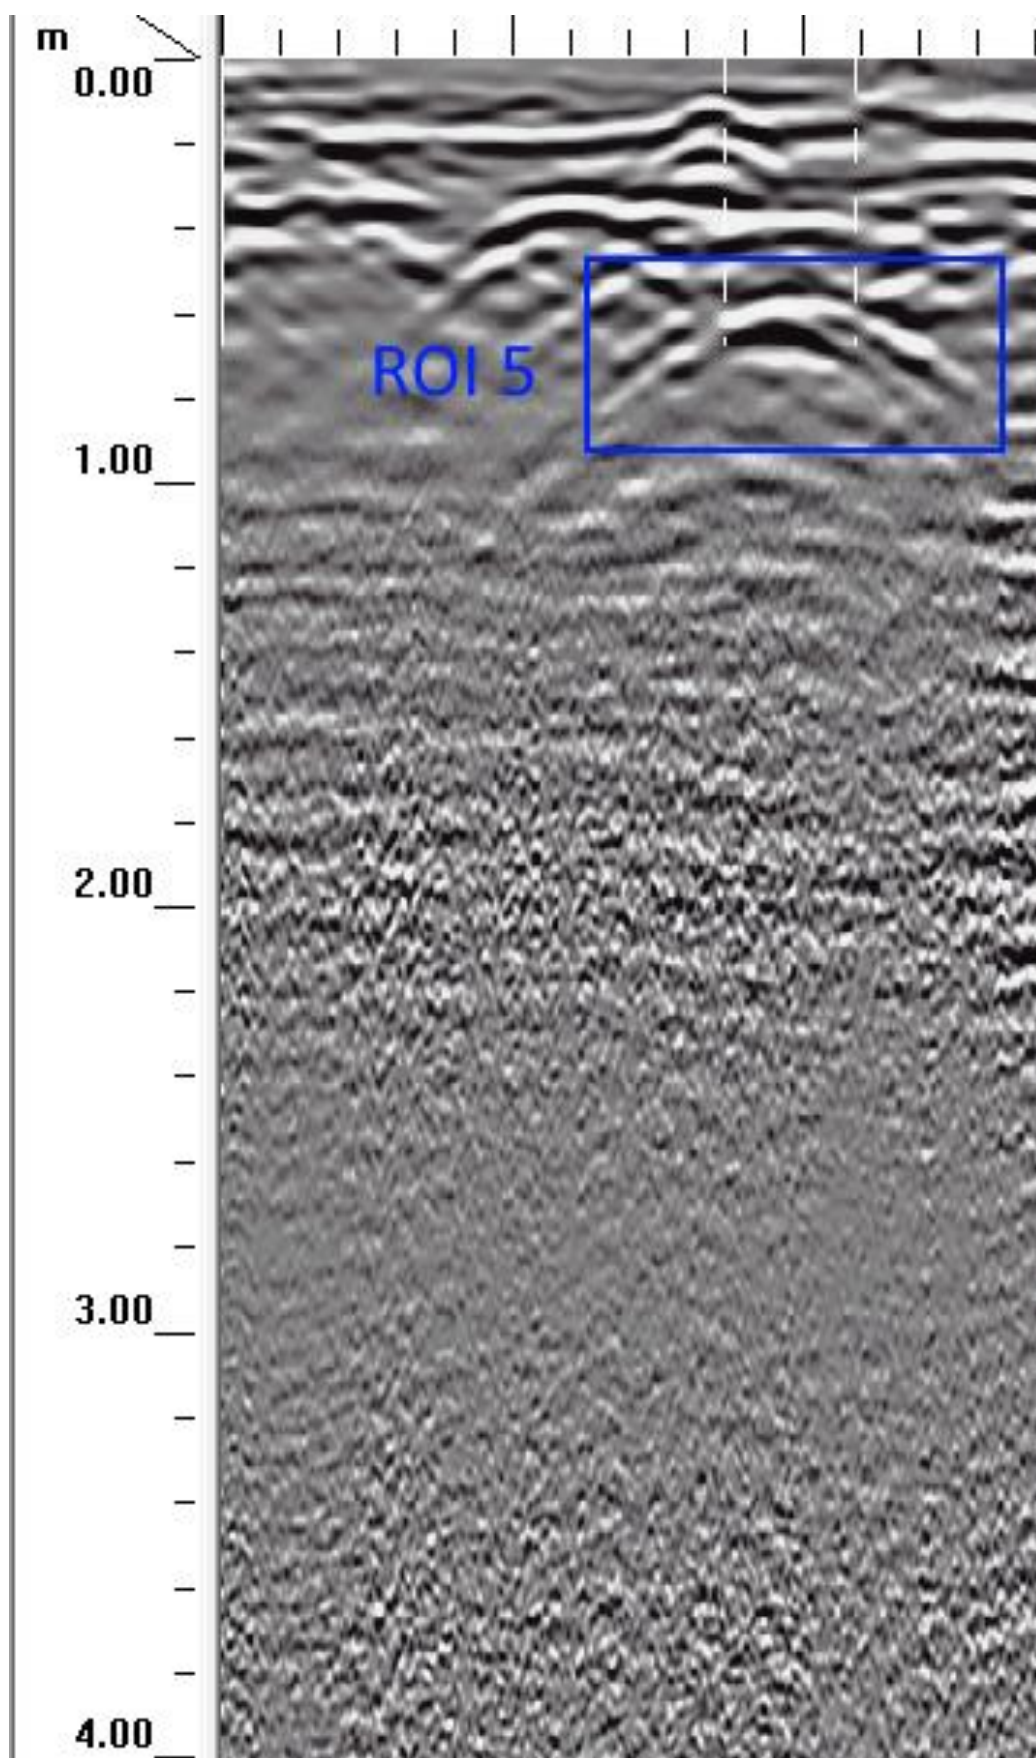
ROI 5 was characterized by a moderate strength, hyperbolic reflection at a depth of $\sim 0.61\text{m}$ (Figure 6). This indicates a non-metallic, buried object but its nature could not be determined in more detail based upon the surrounding features so it has been marked in blue. It is recommended not to drill in this location.

Figure 6: ROI 5 (blue)

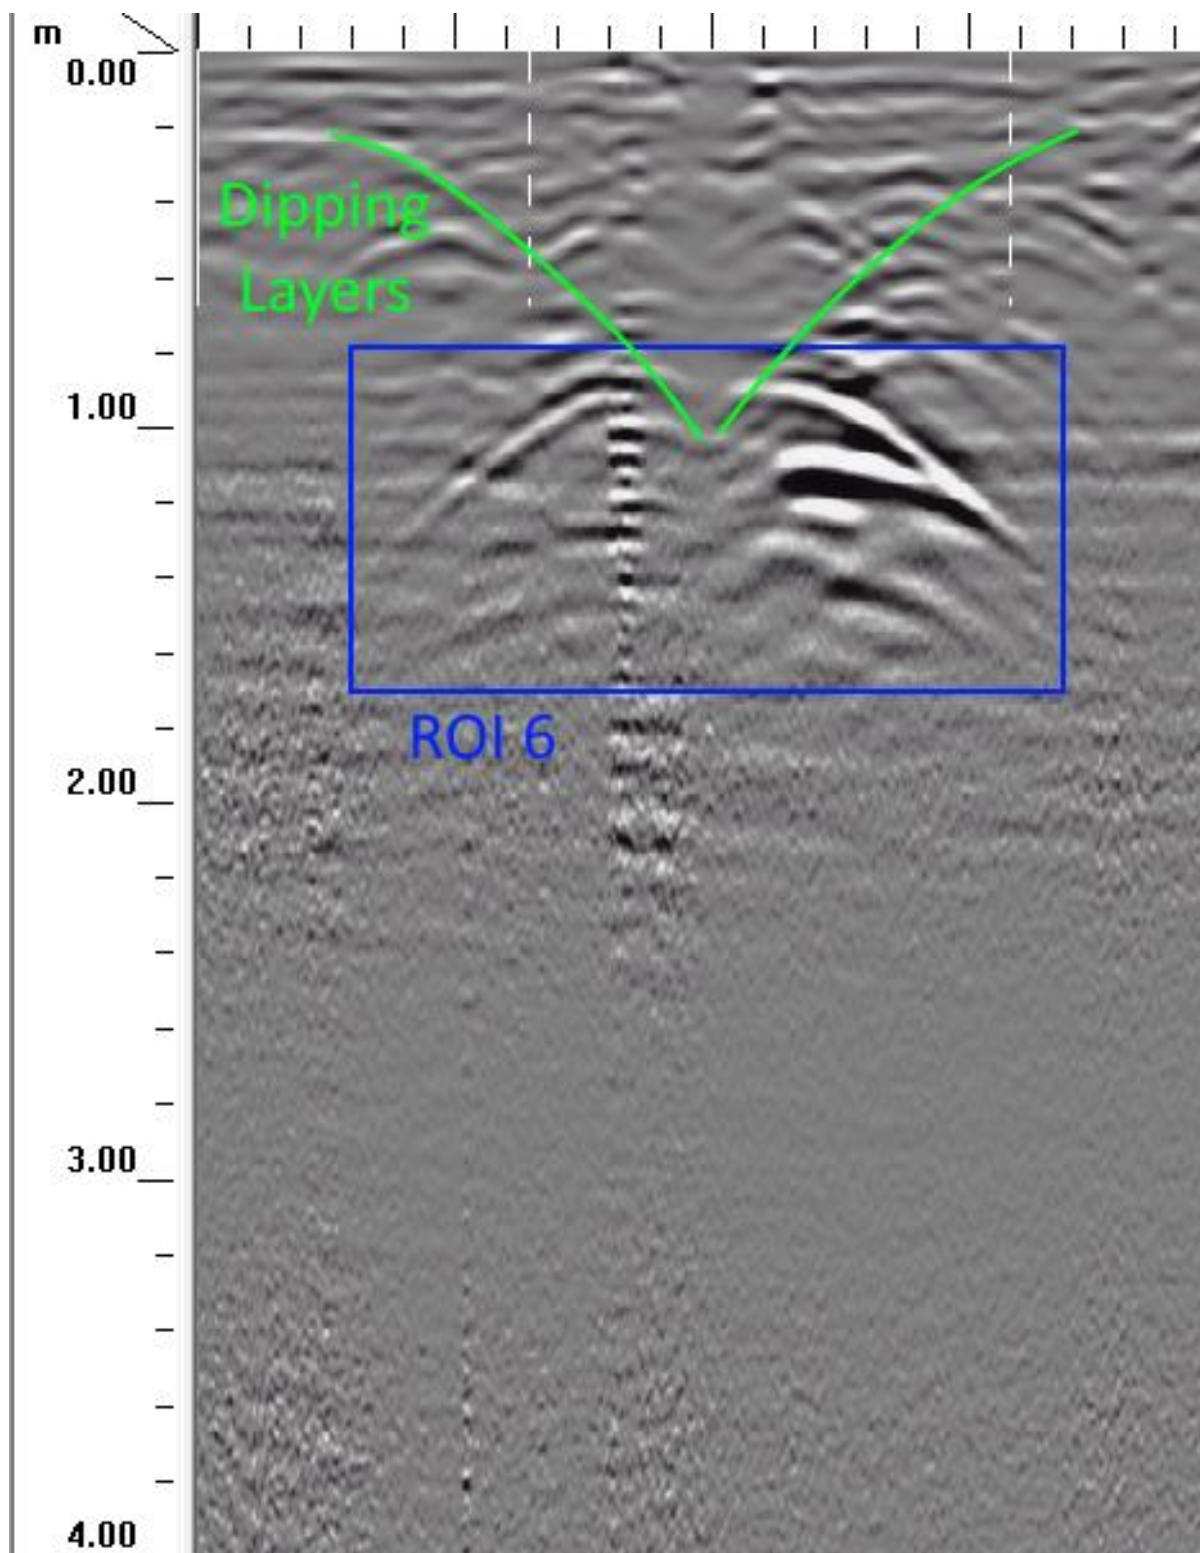
ROI 6 was characterized by a large, flat and strong reflector with hyperbolic tails on each side at a depth of $\sim 0.92\text{m}$ (Figure 7). There also appeared to be an area of previous excavation above the reflector, characterized by a change in texture of the soils and dipping soil layers. This indicates a potential metal pipe or UST. It is strongly recommended not to drill in this location nor in the immediately surrounding area.

Figure 7: ROI 6 (blue) with dipping soil layers indicating previous excavation (green)

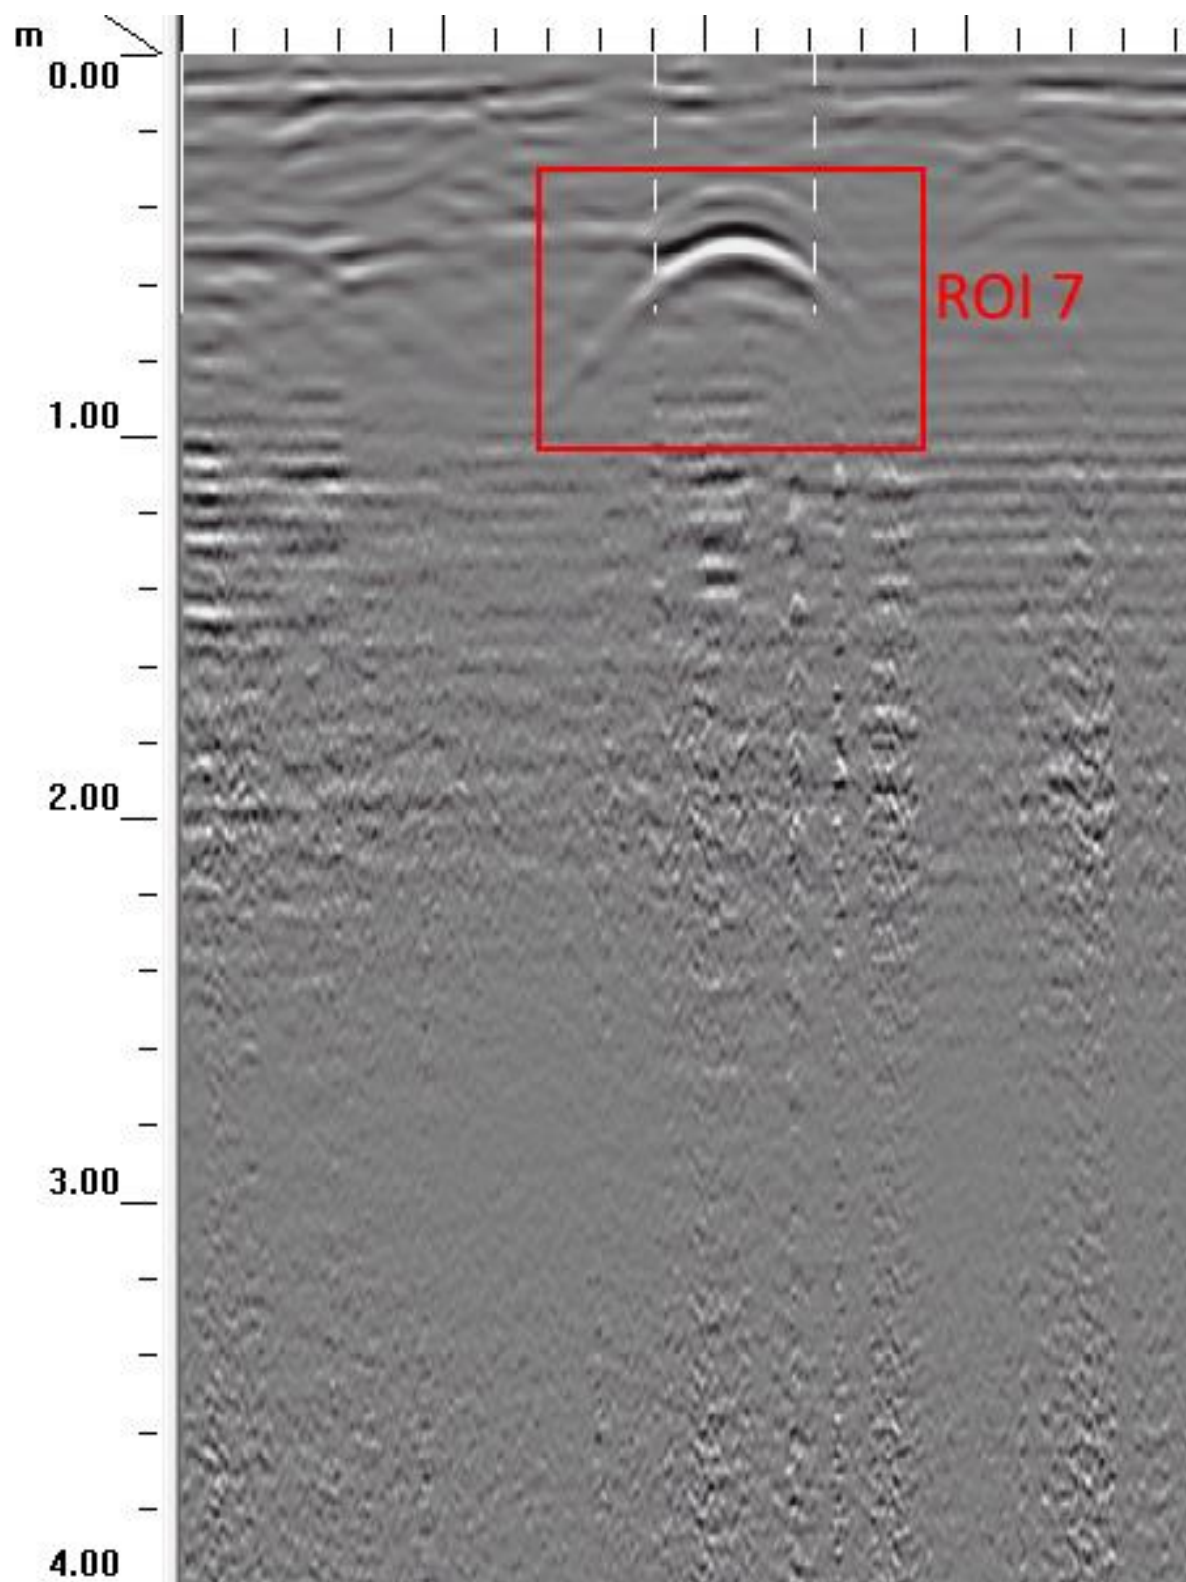
Figure 8: ROI 7

ROI 7 was characterized by a strong, hyperbolic reflection and continued linearly between two sections of grass at a depth of $\sim 0.50\text{m}$ (Figure 8). This indicates a metal, buried linear object, pipe or potential power conduit. Results from the RD7100 were inconclusive. However, for the sake of caution, it has been marked in red. It was not possible to track this anomaly below the grass. This is likely due to inhomogeneity within the soil beneath the grass obscuring the visibility of the object within many hyperbolic reflections from rocks. Concrete is much more homogenous and provides a clearer image. It is recommended not to drill in this location, nor in surrounding locations where a pipe could exist if the anomalous area were extended in its apparent direction across the grass areas.

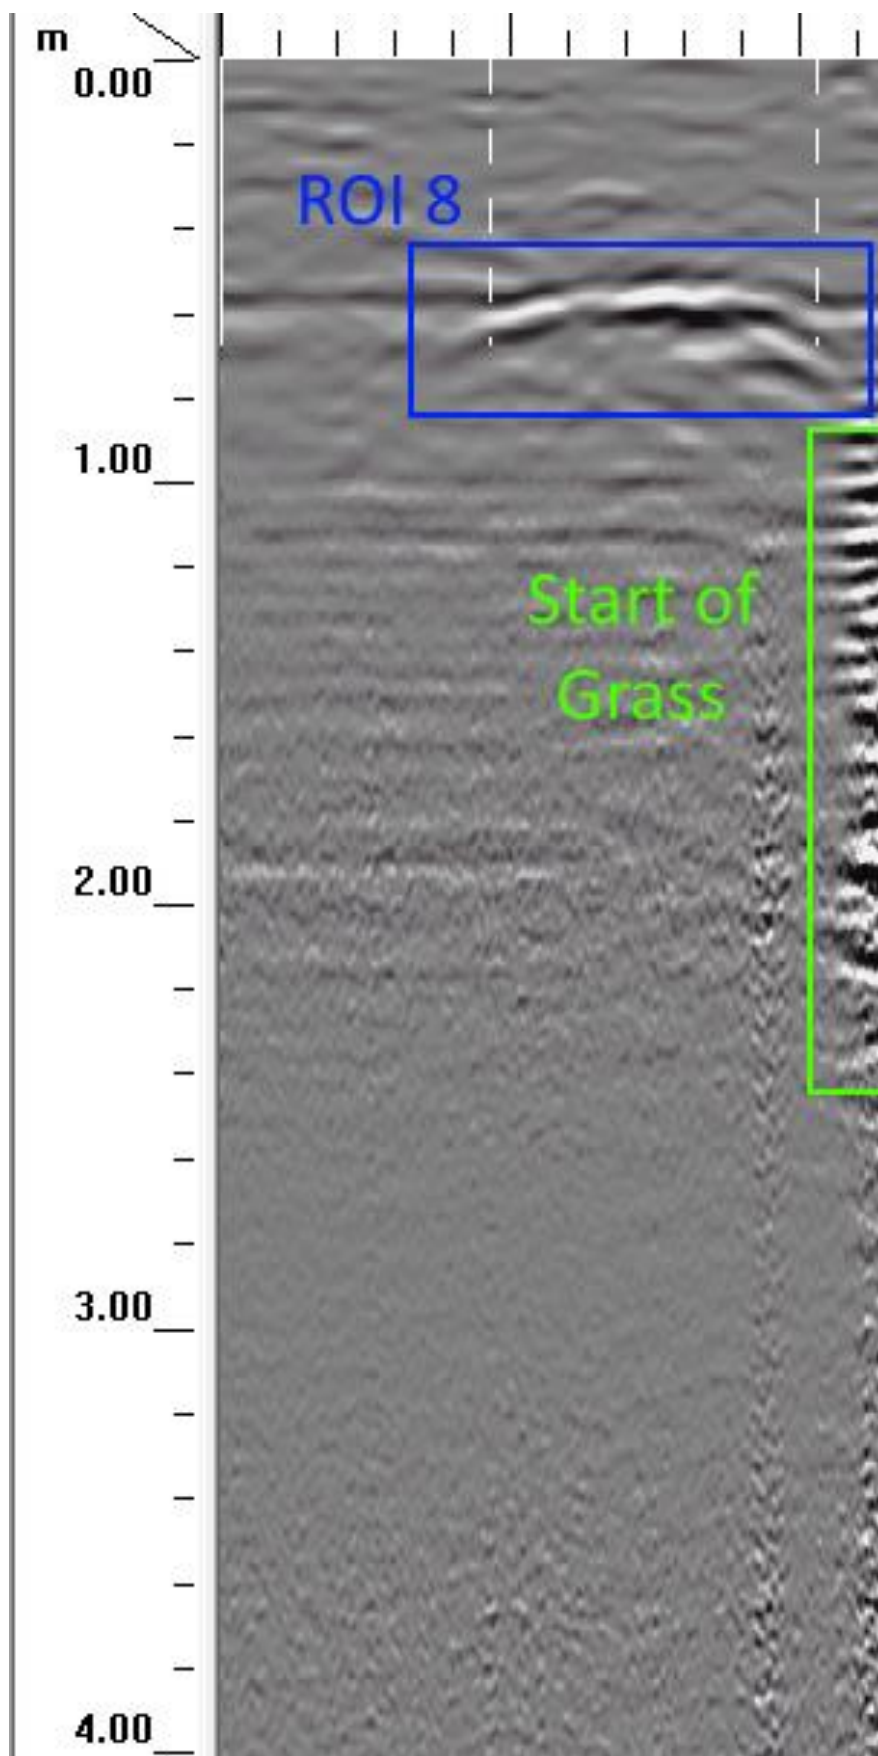
ROI 8 was characterized by a moderate strength, flat reflector at a depth of $\sim 0.56\text{m}$ (Figure 9). This indicates a buried, non-metallic object. Its proximity to an air conditioning unit indicates it may be related infrastructure but further details of its nature could not be determined. So, it has been marked in blue. It is recommended not to drill in this location.

Figure 9: ROI 8 (blue) and high gains at grass/concrete boundary (green)

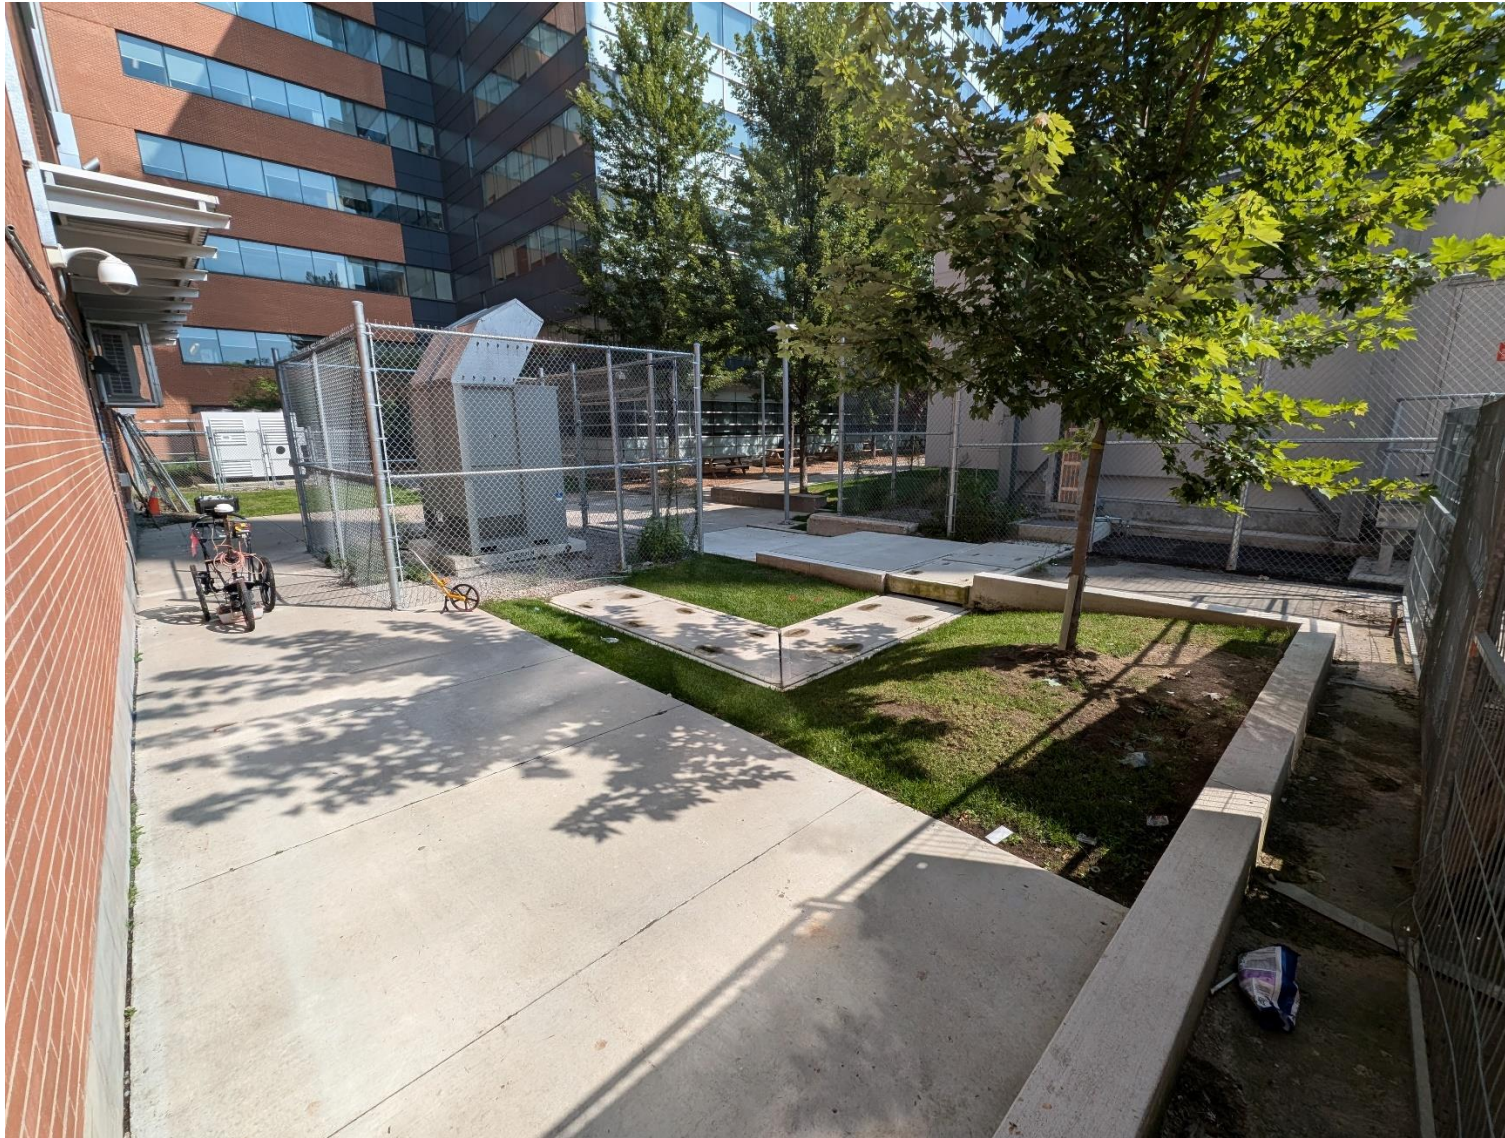
Geophysics GPR International Inc. (GPR) was requested to perform a ground penetrating radar (georadar) survey at Toronto Western Hospital, 339 Bathurst St. in Toronto. The purpose of the investigation was to identify any obstructions or facilities prior to drilling activities. It was also requested to relocate a potential borehole as this southernmost proposed borehole was inaccessible with construction activities occurring on the property.

Figure 10: Photo showing restricted access to borehole location (next to nearest tree) with radar cart (left)
