Curtain Wall Assessment

Curtain Wall Assessment at University Health Network
SEM Centre – Ground Floor
399 Bathurst Street, Toronto, ON

BRM-21013311-C0

July 17, 2024

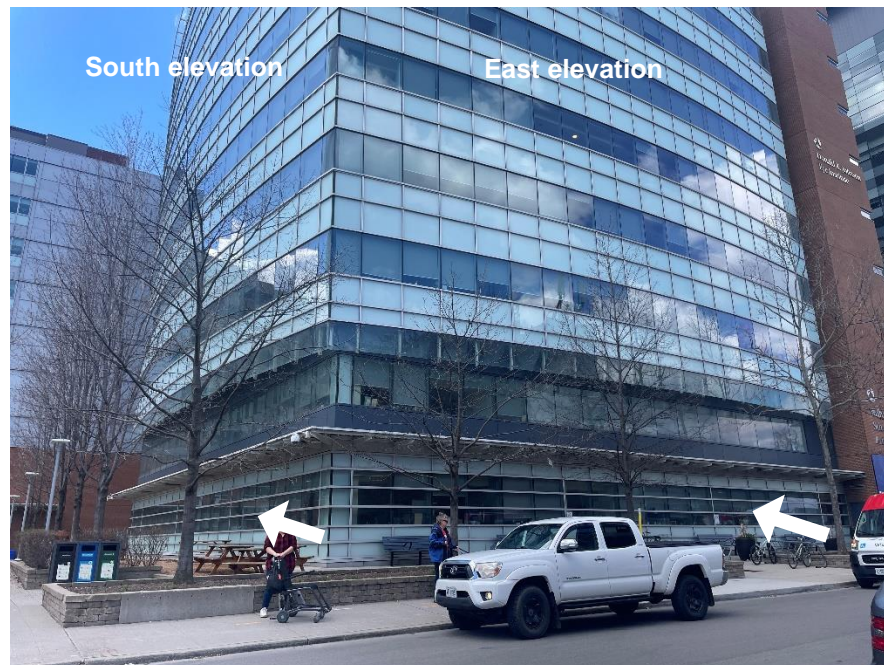
Figure 1: SEM centre – ground floor, south and east elevations (white arrows)

Cumulus Architects is designing renovations at TWH, and the current ground floor offices will be replaced with exam rooms for the new Seniors Emergency Medicine (SEM) department. The SEM centre is located along the south and east elevations (see Figure 1 and Photograph No. 1).

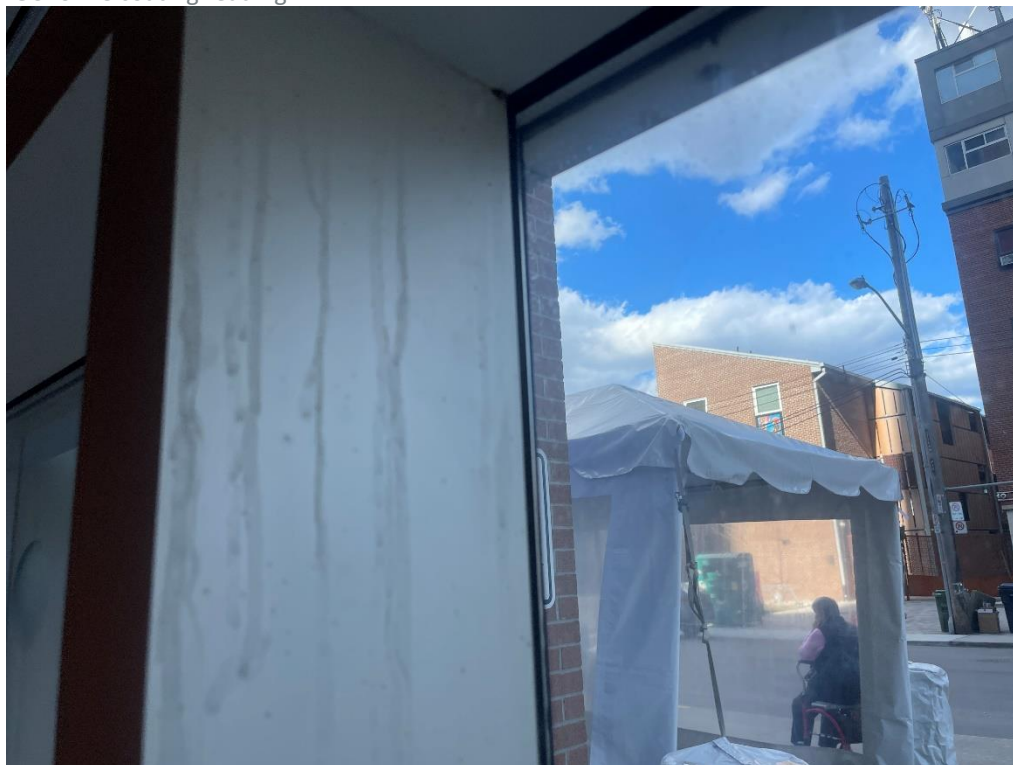
Photograph No. 8

1. Typically, on the interior side of the curtain wall, water stains were observed on the mullions (Photograph No. 8).
2. Typically, evidence of moisture collection via towels was observed at some of the offices which were accessed (Photograph Nos. 9, 10).
3. Interior glazing gaskets were flattened and weathered due to age (Photograph Nos. 11, 12).

The water stains on the interior framing, and the towels located on the framing, indicate potential water penetration, and water testing results are discussed below.. The interior relative humidity measured during the thermography scans was typically at approximately 23%.

Typical water staining.

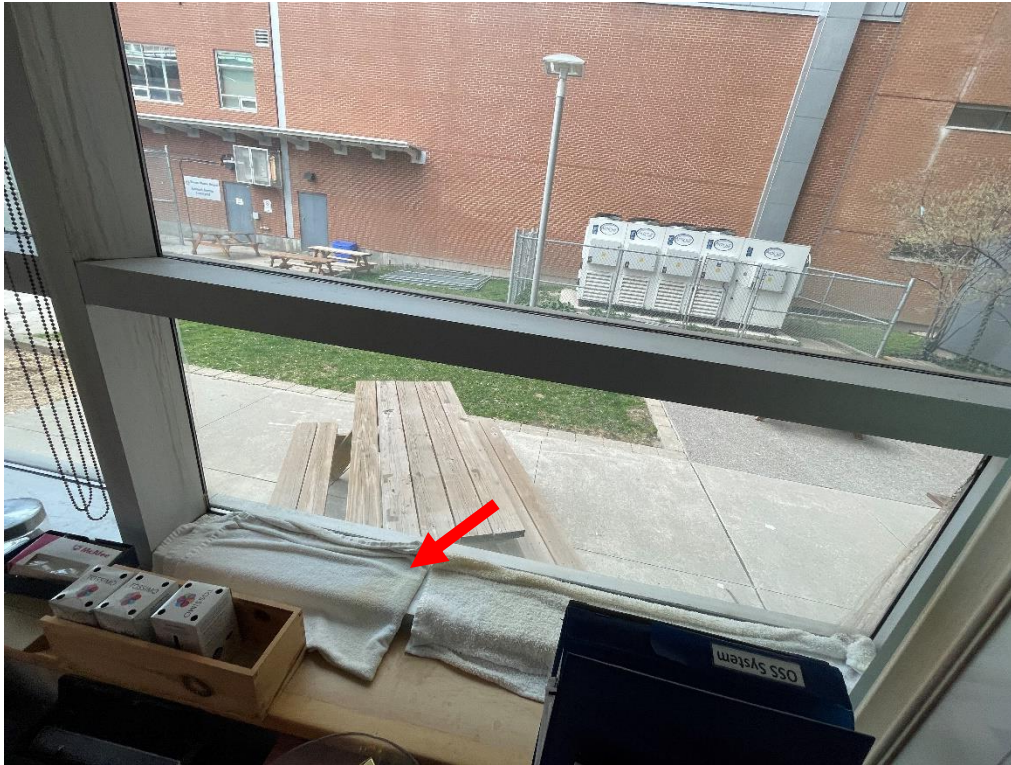
Photograph No. 9

Towels placed by occupant to absorb water.

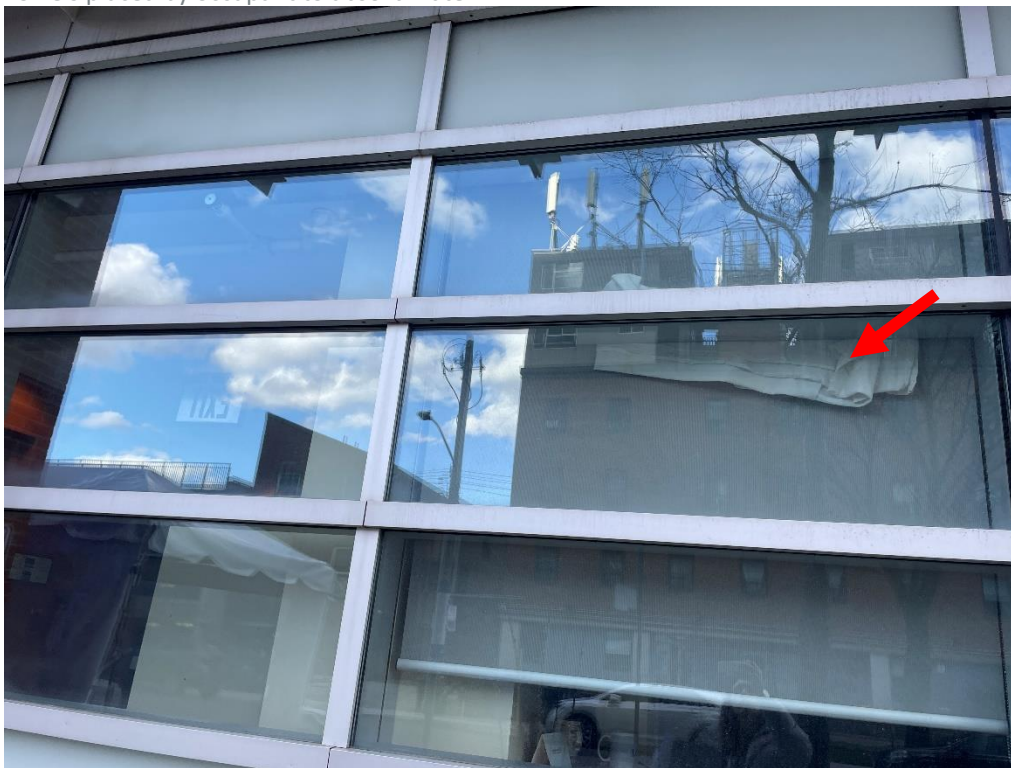
Photograph No. 10

Towel placed by occupant to absorb water.

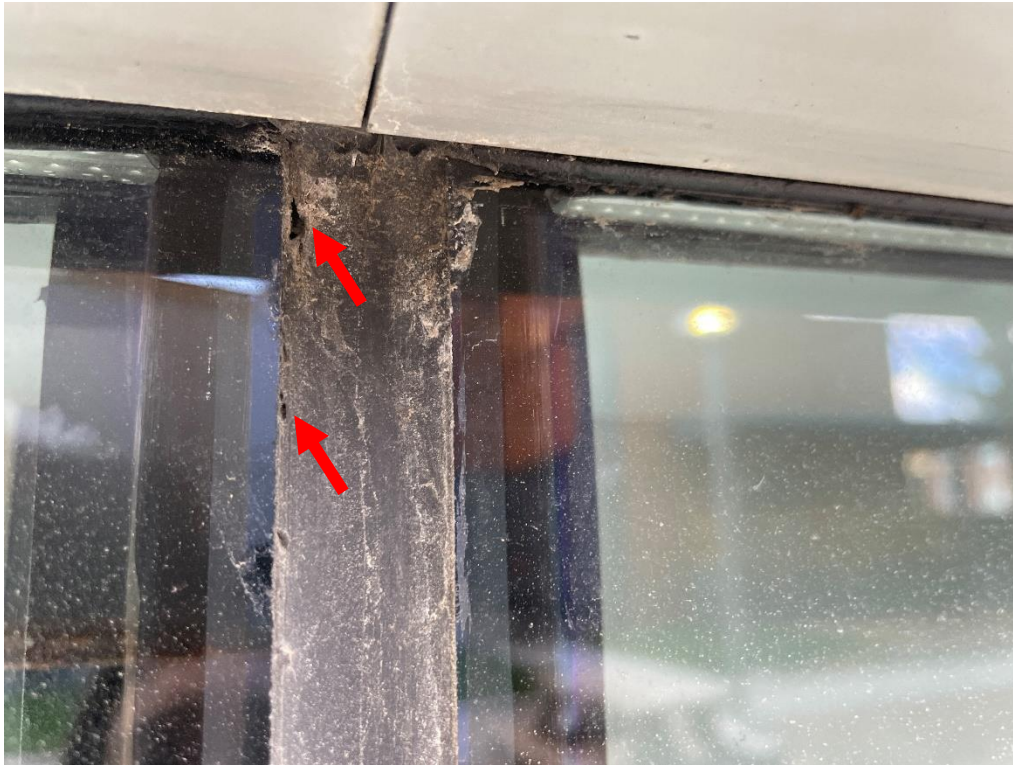
4. Some deterioration of exterior weather sealant joint was observed. The sealant was split along the bond line to the glass edge (Photograph No. 11).
5. The spacer bar was visible at some points where the sealant was discontinuous (Photograph No. 12).

The sealant at the vertical joints of the IGUs was split at some locations, which is likely due to aging and weathering of the material. The sealant should be replaced to prolong the life of the curtain wall system.

Photograph No. 11
Discontinuous sealant

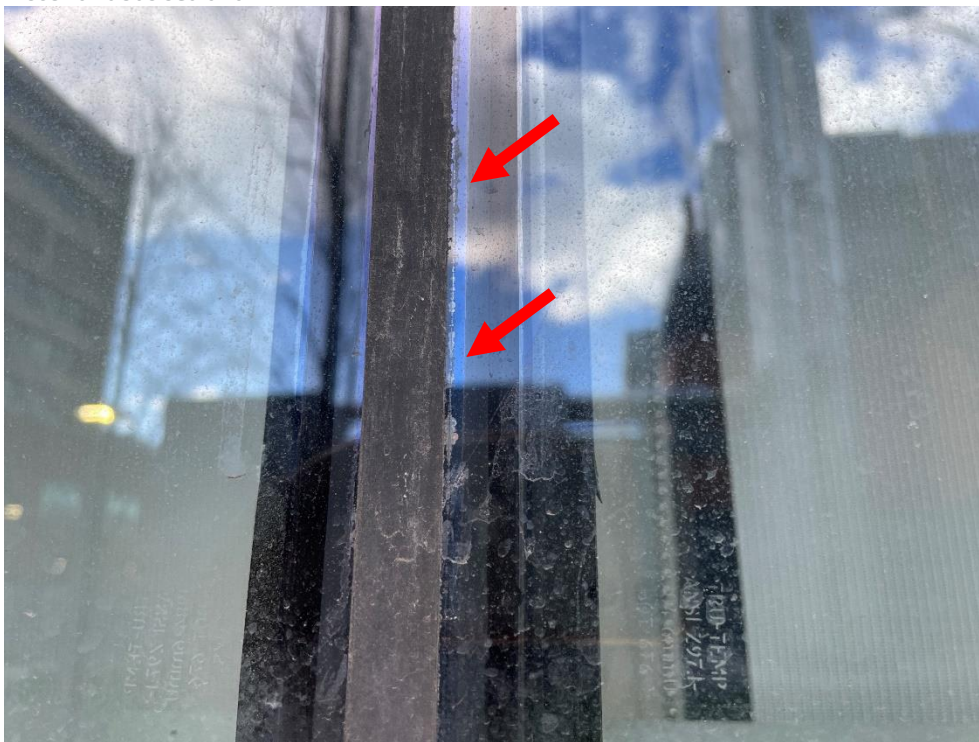
The visible spacer bar from the exterior may be due to inconsistent application of the primary and/or secondary sealant or incorrect glass placement (i.e. setting blocks being too high). However, given the negligible defect amount in comparison to the overall curtain wall area, this is considered acceptable.

Photograph No. 12
Exposed spacer bar.

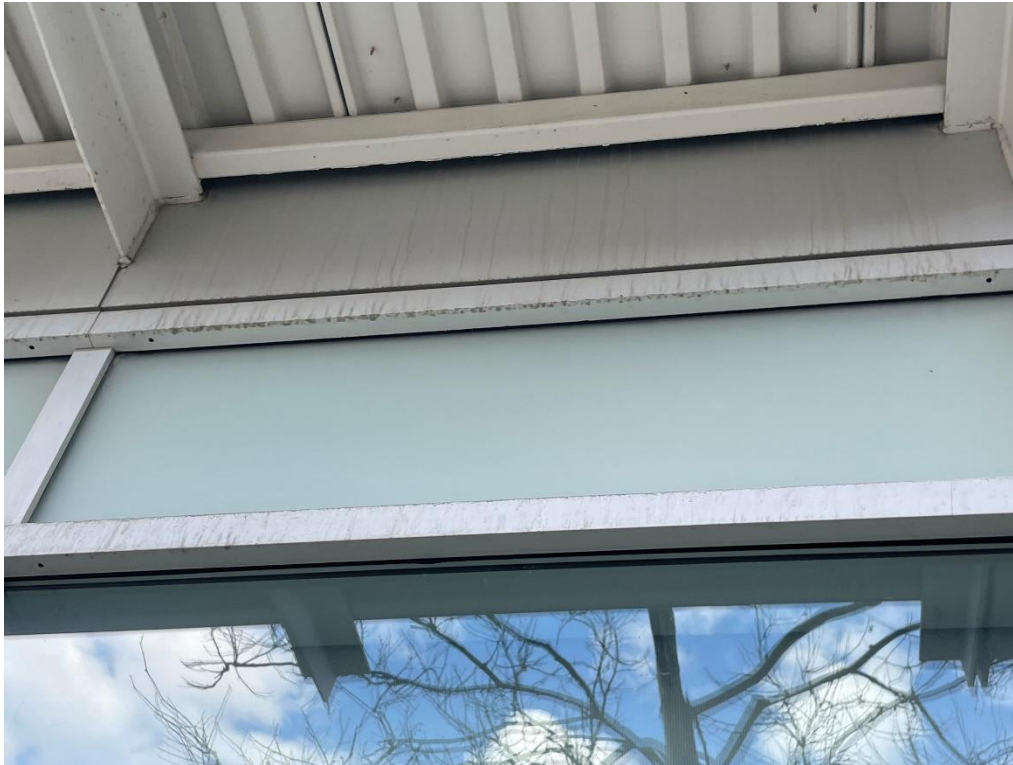
Photograph No. 13

6. Significant staining from dirt was observed below the canopy, on the spandrel panel and framing (Photograph No. 13).
7. Joints of the curtain wall snap caps were not tightly abutted or misaligned at some locations (Photograph No. 14).

The staining of the curtain wall system below the canopy seems to be related to the water management detailing of the canopy above. However, canopy details were not available for our review. EXP would recommend that the curtain wall system be cleaned at this location to allow for any re-occurring staining to be monitored.

Dirt staining on the curtain wall.

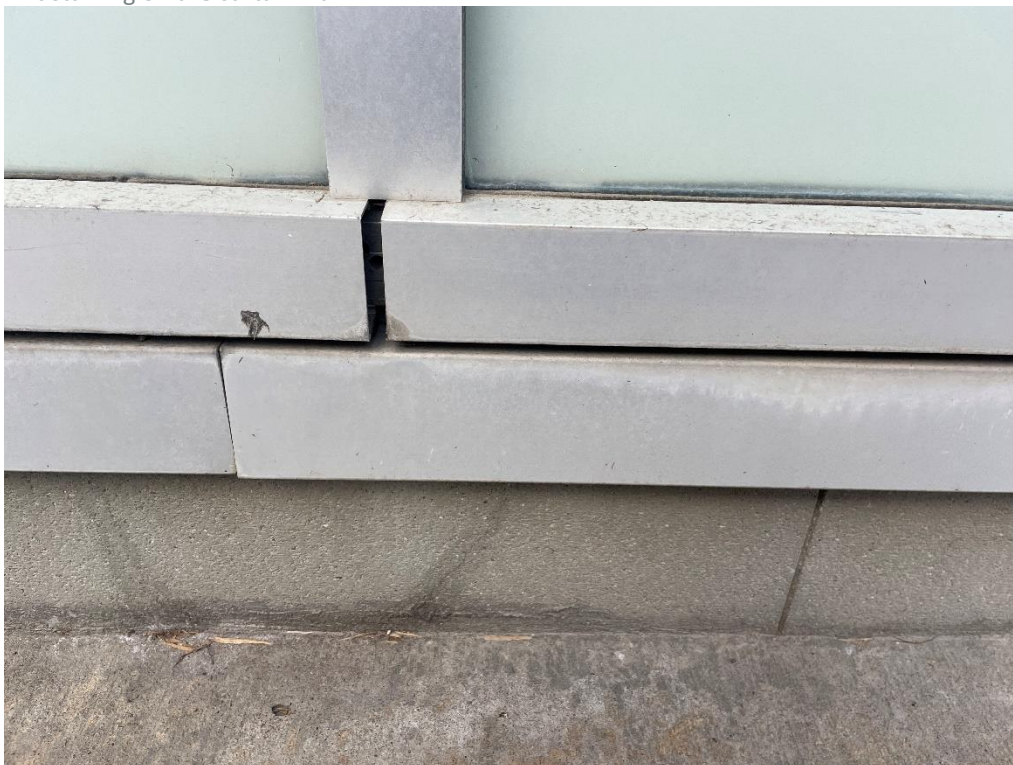
Photograph No. 14

Misaligned framing.

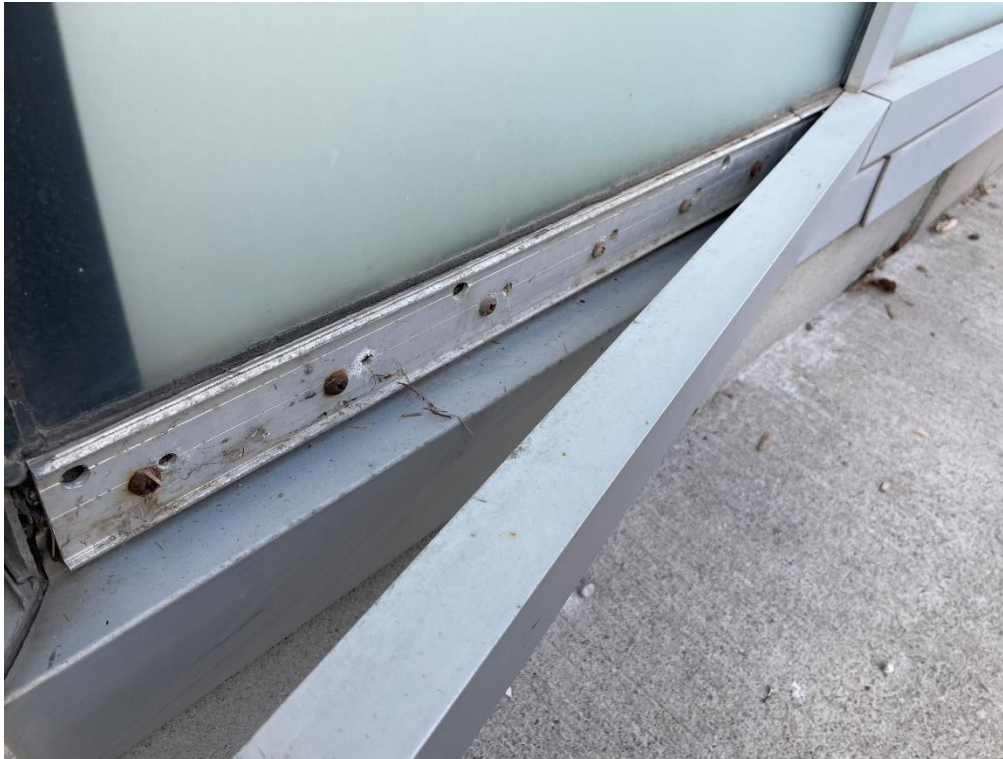
8. A loose snap cover was observed on the southwest corner of the south elevation (Photograph No. 15). The fasteners at the pressure plate were corroded. Additionally, weep holes were an inadequate size on the pressure plates.

Corroded fasteners are indicative of using the incorrect fasteners for the exterior environment – galvanized instead of stainless-steel fasteners. This is critical to keep the pressure plates and IGUs secure since the pressure-plates together

with the structural silicone holds the glass in place. It is unclear what the condition the fasteners are in at other locations, however, it is assumed that the condition of pressure plates is similar throughout the ground floor, at the horizontal pressure plate locations.

Additionally, weep holes on the pressure plates are required to be 32mm (1-1/4”) wide, whereas the site observed weep holes were round and approximately 9mm in diameter, and therefore not as effective for drainage.

Photograph No. 15
Corroded fasteners at pressure plates, and inadequate weep holes.

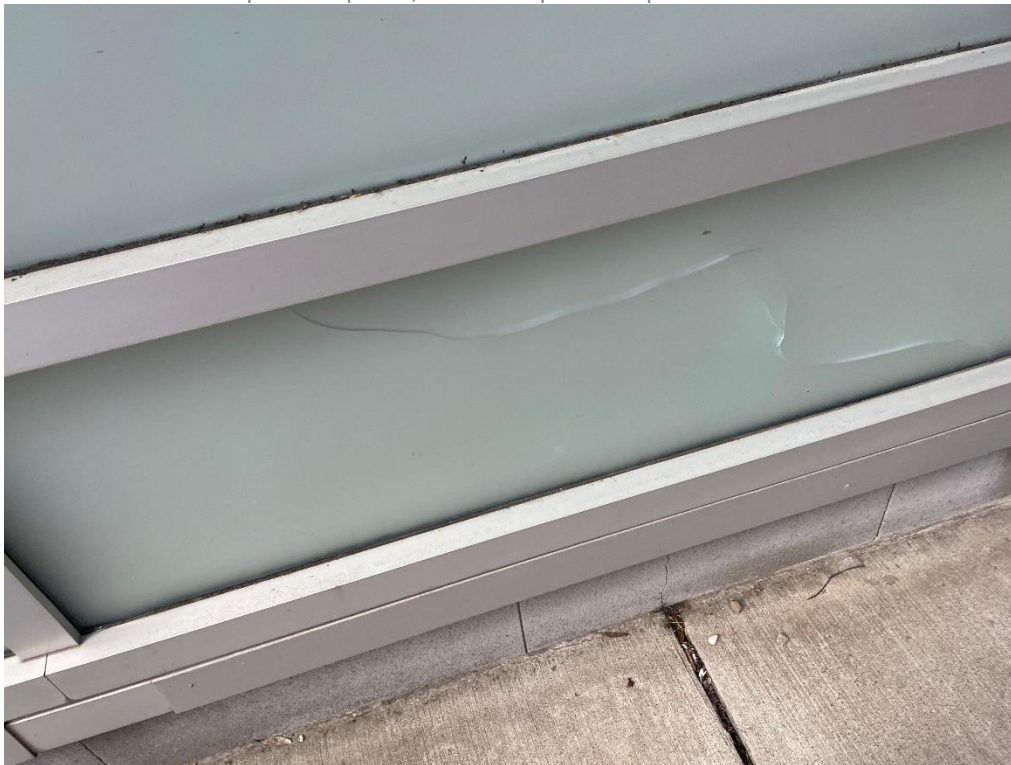
9. A cracked spandrel glass lite was observed on the west elevation (Photograph No. 16). EXP understand this elevation will be enclosed with the SEM renovations.

The broken spandrel glass on the west elevation is an isolated location, and the cause is unknown, however it may be due to impact damage. The broken glass is to be replaced for safety reasons.

Photograph No. 16
Cracked spandrel glass.

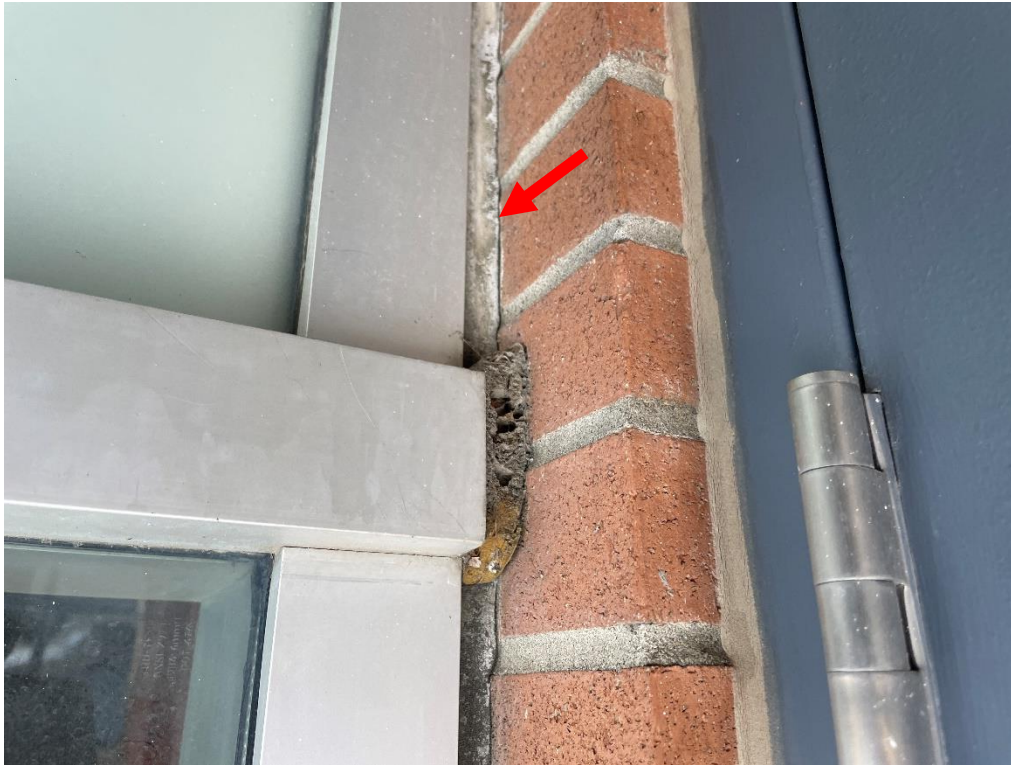
Photograph No. 17

Deteriorated sealant joint and spray foam.

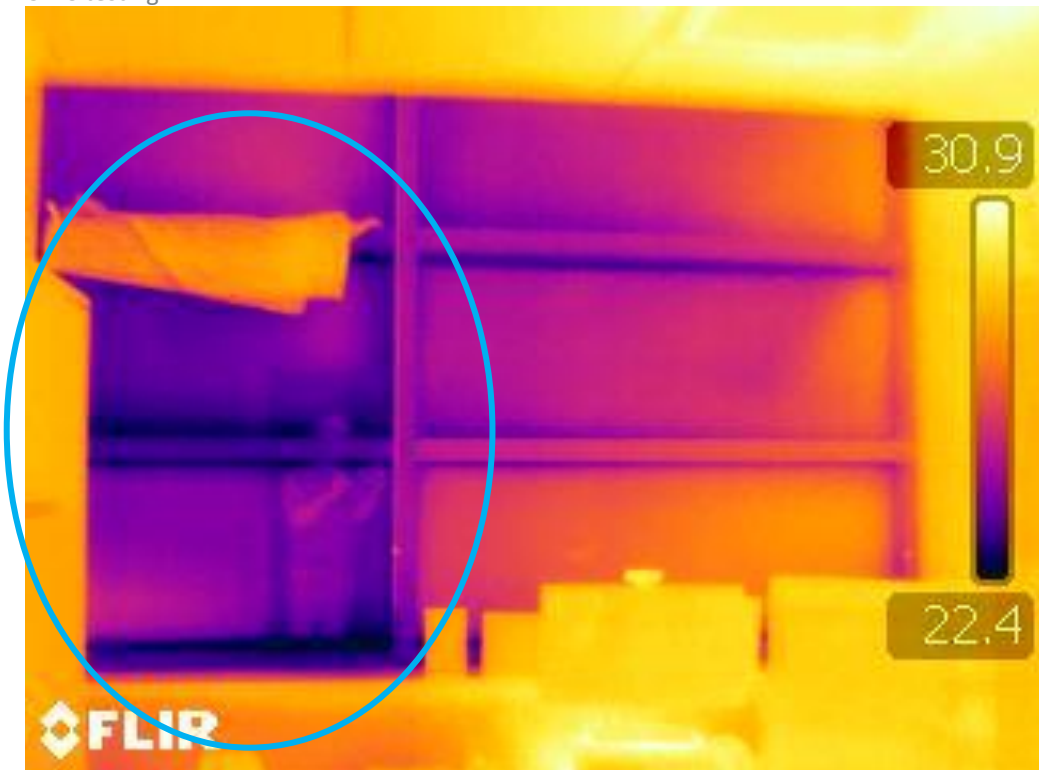
Photograph No. 20
Thermal anomalies at window mullions on left side, from the interior.

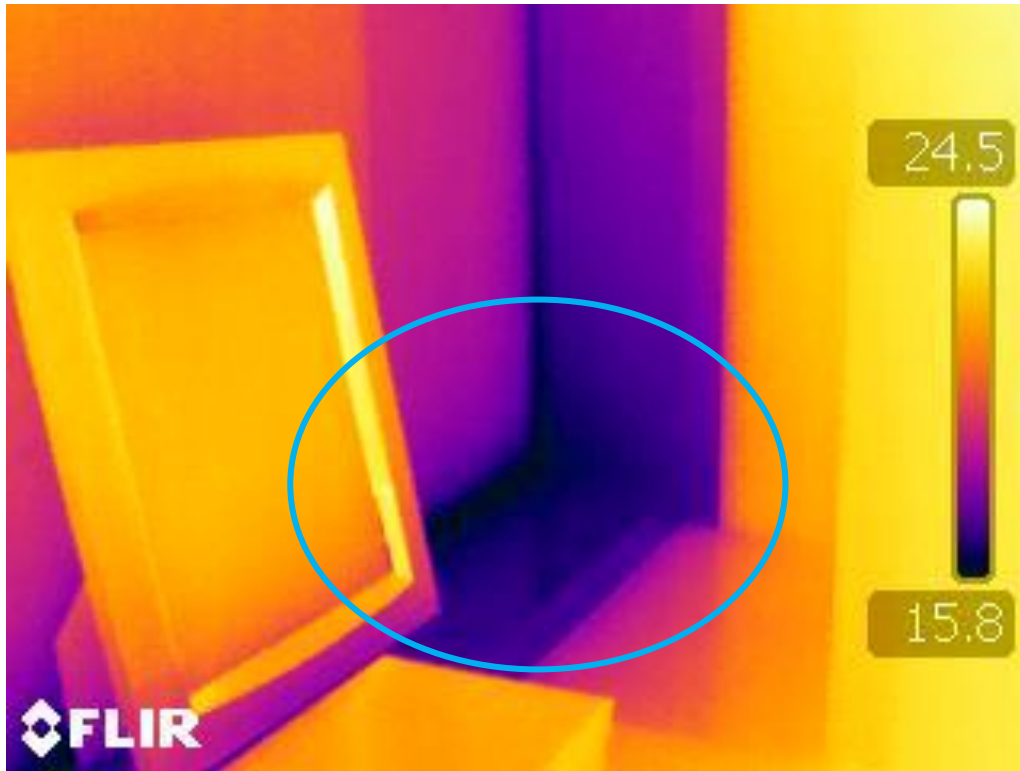
Photograph No. 21

Thermal anomaly at lower mullions (base of windows).

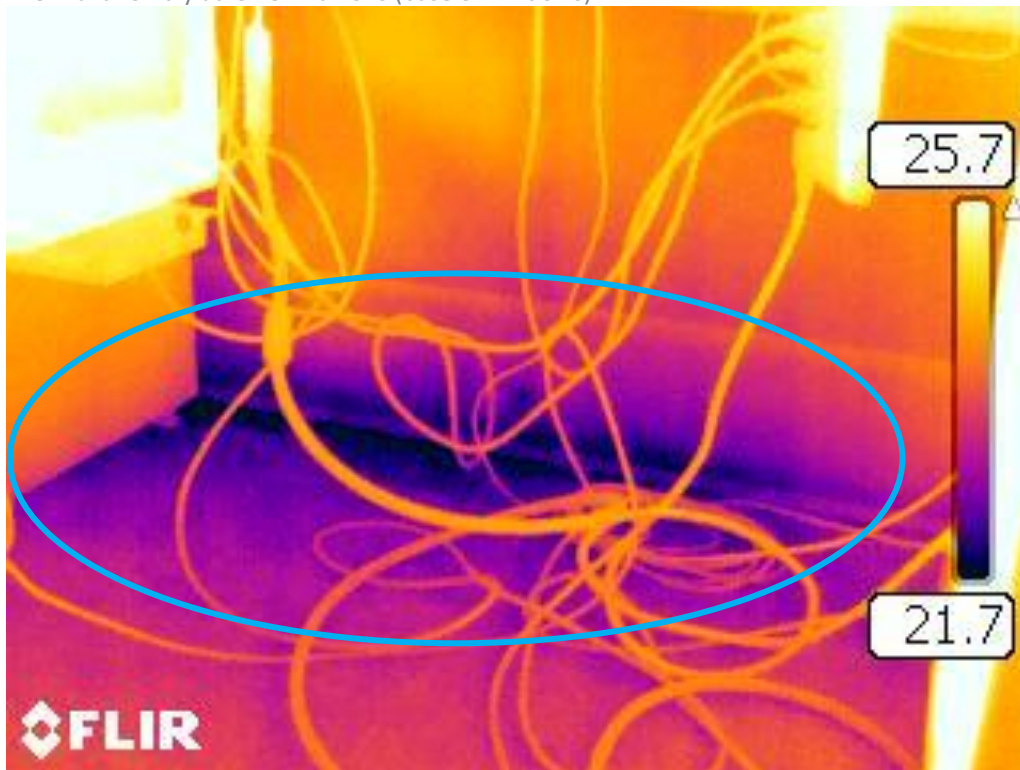
Photograph No. 22

The thermography conducted at the SEM offices identified various thermal anomalies, most notably along the base of the wall. The exploratory opening was carried out at this location and revealed missing insulation and a discontinuity in the air barrier at the base of the curtain wall.

Thermal anomaly at base of wall from interior side.

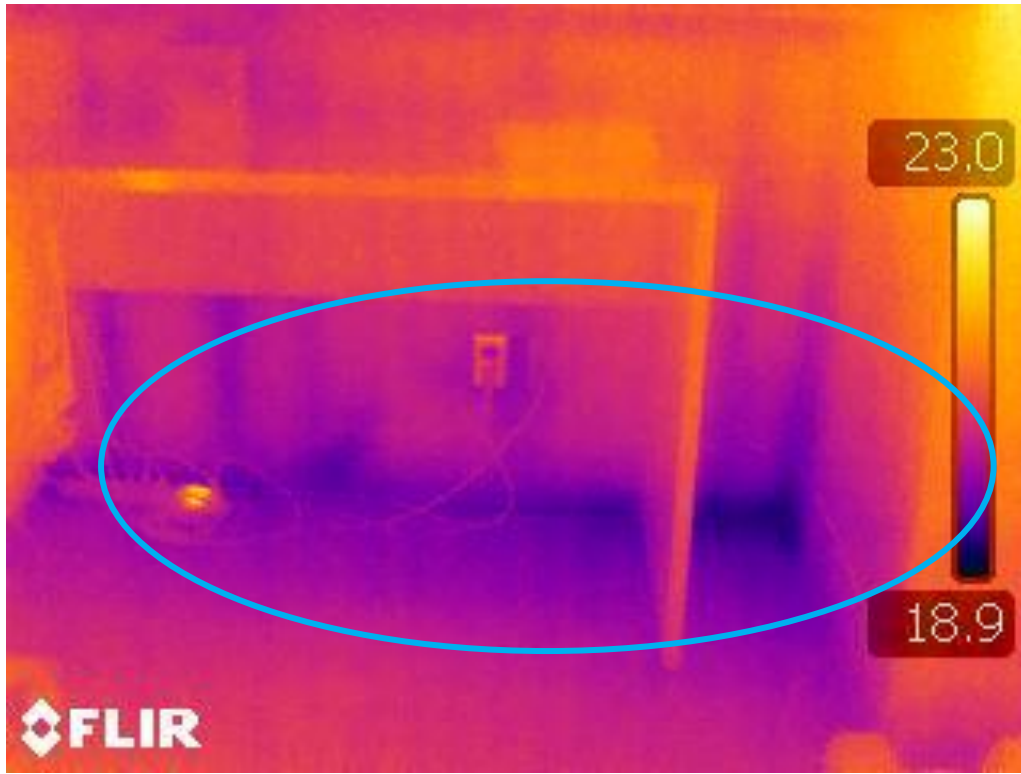
Photograph No. 23

Thermal anomaly at base of wall from interior, adjacent to column to right.

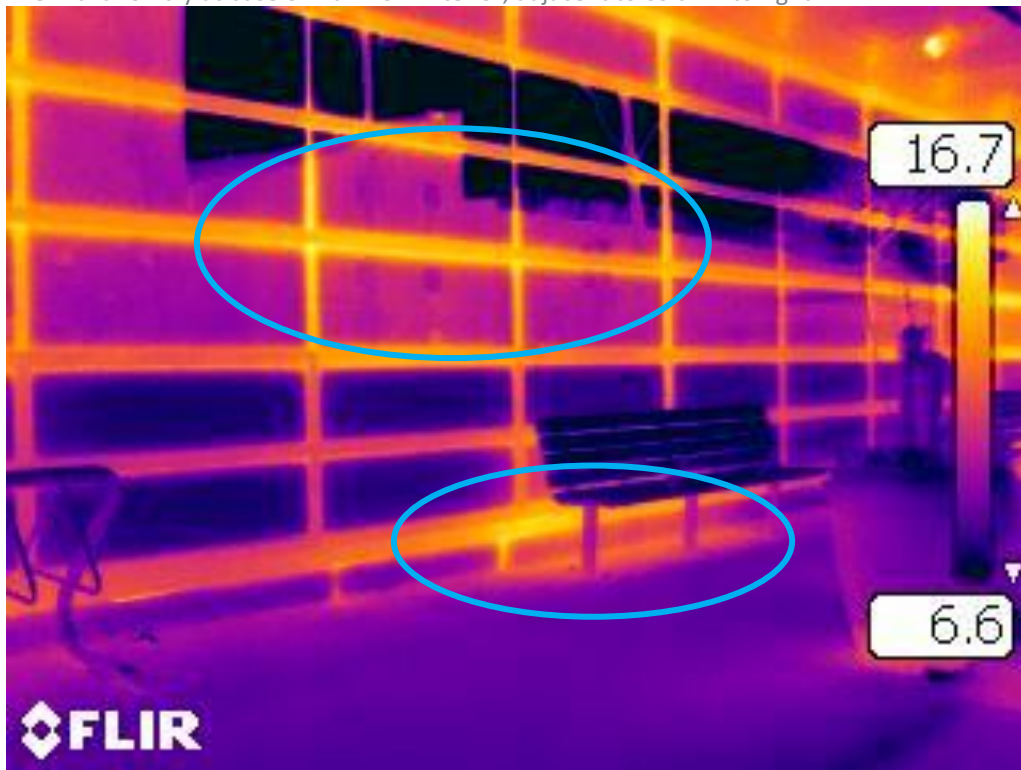
Photograph No. 24

Thermal anomaly at base of wall and at mullions from exterior.

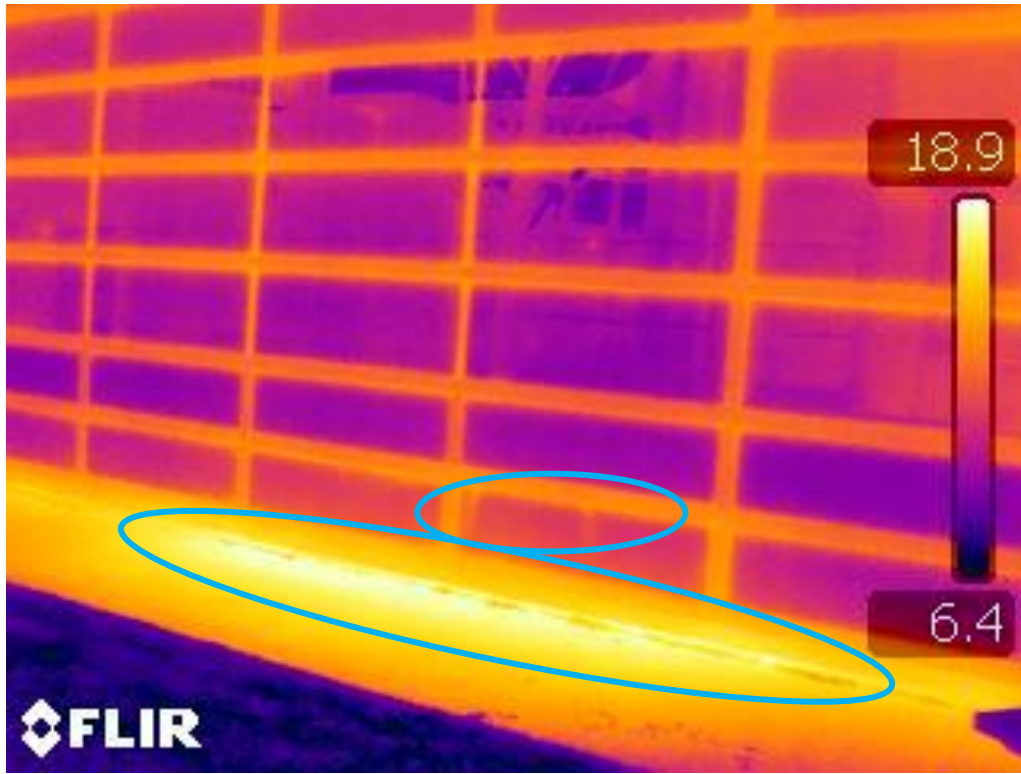
Photograph No. 25

Thermal anomaly at base of wall and glass spandrel panel.

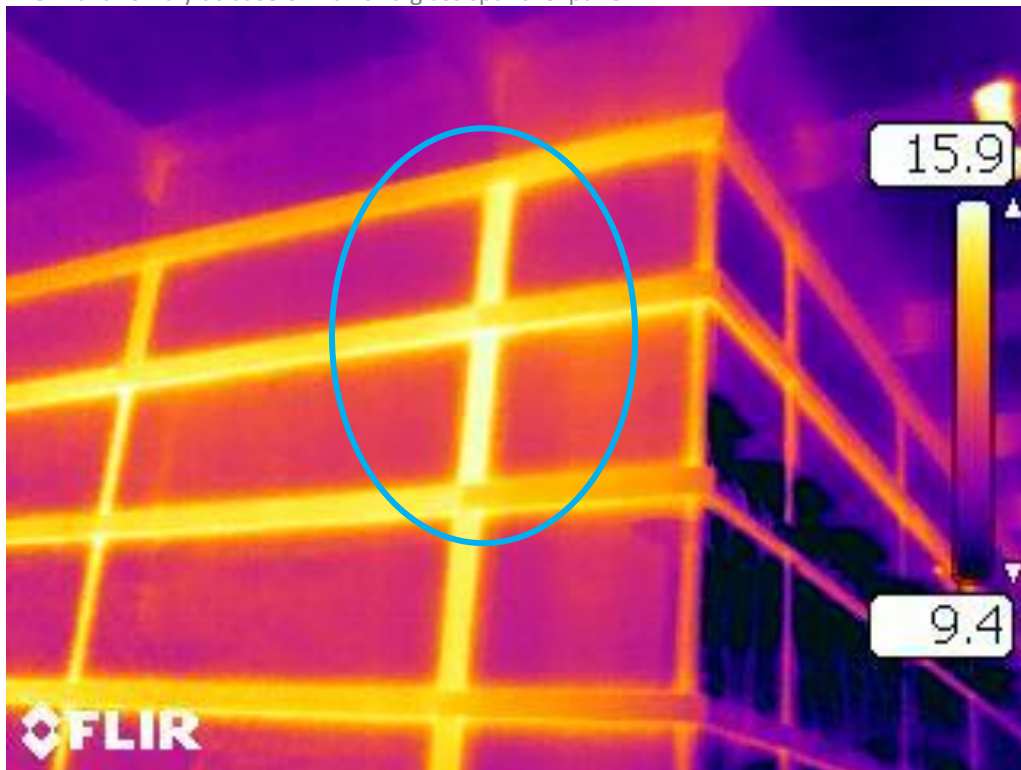
Photograph No. 26

Thermal anomaly at vertical mullion.

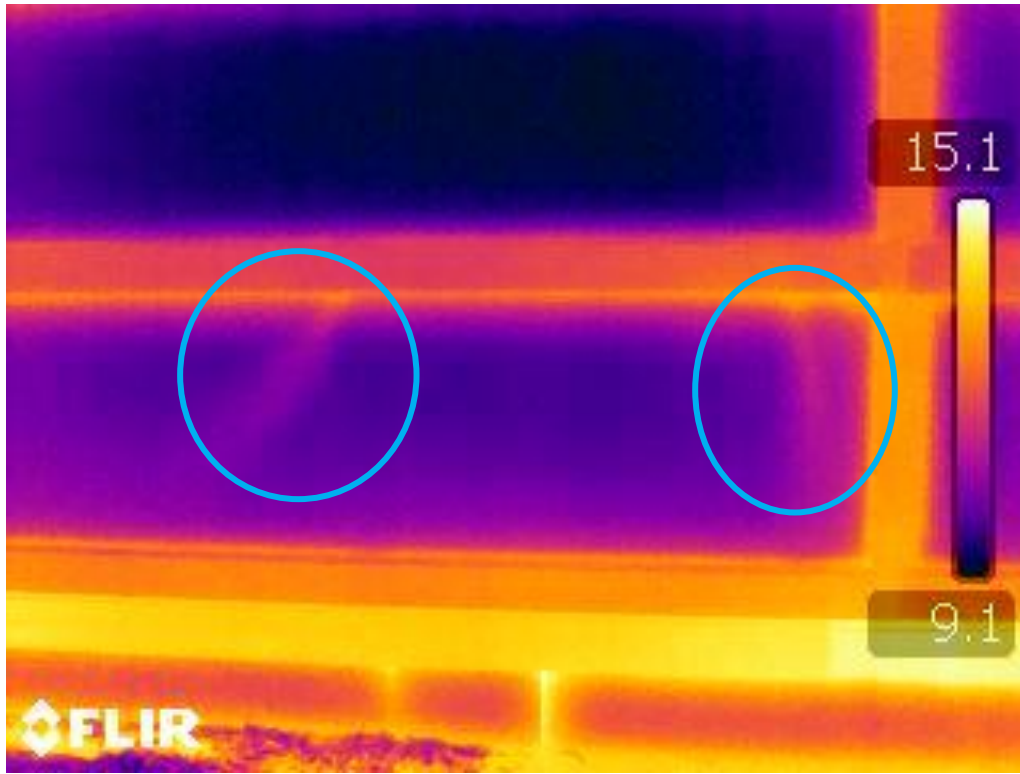
Photograph No. 27

Thermal anomaly showing air leakage at spandrel panel.

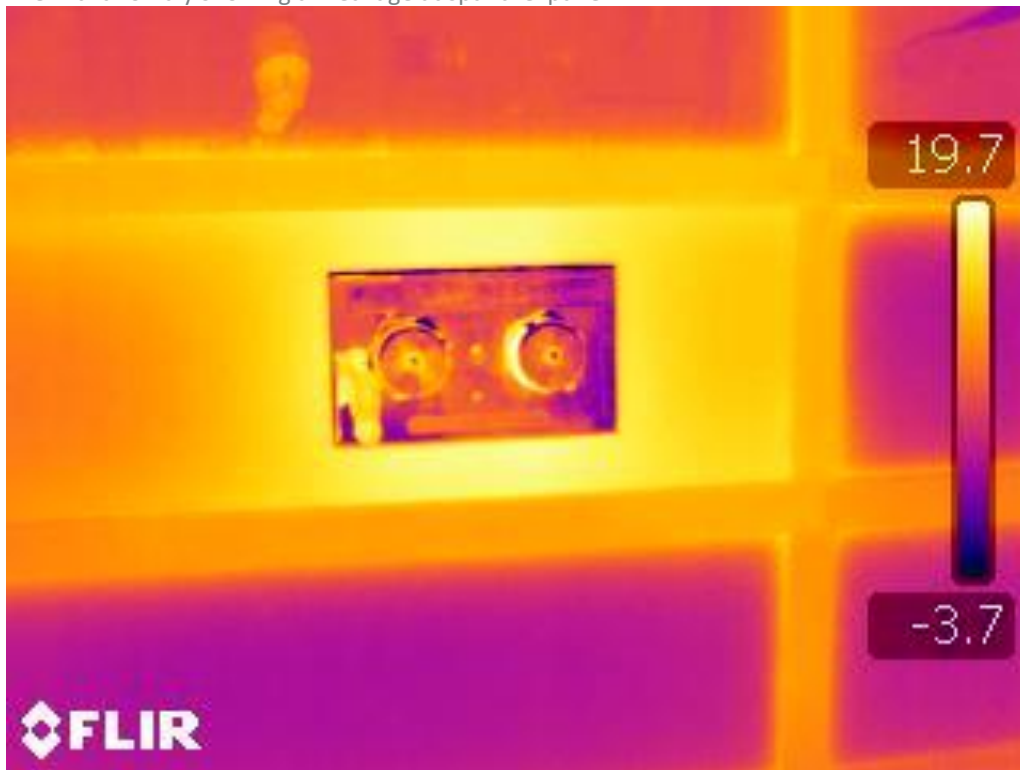
Photograph No. 28

Thermal anomaly at water connection.

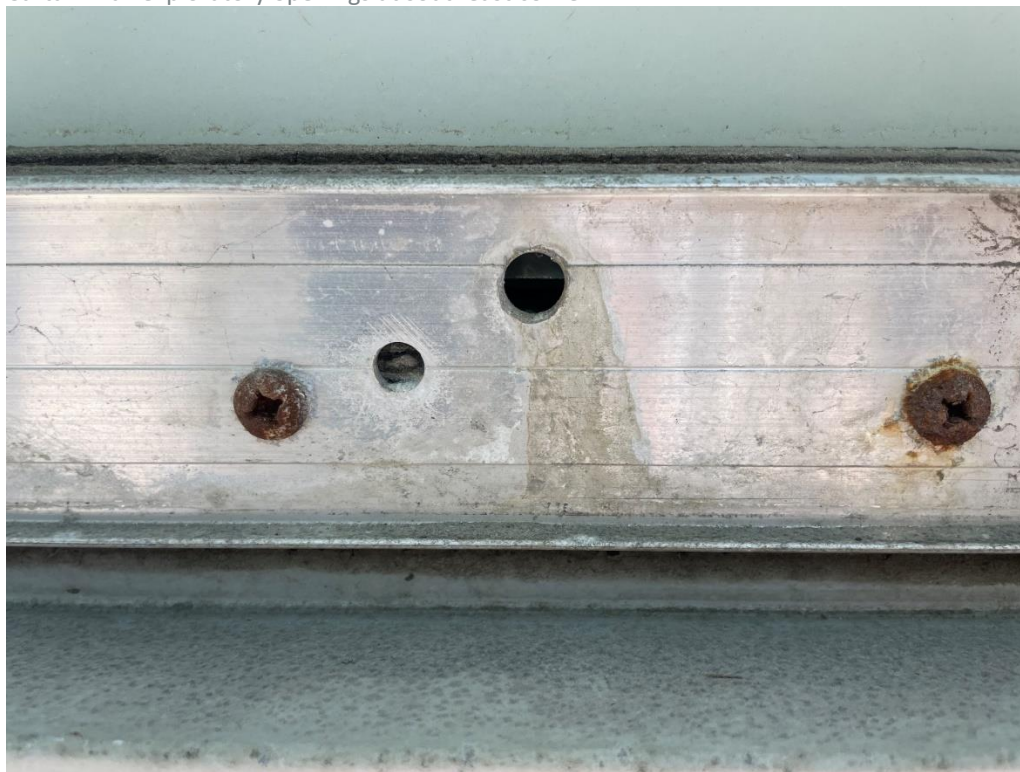
Photograph No. 30

2. Some of the fasteners at the pressure plates were corroded (Photograph 30).
3. The bottom pressure plates were not compressing the glass adequately along the top edge due to the inadequate extruded insulation pocket filler. Also, some of the horizontal pressure plates were missing a gasket along one side. The extruded insulation pocket filler behind the sill closure piece is not rigid enough to support the pressure plate compression (Photograph 31).

At the sill, corroded fasteners were observed on the pressure plates due to improper choice fastener materials being utilized, galvanized steel instead of stainless steel. Corroded fasteners were observed at the base of the metal closure panel, which could also be caused by air leakage.

Sill pressure plate – corroded fasteners; and misplaced weep holes.

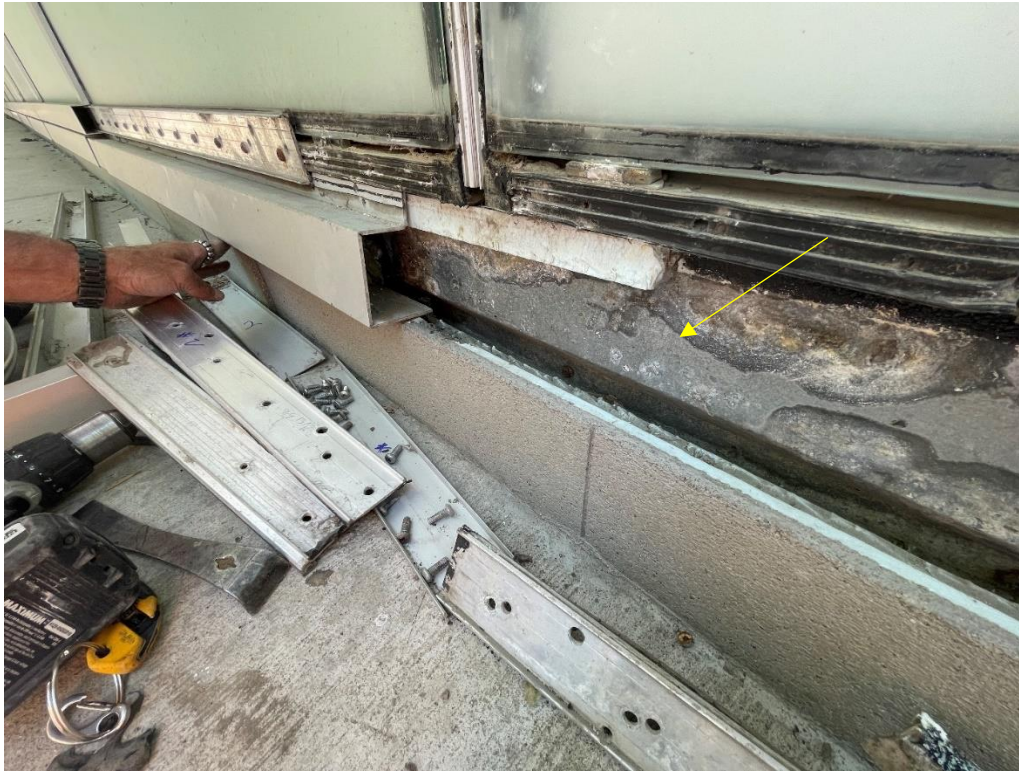
Photograph No. 31

At the sill, inadequate pressure plate compression was observed due to inadequate filler material being utilized (rigid insulation instead of extruded metal or PVC).

Metal closure panel below curtain wall; and uneven pressure plate

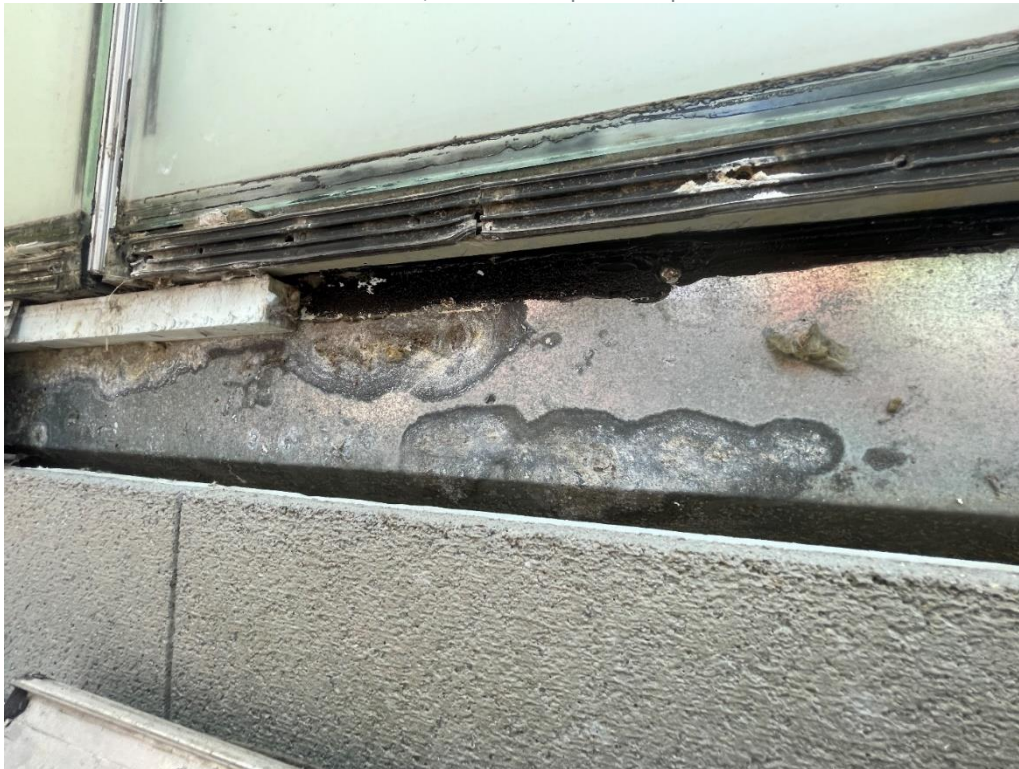
Photograph No. 32

5. The metal closure panel was sealed with sealant along the top edge, which is good practice. However, along the bottom edge, sealant may be missing as air exfiltration was observed during the exploratory opening. The continuity of the air barrier could not be confirmed along the bottom. Additionally, fasteners along the bottom of the metal closure were corroded (Photograph 32).

6. Water stains on the metal closure panel were observed as white stains (Photographs 31, 32).
7. The drainage channels were blocked, and corner blocks were deteriorated (Photograph 34).

Metal closure panel below curtain wall – sealant along top edge; water stains throughout

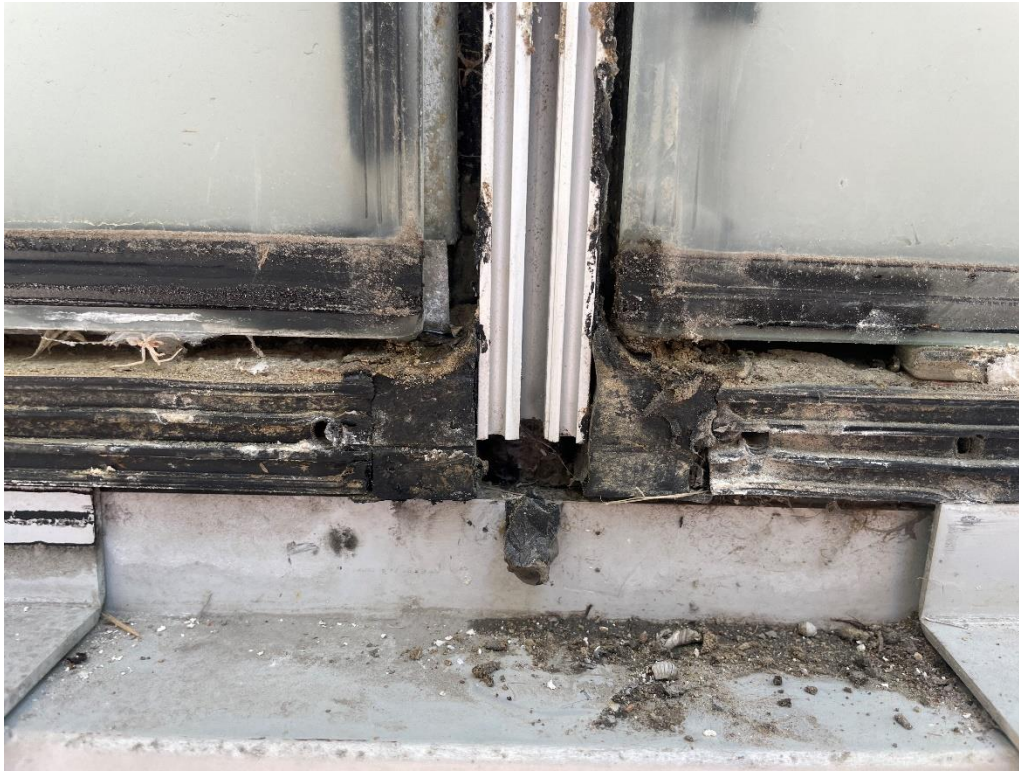
Photograph No. 33

Typically, water was draining adequately from the vertical mullions at some locations, however at other locations, the corners were filled with debris, blocking the drainage. Additionally, weep holes in the pressure plates were missing and/or misplaced, affecting the efficacy of the water drainage. Inadequate drainage resulted in staining on the metal closure panel, and potentially fastener corrosion.

Drainage channels are blocked and corner blocks deteriorated

EXP recommends that the curtain wall be re-furbished by cleaning the drainage channels, replacing corner blocks, and augmenting or replacing the horizontal pressure plates and fasteners. At the base of the curtain wall, the metal closure panel can be replaced with an insulated metal backpan, complete with an air seal to the concrete floor slab. Additionally, exterior sealant replacement at IGU vertical joints, and exterior sealant replacement at the curtain wall-to-brick masonry joints should be implemented.

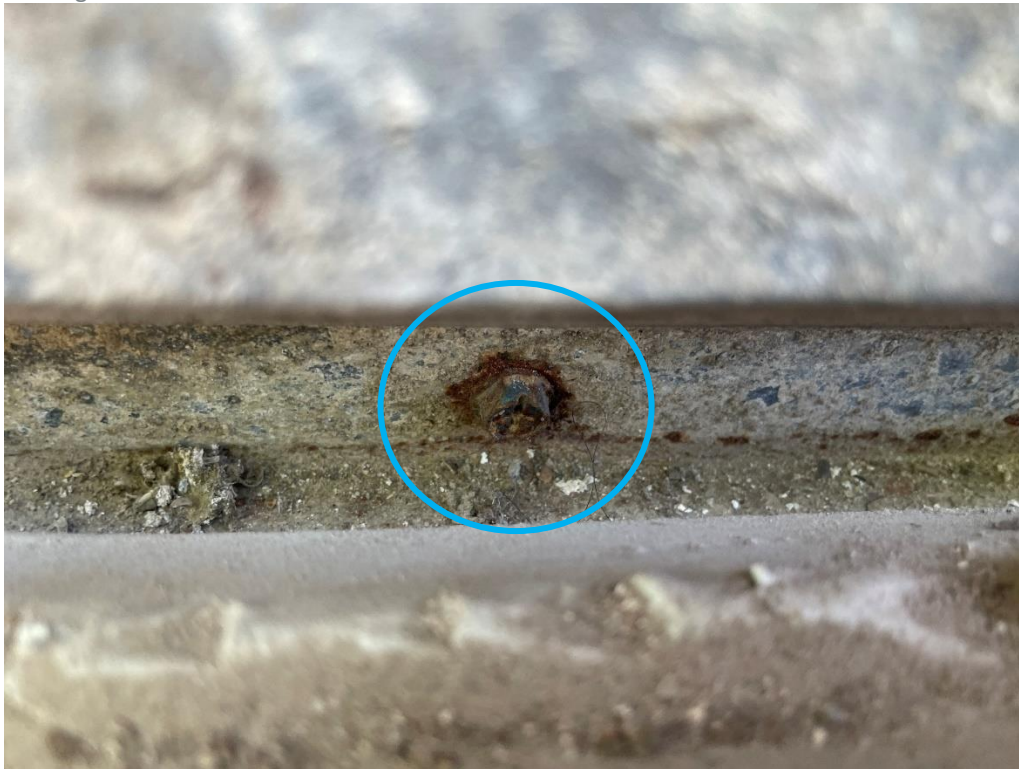
Photograph No. 34

Metal closure panel with corroded fasteners along bottom edge

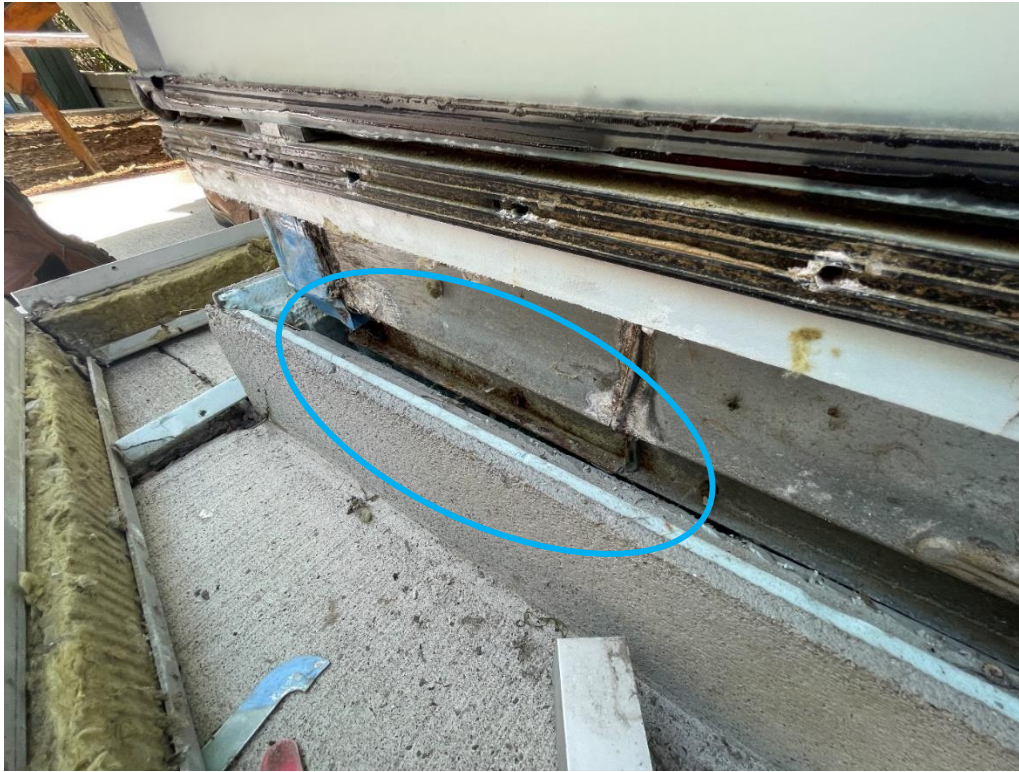
8. On the east elevation, the bottom of the metal panel was corroded (Photograph 35).
9. The metal backpan was filled with mineral wool insulation as per good practice (not shown in photo), and the metal joints were sealed with sealant at the perimeter for continuity of the air barrier (Photograph 36).
10. Directly behind the spandrel glazing, a painted metal “screen” was installed in front of the mineral wool insulation (not shown in photo).
11. At the interior exploratory opening, the bottom of the curtain wall was not insulated (Photograph 37).

Photograph No. 35
Corroded metal closure panel on east elevation
