Curtain Wall Assessment

Curtain Wall Assessment at University Health Network
SEM Centre – Ground Floor
399 Bathurst Street, Toronto, ON

BRM-21013311-C0

July 17, 2024

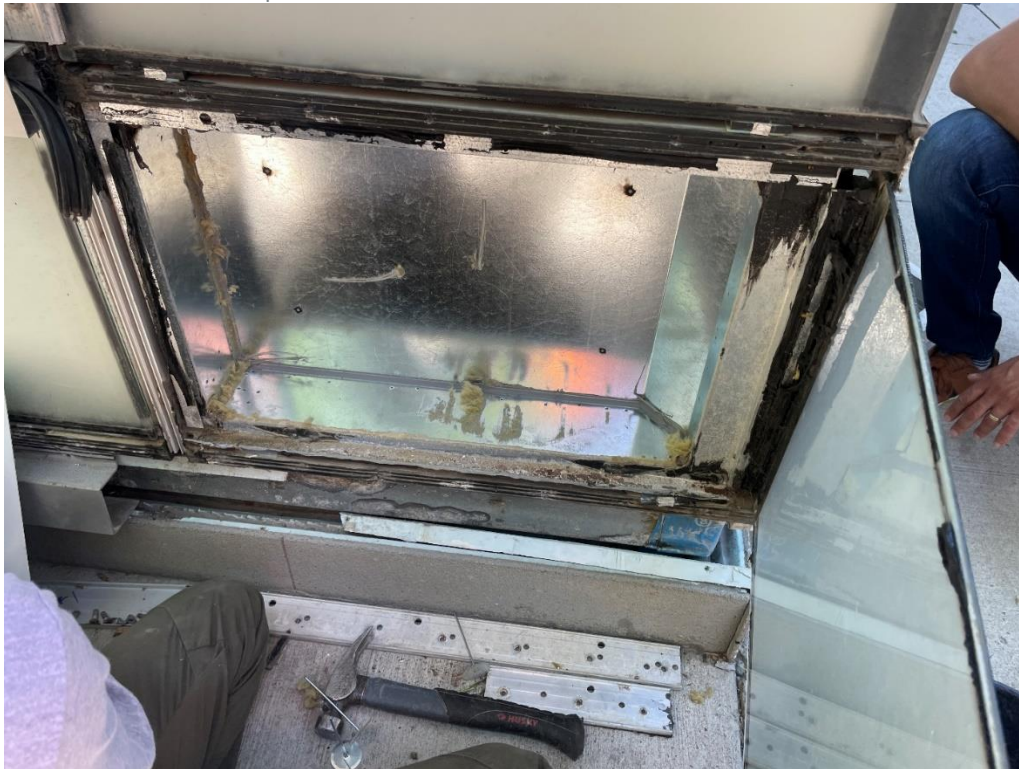
Photograph No. 36
Spandrel glazing and metal panel behind with removed insulation.

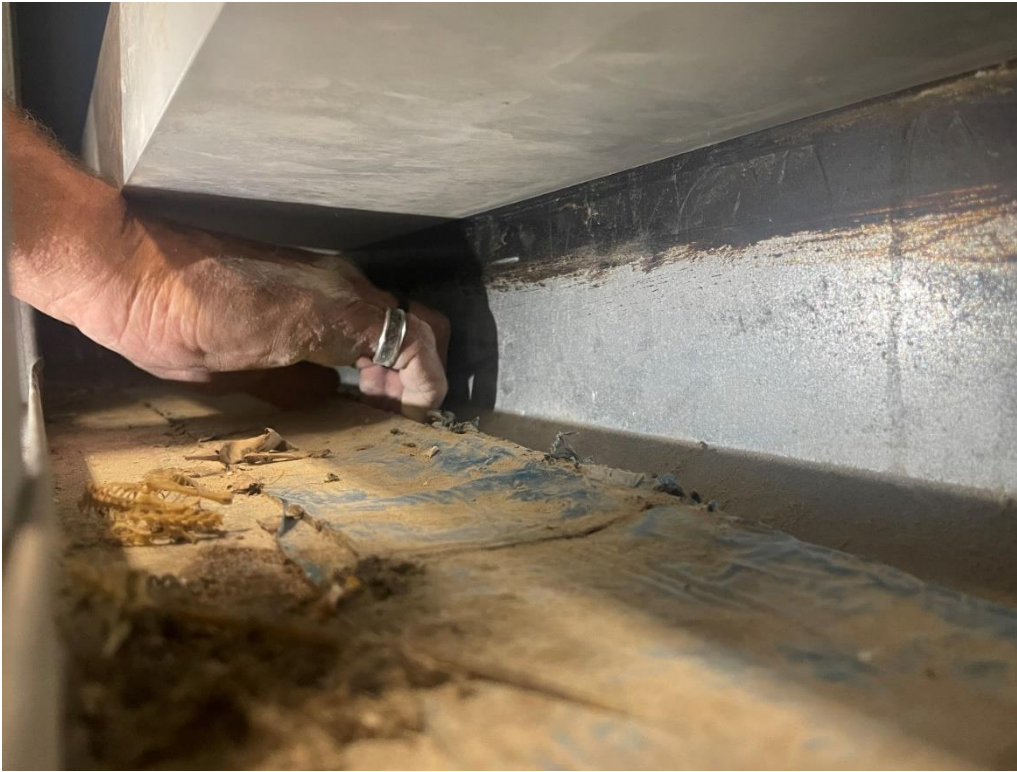
Photograph No. 37

8. On the east elevation, the bottom of the metal panel was corroded (Photograph 35).
9. The metal backpan was filled with mineral wool insulation as per good practice (not shown in photo), and the metal joints were sealed with sealant at the perimeter for continuity of the air barrier (Photograph 36).
10. Directly behind the spandrel glazing, a painted metal “screen” was installed in front of the mineral wool insulation (not shown in photo).
11. At the interior exploratory opening, the bottom of the curtain wall was not insulated (Photograph 37).

Interior exploratory opening – uninsulated wall area below curtain wall

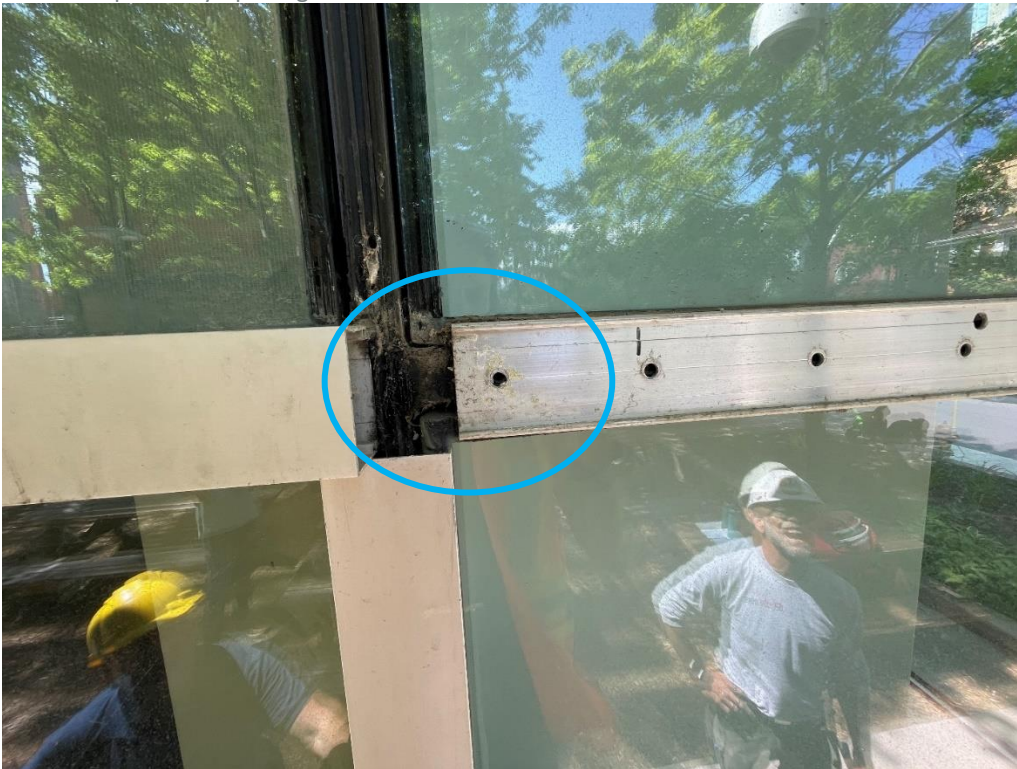
Photograph No. 38

1. Short pressure plates were observed at the horizontal mullions (Photograph 38), in other words, the pressure plate does not extend the full width of the glass.
2. The pressure plate weep hole was missing next to the setting block (Photograph 38); and was misplaced on the east end since it was partially blocked by the setting block (Photograph 39)

Upper mullions - "short" pressure plates and missing weep hole

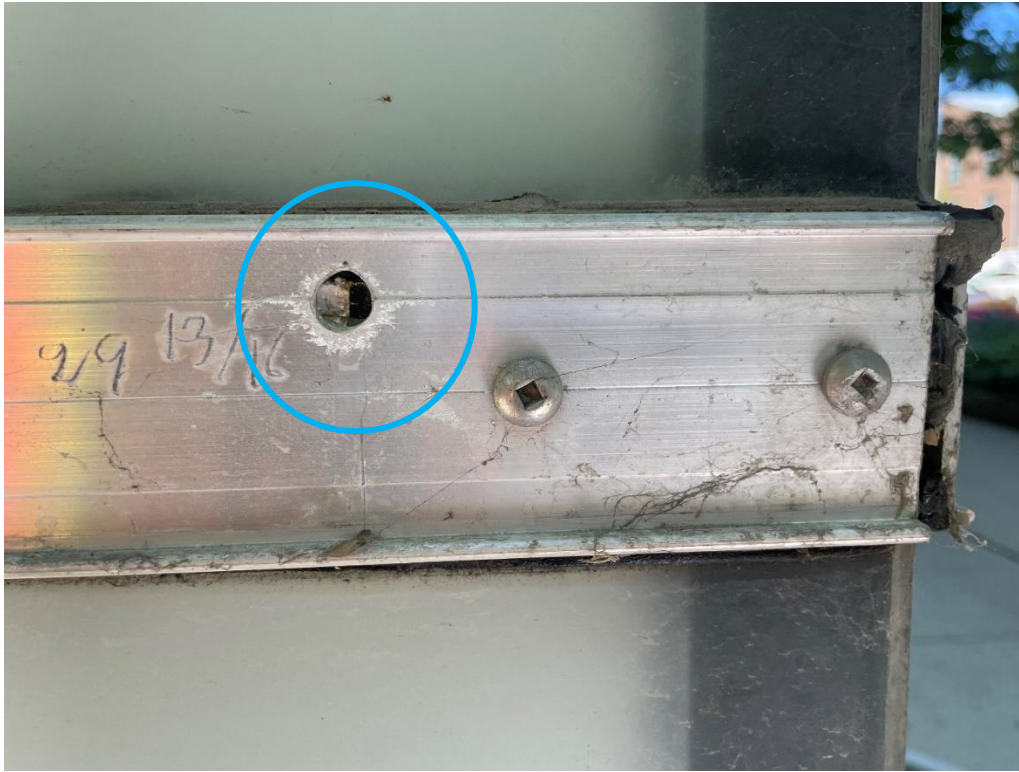
Photograph No. 39

Misplaced weep hole – it is blocked by setting block.

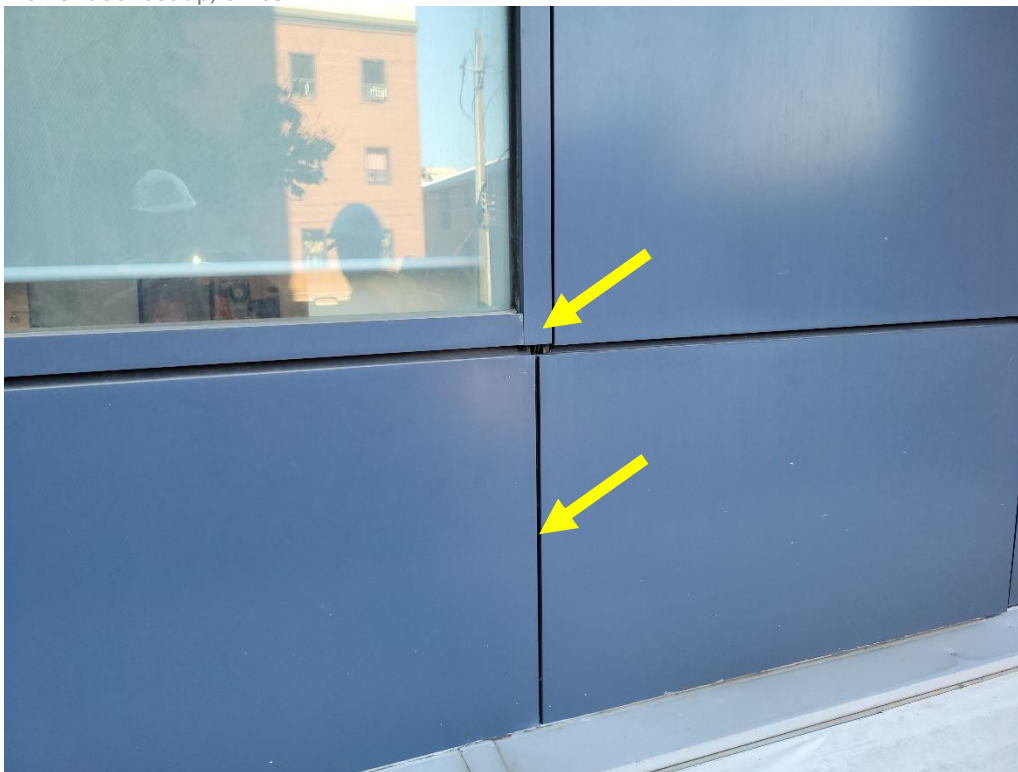
- d) Test 4: Above the canopy, at the bottom-right corner of the glazing unit (Photograph 42). Water leakage was observed during this test. The water on the interior was observed at a small section at the head of the curtain wall, not the full length of the curtain wall (Photograph 43).

- e) Test 5: Above the canopy, in the vertical metal cladding joint above the metal flashing (Photograph 42). Water leakage was observed during this test, at the same location as in Test 4.

The water testing on the east elevation confirmed water entering the system from above the canopy. The water entered the interior from the 2nd floor exterior vertical metal panel joint. Additionally, the tie-in at the head of the curtain wall and slope of the canopy can be impacting the water leakage.

Photograph No. 42
Water penetration occurring above canopy, at arrow locations.

Additionally, due to water entry from the water testing, EXP recommends repairing the 2nd floor joint above the office and canopy. This will include dismantling the metal cladding, metal flashing and sealant joint to review and repair any defects.

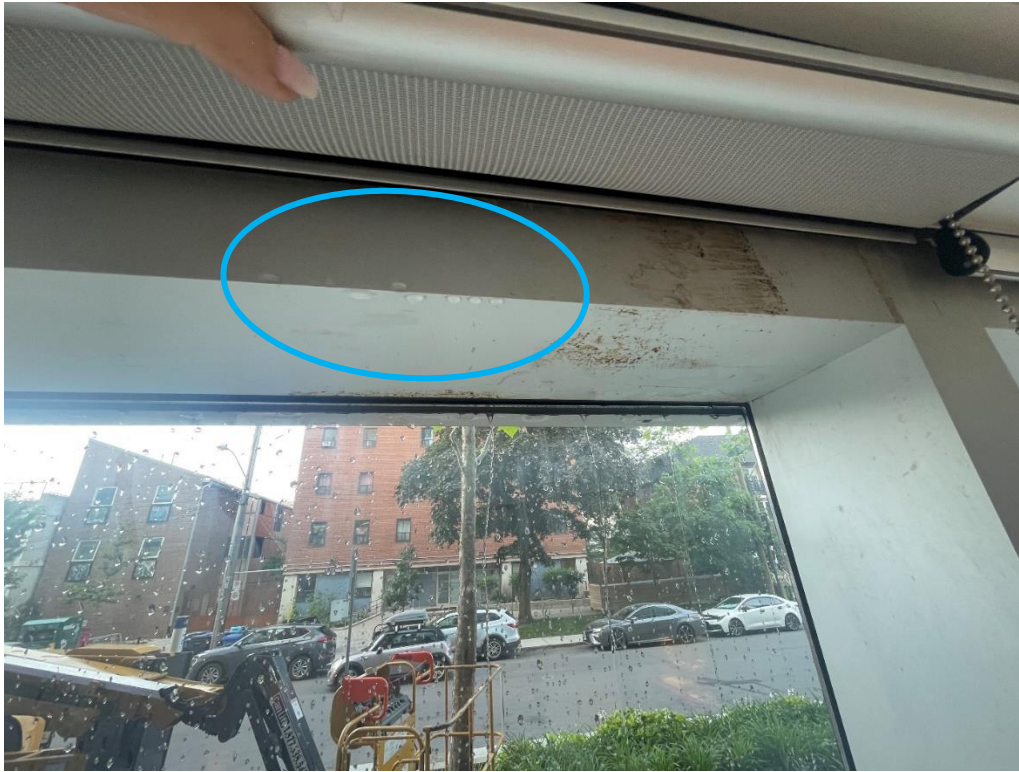
Photograph No. 43

Observed water penetration at the top of the curtain wall.

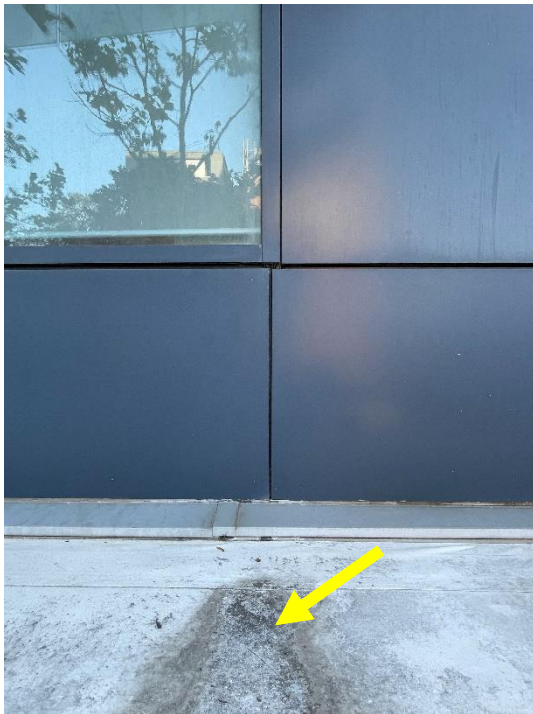
Photograph No. 44

It was also observed that the canopy was installed with a TPO membrane, and a low spot in the “roof” was observed near the water leakage area (Photograph 44).

Low spot in roof membrane

The service life of a TPO membrane is approximately 20 years and its replacement should be considered. Replacement will allow for improvement in roof slope on the canopy to avoid ponding.
