Toronto Western Hospital – FP Building Envelope Assessment

TWH- FP Building Envelope Assessment, UHN #110023024

399 Bathurst Street, Toronto, ON

BRM-21013311-B0

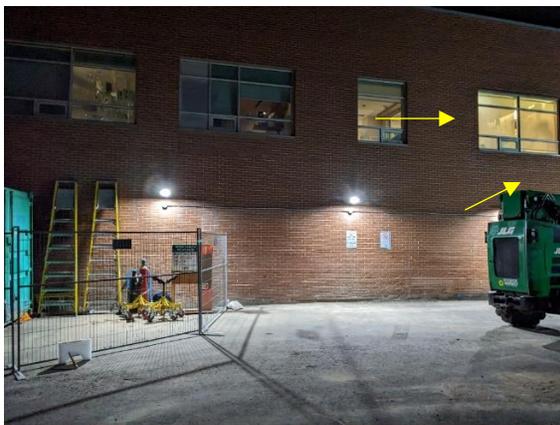
Image 1 –Location of anomalies in image 3 and 4

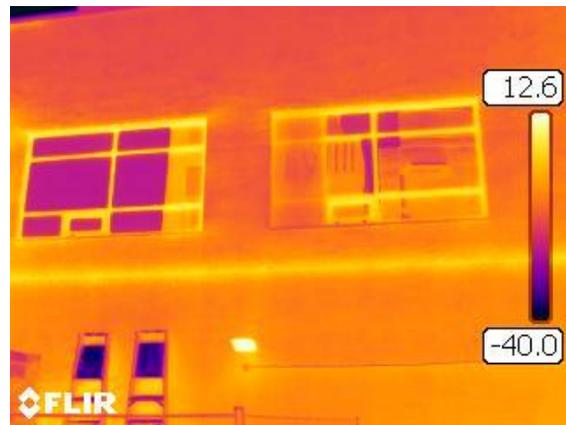
Image 2 – Typical thermal image

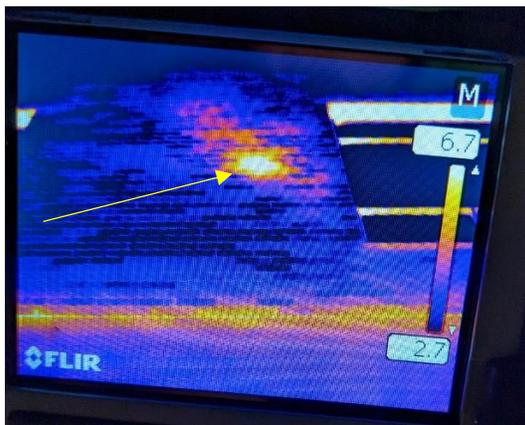
The following photographs display the thermal images with the noted thermal anomalies. The anomaly in Image 3 is a hot spot in the field of the wall, and based on the pattern appeared to be air leakage. The anomaly in Image 4 shows an abrupt change in the temperature profile at the shelf angle between the first and second floor. The warm side was consistent to the left, and the cool side consistent to the right. Masonry exploratory openings were conducted at these locations to review the cause.

Image 3 – Thermal anomaly to left of window

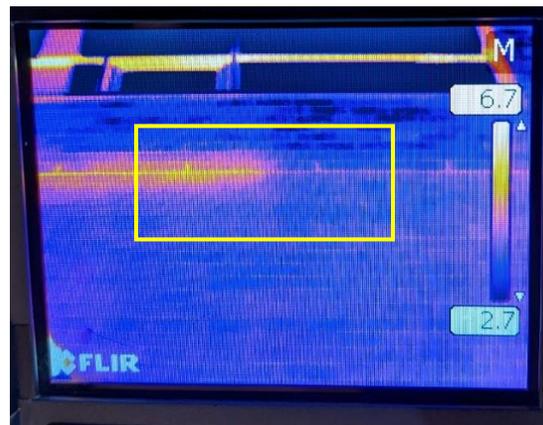
Image 4 – Thermal anomaly beneath window

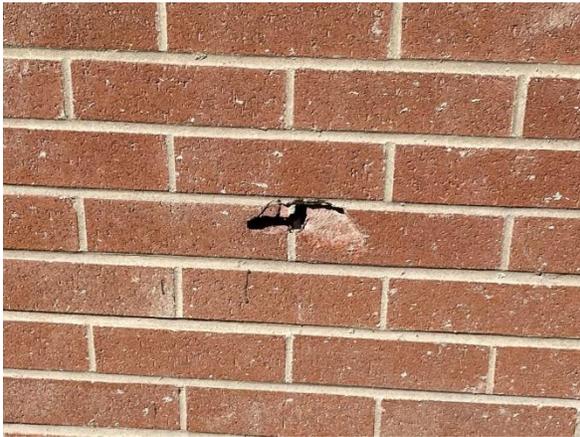
Image 5 – Damaged brick units

- a. Individual brick units which are damaged are to be replaced (approximately 4 in reviewed area). Replacement of 10 brick units has been allowed for in the pricing to account for any additional units on the rest of the wall.
- b. Where loose bricks were noted (1 location in reviewed area at parapet, see image 6, approximately 0.5 square meters), loose bricks to be removed and the area re-bricked. Parapet sheet metal flashing will potentially have to be removed to allow for the brick replacement.
- c. Location with deteriorated mortar joints (1 location in reviewed area, approximately 2 linear meters) to be re-pointed.

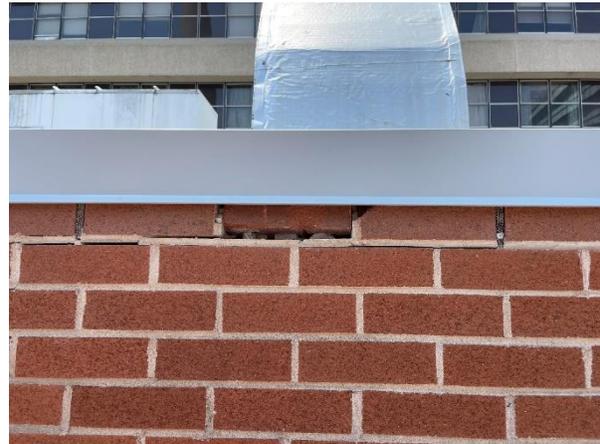
Image 6 – Loose bricks / cracking mortar

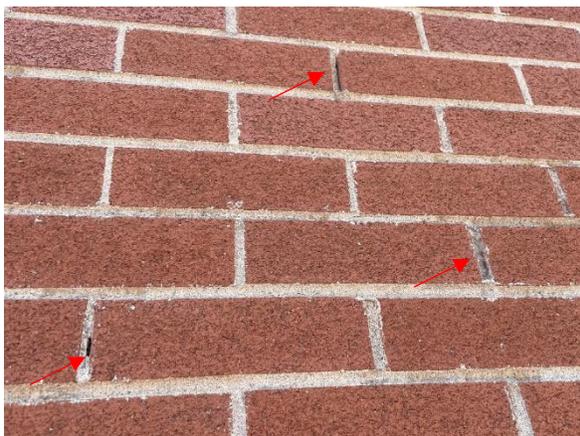
Image 7 – Minor mortar deterioration

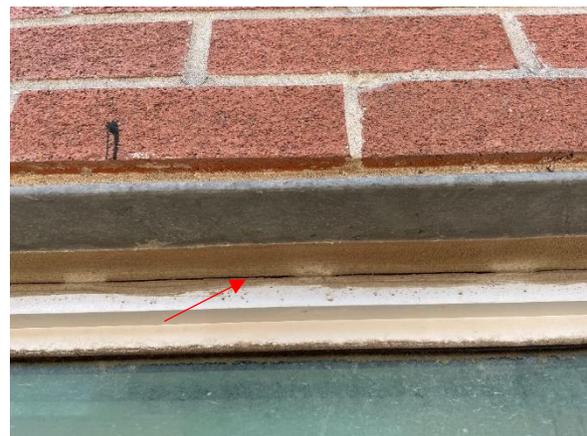
Image 8 – Debonding sealant

- a. All windows (quantity 10) to have sealant and backer rod removed and replaced. This includes all windows on that wall.
- b. Sealant to be Tremco Spectrem 2 or Dowsil 795.

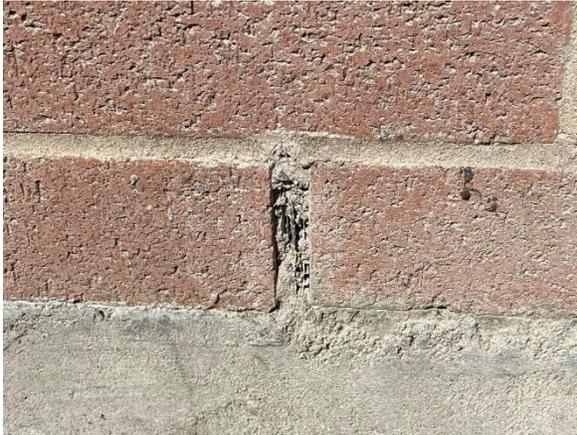
Image 9 – Weep holes obstructed

- g. Insulation re-installed, mortar net installed along base of wall, and new cell vents to be installed in weep holes during masonry reinstatement.
- h. Reinstatement masonry along base of wall.

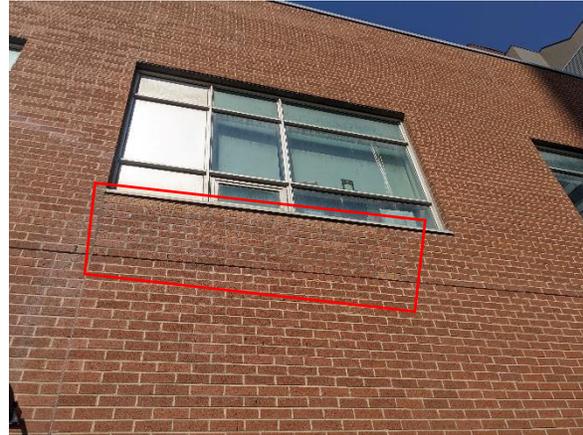
Image 10 – Previous repair area

EXP noted that masonry has previously been replaced beneath the second window north of the stairs. The repair area extended from the shelf angle to the window sill, and from the control joint at the south of the window to approximately three bricks south of the north jamb.

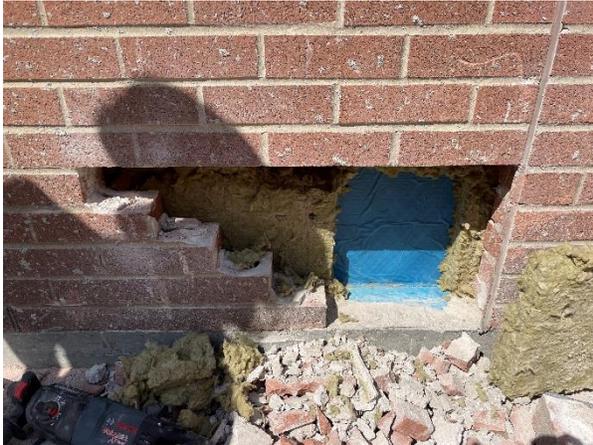
Image 11 – Exploratory opening 1

Five courses of masonry were removed at the base of the wall, adjacent to a control joint, to review the construction details and condition of the through wall flashing. EXP noted that a self-adhered water resistive membrane (Blueskin SA) was installed as through wall flashing on the concrete foundation, with an upturn onto exterior sheathing board installed on steel studs. A lap joint in the membrane was not present within the opening to determine if they are edge sealed. Blueskin SA membrane was installed on the sheathing as the water resistive barrier (WRB), lapped shingle fashion over the through wall flashing and the masonry tie was noted to be sealed with Airbloc 21. 50 mm (2 in) thick mineral wool insulation was installed against the WRB with a 38 mm (1.5 in) air space between insulation and masonry.

EXP noted the following deficiencies at the base of the wall which could lead to and contribute to water infiltration.

- a. A hole/tear was noted in the Blueskin SA through wall flashing at the bottom corner. EXP noted that the membrane was unsupported at this location by approximately 13-19 mm (0.5 – 0.75 in).
- b. No mortar net was present at the base of the wall.
- c. A wire reinforced parging material on the vertical face of the foundation wall extended above the height of the through wall flashing, and masonry was laid in a mortar bed of equal height.
- d. As noted in the visual review, the weep holes were generally obstructed.

There were three locations identified with a breach in the water resistive drainage layer, which would allow water penetration into the wall assembly. At exploratory opening 1, at the base of the wall, the through wall flashing membrane was torn at the bottom corner. EXP noted the membrane was not supported at this location, which can contribute to the membrane being more easily punctured. Any water which penetrates the masonry layer above, which is expected by design, accumulates at the base of the wall, and is to be directed outward and drained from the wall system by the through wall flashing and weep holes. So holes at this location can be a significant source for water ingress. Additionally, with the weep holes being blocked and raised above the height of the membrane, the drainage of the system is restricted, further contributing to the water ingress. A lack of mortar net at the base of wall also contributes to restricted drainage and drying potential of the masonry cavity, as mortar droppings during construction build up at the base of the wall obstructing the drainage and venting paths. The full length of the base of wall should be remediated, as it can be assumed that additional holes in the membrane exist elsewhere.

- a. Along the full length of the base of wall (approximately 15 m), approximately four courses of masonry are to be removed to access the through wall flashing. Repair to be staged and masonry above to be supported during repairs. The repair area has been expanded beyond the reviewed area as it can be assumed that the same construction detail continues for the full length of that wall.

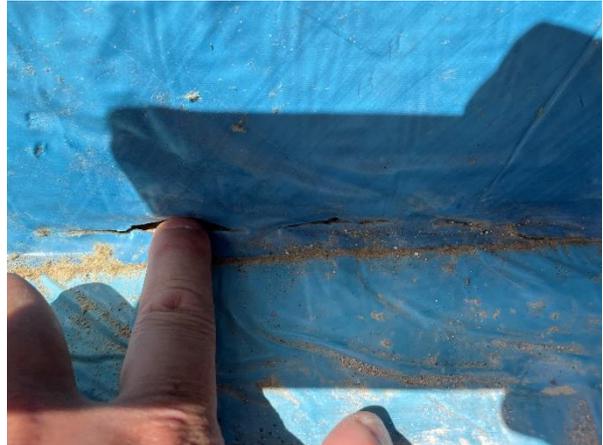
Image 12 – Hole in membrane

- d. Any holes in the membrane are to be sealed. Membrane to be first cleaned with solvent, Blueskin SA membrane patch applied extending a minimum of 100 mm beyond the hole, and edges sealed with BES 925 sealant.

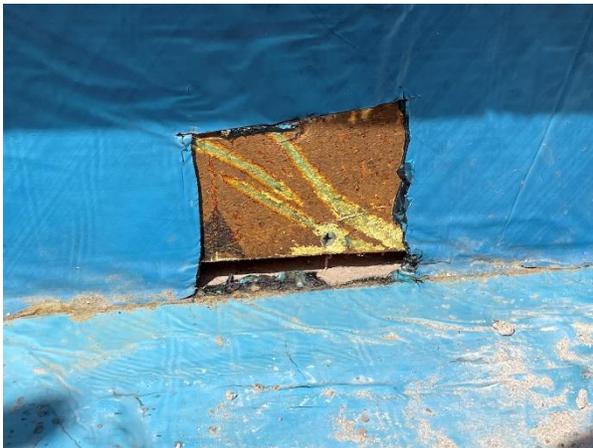
Image 13 – Sheathing substrate, unsupported membrane

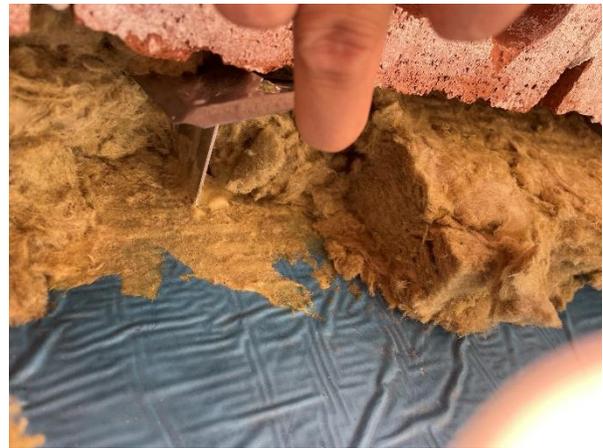
Image 14 – Masonry tie

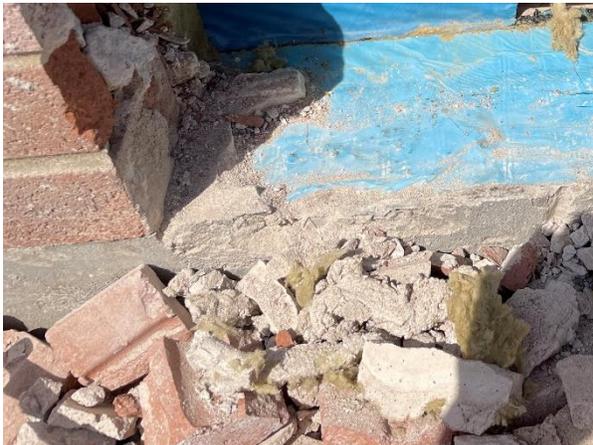
Image 15 – Mortar bed and parging

- b. Insulation to be removed and saved for reuse.
- c. The wire reinforced parging on the vertical face of the foundation wall is to be cut down to be flush with the concrete slab.

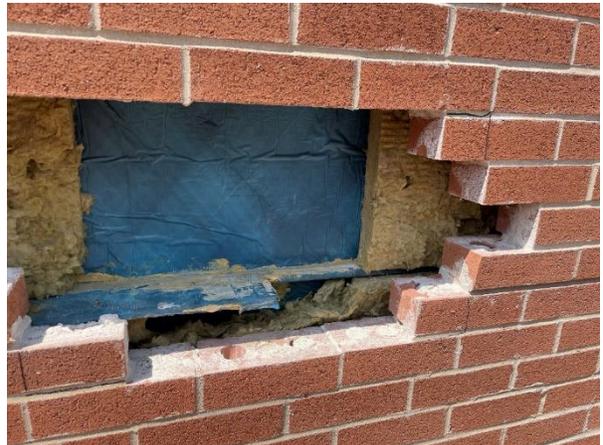
Image 16 – Exploratory opening 2

Five courses of masonry were removed at the shelf angle between first and second floor (four above and one below) at the location of the observed thermal anomaly. EXP noted that the angle to the south extended approximately 100 mm (4 in) out and projected into the masonry by approximately 13 mm (0.5 in). The angle was noted to align with masonry rather than the mortar joint, and the lower masonry unit was cut to

accommodate the angle. The angle to the north only projected out approximately 50 mm (2 in) with clearance behind the masonry. The difference in the depth of the angle was the cause for the observed thermal anomaly. In general, EXP noted the same construction details at this location as the base of the wall.

At exploratory opening 2, at the shelf angle, a small void was noted in the membrane at the inside corner, allowing water to bypass the waterproofing layer, at a location where water from the wall above would be accumulating to drain out. It should be noted that this angle is not performing the function of a shelf angle, which is to support the masonry above, and compartmentalize floors and divert water out of the cladding system, as it doesn't extend adequately beneath the masonry to perform these functions. For a two-storey masonry wall this is not a requirement, but it has an impact on the drainage and venting potential of the masonry cavity. The small void was sealed during reinstatement, and at this time there is no need for additional remediation at the "shelf angle" location.

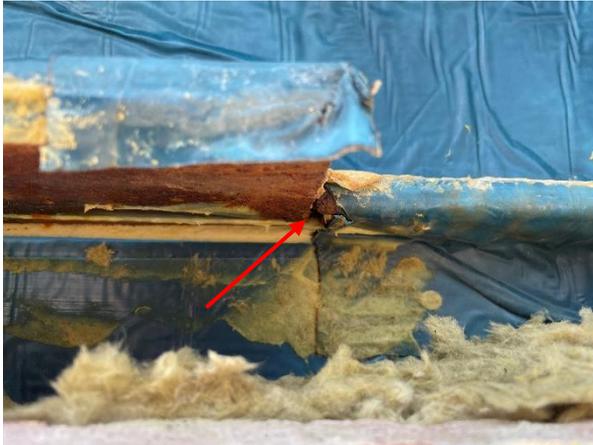
EXP noted one deficiency at this location that could lead to water infiltration. At the step in the steel angle, there was a void in the membrane and angle on the underside at the corner. This was sealed with membrane during reinstatement.

Image 17 – Void at inside corner

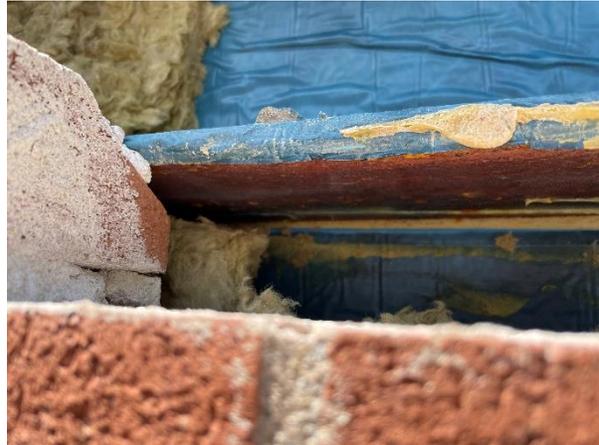
Image 18 – Masonry cut to accommodate angle

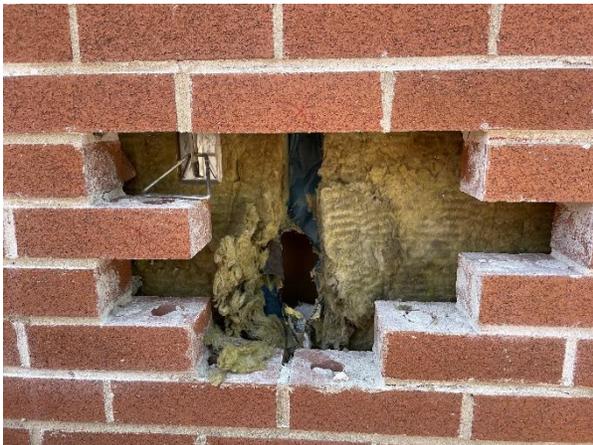
Four courses of masonry were removed at the thermal anomaly location in the field of the wall on the second floor adjacent to the window. Upon removal of the brick masonry only, EXP noted a hole through the insulation, Blueskin membrane (WRB) and exterior sheathing layers. Air exfiltration could be felt from this hole during the review. To the interior of the exterior sheathing layer EXP noted the backside of gypsum wall board on the interior side of the steel studs, which was intact.

Image 19 – Exploratory opening 3, as found

At exploratory opening 3, the thermal anomaly in the field of the wall was confirmed to be a large hole through the insulation, water resistive barrier and sheathing layers. This hole could allow water ingress into the wall cavity, as well as contribute to condensation due to the air leakage and lack of insulation. The void at this location was sealed and insulation added during reinstatement, so there is no need for additional remediation at this location.

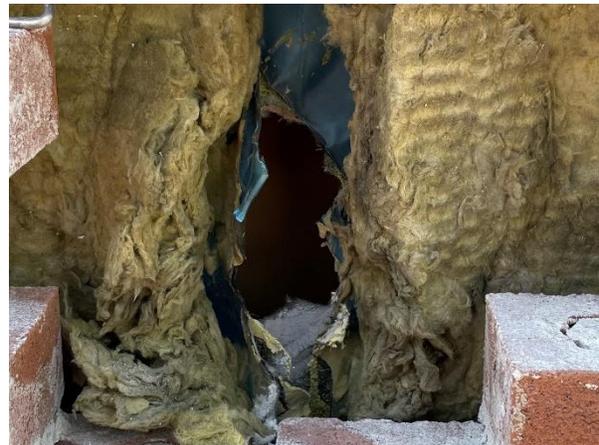
Image 20 – Hole through exterior sheathing

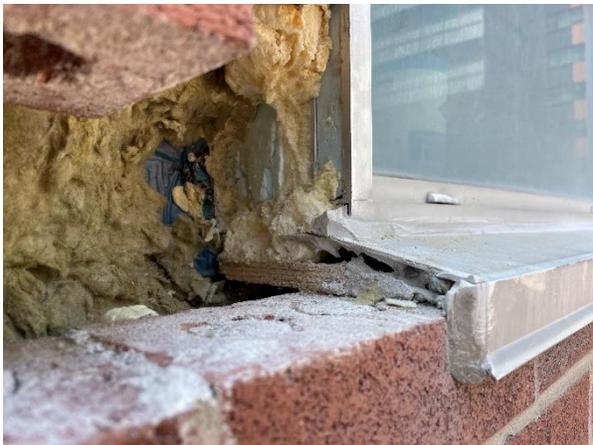
Image 21 – Exploratory opening 4

Two masonry units were removed adjacent to the window jamb at the sill to review the window tie-in details. EXP noted at the jamb, the Blueskin membrane WRB appeared to terminate at the edge of the exterior sheathing. Spray applied foam insulation was present between the rough opening and window frame. Additionally, rigid insulation (extruded polystyrene) was present within the window frame. At the sill, EXP noted a plywood sill pan extending from the rough opening to the masonry.

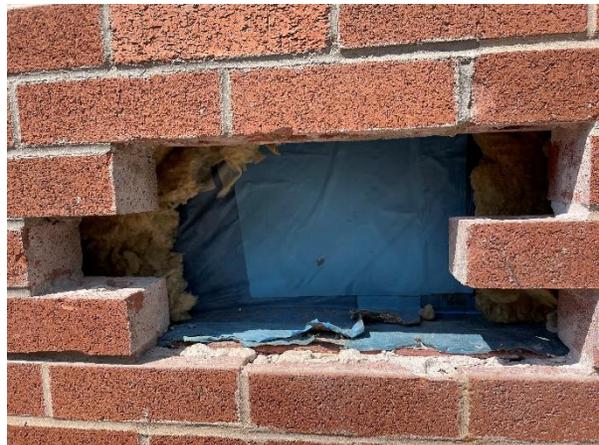
Image 22 – Exploratory opening 5

Three courses of masonry were removed at the edge of the masonry repair area to review the conditions behind. EXP noted a Blueskin SA membrane patch was present at this location. Additionally, EXP noted that the shelf angle projected into the mortar joint at this location.

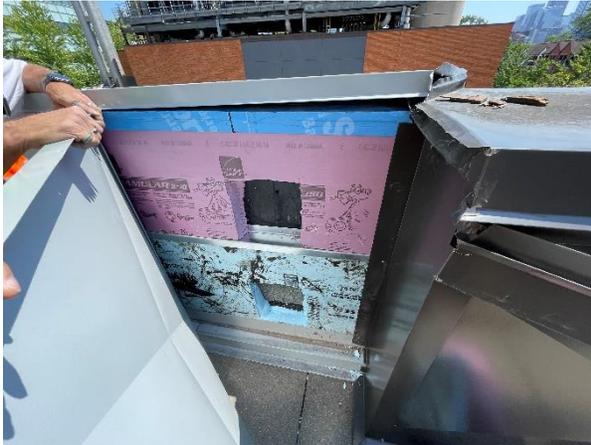
Image 23 – Exploratory opening 6

At the roof parapet the metal cap flashing and metal cladding on the interior side of the parapet were partially dismantled, including the removal of pavers at roof level. At the parapet, beneath the metal cap flashing, Blueskin SA membrane was noted to protect the wood parapet blocking. Beneath the blocking EXP noted the Blueskin WRB from the exterior wall appeared to tie into a modified bituminous roof membrane base sheet which extended from the interior side of the parapet wall over the top of the parapet. At the south end at the transition to darker coloured parapet, EXP noted a poorly installed transition of the membranes at this location.

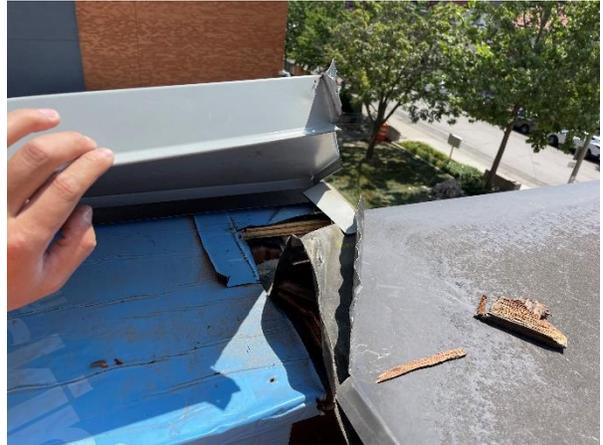
Image 24 – Poor membrane tie-in

At the south end of the parapet, where there is a slight jog and it meets the darker coloured portion, there was a poor tie-in between membranes at the two phases of construction. As different membranes were present, it is likely they were constructed at different times. The membrane discontinuity at this location likely wouldn't allow bulk water ingress as it is protected by the metal flashing, but it may be a source of air leakage, which could contribute to condensation and energy loss. This connection should be further opened and the tie-in of the two constructions made continuous.

- a. At the transition of the two dissimilar parapets, metal cladding and flashing to be removed.
- b. New self-adhered membrane (Blueskin SA) to be applied to transition between the two parapets to maintain continuity.

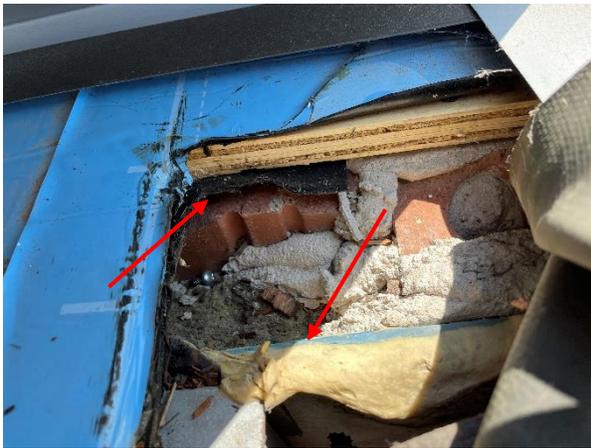
Image 25 – Wall WRB tie-in to mod. bit. membrane

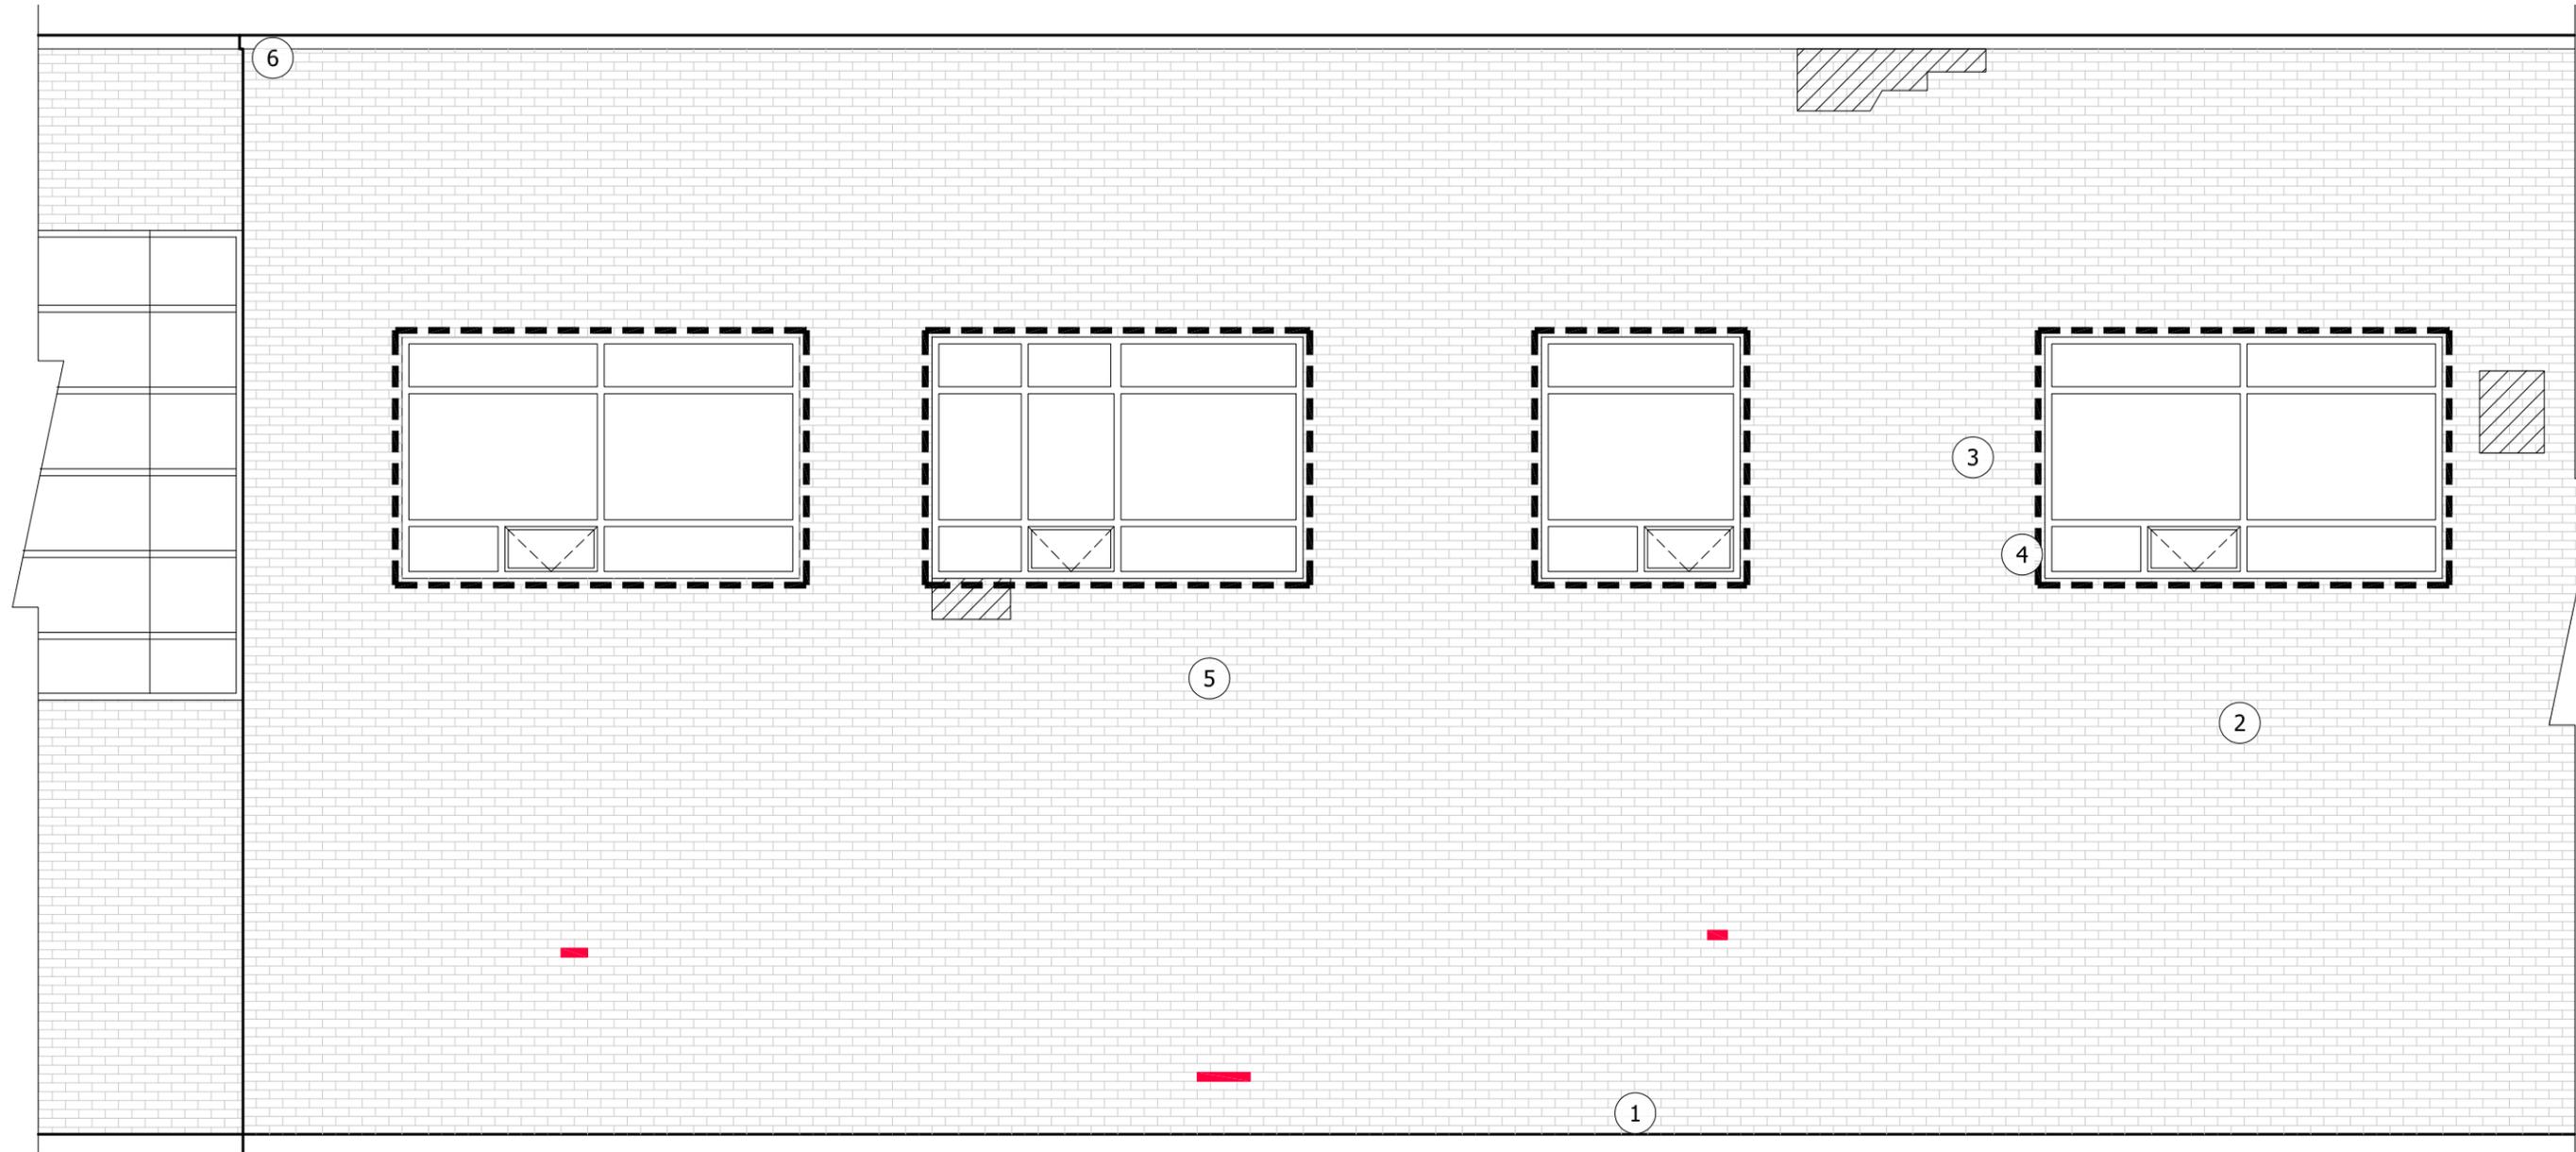
1 PARTIAL ELEVATION
Scale: N.T.S.

The visual review of the masonry wall, sealants and windows identified various deterioration. The following items were noted and identified on Drawing SK-2 in Appendix B.

1. Individual damaged brick units noted at three locations
2. Loose bricks/ cracking mortar joints noted at the parapet, one location
3. Minor mortar deterioration at isolated mortar joints
4. Debonding sealant at window perimeters throughout
5. Weep holes at base of wall partially obstructed with mortar
6. A previous masonry repair area beneath the second window from South, extending from shelf angle to window sill

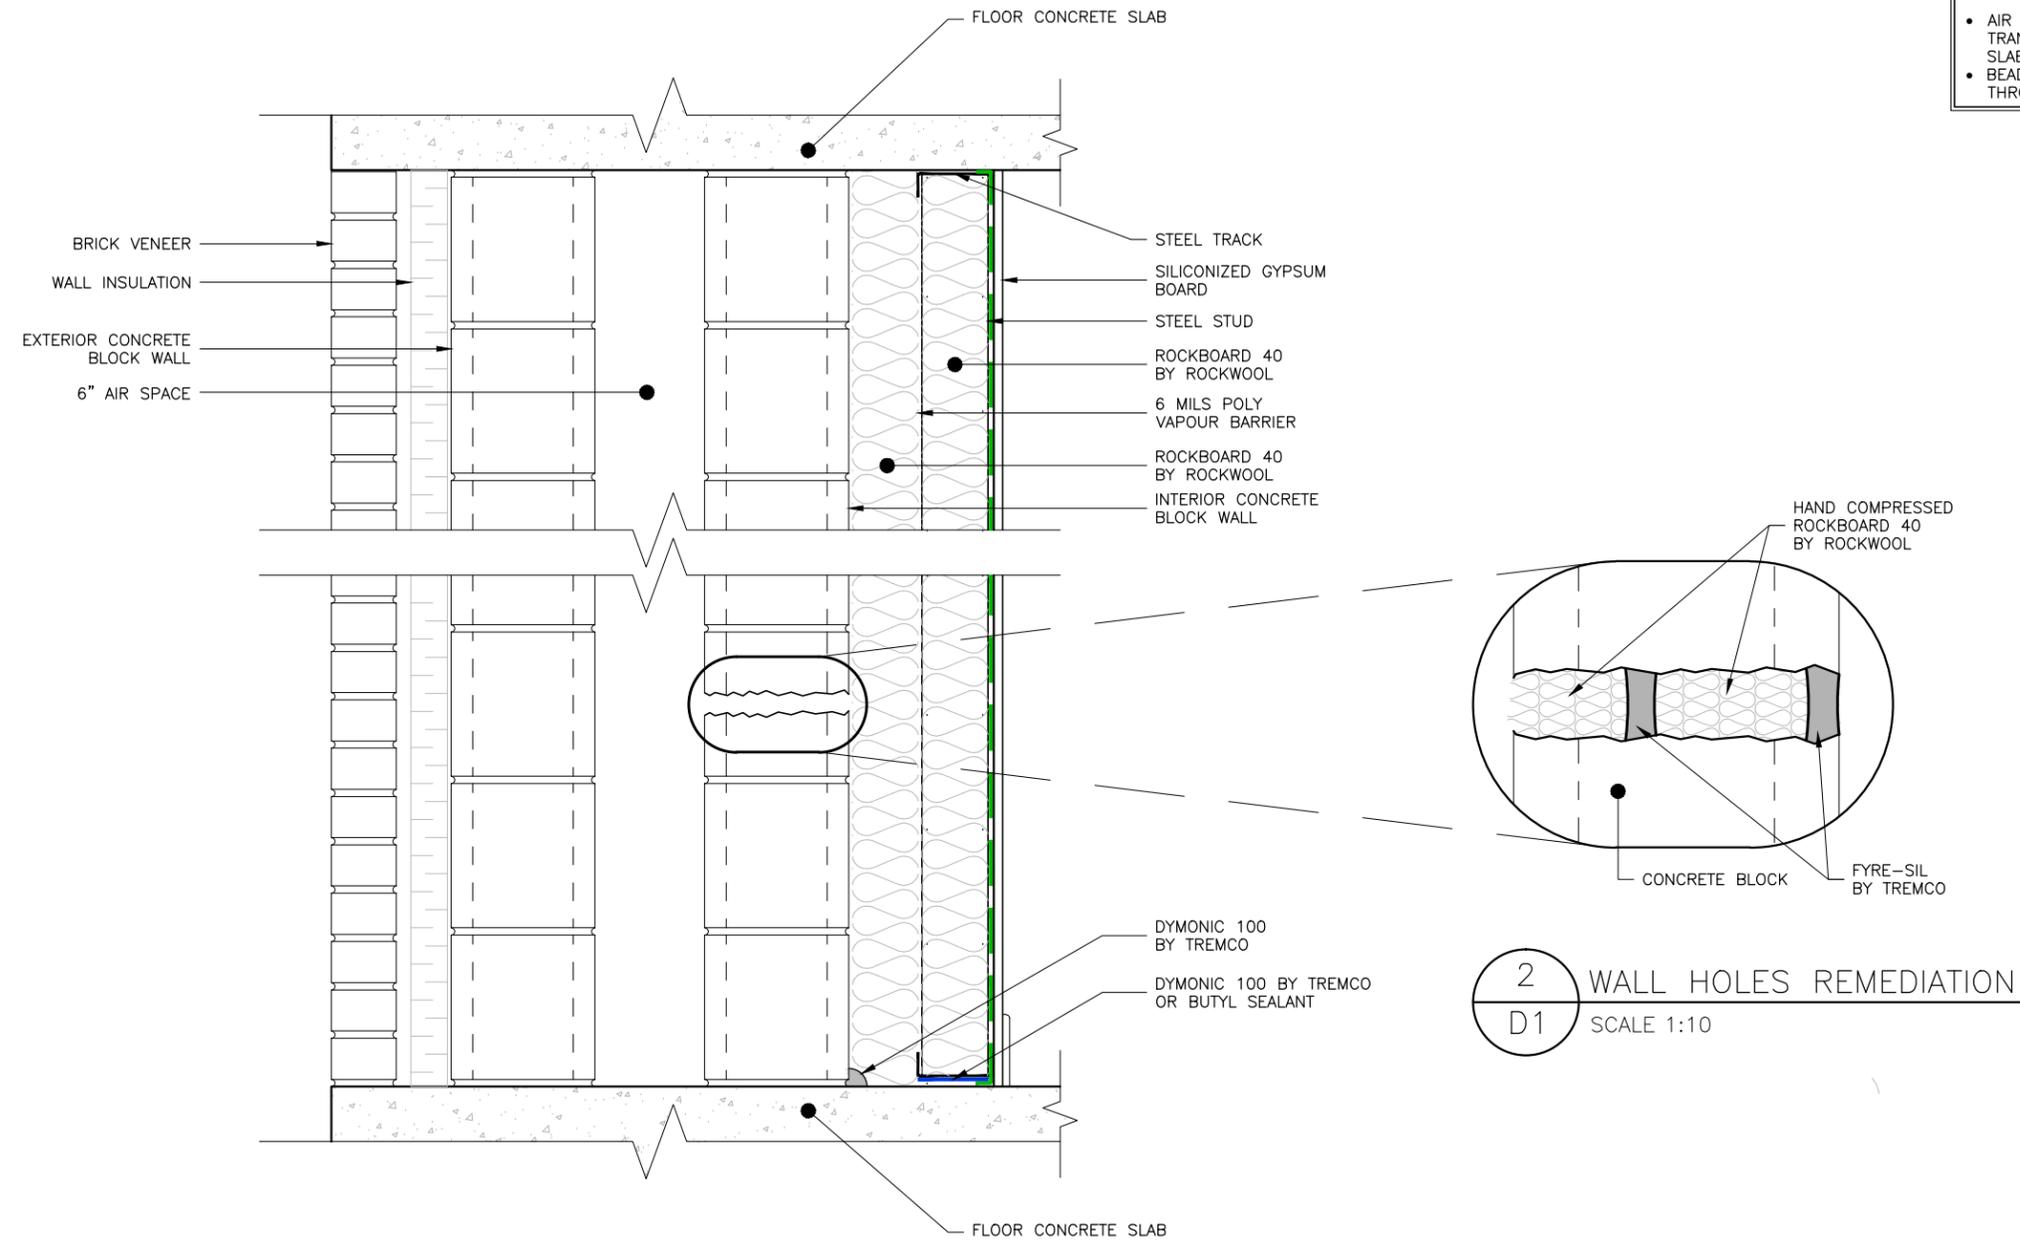
1 WALL SECTION
D1 SCALE 1:10

Lastly, EXP noted that the drawing of the wall section detail, D1, by IRC, did not match the site conditions. The drawing shows concrete block wall behind the exterior masonry cladding, however, after masonry removal, EXP noted Blueskin SA membrane was installed on exterior sheathing which was installed on steel studs (i.e., no concrete block). Additionally, EXP noted that where the interior wall has been remediated in 2020 due to the flooding, a polyethylene vapour barrier was installed on the interior side. As Blueskin SA membrane was installed on the exterior side, a vapour retarder is present on the interior and exterior of the wall section. This could potentially lead to interstitial condensation and the double vapour retarder would prevent drying in either direction, which could lead to moisture problems. It is not clear from the provided documents whether the existing interior wall had a polyethylene vapour barrier installed, or if it was added only in the remediated portion.

Prior to conducting the above noted repairs, EXP recommends further investigation to review the discrepancy between the wall section drawing and the observed conditions, as well as the double vapour retarder. The results from the additional investigation could have an impact on the repair recommendations. EXP recommends conducting additional exterior openings from grade to confirm that the Blueskin on sheathing observed is consistent throughout, and removal of additional layers to verify the wall construction. Additionally, an interior opening at an existing location adjacent to the remediation location would be required to verify the pre-existing conditions along the remaining wall. Once the actual exterior wall construction details are confirmed, a hygrothermal analysis should be conducted to determine if the double vapour retarder could lead to condensation issues, and to determine appropriate remediation options.
