**399 BATHURST STREET
TORONTO, ON**

FCAP-TW ROOF CONDITION ASSESSMENT

FINAL REPORT

October 20, 2017

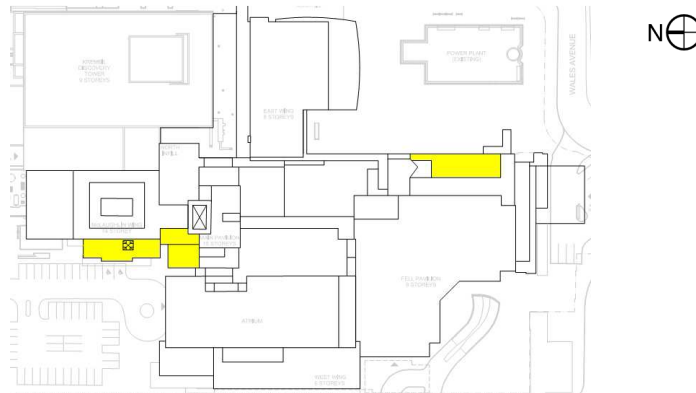
At the time of this report, several of the roof areas were reportedly to have experienced and are experiencing active water leaks as shown in the figure below.

Figure 4 – Past and active roof water leaks as indicated by TWH (shaded yellow).

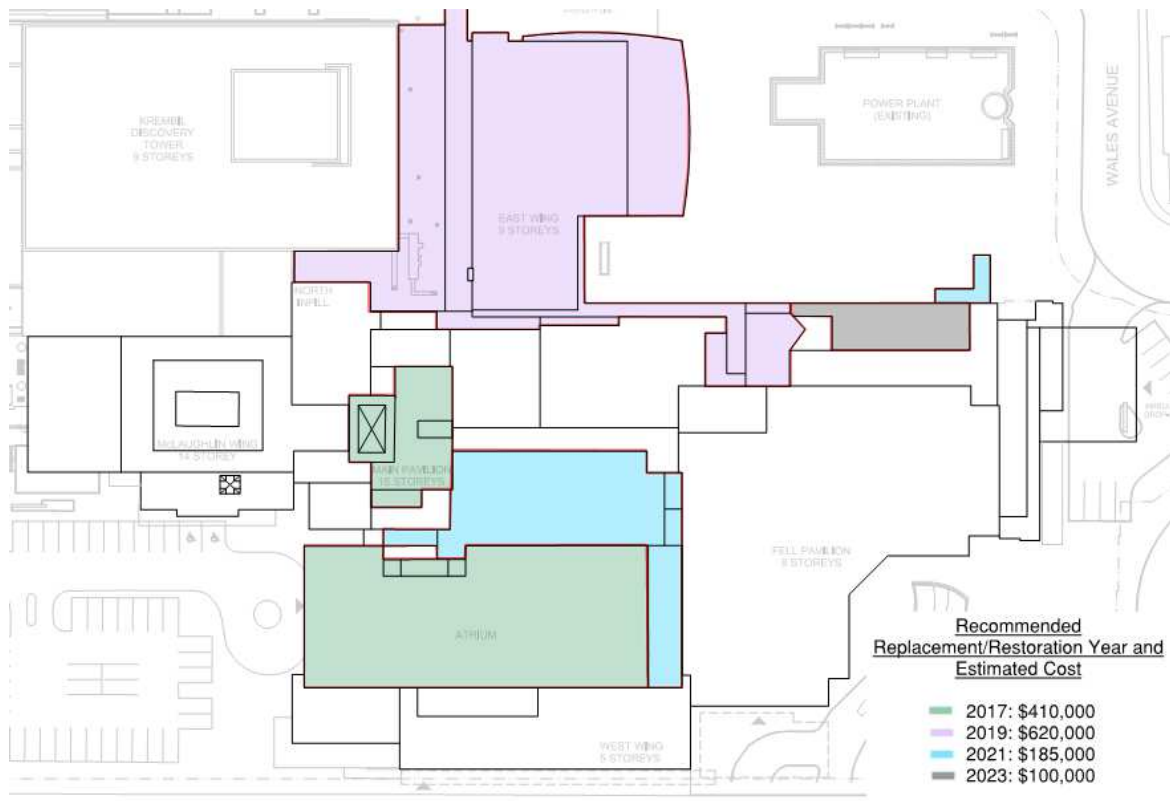
Figure 6: Recommended Repair Year and Estimated Cost

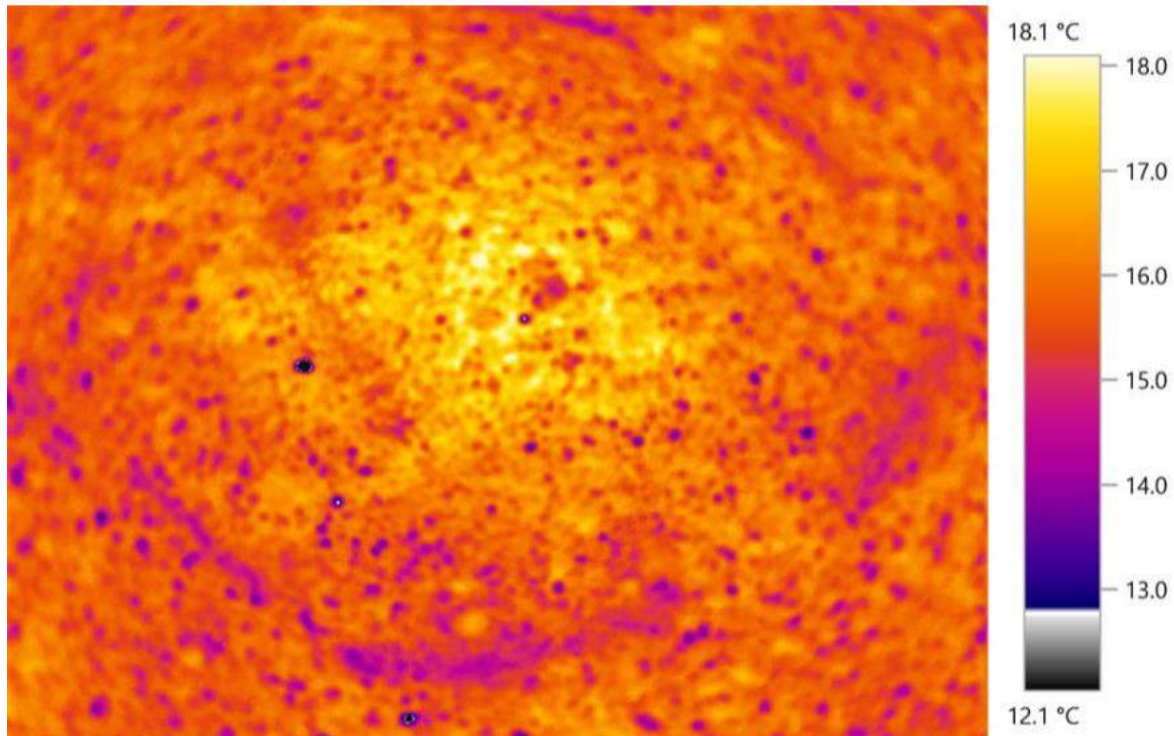
Location 1: M2.0, Dimensions: 3'x3' = 9ft²

Notes: The elevated surface temperature may indicate presence of water under the BUR. Possibility of false positive due to thicker ballasting.

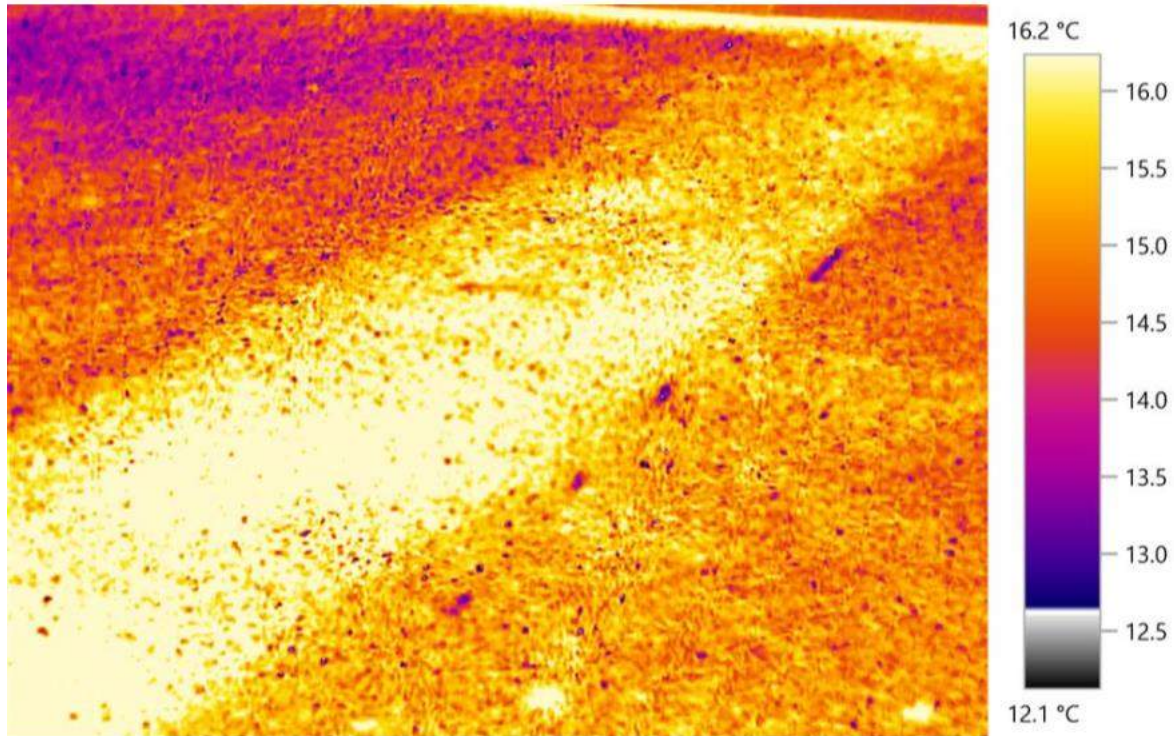
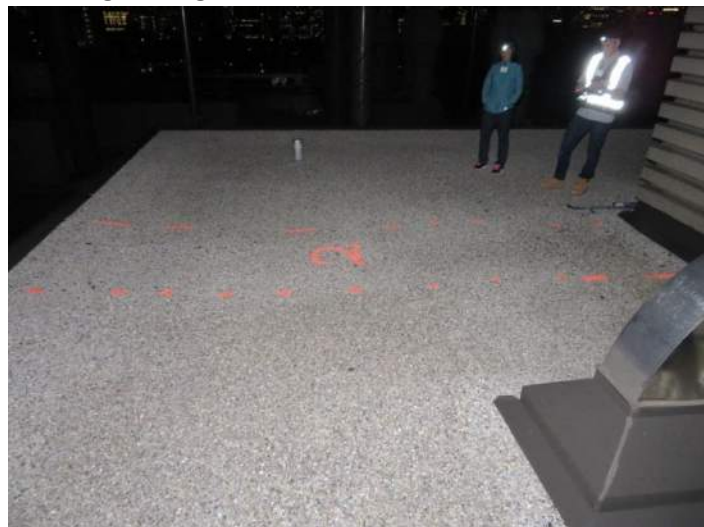
Location 2: M1.2, Dimensions: 4'x18' = 72ft²

Notes: The elevated surface temperature may indicate presence of water under the BUR.

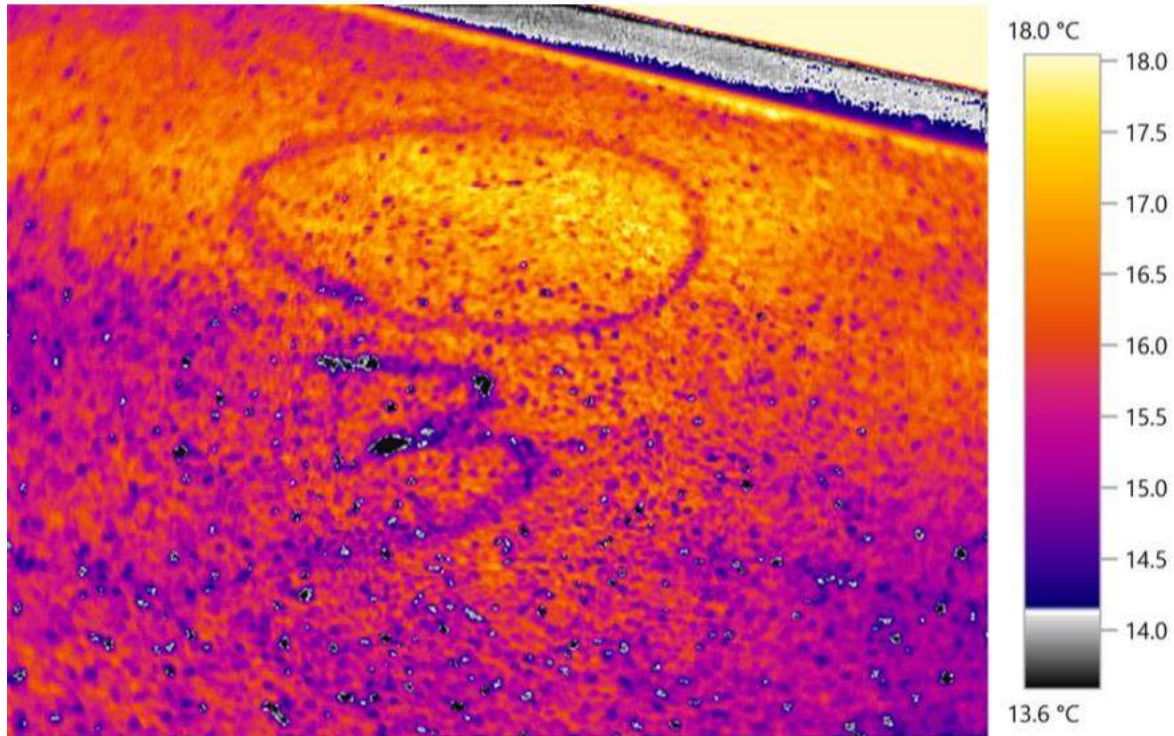
Location 3: M1.2.0, Dimensions: 2'x3' = 6ft²

Notes: The elevated surface temperature may indicate presence of water under the BUR.

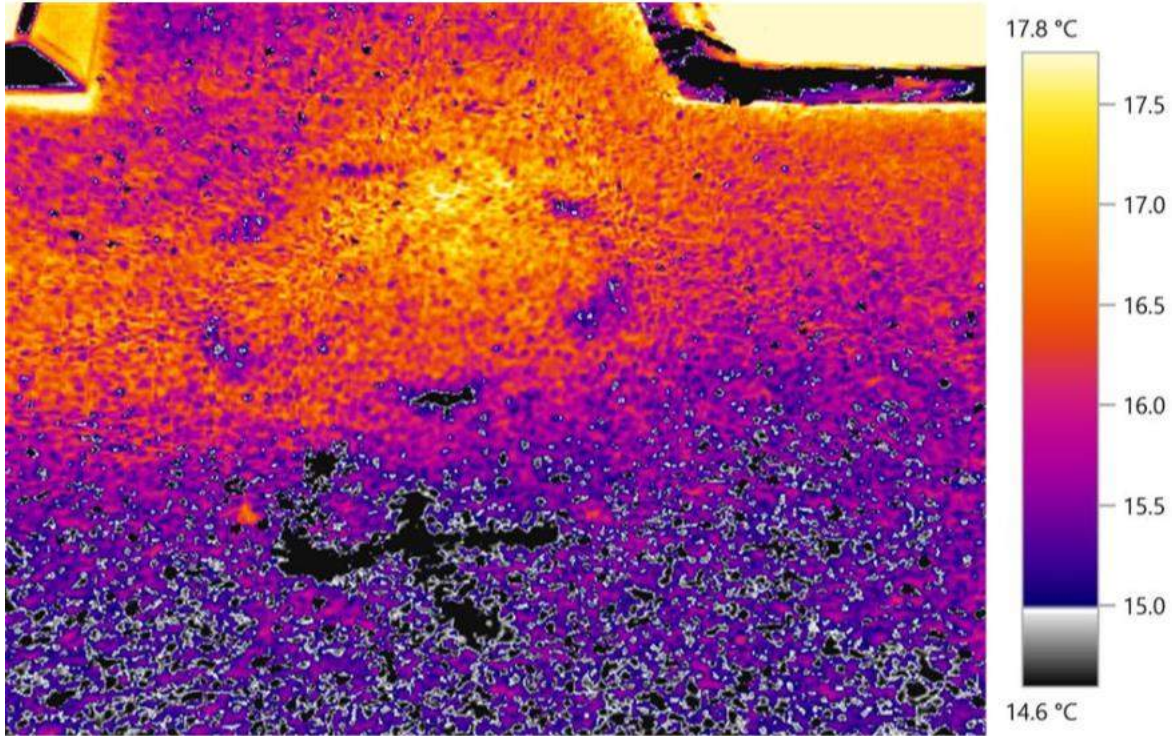
Location 4: M1.2.0, Dimensions: 2'x2' = 4ft²

Notes: The elevated surface temperature may indicate presence of water under the BUR.

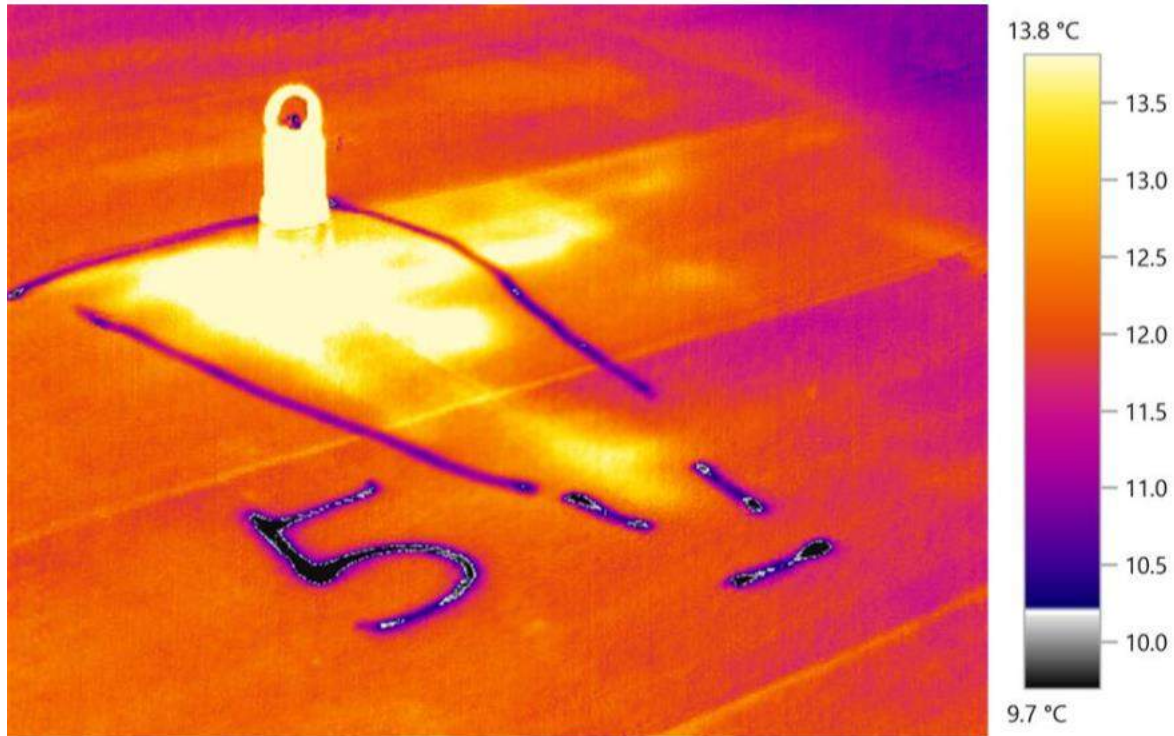
Location 5: EW1.1, Dimensions: 1.5'x6' = 9ft²

Notes: The elevated surface temperature may indicate presence of water under membrane. Signs of picture framing.

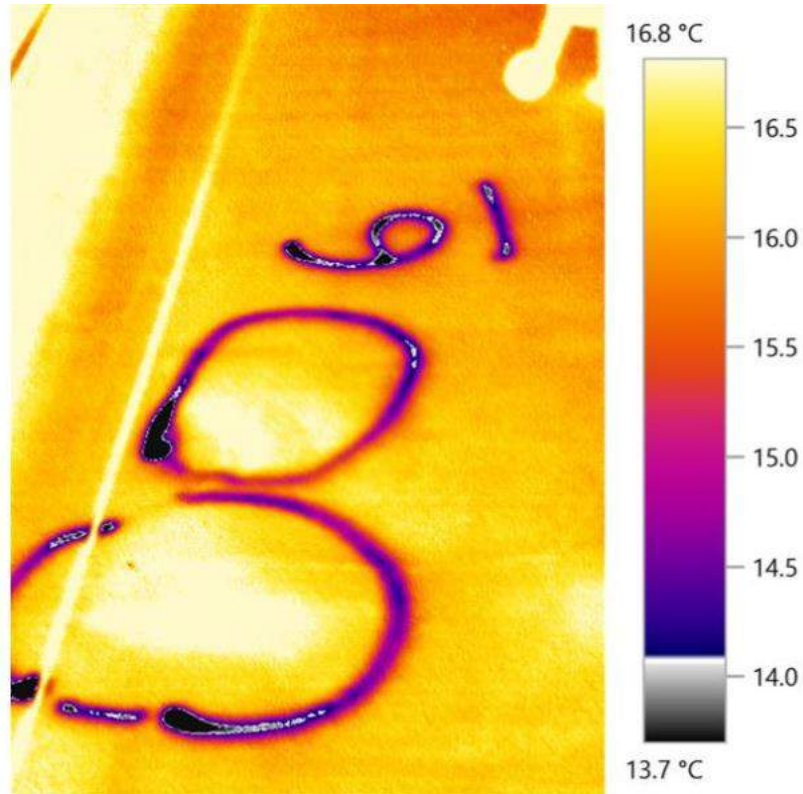
Locations 6 – EW1.2, Dimensions: 2'x3' = 6ft²

Notes: The elevated surface temperature may indicate presence of water under air blister/delamination bubbles.

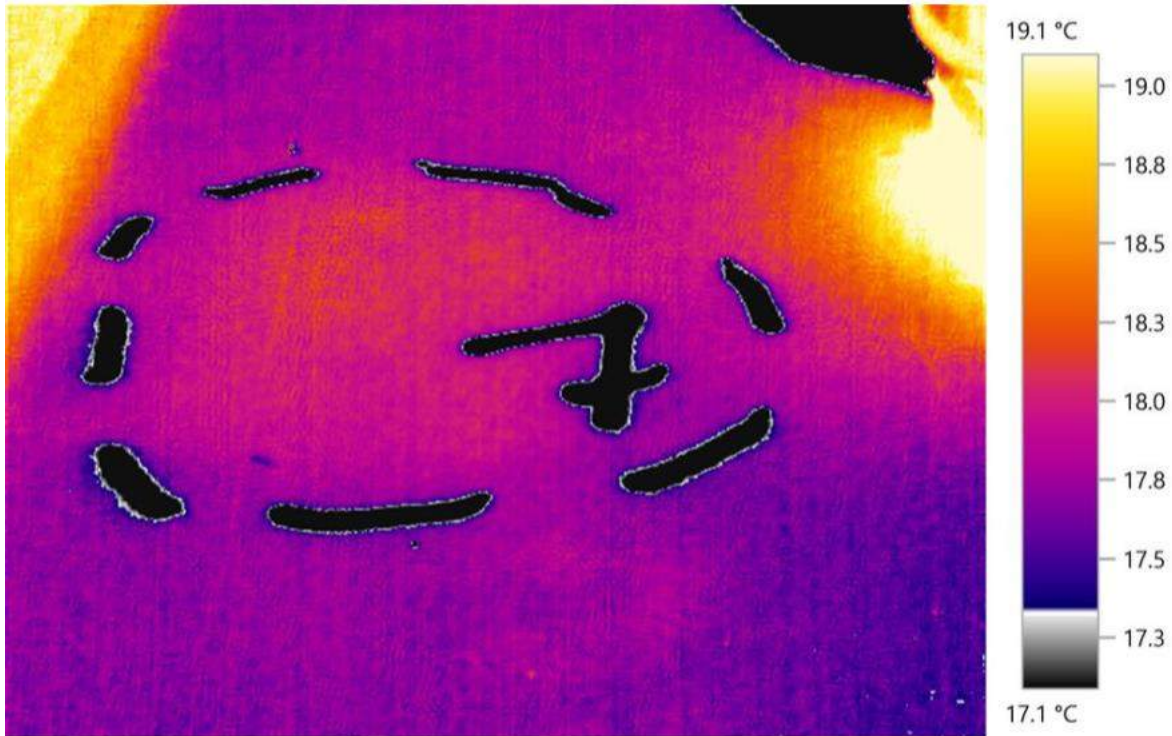
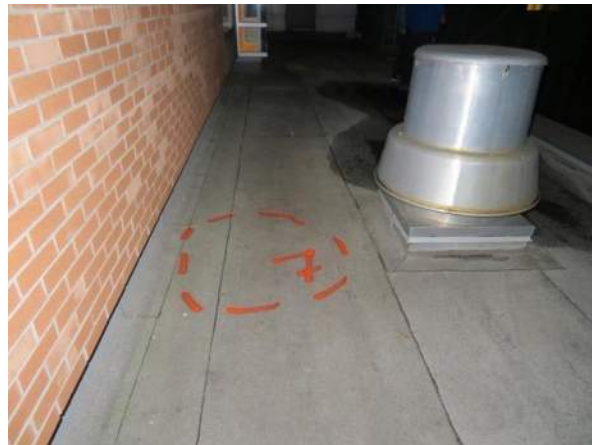
Location 7: EW2.0, Dimensions: 4'x3' = 12ft²

Notes: The elevated surface temperature around the drain may indicate presence of water under the membrane. A deep crescent was observed in the centre of the circle.

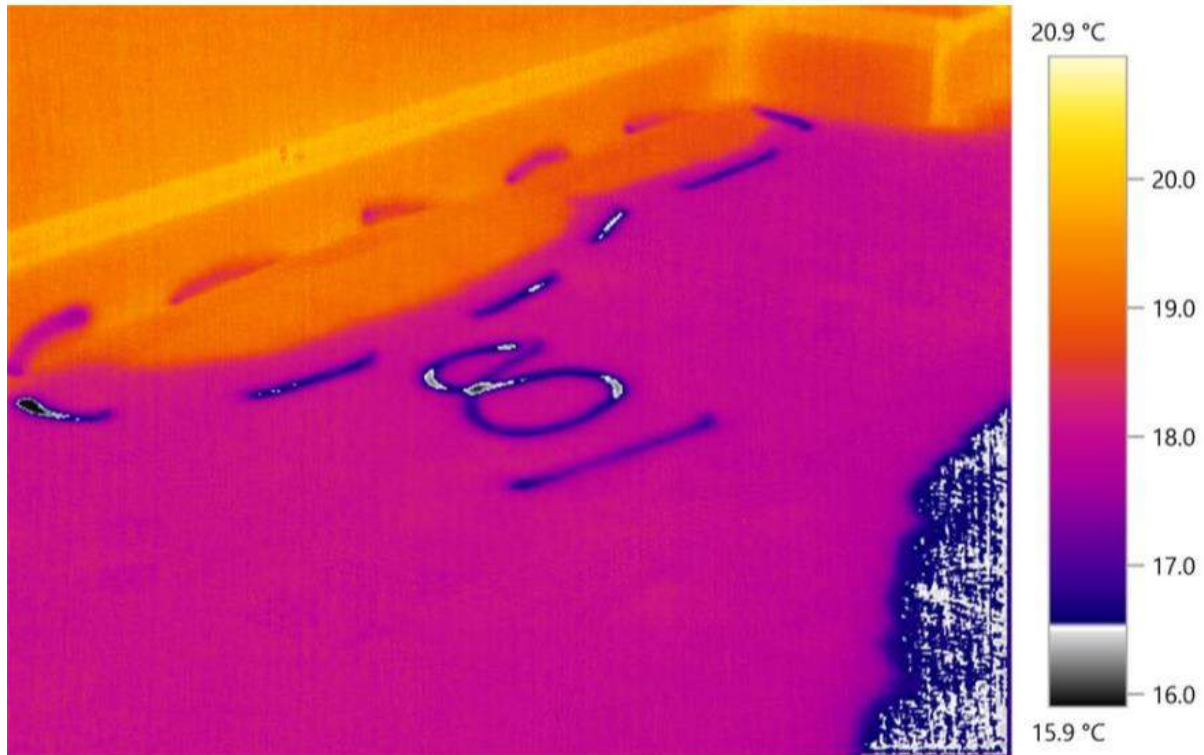
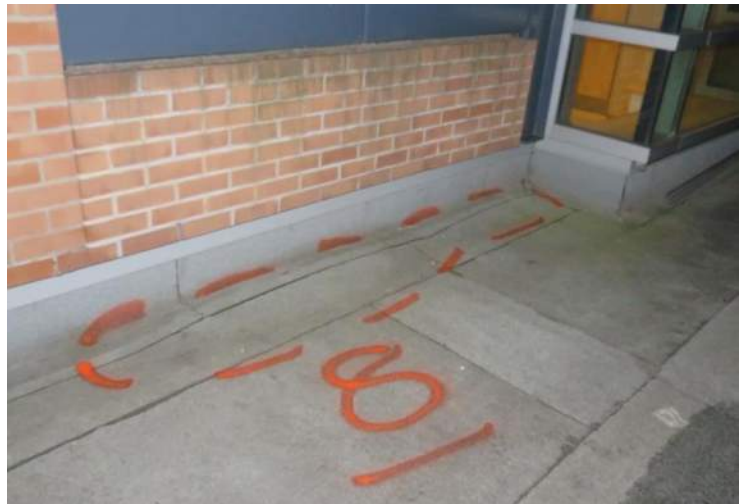
Location 8: EW2.0, Dimensions: 7'x1' = 7ft²

Notes: The elevated surface temperature may indicate presence of water under the bubbling/delaminated membrane.

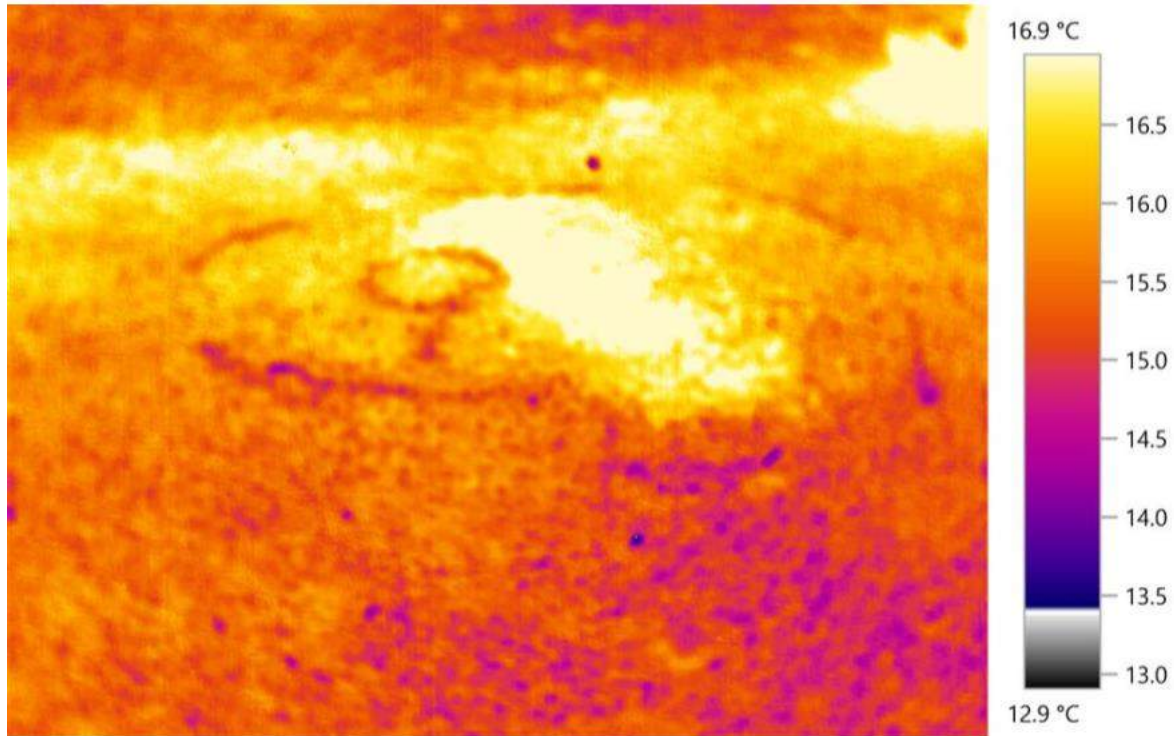
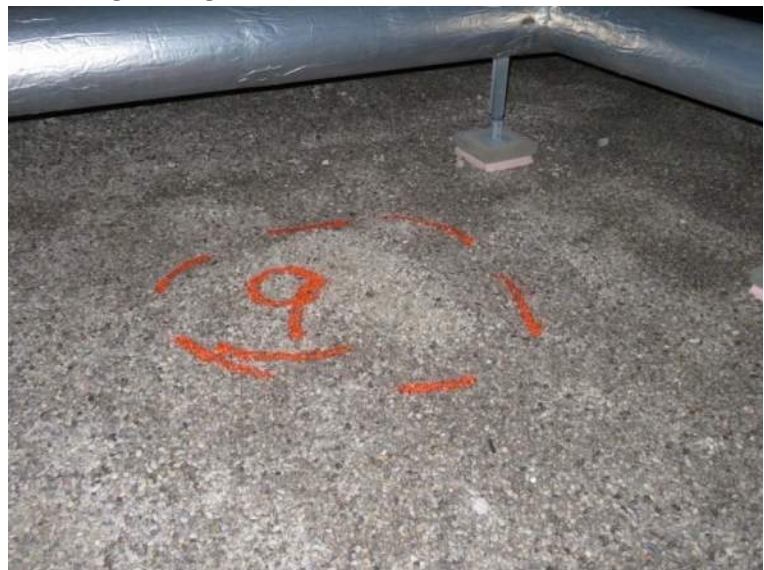
Location 9: F08, Dimensions: 4'x4' = 16ft²

Notes: The elevated surface temperature may indicate presence of water under the BUR.

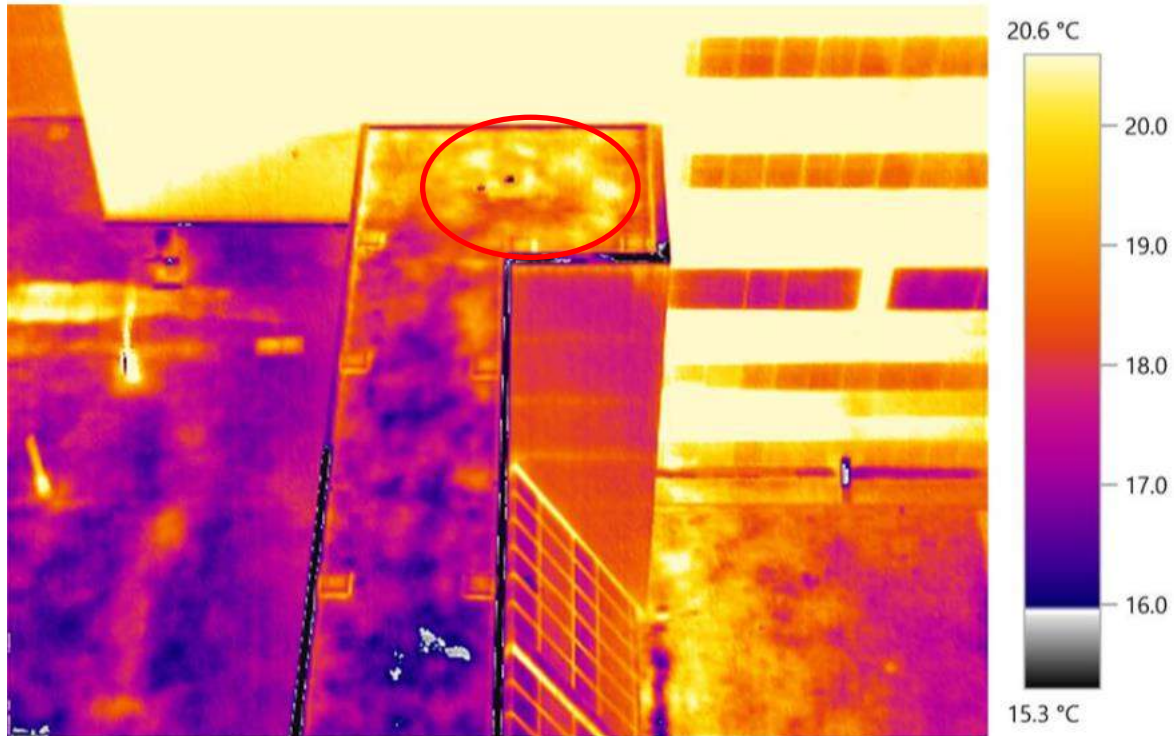
Location 10: F3, Dimensions: max 3'x3' = 9ft²

Notes: The elevated surface temperature may indicate presence of water under the membrane in a radial pattern centered on the vent/drain. We were unable to access this roof and suggest further testing.

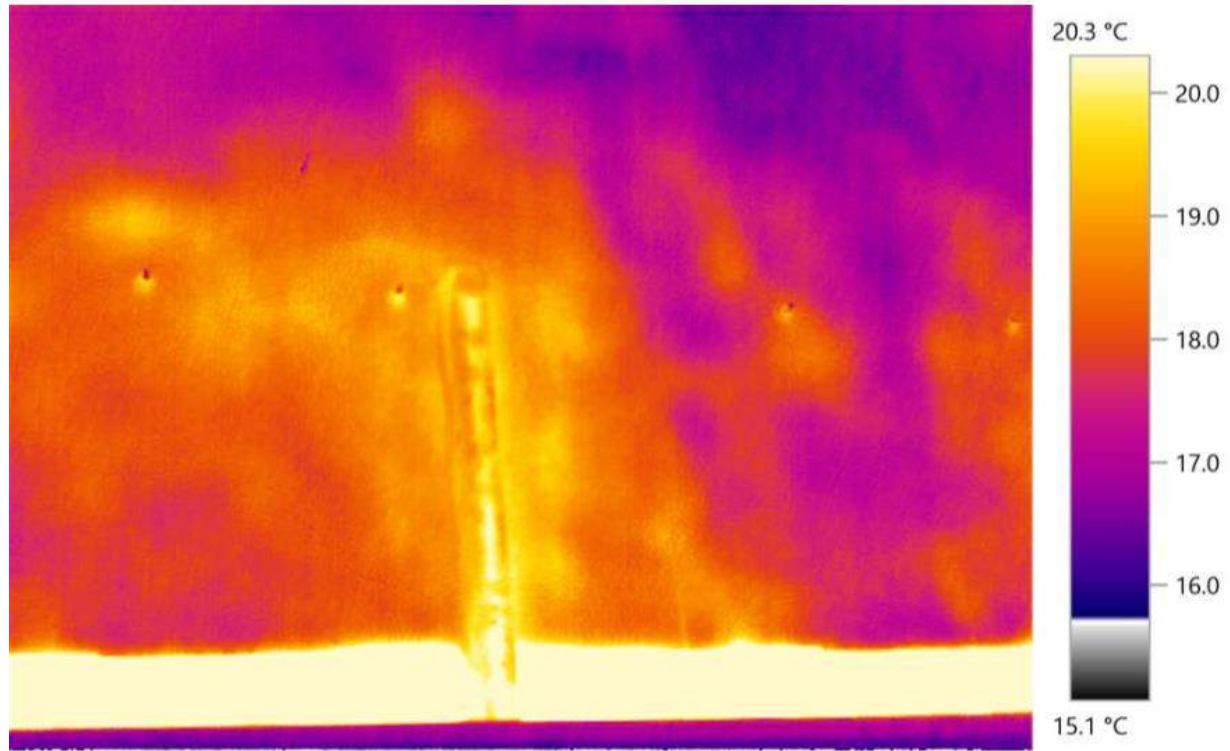
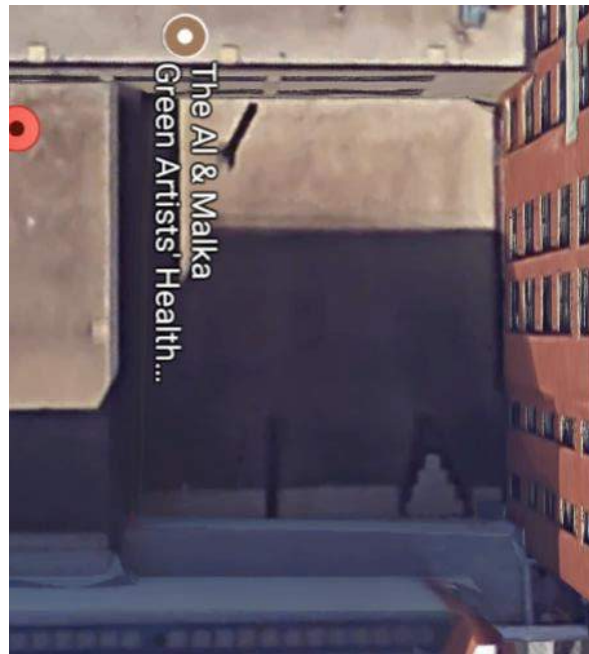
Location 11: F5.0, Dimensions: 12'x12' = 144ft²

Notes: We were unable to access this roof and suggest further testing. The elevated surface temperature may indicate presence of water under the membrane. This roof may not have experienced enough solar gain to radiate as much, but worth further investigation.

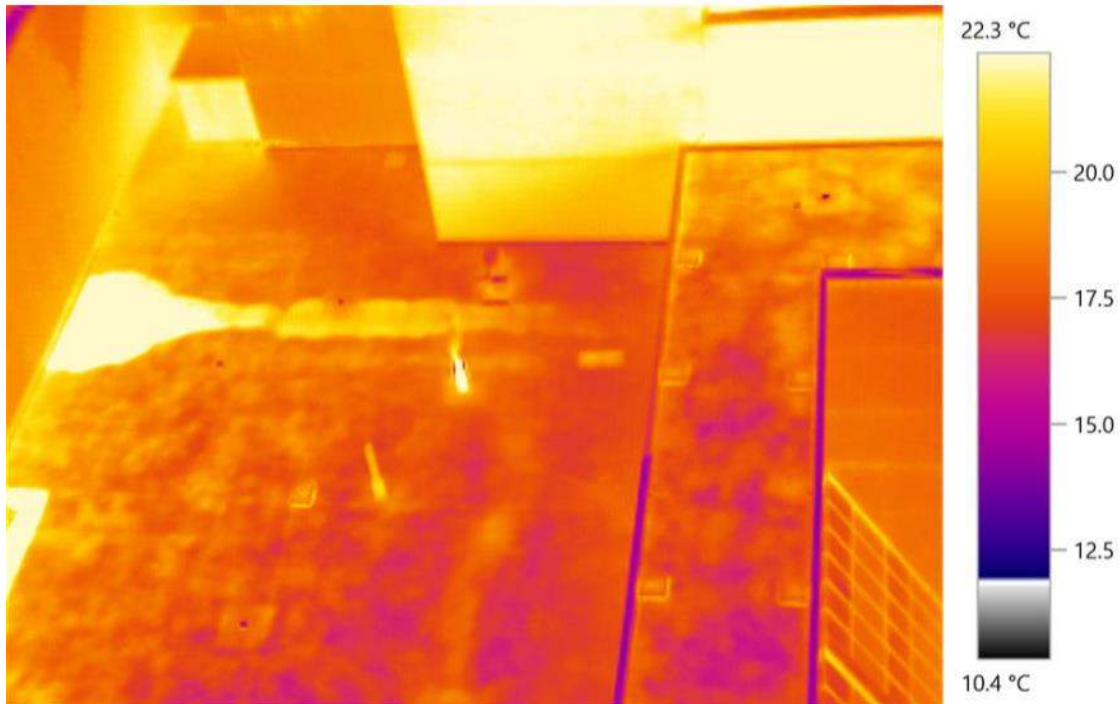
Location 12: F4.0, Dimensions: 3'x12' = 36ft²

Notes: We were unable to access this roof and suggest further testing. The elevated surface temperature may indicate presence of water under the membrane. This roof may not have experienced enough solar gain to radiate as much, but worth further investigation.

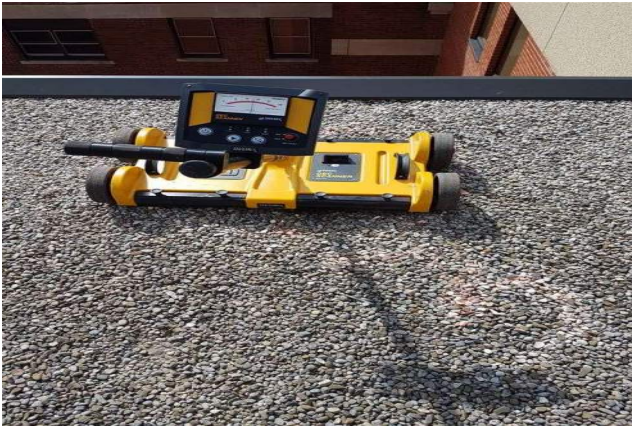
This area was scanned in summer 2017 - a 4' x 18' area of wet insulation was identified

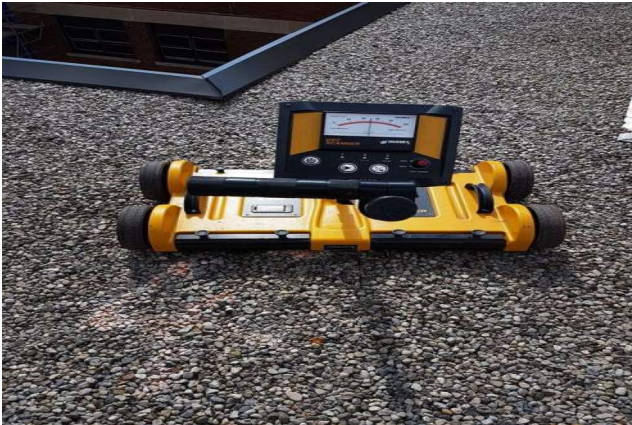
Suspected wet area #3 as per the BlueGreen Consulting scan - slight increase in moisture content but not enough to suggest wet insulation. The false positive from the original scan likely resulted from the heavy coverage of gravel in that specific area.

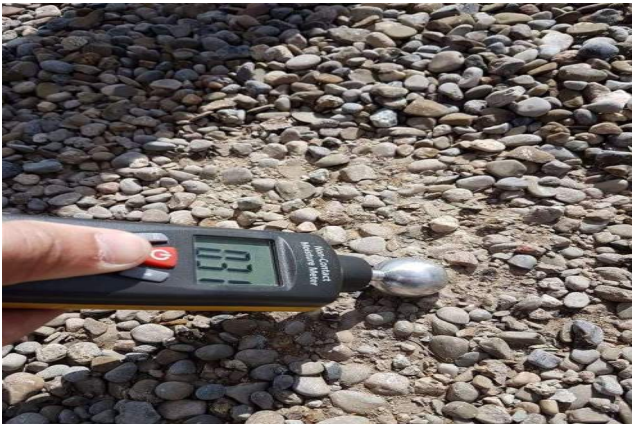
Suspected wet area #4 as per the BlueGreen Consulting scan - slight increase in moisture content but not enough to suggest wet insulation. The false positive from the original scan likely resulted from the heavy coverage of gravel in that specific area.

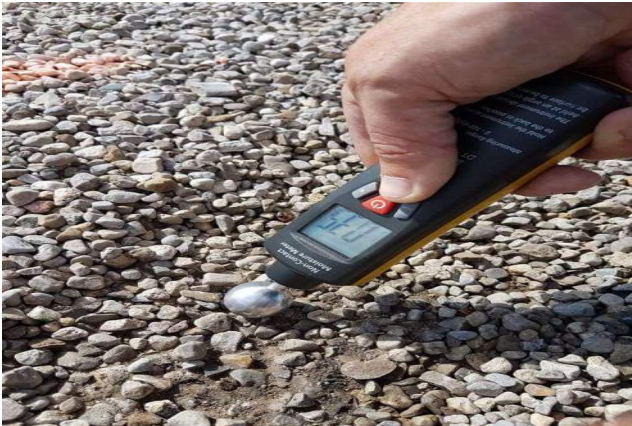
Suspected wet area #3 - Non destructive moisture probe reads 31 compared to 30 on a dry area. This is a negligible increase in sub surface moisture content.

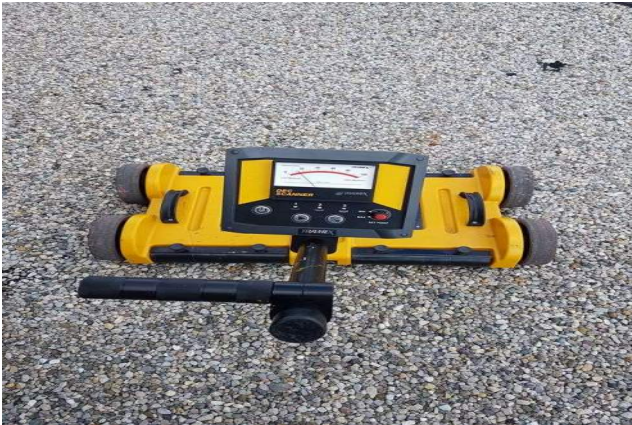
Suspected wet area #4 - Non destructive moisture probe reads 35 compared to 30 on a dry area. This is a negligible increase in sub surface moisture content.

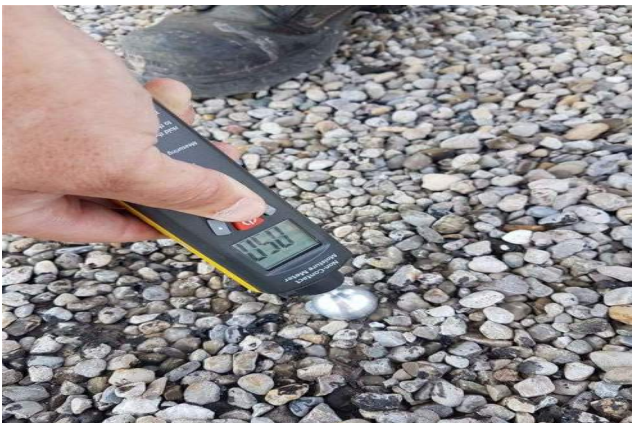
Suspected Wet Area #2 - Trammex reading on suspected area is 100. The original scan on this area is accurate. It has around 72 Sq. Ft. of wet.

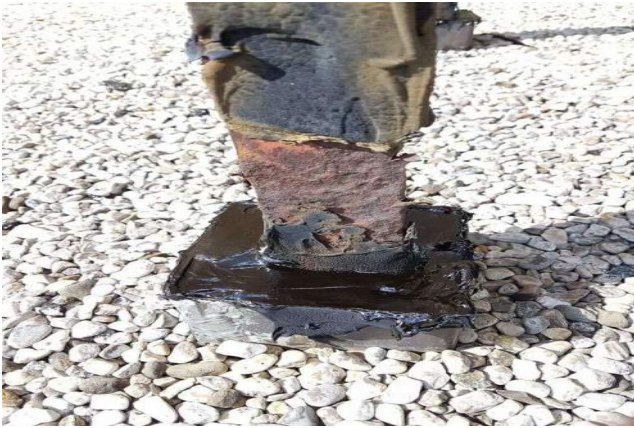
Suspected Wet Area #2 - non destructive moisture probe read 51 vs. baseline of 23. This area is wet.

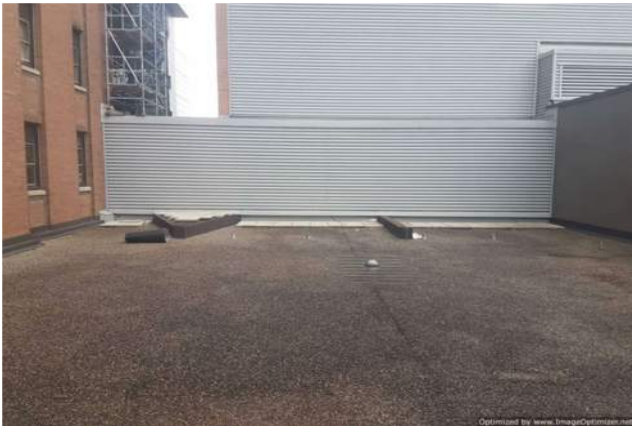
A reading of 54 on the area divider indicating that there is sub surface moisture. It also felt wet to the touch. This membrane was not part of the original Tremco roof and was altered after the fact, voiding the warranty.

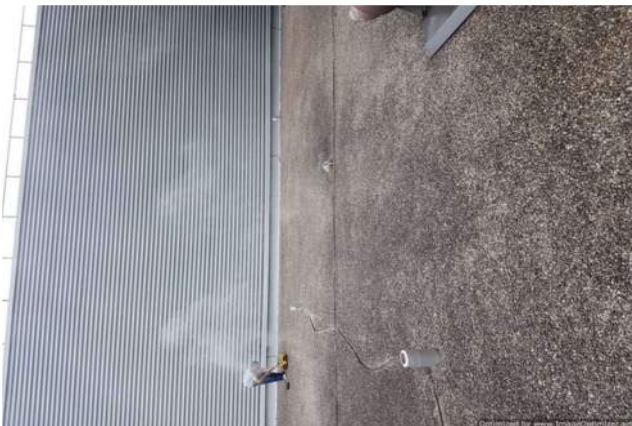
Anomaly #12 - The Tramex Dec scanner verifying that anomaly #12 in the BlueGreen report is accurate and this area of roof (approx. 36 sq. ft) is wet.

Due to the age of the warranted Tremco roof and the lack of penetration near the area of wet insulation we would like to investigate the roof/wall connection at the top of this wall to verify that it isn't the source of the moisture entry.

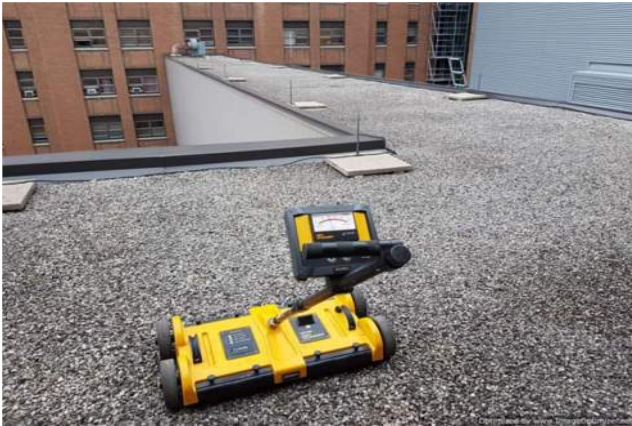
This roof was scanned in summer 2017 - no wet insulation was identified

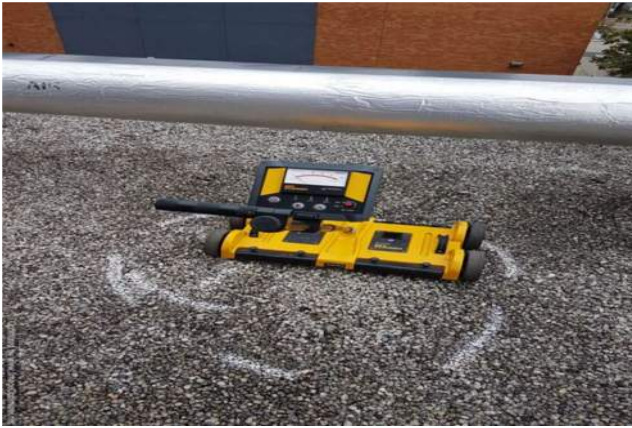
Anomaly # 9 - the Tramex confirmed that this was a false positive likely caused by a heavy distribution of aggregate on the roofs surface
