**LIMITED DESIGNATED SUBSTANCE SURVEY  
REPORT  
(RENOVATION AREAS)**

**Sunnybrook Health Sciences Center K Wing 3<sup>rd</sup>  
Floor Center and East Pod  
2075 Bayview Avenue  
Toronto, Ontario**

**August 4, 2020**

**Maple Project No. 18903**

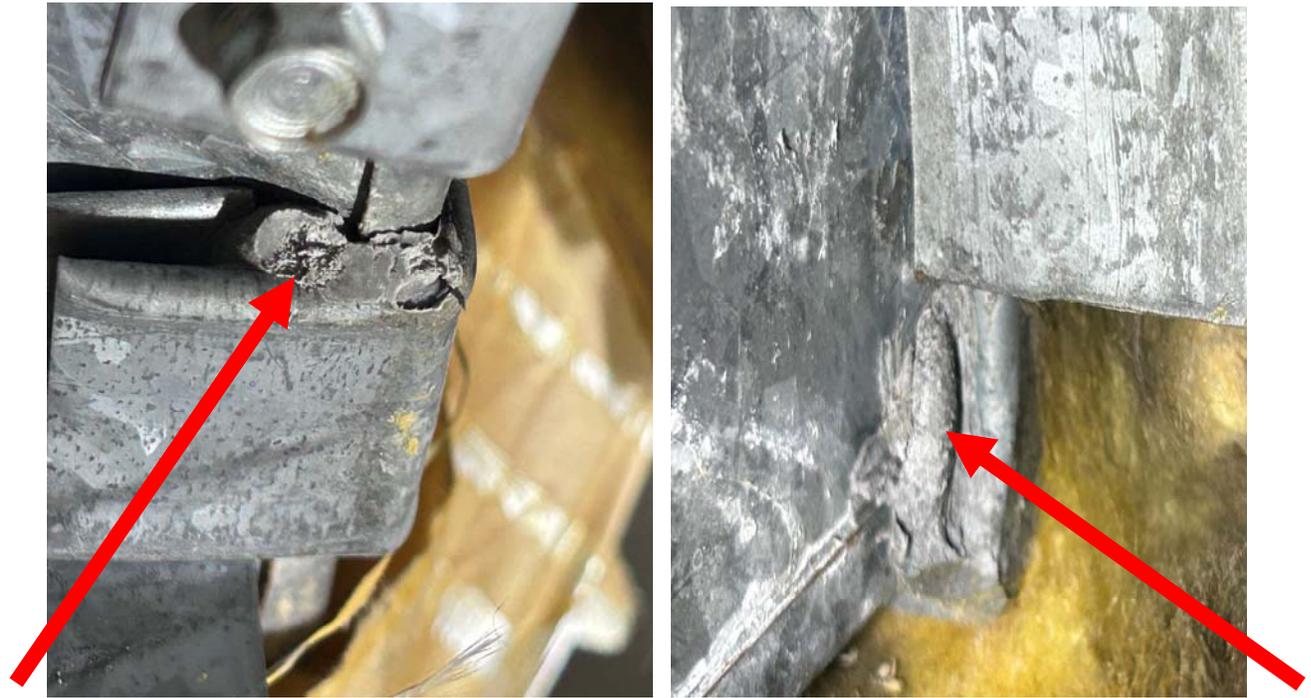
Figure 1

On K2C survey area, there was a grey mastic material observed at the flange of the Ductwork where the sections are joined together on the main line.

Three (3) representative samples of duct mastic were collected (Sample Set 21292 S01) and was analyzed for asbestos content. Analysis of Sample Set S01A found that the mastic contained **2% Chrysotile asbestos**. The mastic was concealed by the flange as shown in Figures 1 and 2.

The grey duct mastic material was observed to be in GOOD condition at the time of the assessment.
