DESIGNATED SUBSTANCES and HAZARDOUS MATERIALS SURVEY

LONG TERM CARE HOMES & SERVICES **Lakeshore Lodge** **3197 Lake Shore Boulevard West** **Toronto, Ontario**

Project Number: FE 23-12800

SEPTEMBER 1, 2023

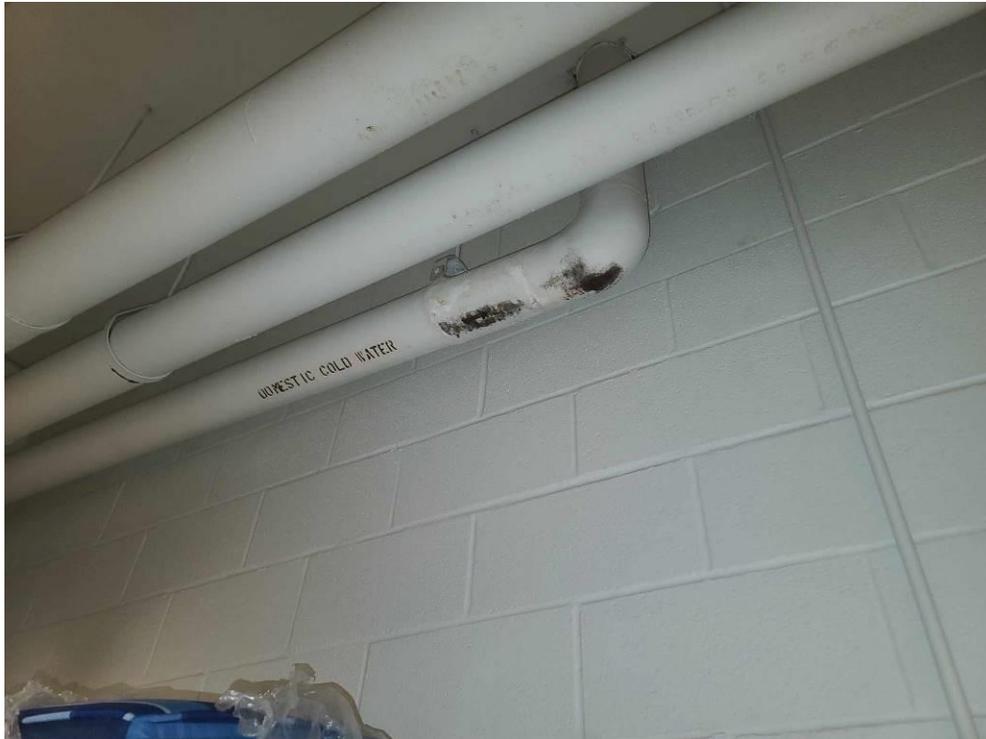
Photo 1: Mould Impacted pipe insulation in Location B-009.

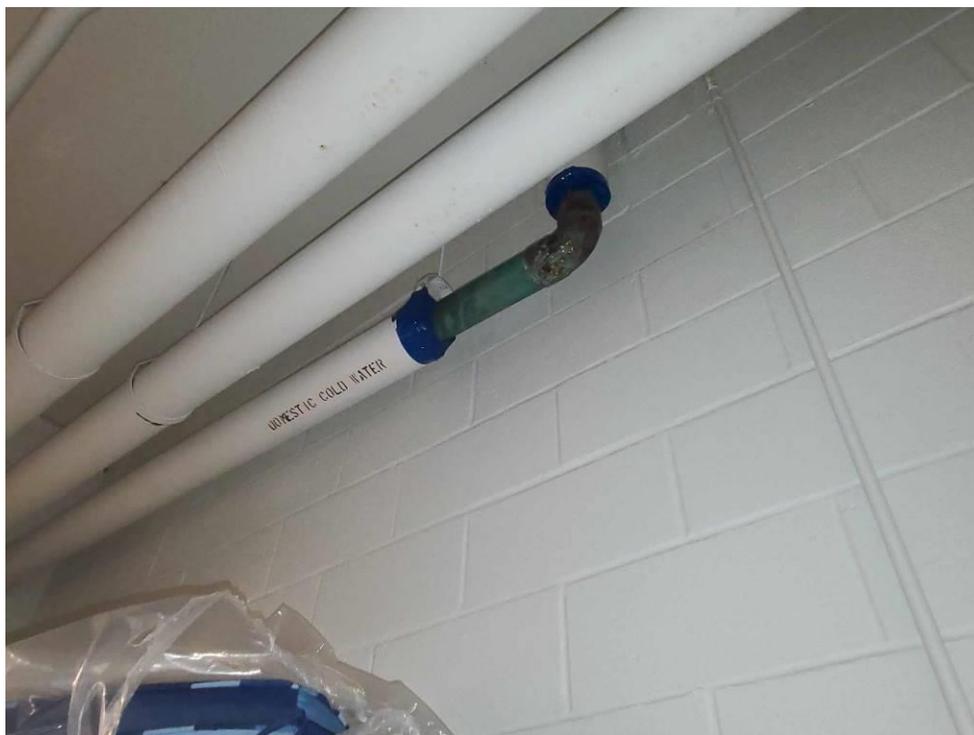
Photo 2: View of the pipe in Location B-009 after remediation works

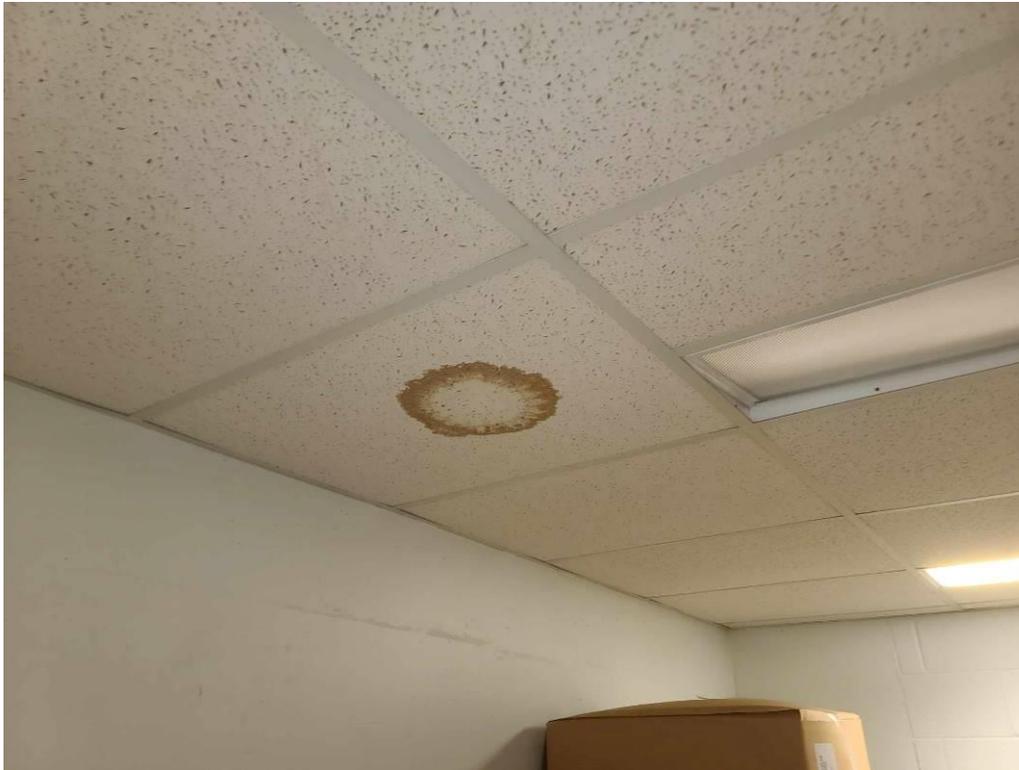
Photo 3: Mould Impacted ceiling tiles in Location B-007.

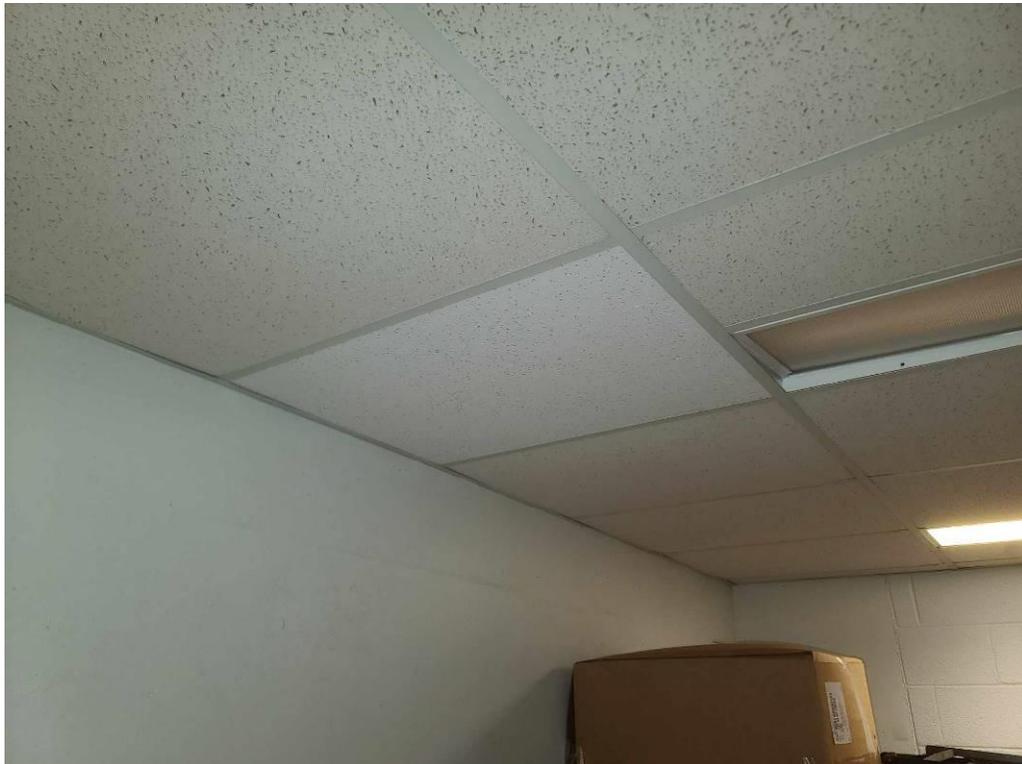
Photo 4: View of the replacement ceiling tile in Location B-007.

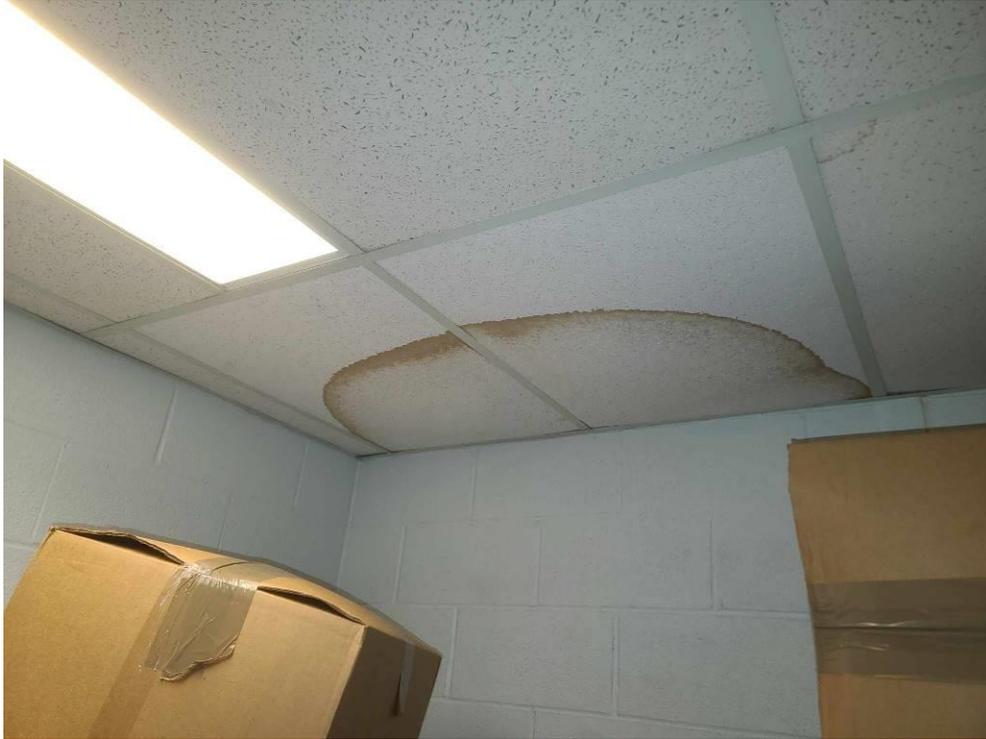
Photo 5: Mould Impacted ceiling tiles in Location B-007.

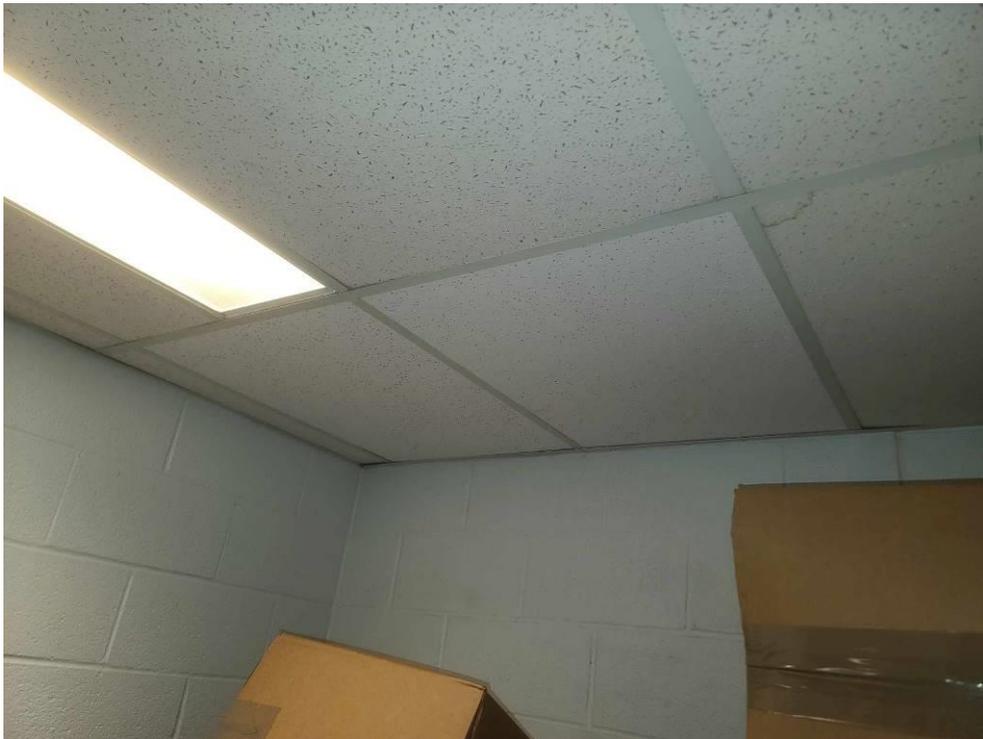
Photo 6: View of the replacement ceiling tile in Location B-007.

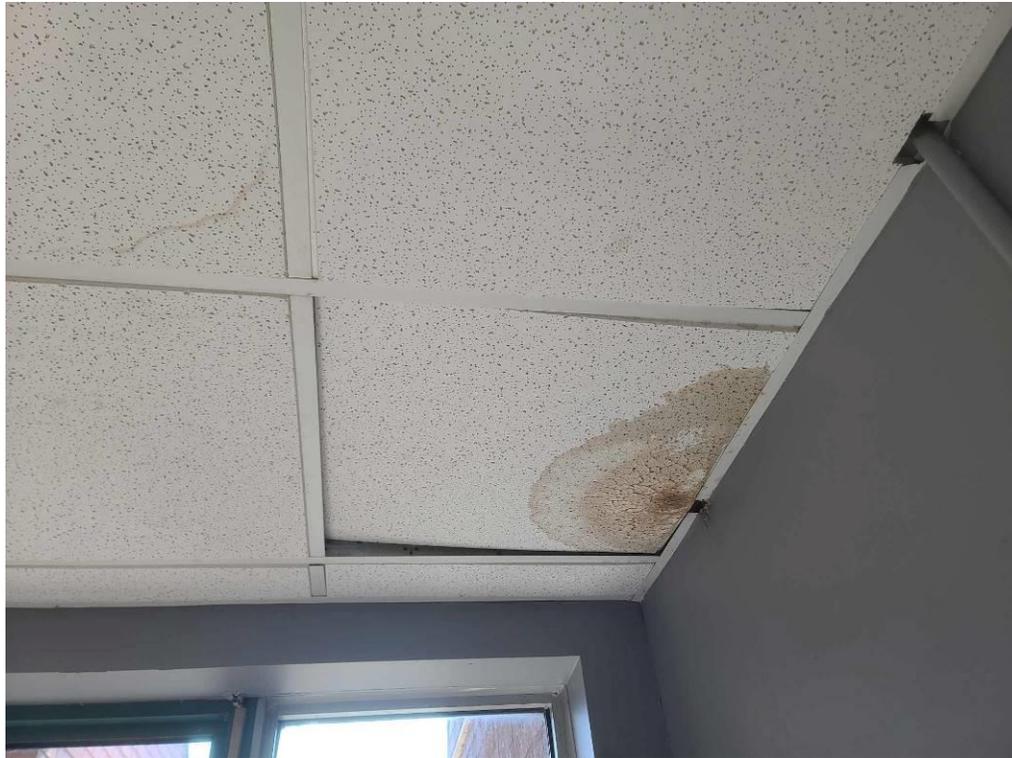
Photo 7: Mould Impacted ceiling tiles in Location 1-045.

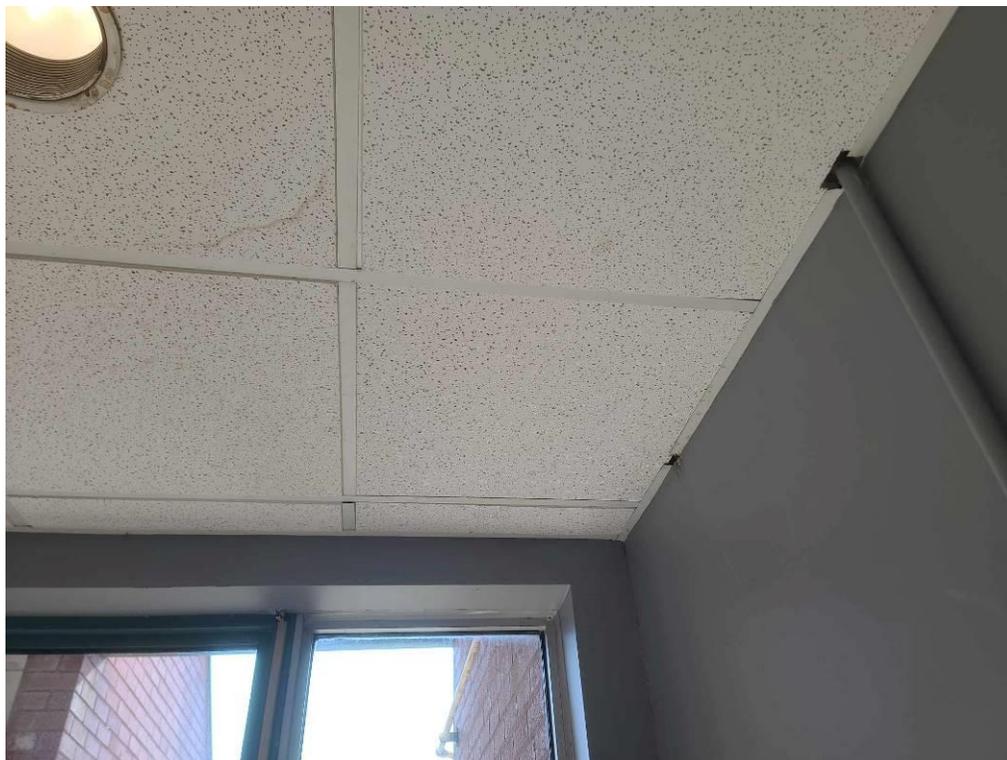
Photo 8: View of the replacement ceiling tile in Location 1-045.

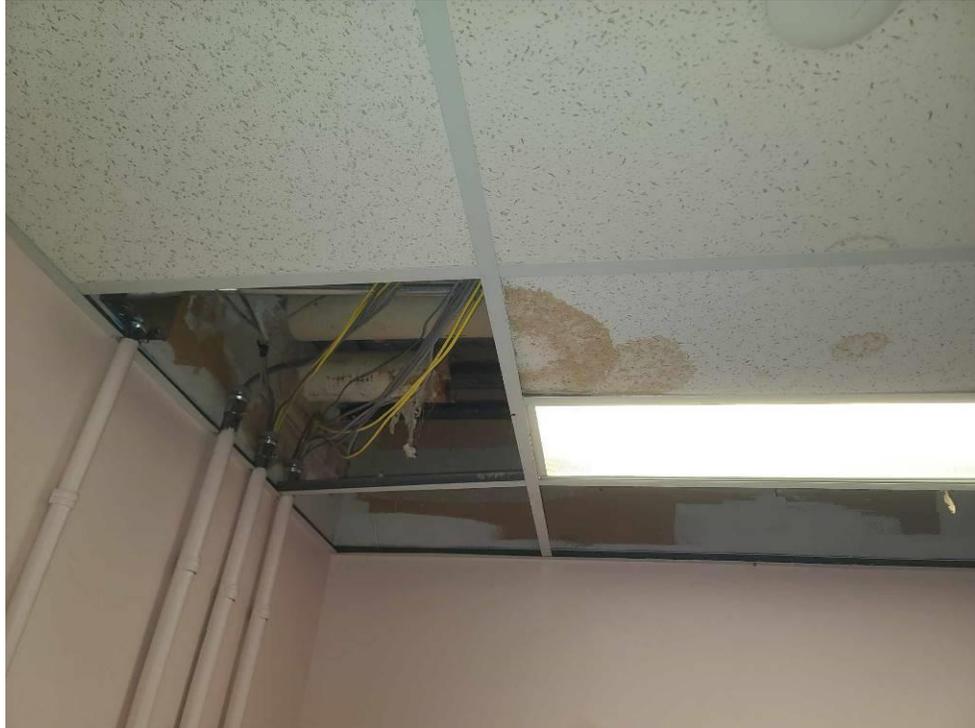
Photo 9: Mould Impacted ceiling tiles in Location 3-026.

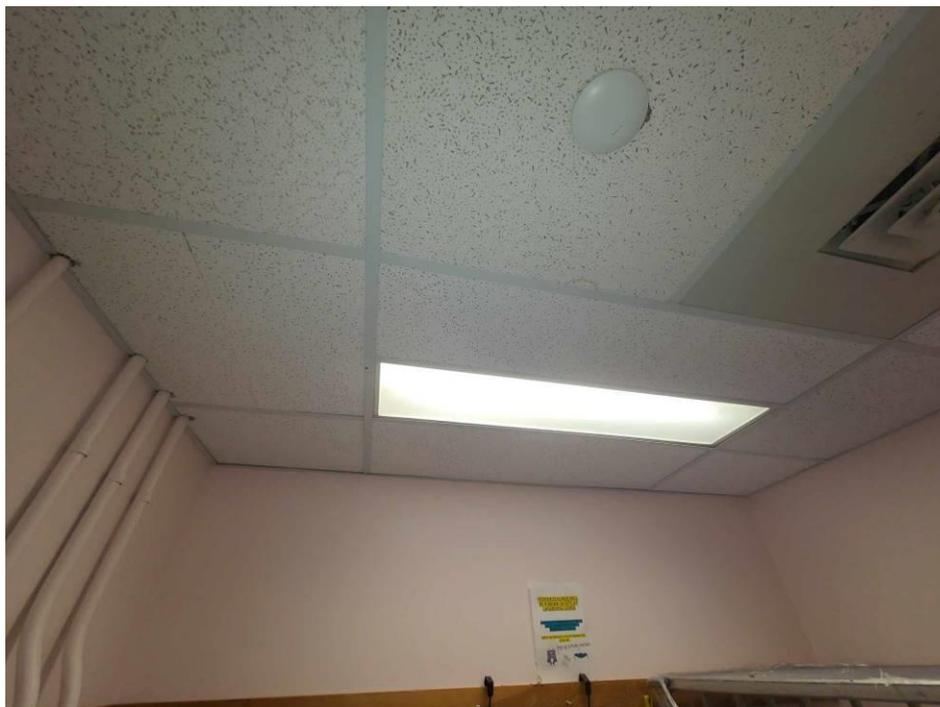
Photo 10: View of the replacement ceiling tile in Location 3-026.

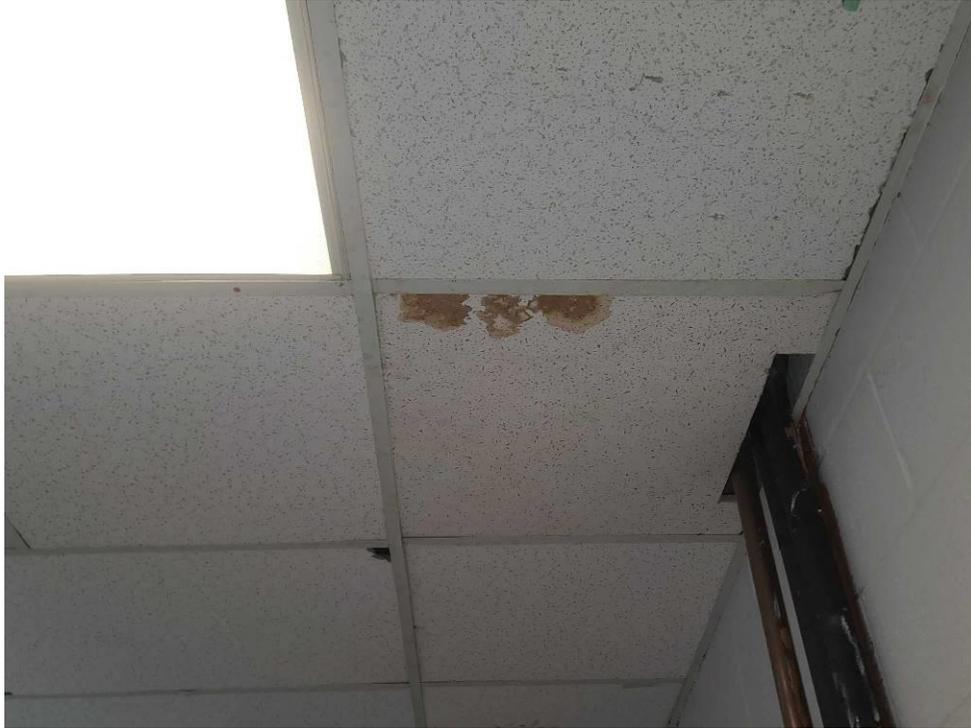
Photo 11: Mould Impacted ceiling tiles in Location 1-039.

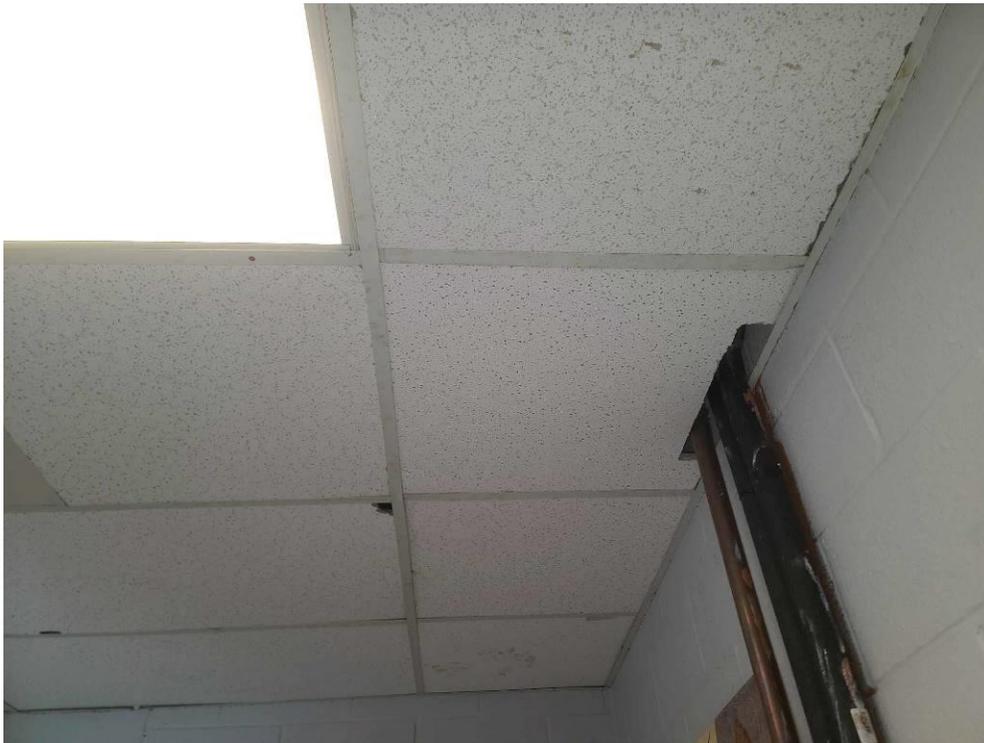
Photo 12: View of the replacement ceiling tile in Location 1-039.

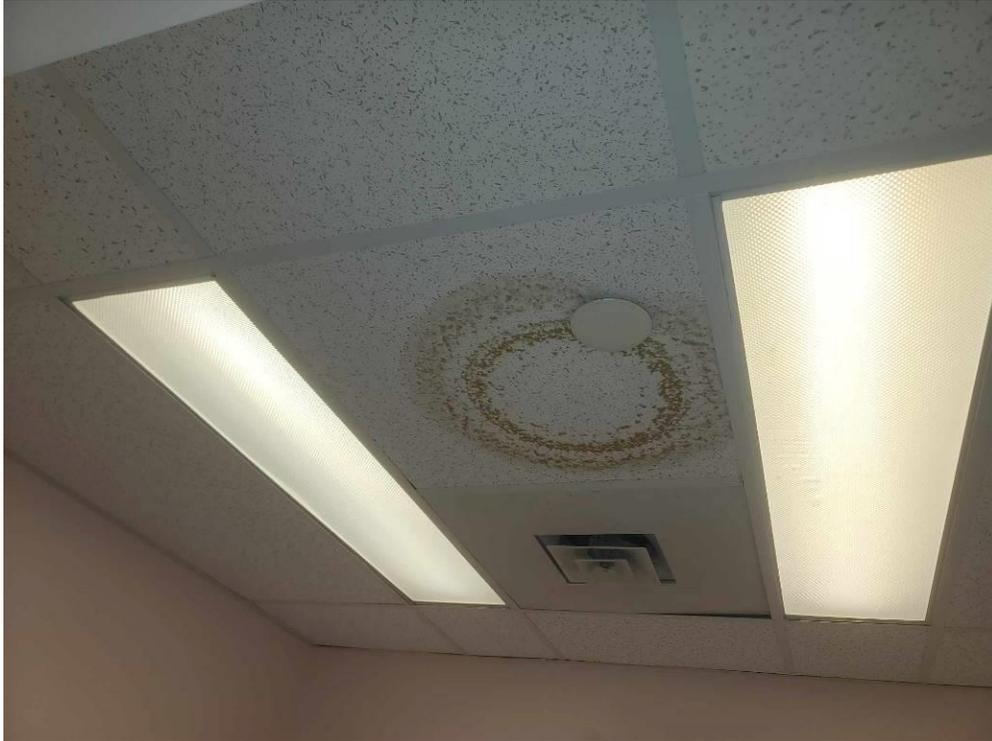
Photo 13: Mould Impacted ceiling tiles in Location 2-066.

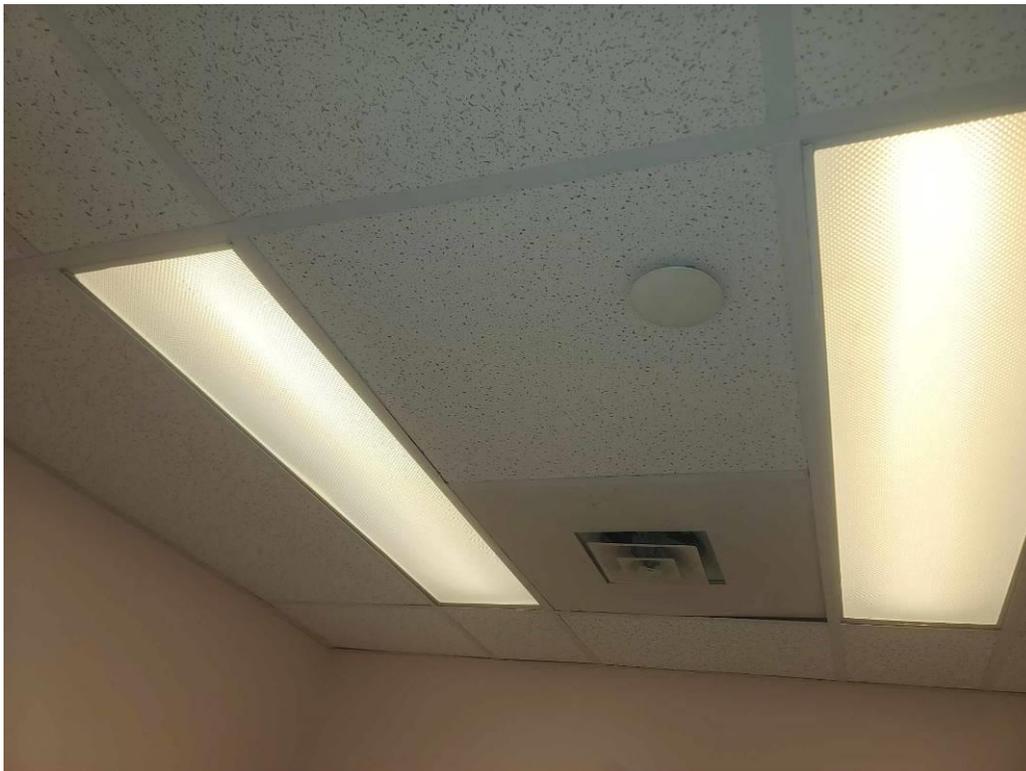
Photo 14: View of the replacement ceiling tile in Location 2-066.
