**DESIGNATED SUBSTANCES and HAZARDOUS
MATERIALS SURVEY**

**LONG TERM CARE HOMES & SERVICES
Cummer Lodge
205 Cummer Avenue
Toronto, Ontario**

Project Number: FE-P 23-12800

SEPTEMBER 1, 2023

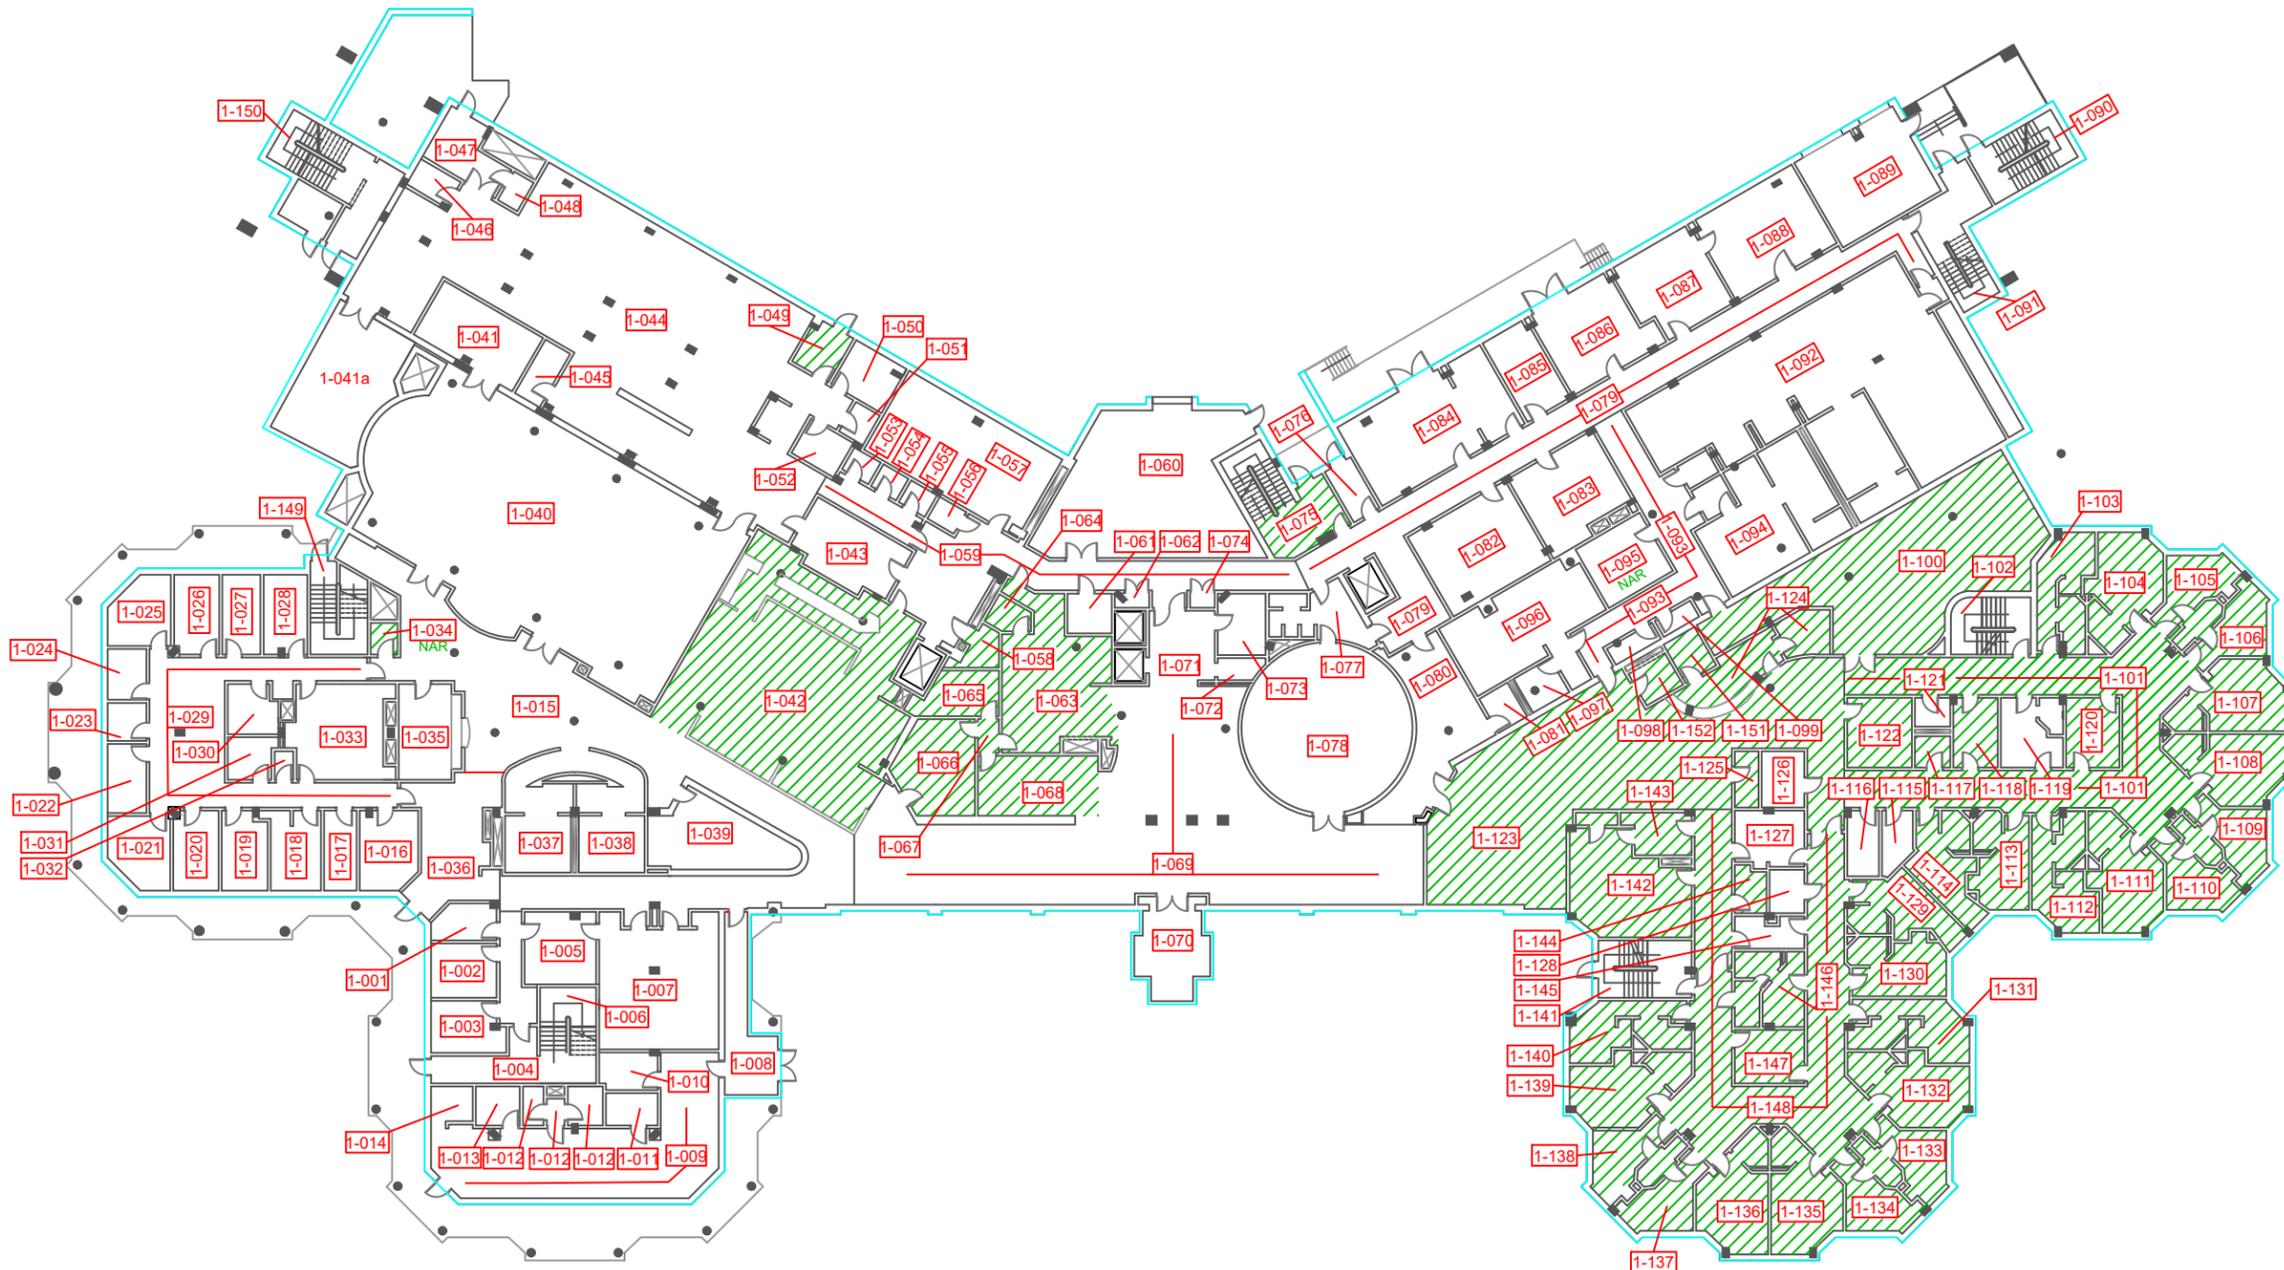
Figure 2

First Floor Plan Asbestos-Containing Material Locations

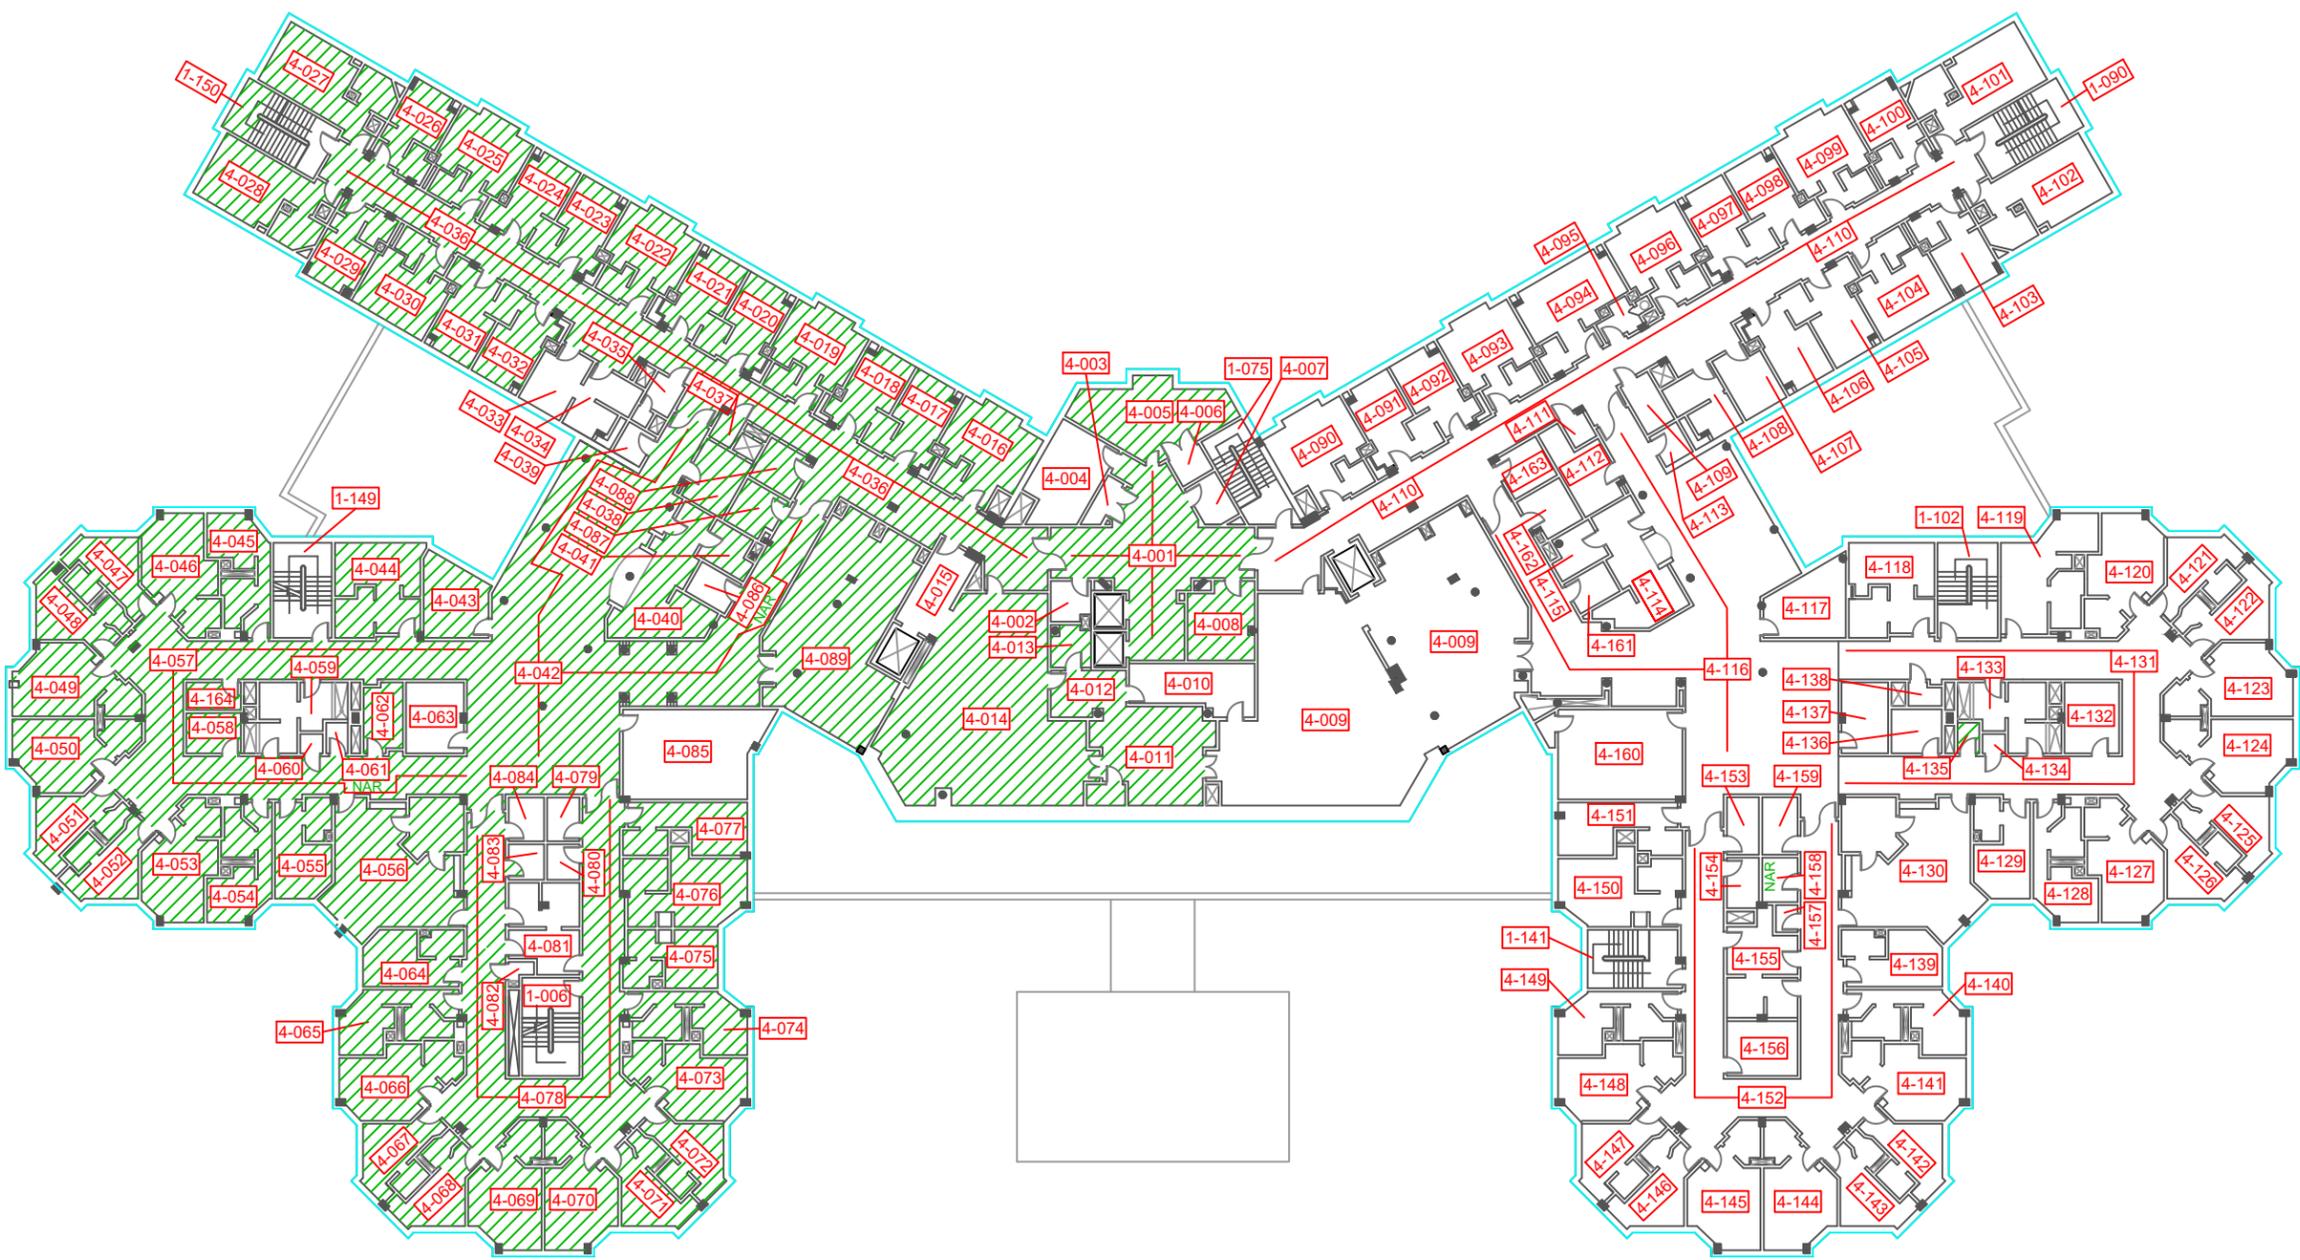
Figure 5

Vinyl Floor Tile 13 (1.5' × 1.5' Beige with Brown Splatters) not identified during previous assessment surveys, was observed in location 4-078 Corridor.

Vinyl Sheet Flooring 12 (Grey) not identified during previous assessment surveys, was observed in all residents room on 4th floor in North wing, and additionally in the following locations: Elevator Lobby 4-001, Exercise Therapy 4-005, Dining Room 4-014, Corridor 4-036, Electrical Closet 4-037, Office 4-038, Nurses Station 4-040, Medical Supply 4-041, Corridor 4-042, Family Lounge 4-043, Activity Room 4-056, Corridor 4-057, Lounge 4-058, Storage 4-062, Housekeeping 4-087, Office 4-088, Dining Room 4-089, and in Change Locker 4-164.

Vinyl Sheet Flooring 11 (Grey with Dark Dots) previously identified in the building was also observed inside washrooms in all resident's room on 4th floor in North Wing.

During the visual inspection of the surveyed areas, water stains and mould growth on non-ACM ceiling tile was observed in location 4-137 Reading Room.

Fourth Floor Plan Asbestos-Containing Material Locations

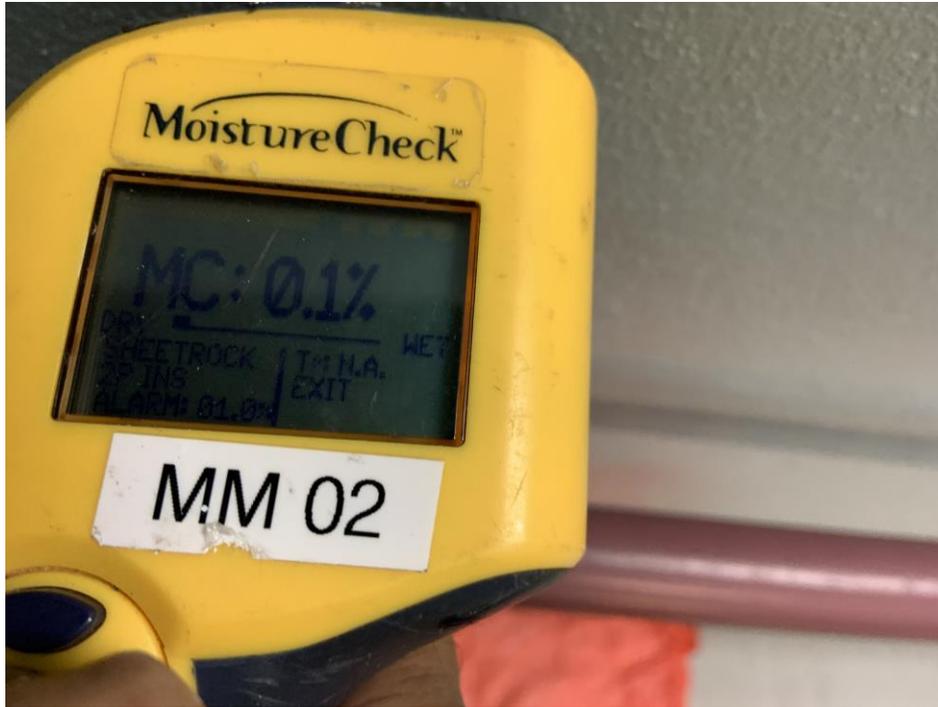
Photo 1: Moisture reading indicated the wall was dry at the time of assessment

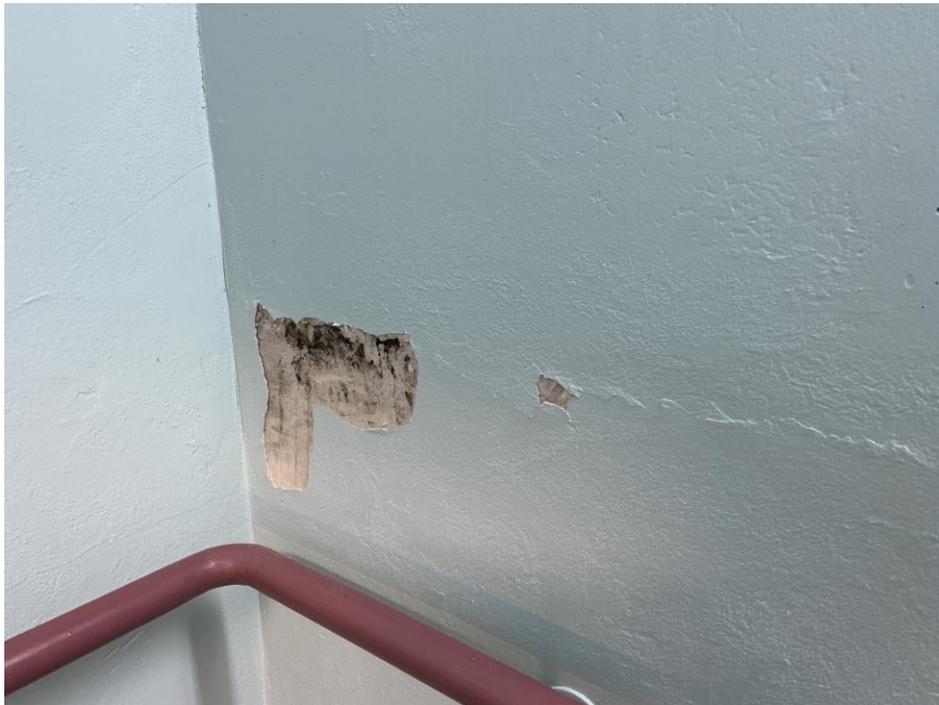
Photo 2: Black stain on the concrete wall in the Stairwell 6 (Loc. 1-102).
