DESIGNATED SUBSTANCES and HAZARDOUS MATERIALS SURVEY

LONG TERM CARE HOMES & SERVICES Seven Oaks 9 Neilson Road Toronto, Ontario

Project Number: FE 23-12800

SEPTEMBER 8, 2023

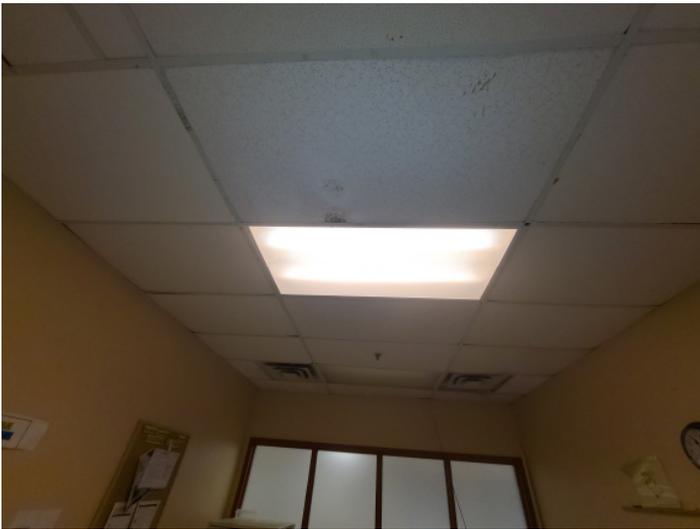
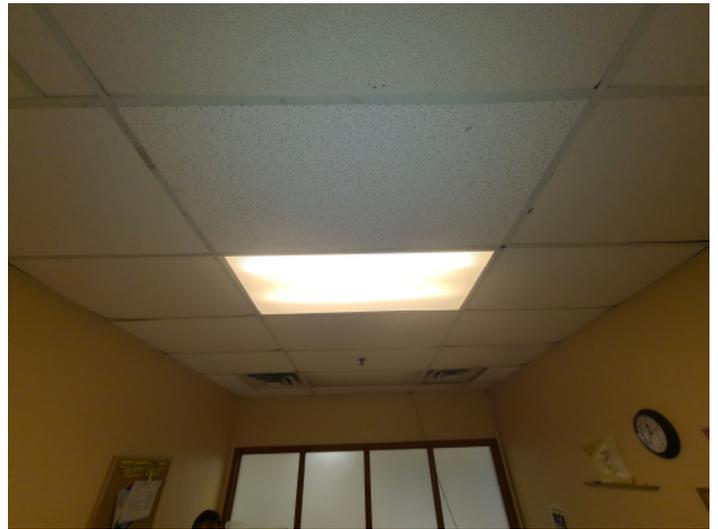
During the visual inspection of the surveyed areas, visible mould growth and water staining on non-ACM ceiling tiles were observed in the following locations: Corridor, B-008, Lounge 2-020, Lounge 3-046 and Lounge 4-046.

Before abatement

After Abatement

Fisher Engineering Limited communicated the reported deficiencies and recommendations for corrective actions to the City of Toronto. These activities have been completed and an Addendum was made to this report to confirm completion of the corrective actions. Details of the abatement work can be found in the Corrective Actions Inspection Report (Project No. FE 23-13254), which are provided in Appendix V.

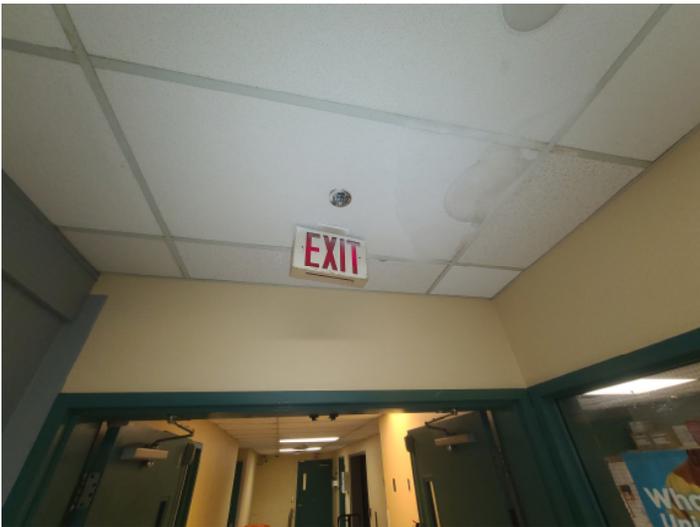
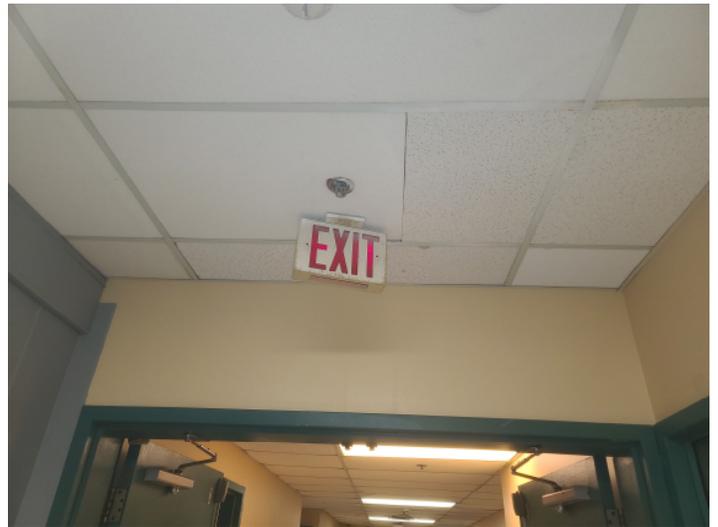
Before abatement

After Abatement

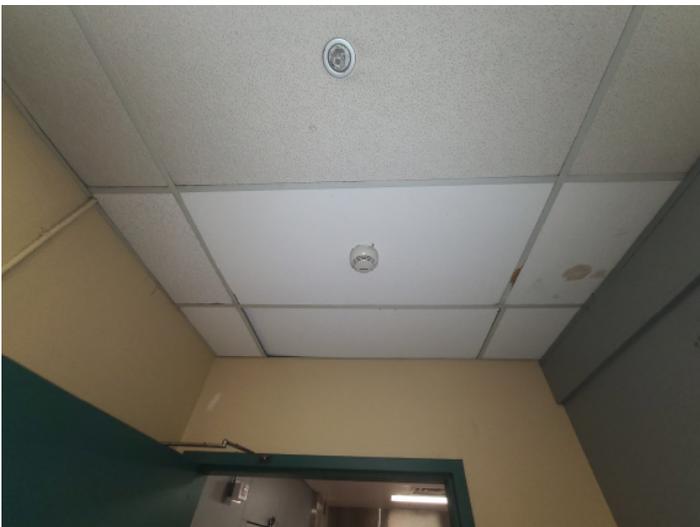
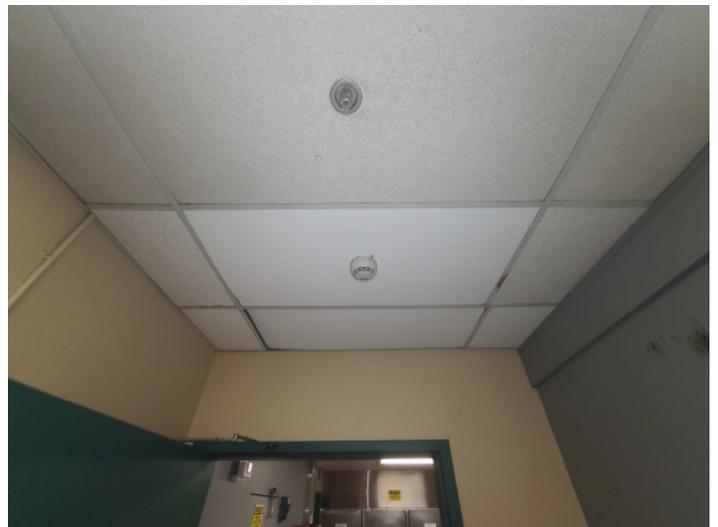
Before abatement

After Abatement
