Designated Substances and Hazardous Materials Survey

Lakeridge Health, Bowmanville Hospital
(Project 185-LHBSR)
47 Liberty Street South, Bowmanville, Ontario

Infrastructure Ontario

22 November 2023

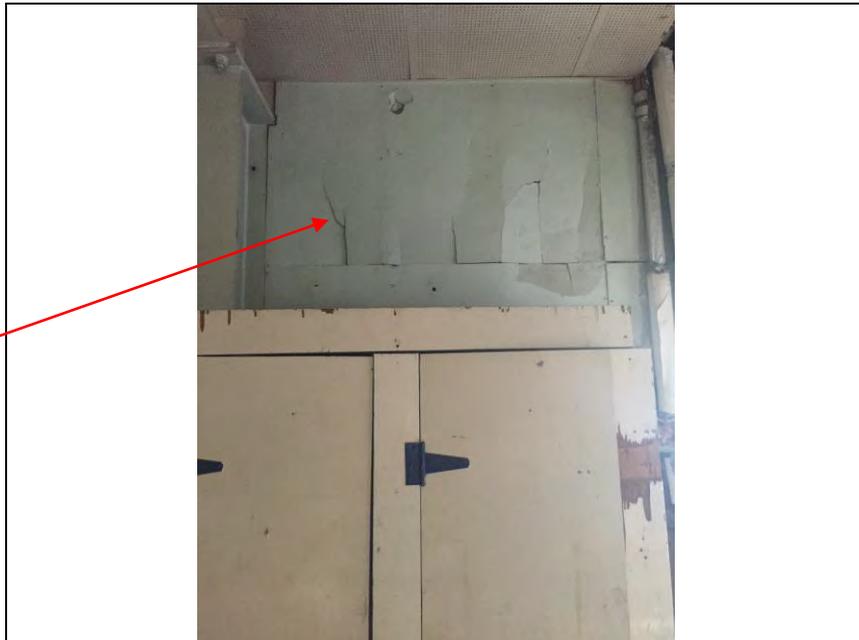
P3 –

View of asbestos-containing transite ceiling and wall panels within the Blue Shed.

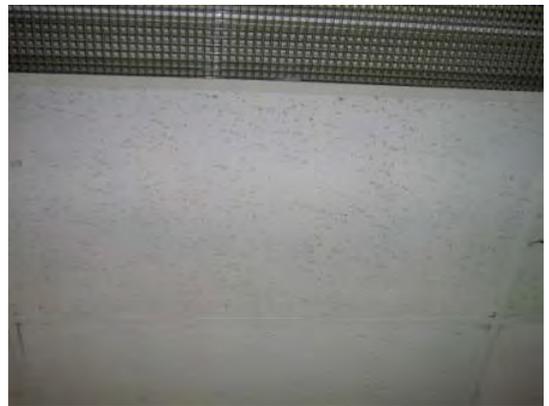
Sweatwrap not containing asbestos (samples 001A-C), parging cement on seams containing asbestos (sample 002A), room NG20

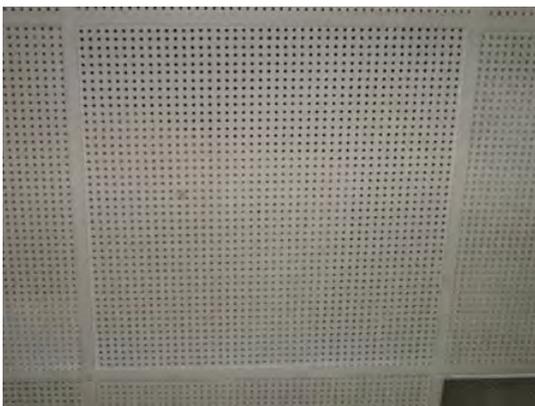
Acoustic ceiling tile, 2'x4', white with pattern of medium fissures and pinholes, contains asbestos (sample 008A), location – blue storage shed

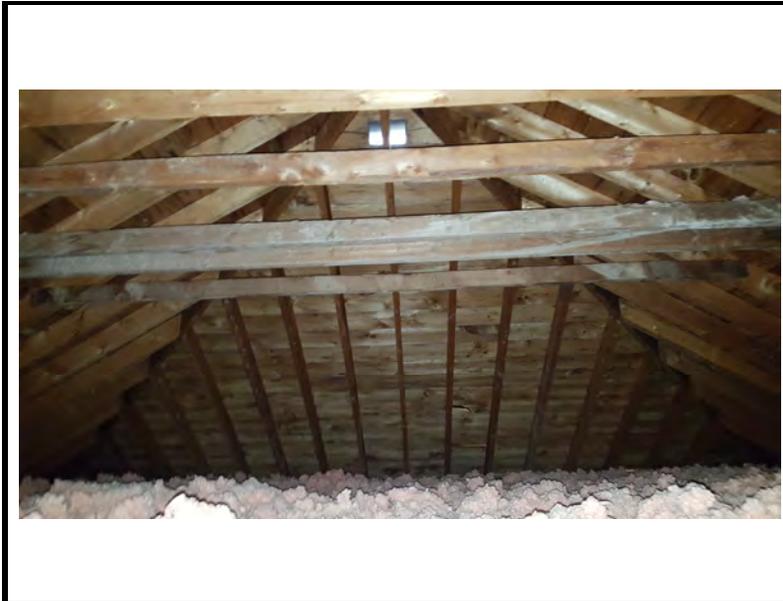
P1	Attic: No obvious visible mould growth or water damage was observed to the wooden plank sheathing.
-----------	---

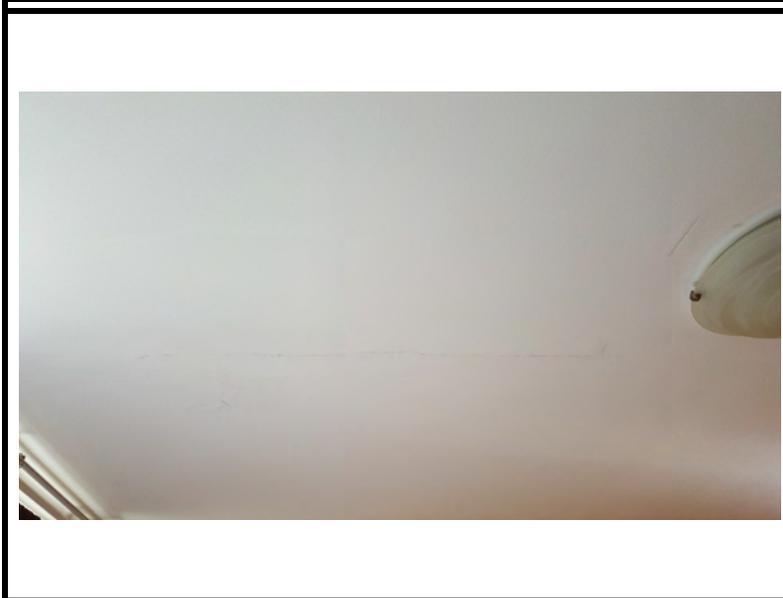
P2	Living Room: Paint cracking observed to the plaster ceiling.
-----------	---

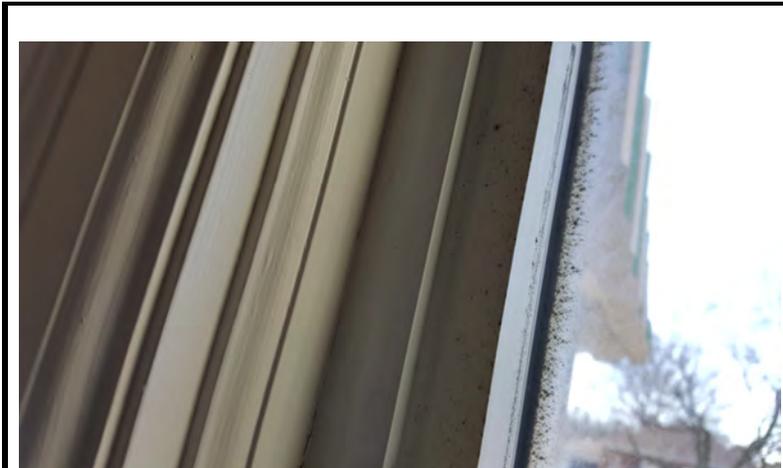
P5

Room #3: Superficial mould growth was identified to the window framing of the south window.

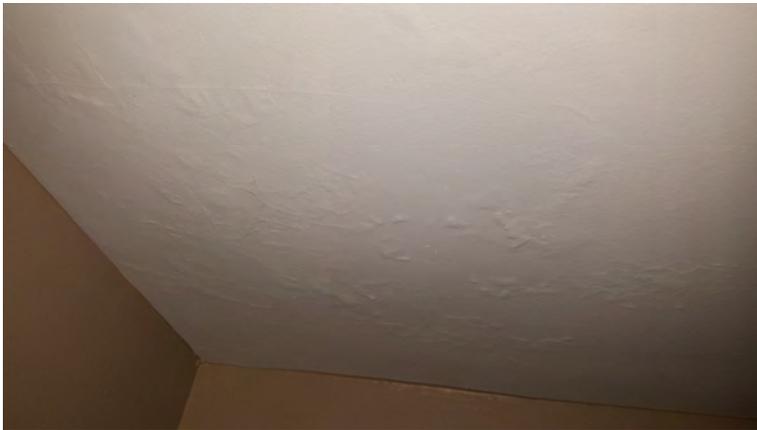
P8

Bathroom: Paint delamination was observed to the plaster ceiling.

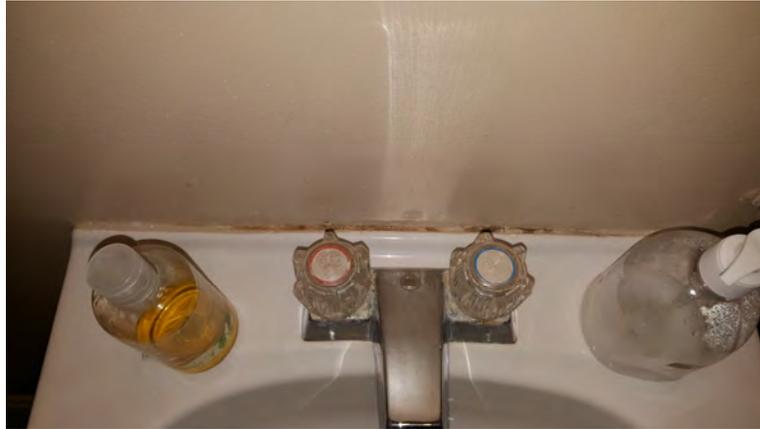
P9

Bathroom: Minor superficial mould growth was observed to the sink vanity caulking.

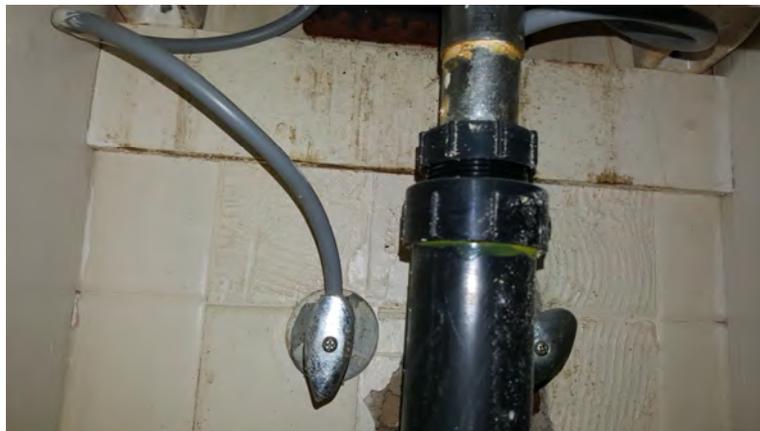
P10

Bathroom: Minor visible mould growth was observed to the wood supporting the sink.

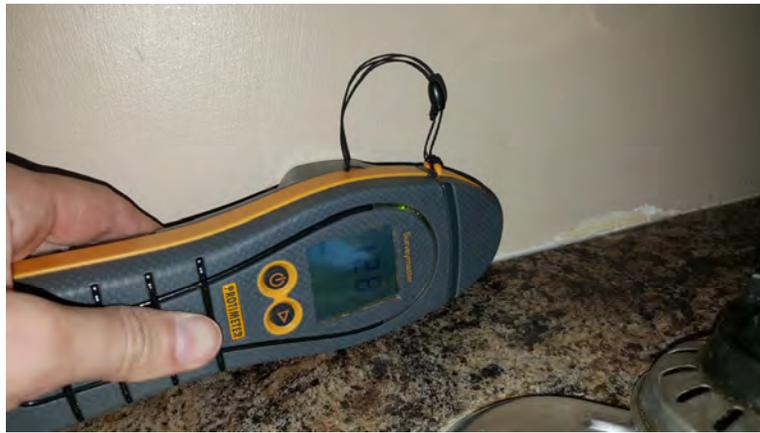
P11

Kitchen: Minor water damage was observed to the plaster wall adjacent to the sink.

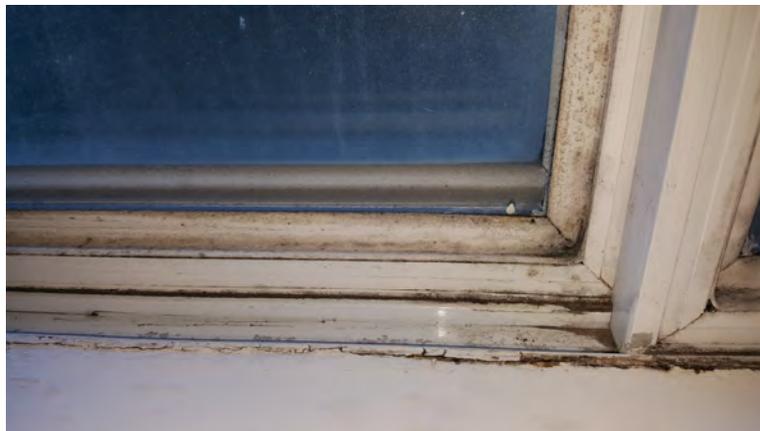
P12

Kitchen: Superficial mould growth was observed to the window framing.
