Pre-engineered Building
3265 Principal's Road, Mississauga
University of Toronto Mississauga

Version 1.4

Arborist Report

Re: **Arborist Report for the Pre-engineered Building at the University of Toronto
Mississauga**

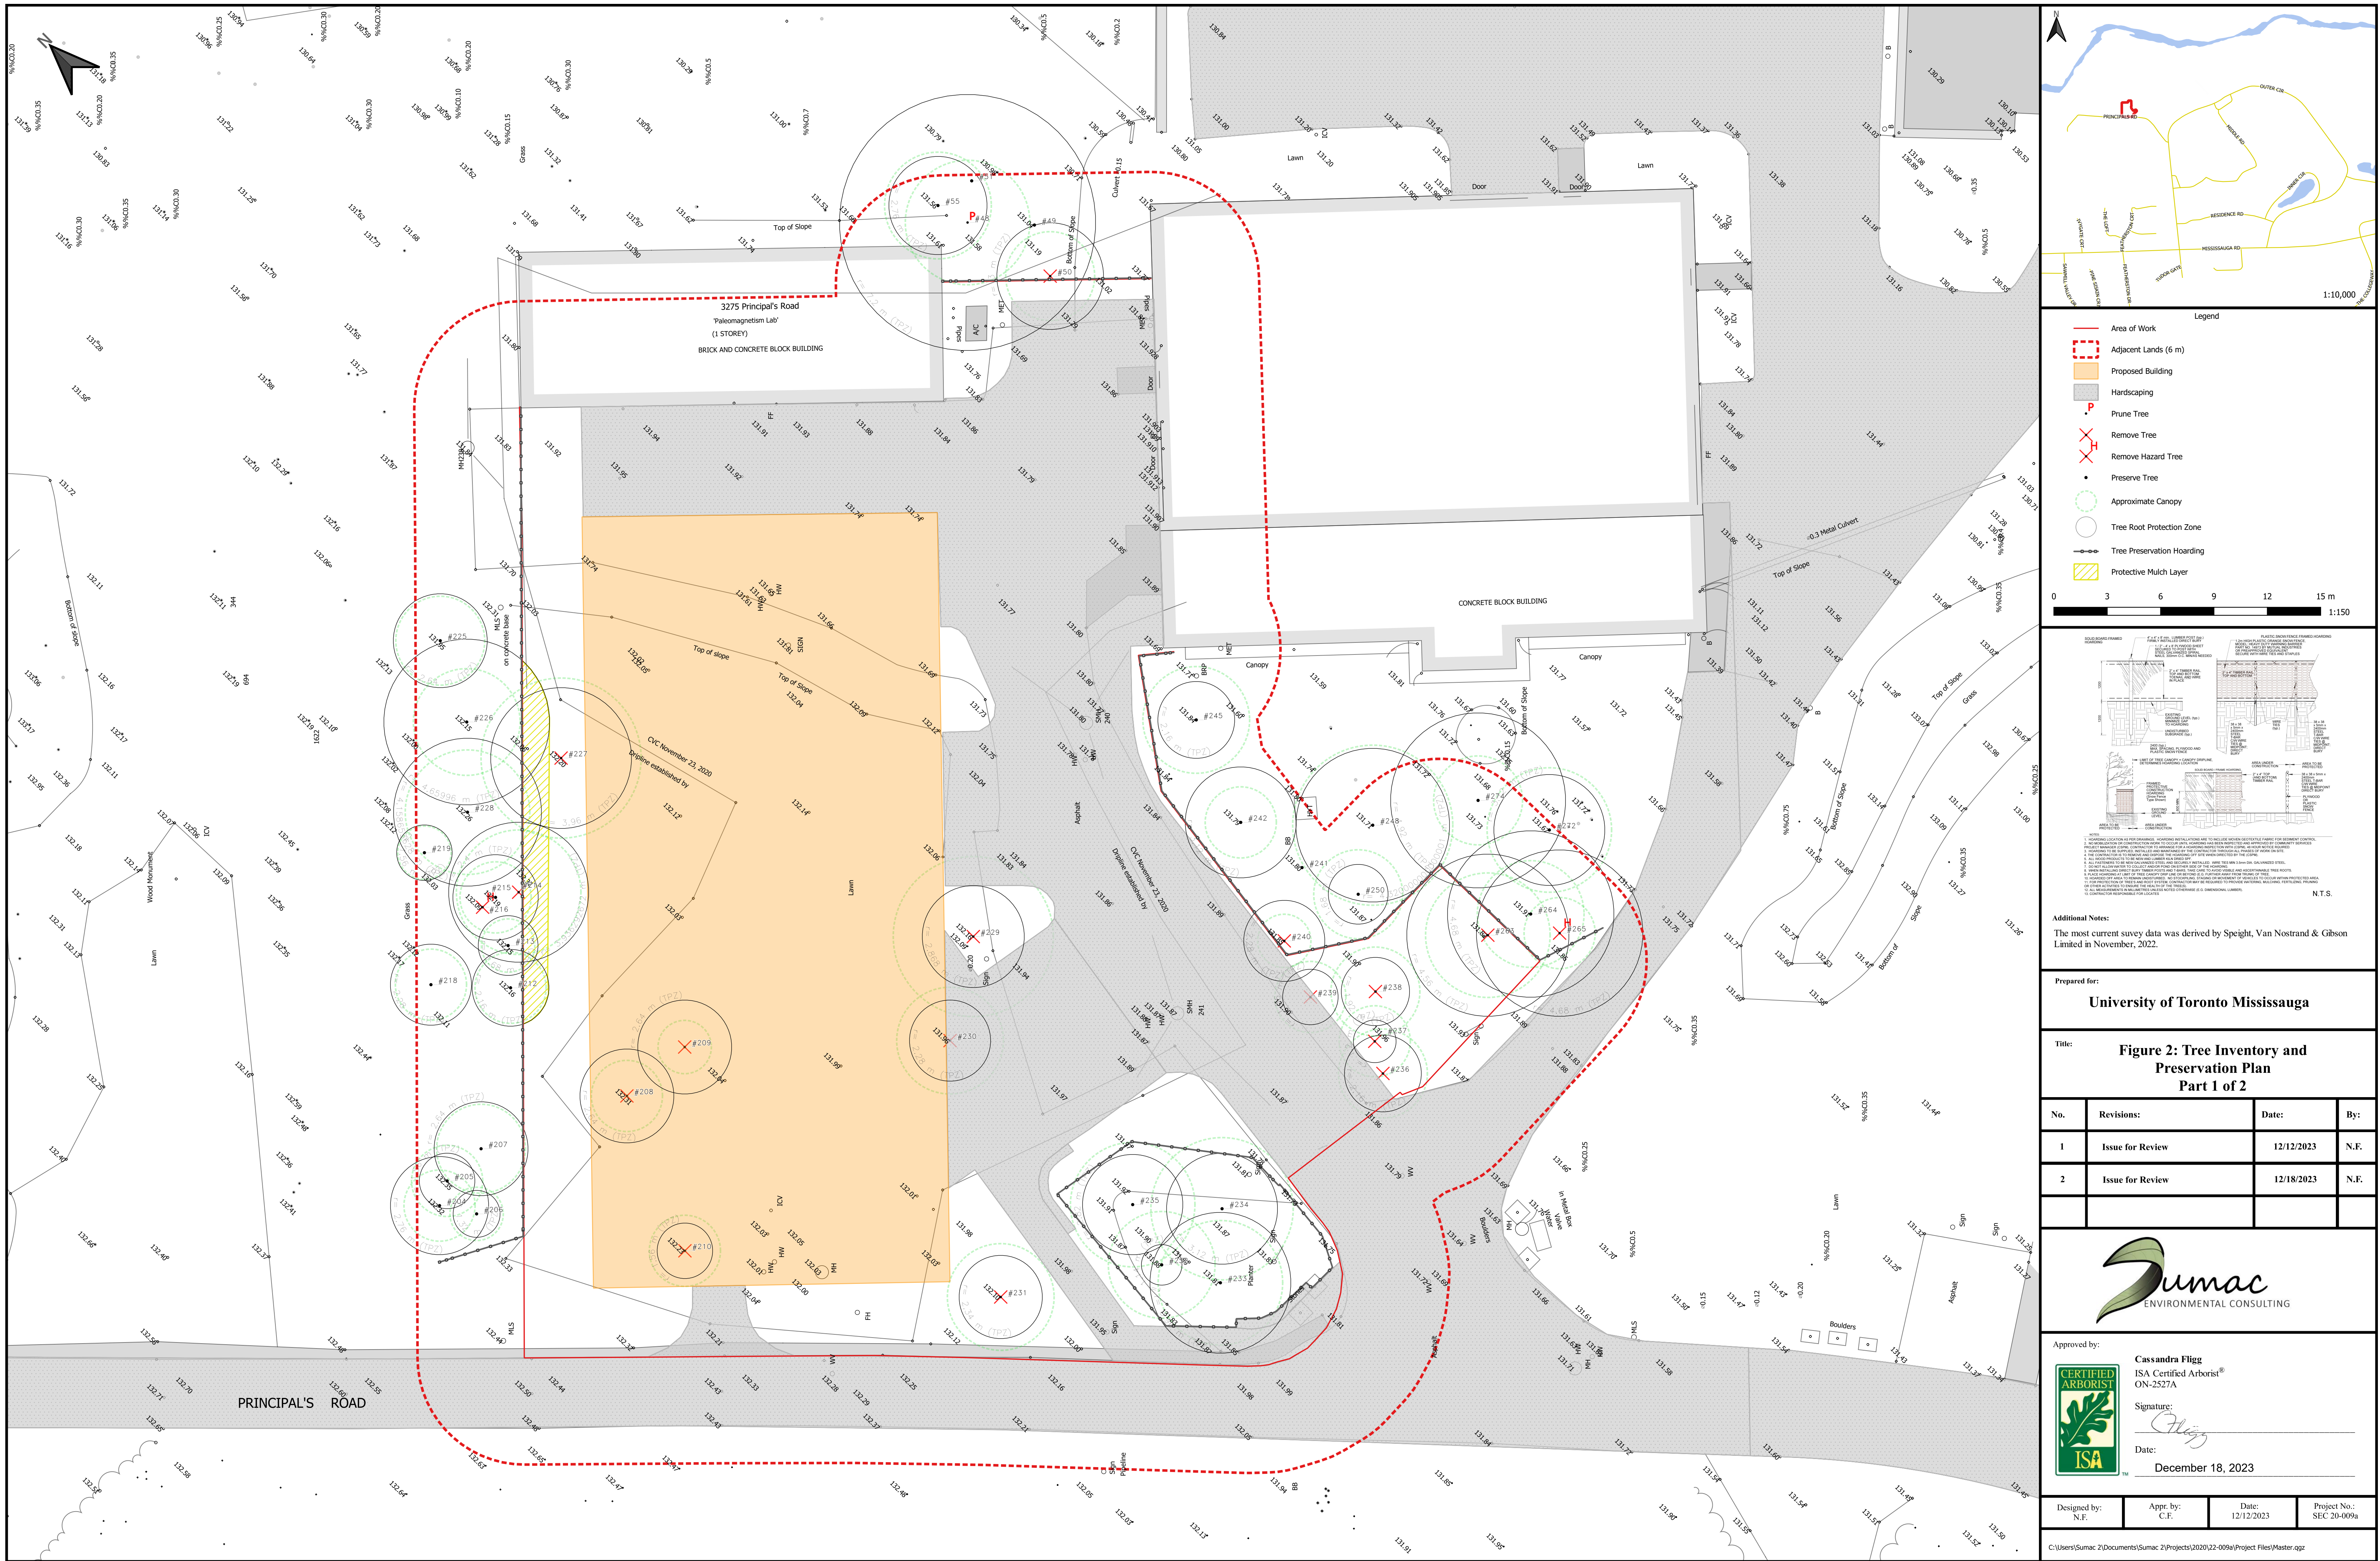
Title:
**Figure 2: Tree Inventory and Preservation Plan
Part 2 of 2**

Tree Inventory										
Tree ID	Tag No.	Scientific Name	Common Name	DBH (cm)	Tree Protection Zone Radius (m)	Approximate Canopy Size (m)	Health	Comments	Hazard	Recommendation
48	763	<i>Acer saccharinum</i>	Silver Maple	60	7.2	7	Fair	-Two stems diverging at 2m -Second stem is hollow and leaning towards building	Yes	Prune and Retain
49	771	<i>Fraxinus americana</i>	White Ash	25		0	Dead	-EAB infected -Peeling bark -Virginia creeper noted on main stem		Preserve
50	769	<i>Acer platanoides</i>	Norway Maple	25	3	5	Good	-Virginia creeper noted on main stem		Remove
51	768	<i>Crataegus sp.</i>	Hawthorne Sp.	12		0	Dead	-Virginia creeper noted on main stem		Preserve
55	762	<i>Acer platanoides</i>	Norway Maple	23	2.76	6	Good	-Virginia creeper noted on main stem		Preserve
204	657	<i>Acer platanoides</i>	Norway Maple	23	2.76	4	Good			Preserve
205	656	<i>Acer platanoides</i>	Norway Maple	13	1.56	4	Good			Preserve

206	1648	<i>Acer platanoides</i>	Norway Maple	11	1.32	3	Good			Preserve
207	654	<i>Acer platanoides</i>	Norway Maple	22	2.64	5	Good			Injure
208	1641	<i>Acer saccharum</i>	Sugar Maple	22	2.64	4	Fair	-Callousing wound at base -Damaged bark at 10 m		Remove
209	669	<i>Cornus florida</i>	Eastern Flowering Dogwood	22	2.64	3	Poor	-Three stems diverging at 35cm -Included bark -Loose bark at root flare -Second and third stem are dead -Epicormic growth throughout		Remove
210	651	<i>Quercus rubra</i>	Northern Red Oak	26	1.56	4	Good	-Slight lean		Remove
212	671	<i>Acer platanoides</i>	Norway Maple	18	2.16	4	Fair	-Epicormic growth throughout		Injure
213	673	<i>Acer platanoides</i>	Norway Maple	14	1.68	3	Fair	-Epicormic growth throughout		Injure
214	681	<i>Acer platanoides</i>	Norway Maple	26,20	3.936292672	7	Fair	-Epicormic growth throughout		Remove
215	680	<i>Acer platanoides</i>	Norway Maple	20	2.4	4	Fair	-Epicormic growth throughout		Injure

216	679	<i>Pinus resinosa</i>	Red Pine	29		0	Dead	-Loose bark -Hollow	Yes	Remove Hazard Tree
218	674	<i>Acer platanoides</i>	Norway Maple	19	2.28	4	Good			Preserve
219	683	<i>Acer platanoides</i>	Norway Maple	13	1.56	3	Good			Preserve
225	692	<i>Acer platanoides</i>	Norway Maple	22	2.64	5	Fair	-Epicormic growth throughout		Preserve
226	689	<i>Acer platanoides</i>	Norway Maple	32,22	4.65996	6	Fair	-Two stems diverging at 20cm -Second stem leaning		Injure
227	1694	<i>Acer platanoides</i>	Norway Maple	33	3.96	9	Fair	-Significant lean		Remove
228	682	<i>Acer platanoides</i>	Norway Maple	25,24	4.158653628	7	Fair	-Epicormic growth throughout -Included bark		Injure
229	715	<i>Quercus rubra</i>	Northern Red Oak	29,38	2.868	9	Fair	-Two stems diverging at 5cm -Epicormic growth throughout -Lean over parking lot		Remove
230	716	<i>Juglans x bixbyi</i>	Walnut Hybrid	38	2.28	6	Fair	-Epicormic growth throughout -Dieback throughout -Dead limbs overhanging road		Remove

231	717	<i>Liquidambar styraciflua</i>	Sweetgum	39	2.34	6	Good	-Some lower limb dieback		Remove
232	719	<i>Cercis canadensis</i>	Eastern Redbud	19	1.14	6	Fair	-Slight lean -Limb dieback throughout -Epicormic growth throughout		Preserve
233	720	<i>Cercis canadensis</i>	Eastern Redbud	33	3.96	7	Poor	-Significant lean -Epicormic growth throughout -Large cracks on main stem -Some limb dieback		Injure
234	723	<i>Pinus sylvestris</i>	Scots Pine	52	3.12	8	Fair	-Lower and mid limb dieback -Fungal growth at root flare		Preserve
235	722	<i>Pinus sylvestris</i>	Scots Pine	47	2.82	7	Fair	-Limb dieback -Some chlorosis		Preserve
236	725	<i>Acer platanoides</i>	Norway Maple	18	2.16	5	Good	-Deer scratches on main stem		Remove
237	1660	<i>Acer platanoides</i>	Norway Maple	10	1.2	4	Fair	-Slight lean -Crack on main stem but callusing over		Remove
238	1658	<i>Acer platanoides</i>	Norway Maple	16	1.92	5	Fair	-Cracks on main stem but callusing over		Remove

239	1638	<i>Acer platanoides</i>	Norway Maple	13	1.56	4	Good	-Slight lean		Remove
240	728	<i>Prunus serotina</i>	Black Cherry	19	2.28	3	Fair	-Thin crown		Remove
241	729	<i>Fraxinus americana</i>	White Ash	26		0	Dead	-EAB infected		Preserve
242	750	<i>Scandosorbus intermedia</i>	Swedish Whitebeam	26	3.12	4	Fair	-Large cracks on main stem -Damage at root flare		Injure
245	752	<i>Celtis occidentalis</i>	Common Hackberry	25,26	2.16	6	Good			Preserve
248	749	<i>Juglans x bixbyi</i>	Walnut Hybrid	36	4.32	9	Fair	-Some cankers -Slight lean		Preserve
250	730	<i>Acer platanoides</i>	Norway Maple	14	1.68	5	Good			Preserve
263	731	<i>Acer negundo</i>	Manitoba Maple	38	4.56	7	Fair	-Significant Lean		Remove
264	732	<i>Acer rubrum</i>	Red Maple	39	4.68	6	Fair	-Large hollow at root flare -Included bark		Injure
265	733	<i>Acer saccharinum</i>	Silver Maple	39	4.68	4	Poor	-Large dead limb over road -Dieback -Epicormic shoots	Yes	Remove Hazard Tree

272	739	<i>Acer platanoides</i>	Norway Maple	26	3.12	7	Good	-slight lean		Preserve
274	742	<i>Acer platanoides</i>	Norway Maple	41	4.92	5	Fair	-2 stems diverge at 0.5 m -Included bark		Injure

Solid tree preservation hoarding is recommended to protect trees selected for preservation. The location of tree preservation hoarding has been depicted (Figure 2). We recommend the location of hoarding be staked by an Ontario Land Surveyor prior to its erection. The tree preservation hoarding should be erected prior to the onset of siteworks and must remain in place for the duration of all construction activity. There should be no disturbance (e.g., digging, trenching, compaction, changes in grade or other soil disturbance) beyond the limits of tree preservation hoarding. Fill should never be placed beyond the limits of the tree preservation hoarding. Tree preservation hoarding should be monitored throughout the undertaking of the proposed works.

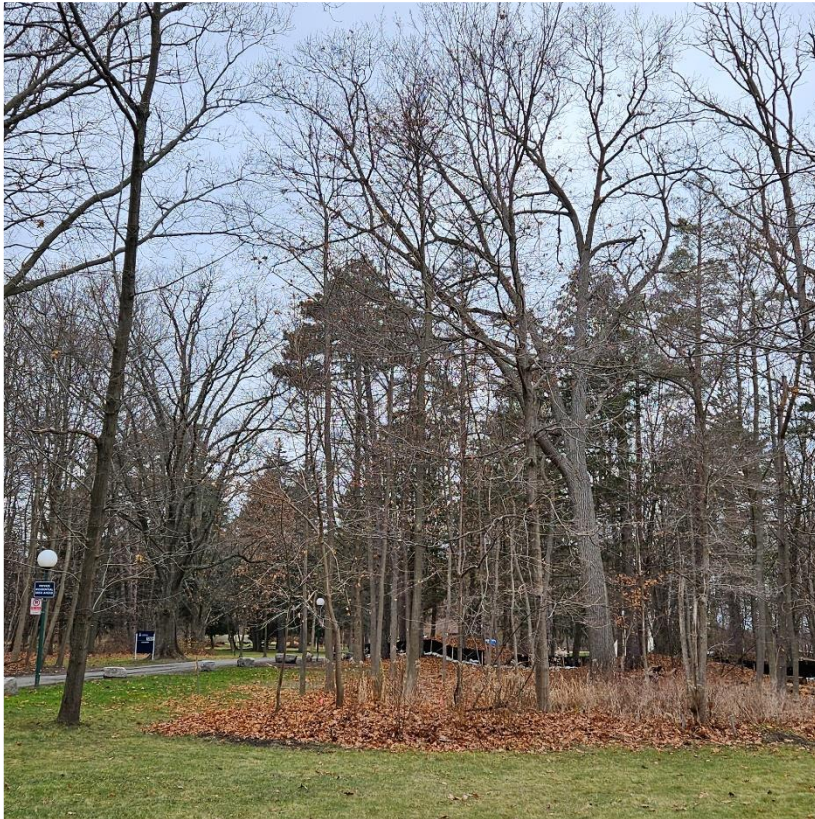
A SAR tree (Tree ID 209) was encountered in the inventoried area. This tree was noted as a three-stem Eastern flowering dogwood measuring approximately 6 m in height. Included bark was noted at the point of attachment. Loose/damaged bark was noted at the root flare. Two (2) of the three (3) stems are dead and have broken off from the tree. Epicormic growth was noted throughout the living stem and at the root flare. No evidence of dogwood anthracnose fungus was observed. Overall, the Eastern flowering dogwood was in poor condition.

Western corner of Study Area viewing
Principal's Road
(Trees 204-210)

For the purpose of the ESA, the proponent should obtain authorization from the Ministry of Environment, Conservation and Parks to remove the Eastern flowering dogwood.

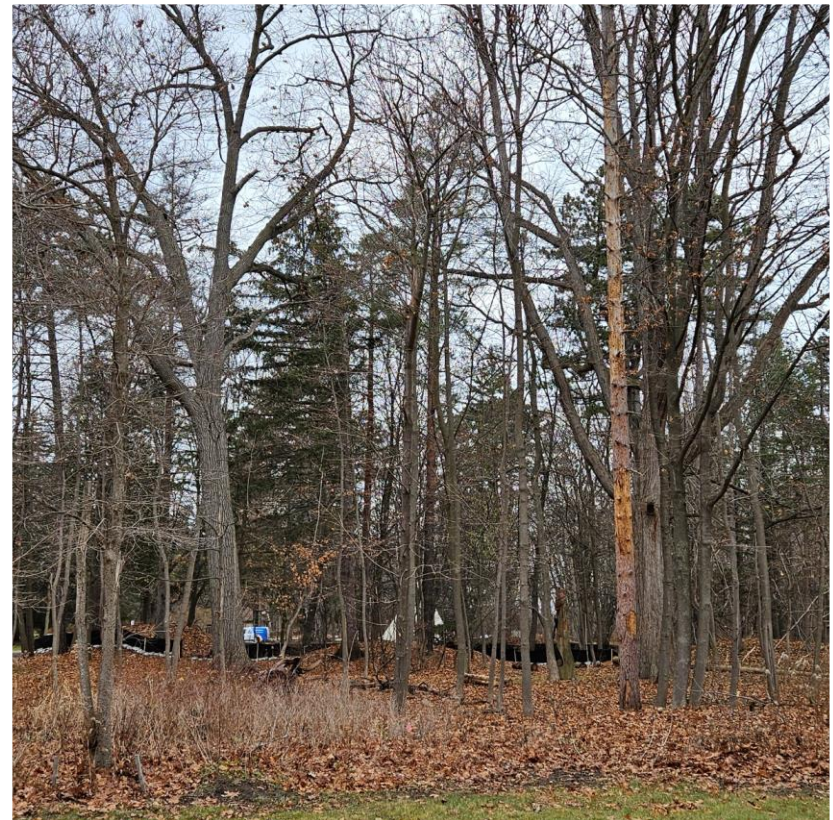
Western edge of subject property viewing
woodland
(Trees 212-216, 219)

To minimize compaction impacts from the weight of construction machinery to the root system of Tree ID 212, 213, 226 and 228, it is recommended that a layer of mulch with a depth of approximately 10-15 cm be applied at the base of said trees and covered in plywood (Figure 2). Mulch should be certified pest-free, dye-free and made of native species. Mulch should be removed immediately following completion of all site works.

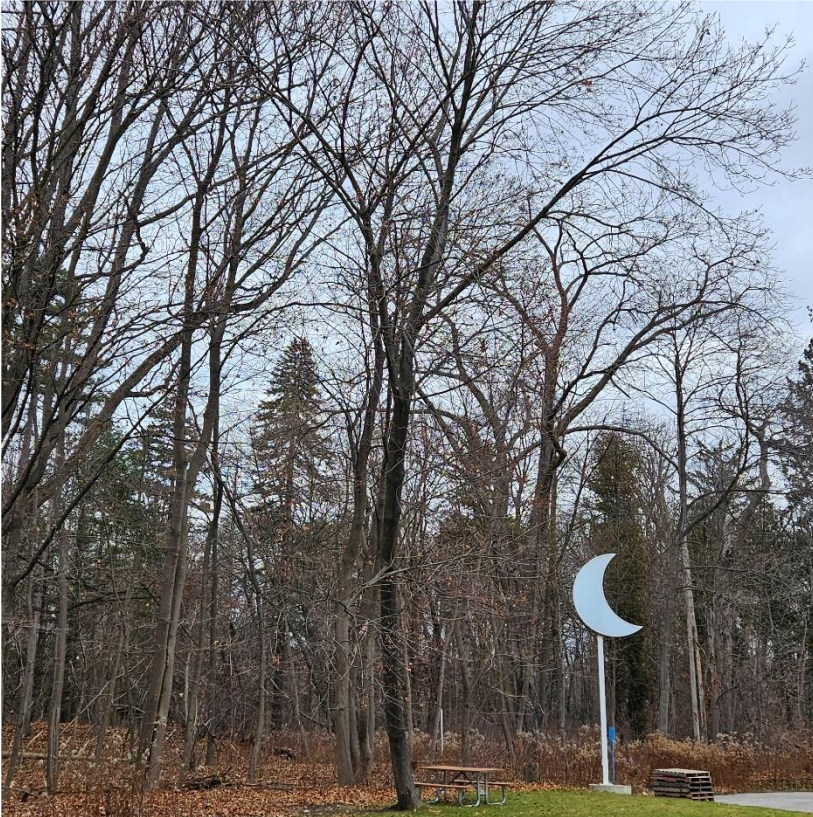
Western edge of subject property viewing
woodland continued
(Trees 225-228)

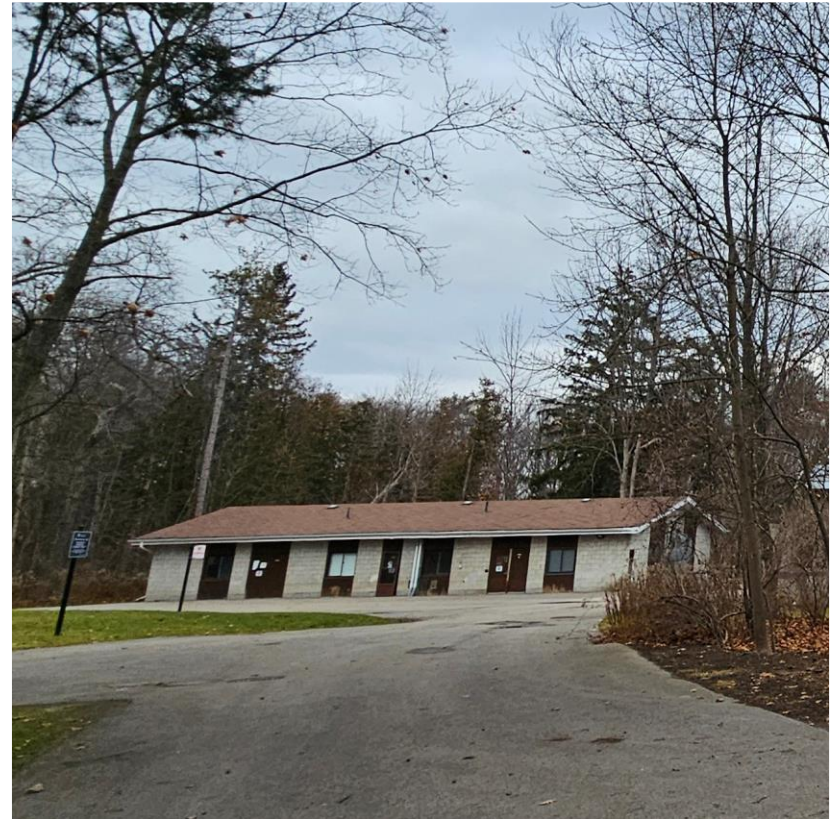
Paleomagnetism Laboratory located at
northern limit of Study Area
(Trees 48-51, 55, 59-62, 69, 74, 186)

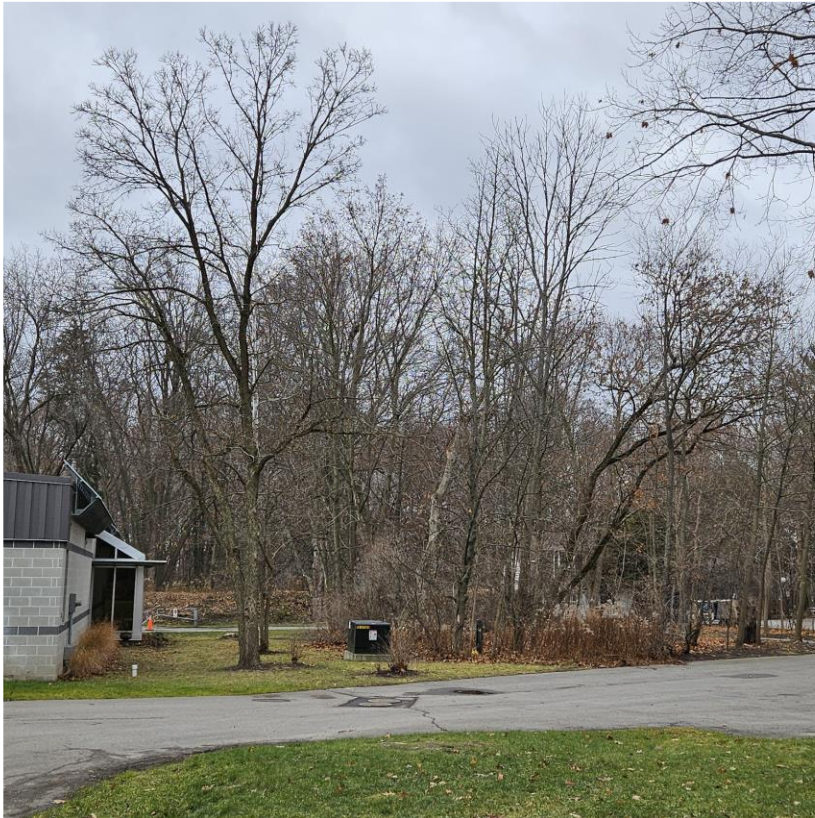
Eastern edge of subject property adjacent to
the Grounds Building

(Trees 236-242, 245, 248, 250, 263-265, 272,
274)

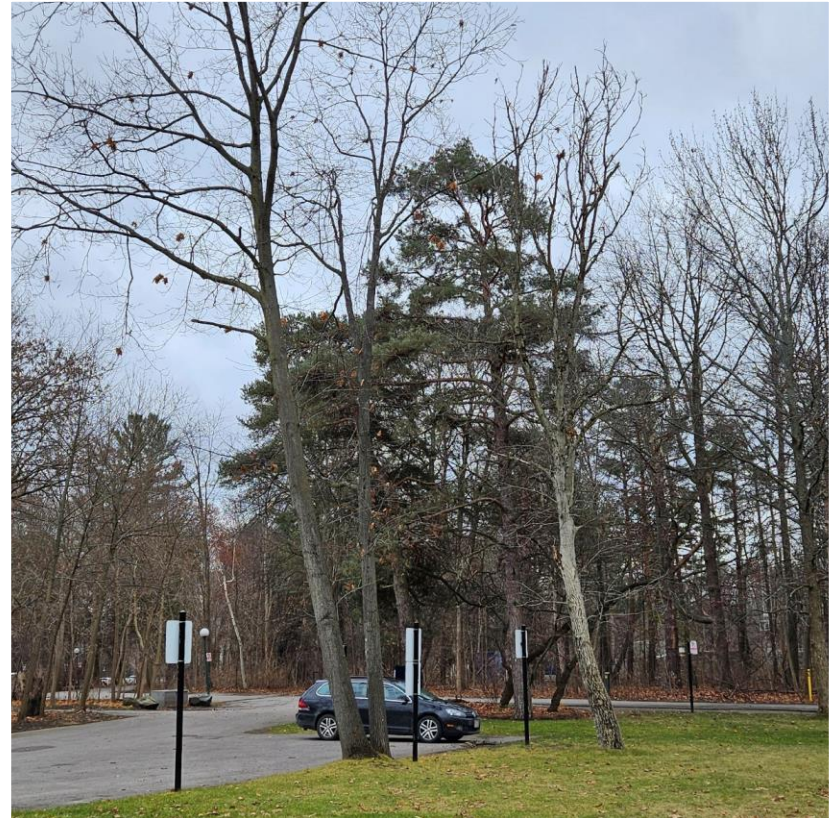
Existing laneway and parking area in Study
Area

(Trees 229-235)
