DESIGNATED SUBSTANCES AND HAZARDOUS BUILDING MATERIALS ASSESSMENT

FINAL REPORT

YWCA Kitchener-Waterloo, Emergency Shelter
84 Frederick Street, Kitchener, Ontario

July 5, 2024

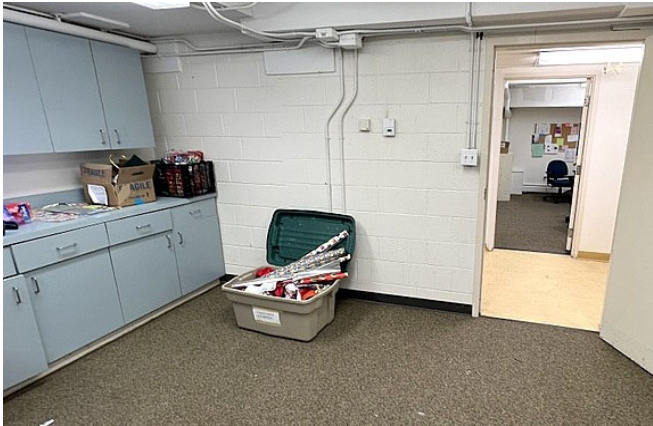
Samples: 018B
Lab Result: 0.5% Chrysotile
Comment: Block wall primer tested contains asbestos.

Location #	Area Description	Quantity	Condition	Damaged	Qty.	Acc.	Vis.	Comments	Recommendation
Various	Where present in the 1914 building.	nq	good	-		A	Yes	Primer on block walls in other areas of the building should be presumed to contain asbestos.	Maintain in good condition. Implement safe work procedures in accordance with the requirements of O. Reg. 278/05 if the primer is likely to be disturbed.

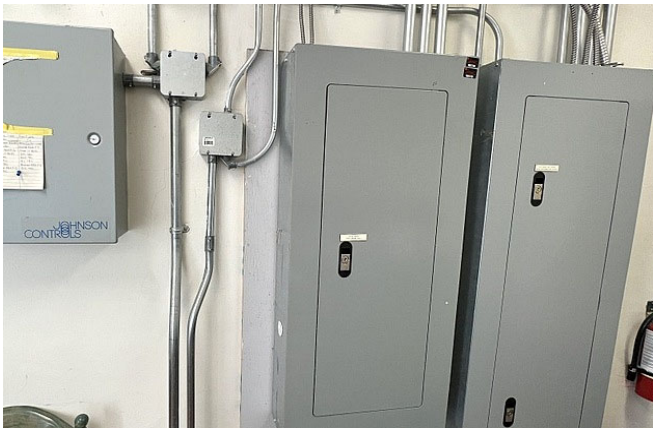
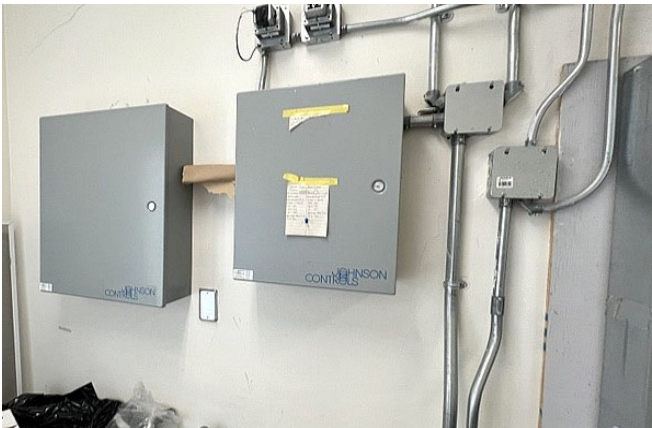
Comment: Electrical equipment (i.e. wire sheathing, cable wrap, circuit breakers, switches, switchgear, fuse holders etc.) are presumed to contain asbestos until testing proves otherwise.

Location #	Area Description	Quantity	Condition	Damaged Qty.	Acc.	Vis.	Comments	Recommendation
Various	Where present in the 1914 building.	nq	-	-	-	-		Avoid disturbance. When deenergized, assess electrical equipment that may be disturbed for asbestos-containing wiring and components. Confirmed and presumed asbestos components should be managed in accordance with O. Reg. 278/05 requirements.

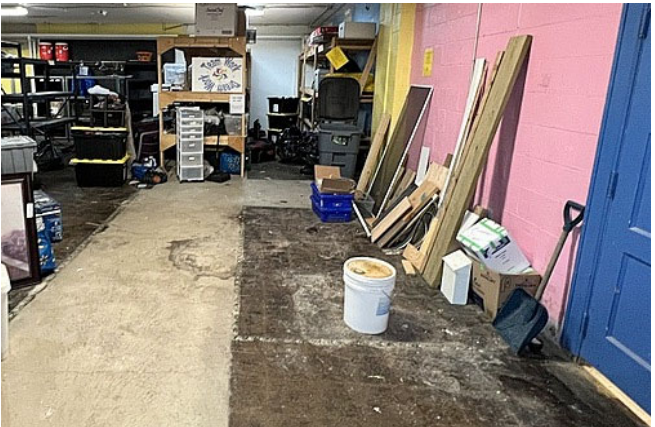
Comment: Mastic tested contains asbestos. Similar asbestos mastic is likely present concealed beneath flooring in other areas of the 1937 addition.

Location #	Area Description	Quantity	Condition	Damaged Qty.	Acc.	Vis.	Comments	Recommendation
L0-27 L0-37	Heritage Hall (B33) Corridor.	nq	good	-	A	Yes	Similar asbestos mastic is likely present concealed beneath flooring in other areas of the 1937 addition.	Remove mastic following O. Reg. 278/05 Type 1 operations using only non-powered handheld tools while wetting the material. Or remove following O. Reg. 278/05 Type 2 operations using HEPA filtered grinding equipment otherwise Type 3 operations apply.

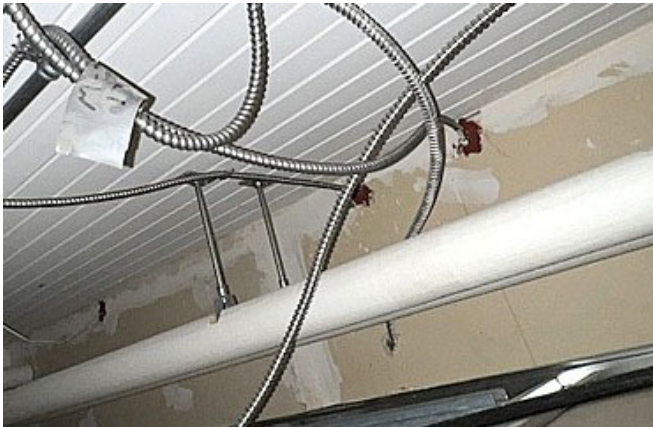
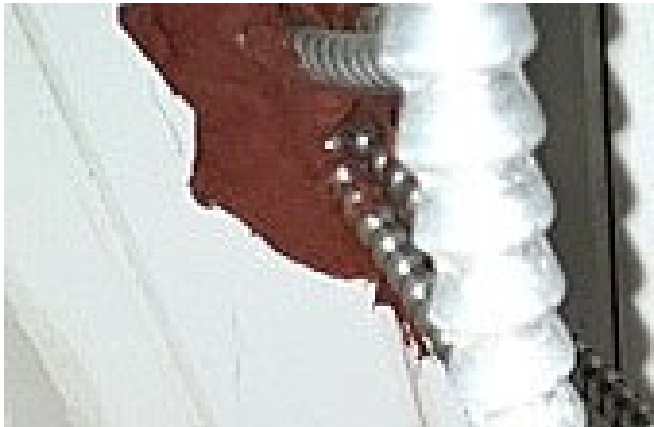
Comment: Fire stop is not expected to contain asbestos (new installation). Other older forms of fire stop may contain asbestos.

Location #	Area Description	Quantity	Condition	Damaged Qty.	Acc.	Vis.	Comments	Recommendation
								If encountered and likely to be disturbed, test older forms of fire stop for asbestos.

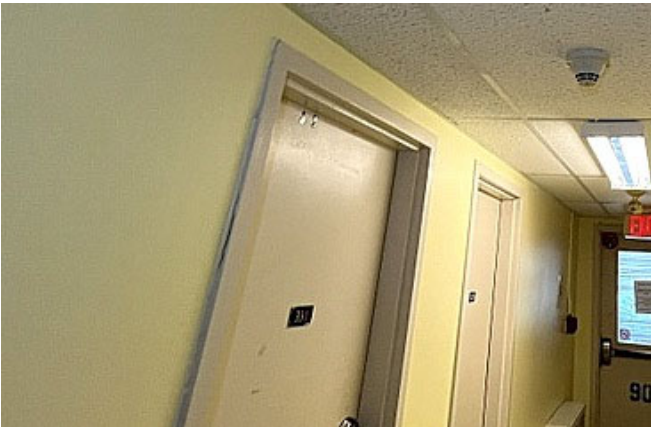
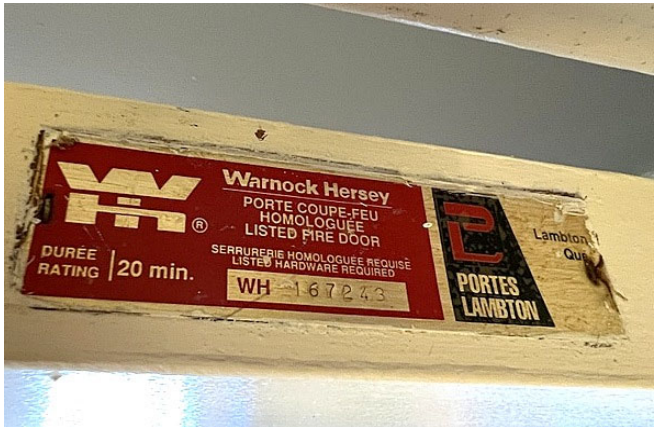
Comment: Fire-rated doors are presumed to contain asbestos until testing proves otherwise.

Location #	Area Description	Quantity	Condition	Damaged Qty.	Acc.	Vis.	Comments	Recommendation
Various	Where present in the 1937 addition.	nq	good	-	D	No	Cores of fire-rated doors are presumed to contain asbestos until intrusive inspection and testing prove otherwise.	Intrusive testing of door core for insulation should be undertaken when door is removed or insulation may be disturbed to determine if it contains asbestos. Dispose of door in accordance with O. Reg. 278/05 requirements if core contains asbestos.

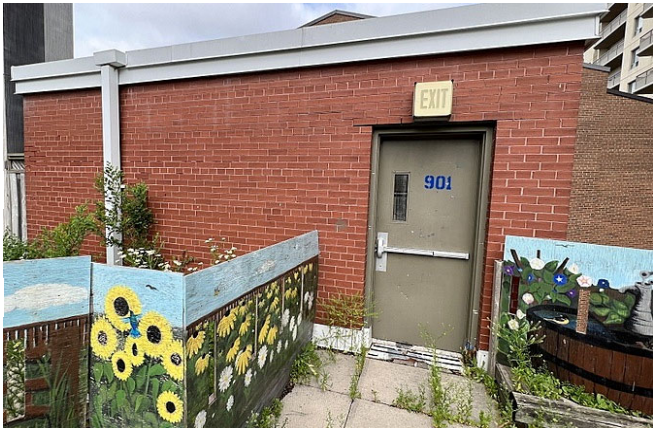
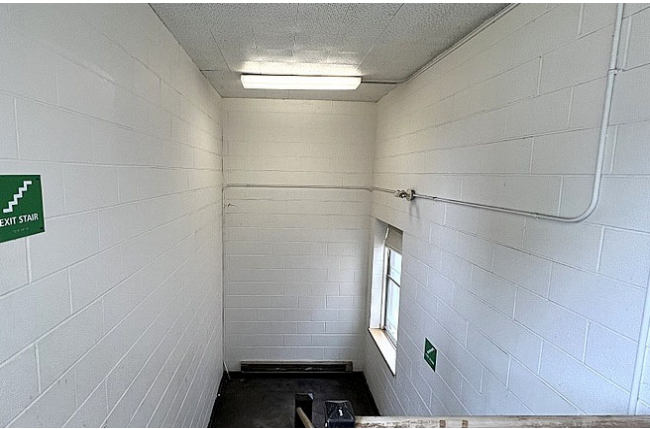
Comment: *Primer tested contains asbestos. Primer on block walls in other areas of the 1988 addition should be presumed to contain asbestos.*

Location #	Area Description	Quantity	Condition	Damaged Qty.	Acc.	Vis.	Comments	Recommendation
L0-33 L1-30 L2-30 L3-01	Staircase 1988 addition.	nq	good	-	A	Yes	Primer on block walls in other areas of the 1988 addition should be presumed to contain asbestos.	Maintain in good condition. Implement safe work procedures in accordance with the requirements of O. Reg. 278/05 if the primer is likely to be disturbed.

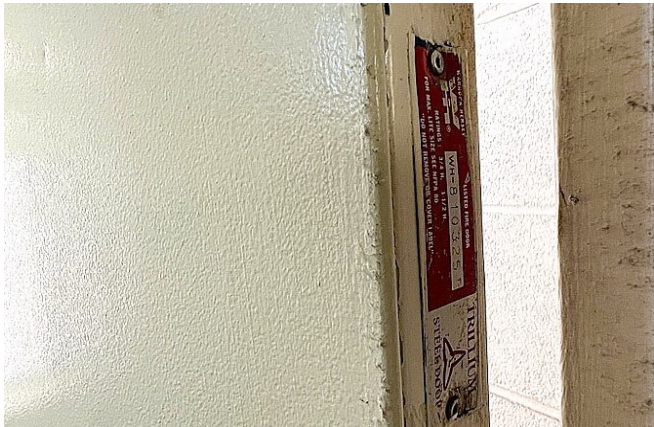
Comment: Fire-rated doors are presumed to contain asbestos until testing proves otherwise.

Location #	Area Description	Quantity	Condition	Damaged Qty.	Acc.	Vis.	Comments	Recommendation
Various	1988 addition.	nq	good	-	D	No	Cores of fire-rated doors are presumed to contain asbestos insulation until intrusive inspection and testing prove otherwise.	Intrusive testing of the door core should be undertaken when door is removed to determine if core insulation contains asbestos. Dispose of door in accordance with O. Reg. 278/05 requirements if core contains asbestos.

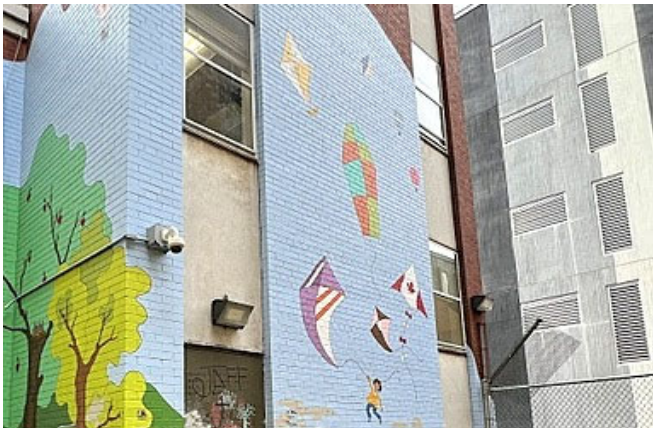
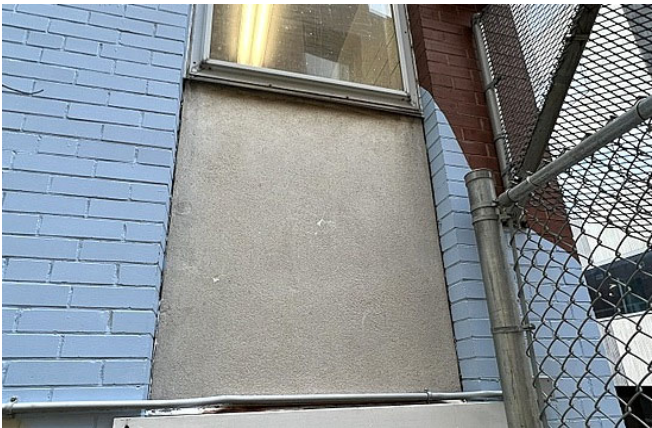
Comment: *Cladding material tested contains asbestos.*
