**DESIGNATED SUBSTANCES AND HAZARDOUS
BUILDING MATERIALS ASSESSMENT**

**MILL COURTLAND COMMUNITY CENTRE
216 MILL STREET, KITCHENER, ON**

JULY 9, 2023

PROJECT #: 100103.026

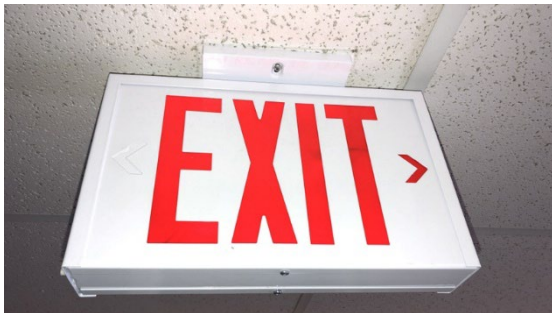
Photo 1: Emergency lighting with suspect lead-acid batteries.

- Building materials containing lead should be tested for leachable lead prior to disposal as they may be subject to classification as hazardous waste.
- Lead-containing batteries should be recycled when taken out of service.

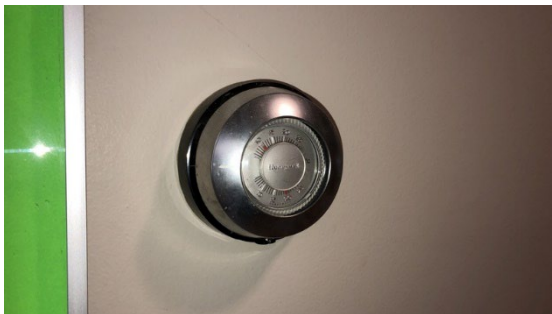
Photo 2: Thermostat with mercury bulb.

- Avoid damage to mercury-containing equipment.
- Complete removal of mercury-containing equipment is required when the equipment is taken out of service or prior to renovation work.
- Mercury-containing equipment can be sent for recycling.

- Mercury is a hazardous waste and should be disposed of in accordance with the requirements of O.Reg. 347/90.

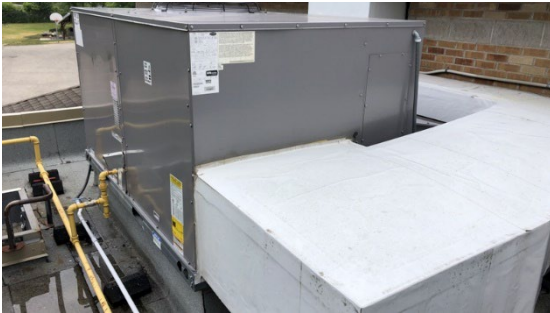
Photo 3: Rooftop HVAC unit.

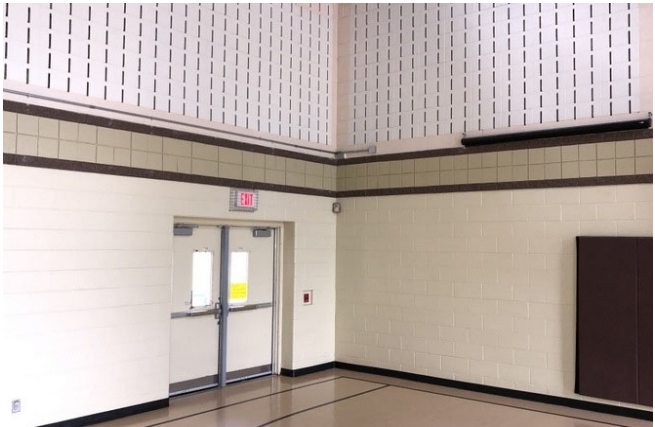
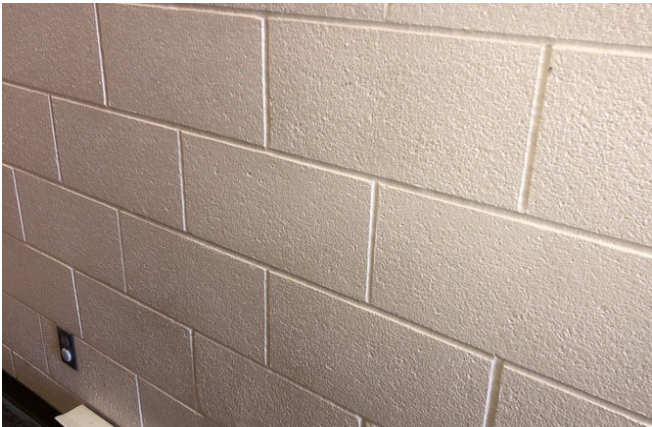
Comment: *Destructive testing of block wall cavities was not conducted. Concealed asbestos vermiculite insulation could be present within cavities.*

Location #	Area Description	Quantity	Condition	Damaged Qty.	Acc.	Vis.	Comments	Recommendation
--	Where Present	nq	na	na	A	No		Manage in place. Examine block wall cavities prior to disturbance for the presence of vermiculite insulation. If ACM, remove following O.Reg. 278/05 Type 3 procedures.

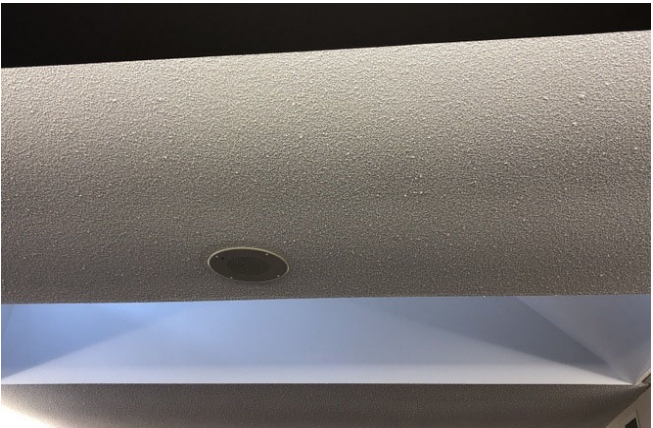
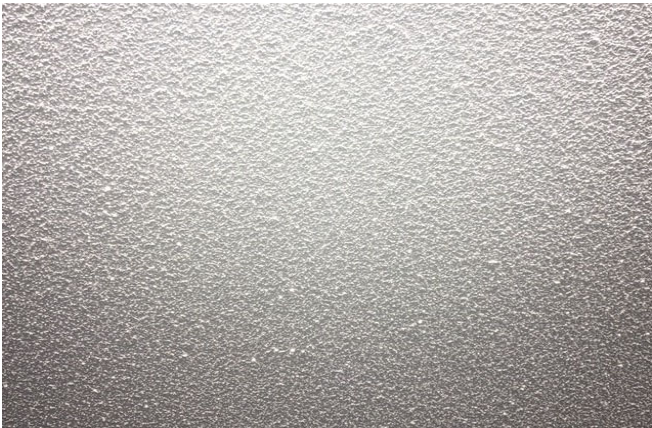
Comment: *Texture ceiling finish tested does not contain asbestos.*

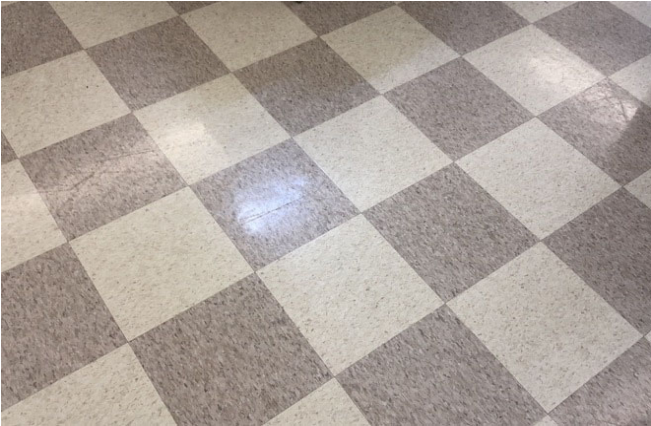
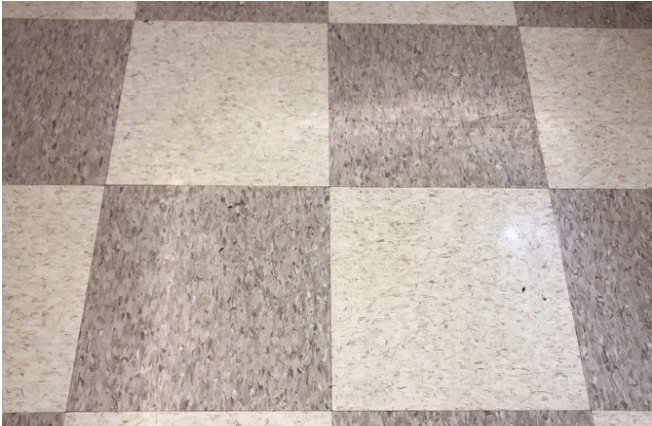
Comment: Floor tiles and mastic tested do not contain asbestos.

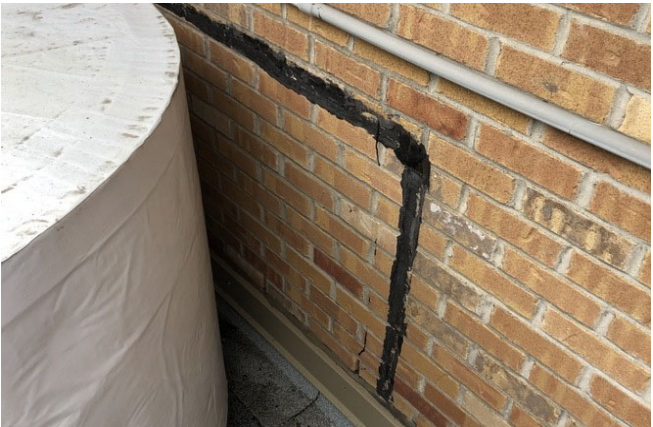
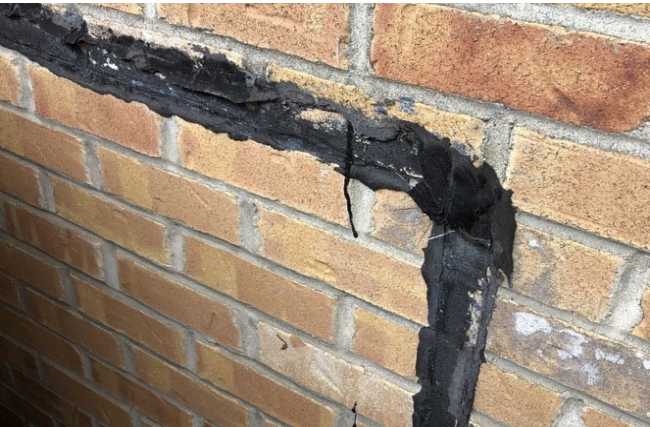
Comment: *Chrysotile asbestos was detected in one sample analyzed however the amount was less than 0.5% which is below the cut-off threshold within Ontario for a building material to be deemed asbestos-containing.*

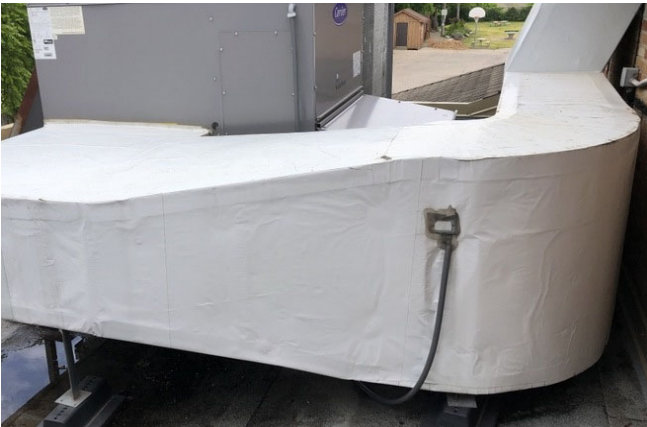
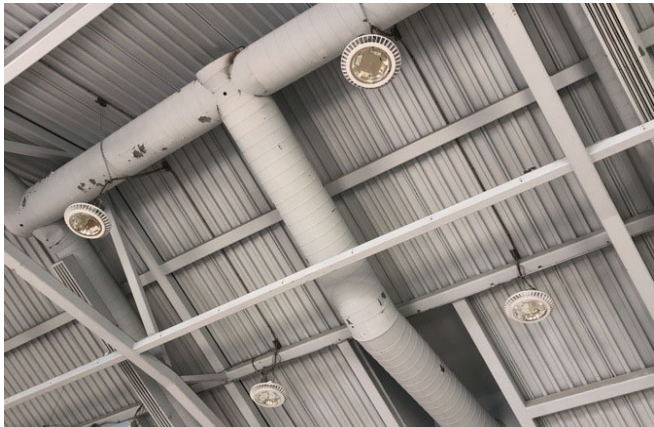
Comment: *Fibreglass does not contain asbestos.*

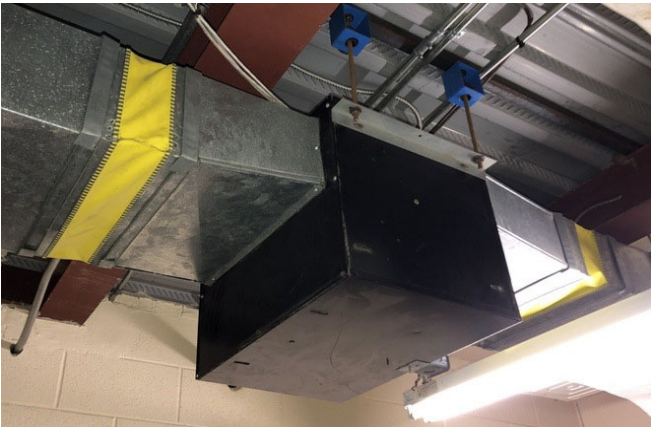
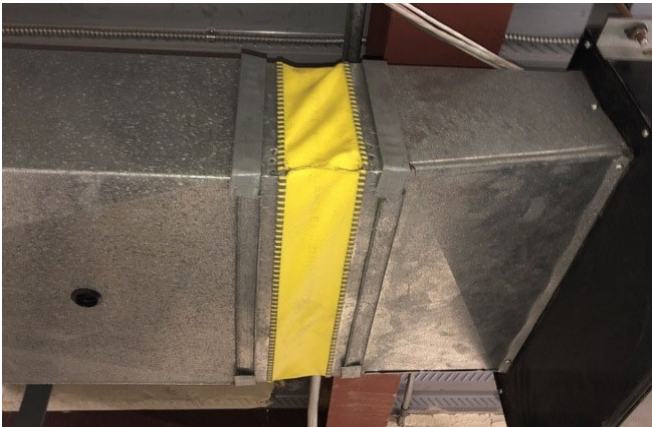
Comment: *Rubber flex joints do not contain asbestos.*

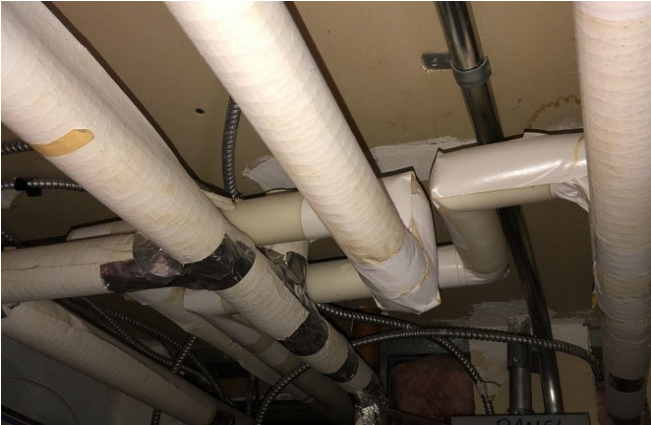
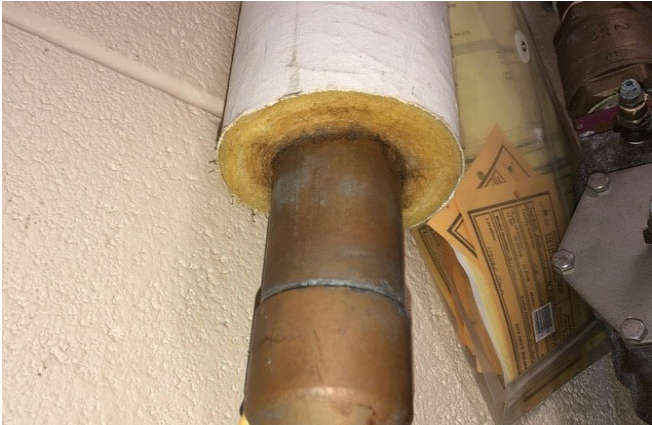
Comment: *Fibreglass does not contain asbestos.*

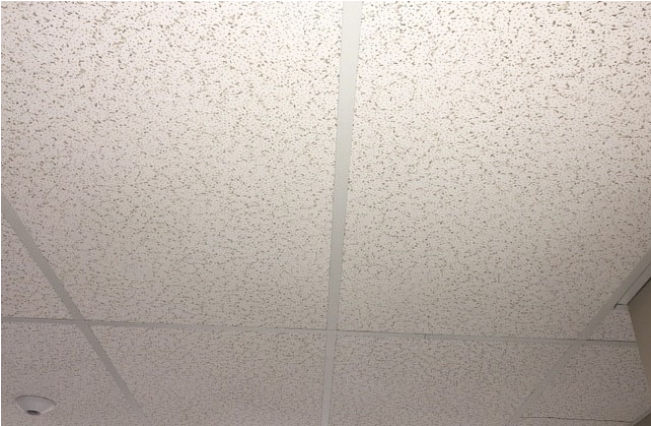
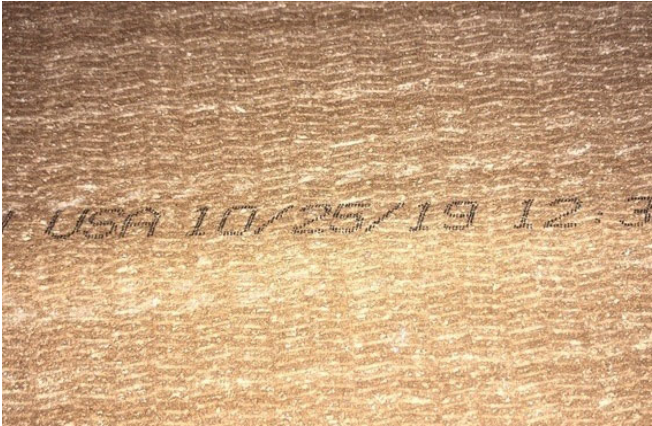
Comment: Ceiling tiles do not contain asbestos (date stamp 1993 or 2019).

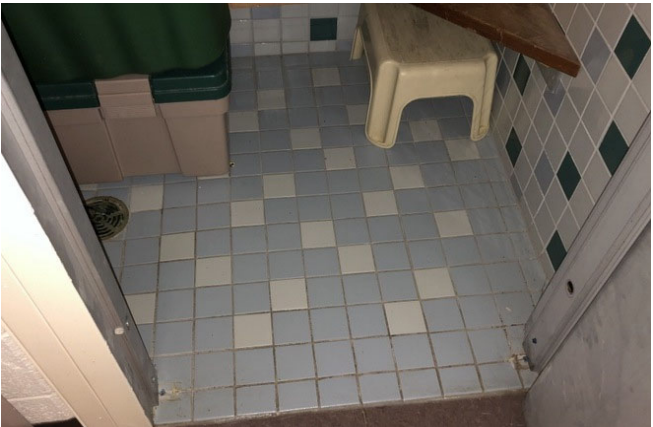
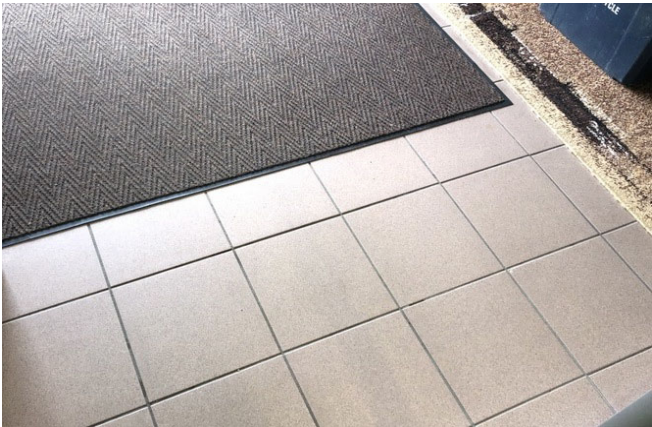
Comment: *Ceramic tiles are not suspect to contain asbestos.*

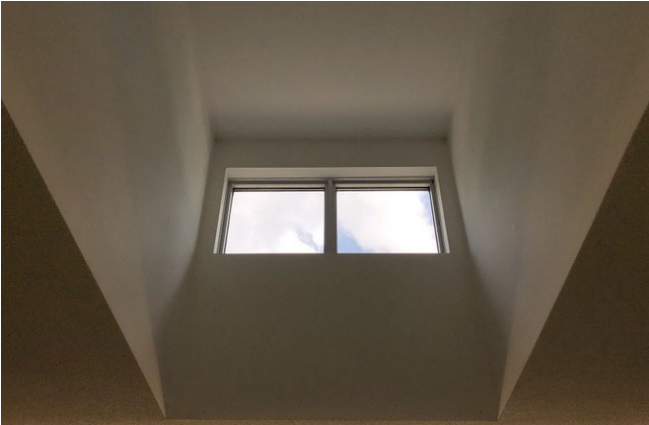
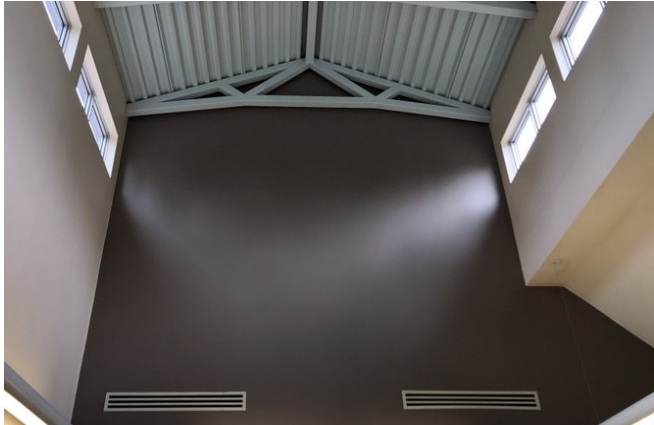
Comment: *Drywall joint-fill compound is not suspect to contain asbestos (installed 1993).*

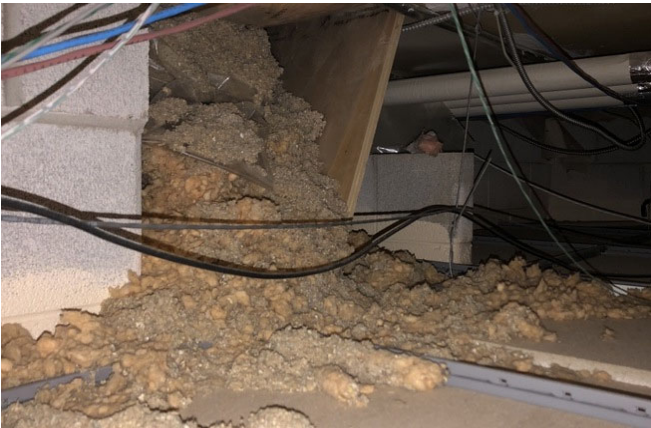
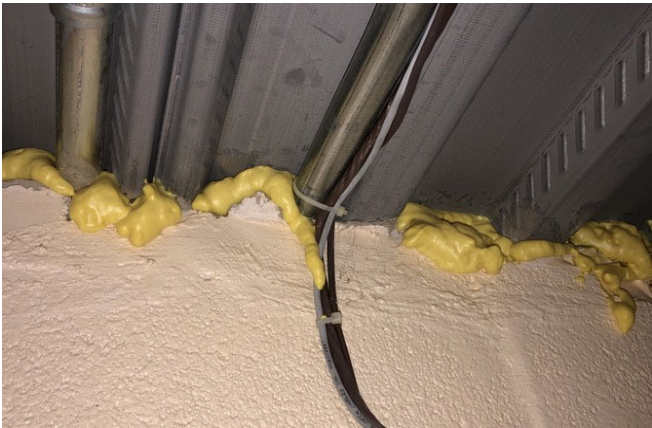
Samples: *ns*
Lab Result: *na*
Comment: *Cellulose, fibreglass batt and expanded spray foam are not suspect to contain asbestos (installed 1993).*

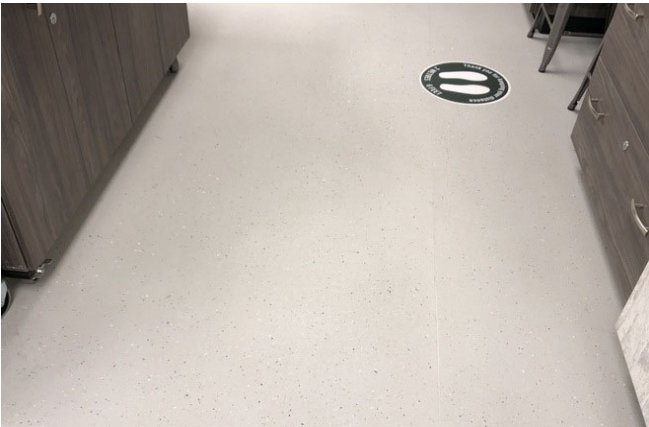
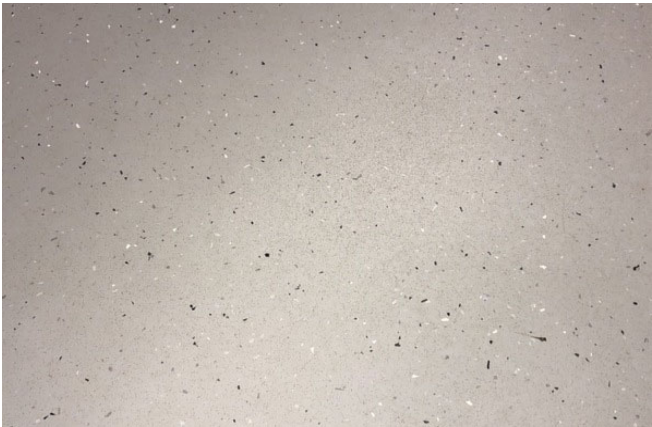
Comment: *Sheet flooring is not suspect to contain asbestos (installed 1993 or post and no paper backing observed in areas examined).*

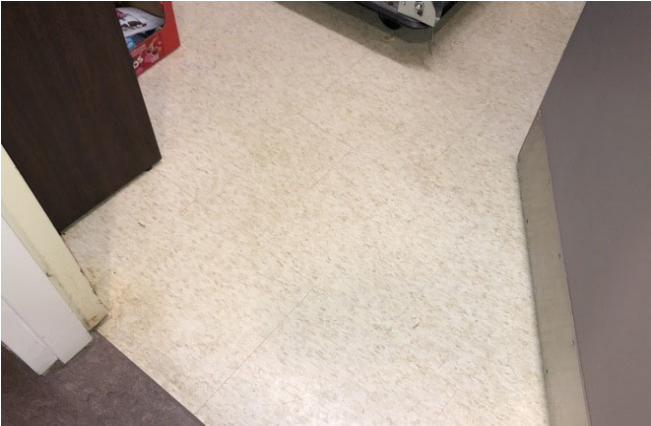
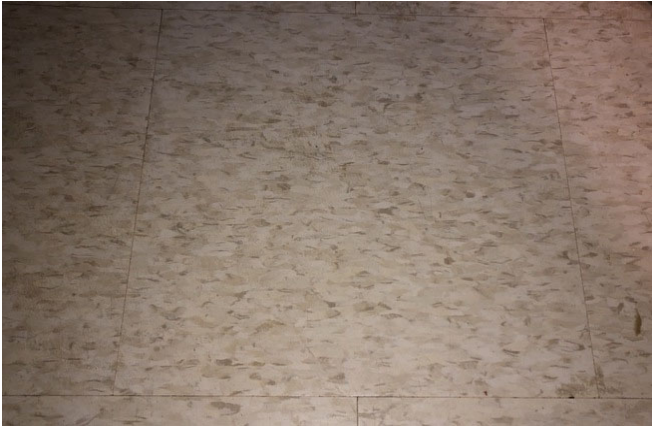
Comment: Floor tiles are not suspect to contain asbestos (installed post 2010).

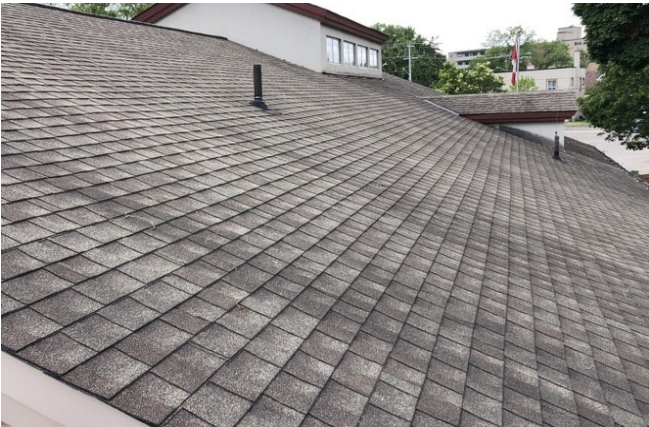
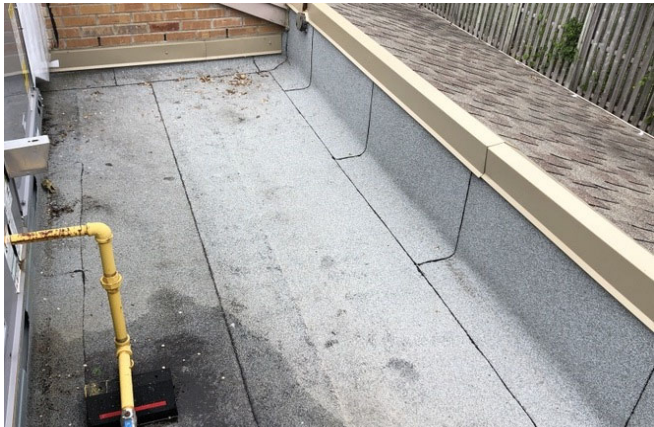
Comment: *Asphalt shingles and rolled roofing are not suspect to contain asbestos (installed 1993).*

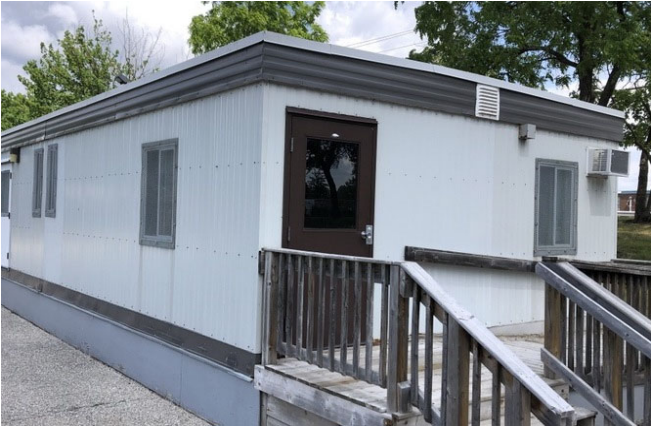
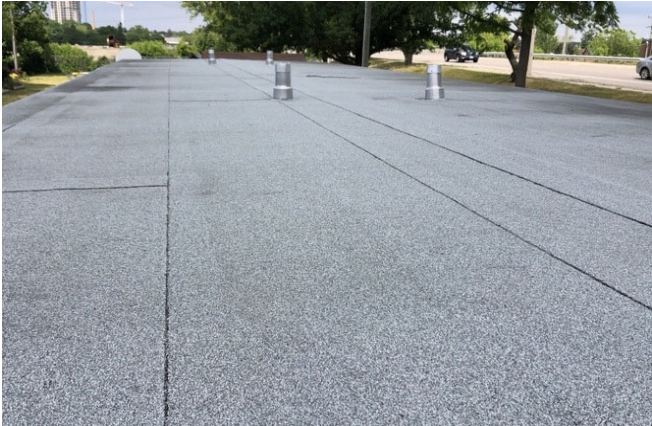
Comment: *Asphalt rolled roofing is not suspect to contain asbestos (installed post 1995).*

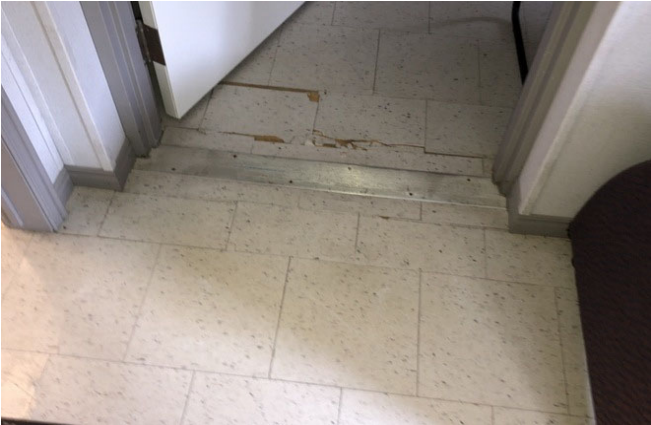
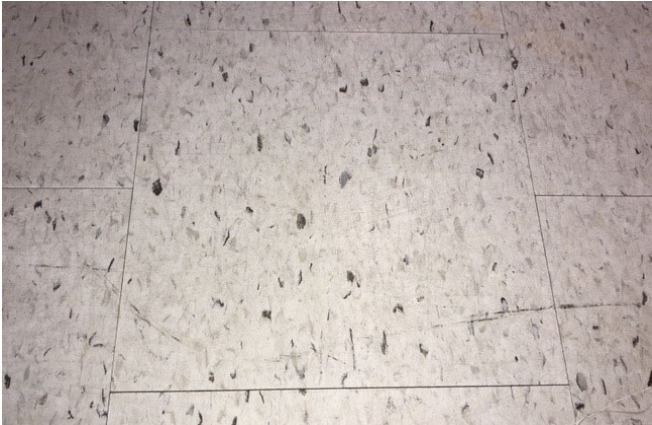
Comment: Floor tiles and mastic are not suspect to contain asbestos (installed post 1995).

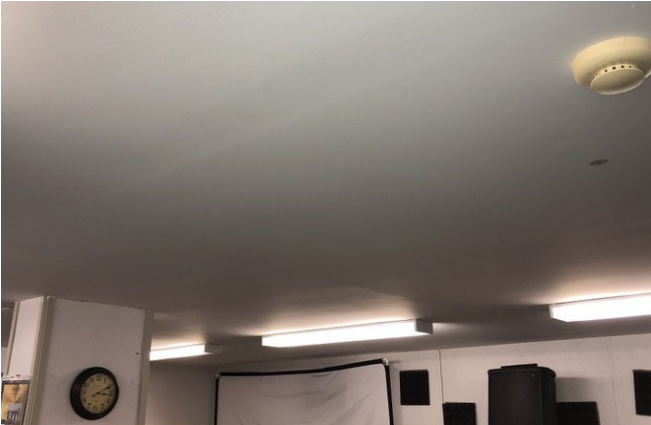
Comment: *Drywall joint-fill compound is not suspect to contain asbestos (installed post 1987).*

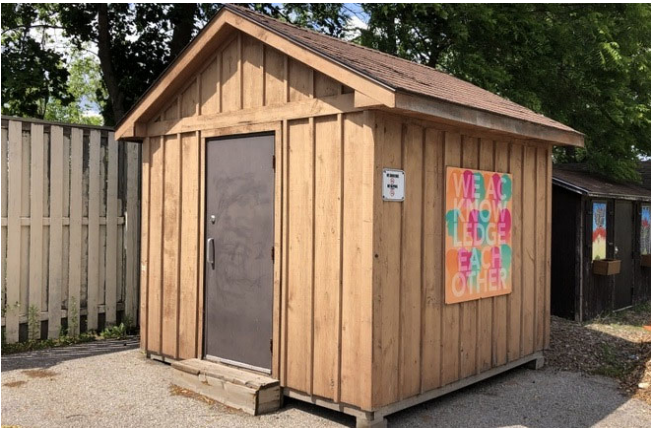
Comment: *Asphalt shingles are not suspect to contain asbestos (installed post 1995).*

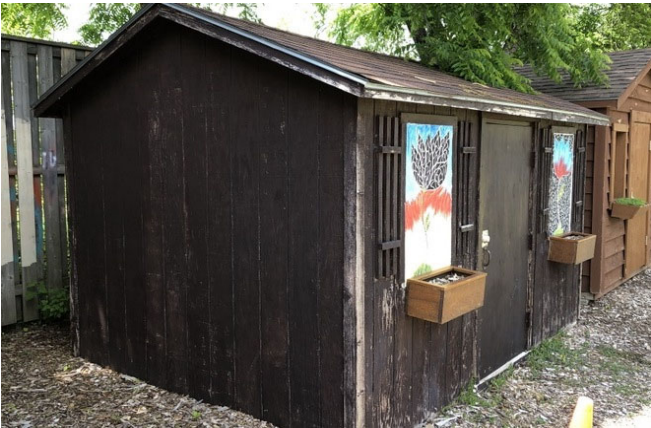
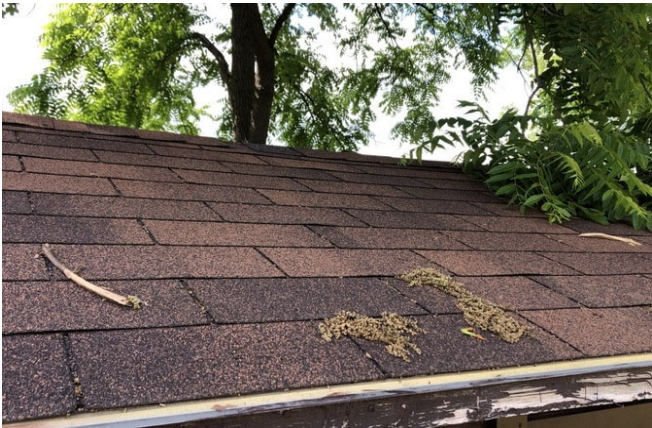
Comment: *Asphalt shingles are not suspect to contain asbestos (installed post 1995).*

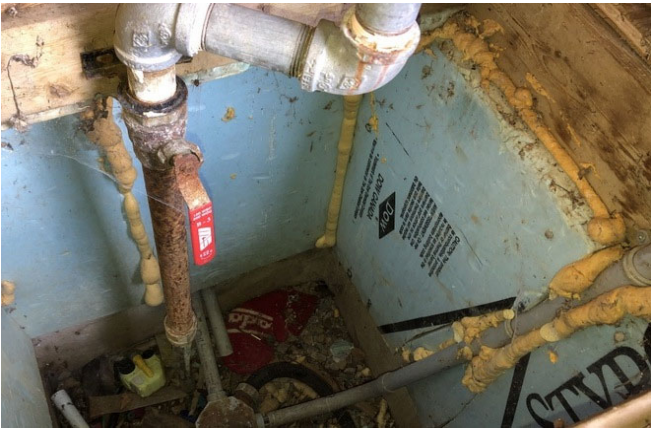
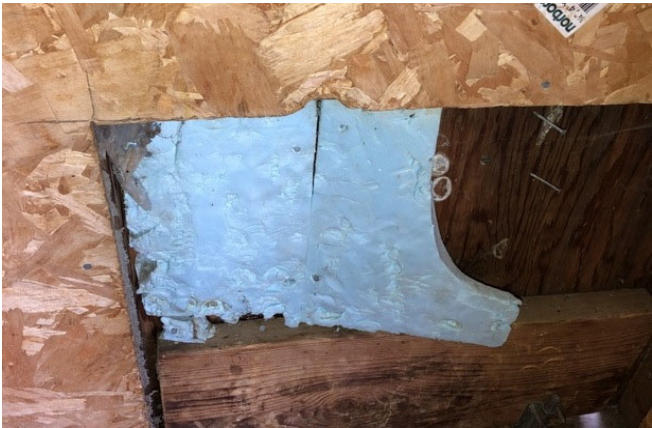
Comment: *Rigid foam board and expanded spray foam insulations do not contain asbestos (installed post 1995).*

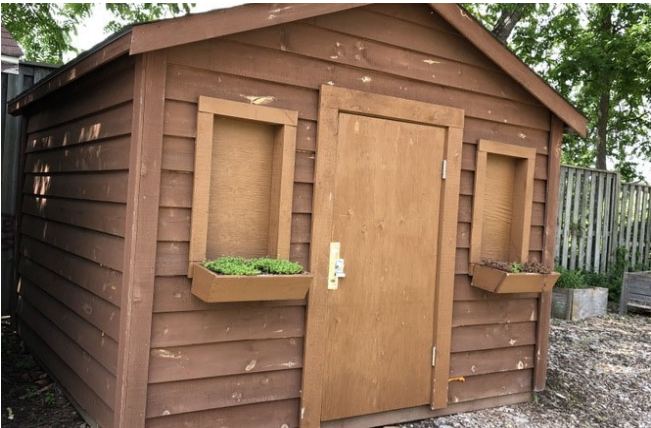
Comment: *Asphalt shingles are not suspect to contain asbestos (installed post 1995).*

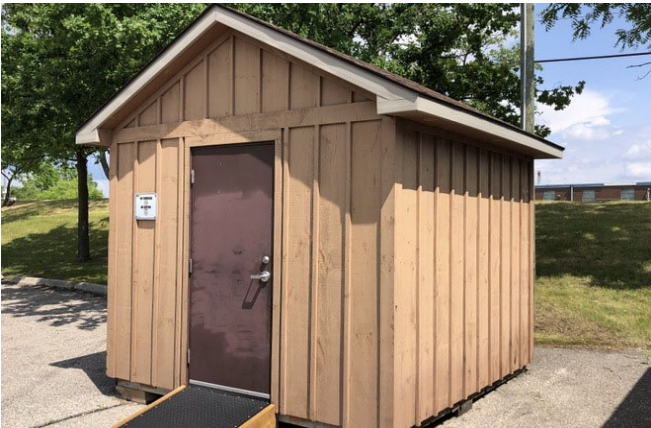
Comment: *Asphalt shingles are not suspect to contain asbestos (installed post 1995).*
