DESIGNATED SUBSTANCES SURVEY

Building A-243

17 Hangar Road, Borden, Ontario

March 23, 2022

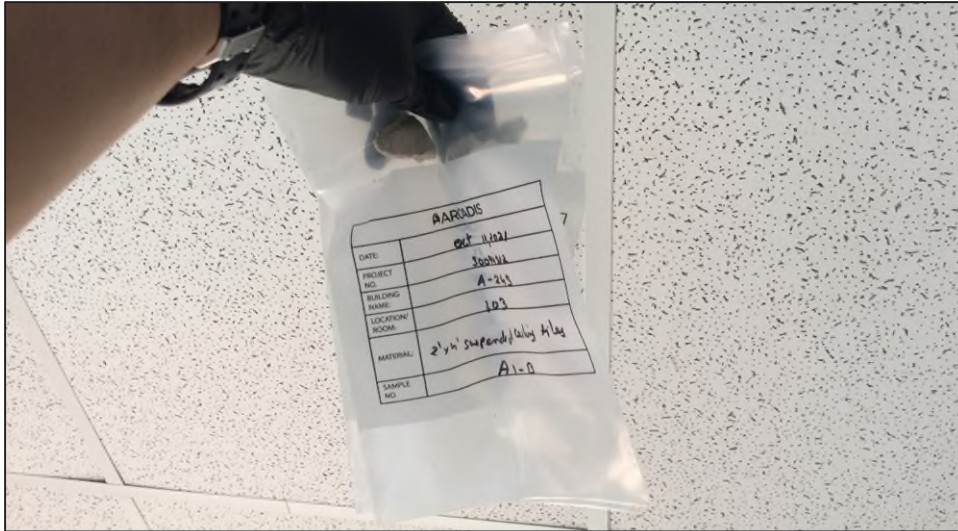
Photo: 4

Room 103/Sample A1-B –
Non-asbestos-containing 2'x4'
ceiling tile with pinholes and
fissures.

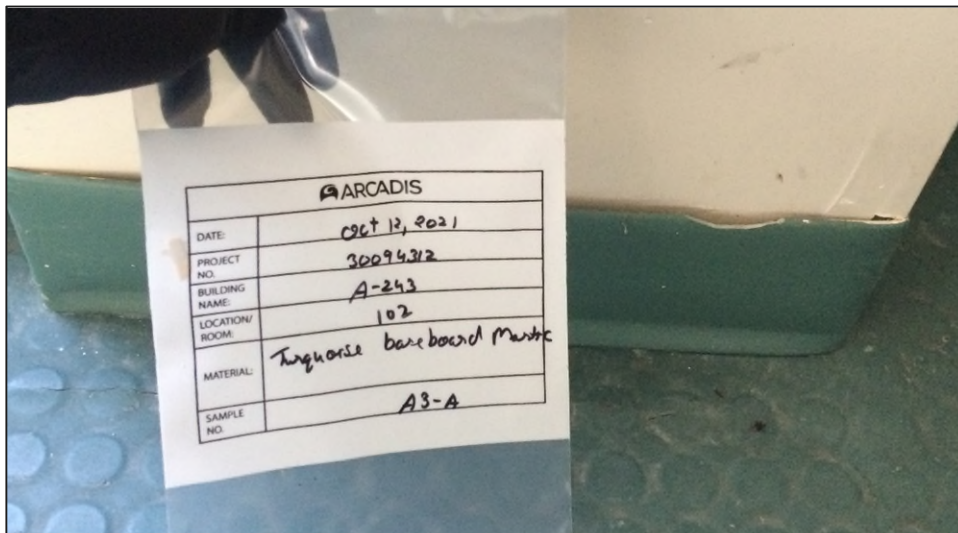
Photo: 5

Room 102/Sample A3-A –
Non-asbestos-containing
mastic behind baseboard –
turquoise.

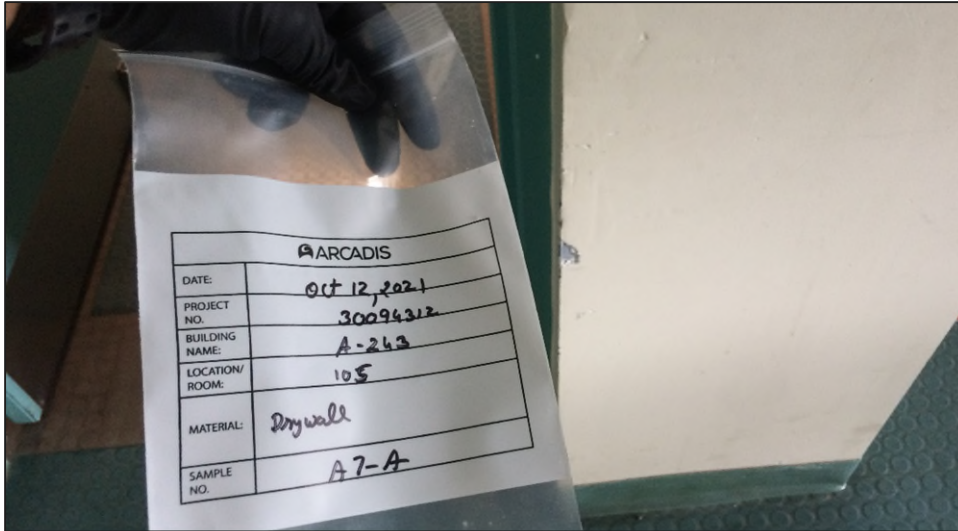
Photo: 7

Room 105/Sample A7-A –
Non-asbestos-containing
drywall joint compound.

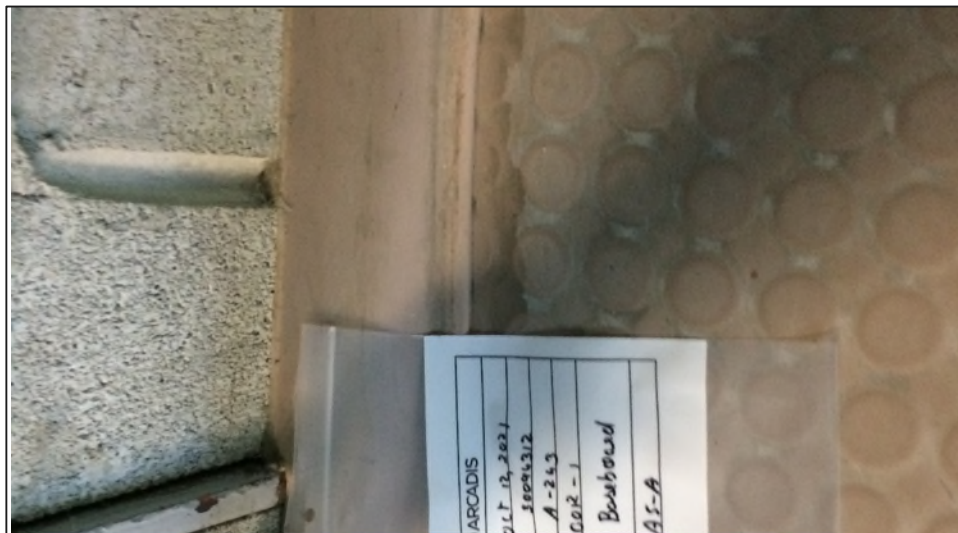
Photo: 8

Corridor-1/Sample A5-A –
Non-asbestos-containing
beige vinyl baseboard.

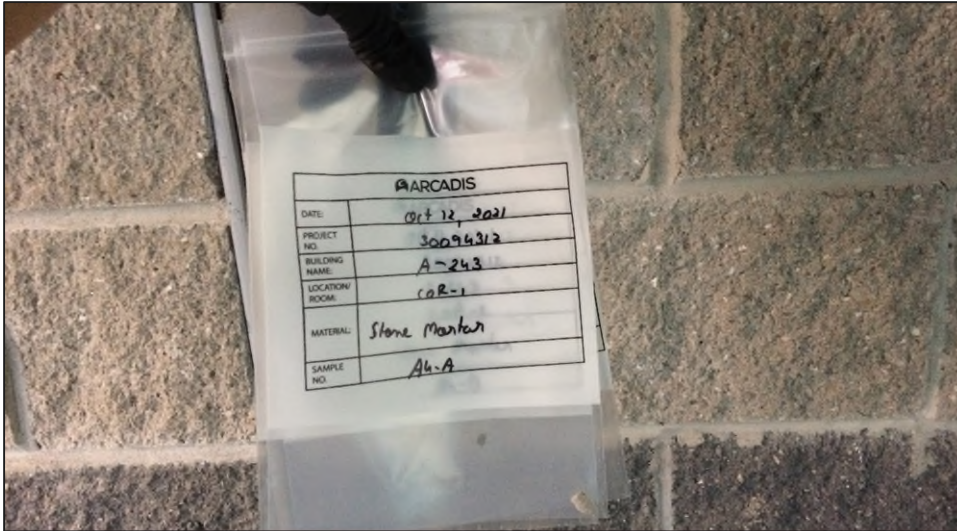
Photo: 10

Corridor-1/Sample A4-A –
Non-asbestos-containing
stone mortar.

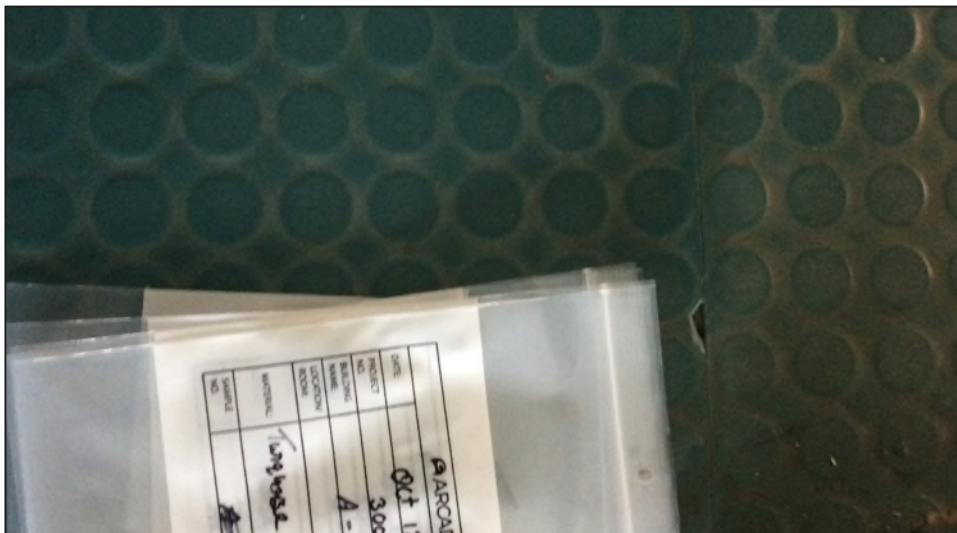
Photo: 11

Room 105/Sample A8-A –
Non-asbestos-containing
turquoise vinyl sheet flooring.

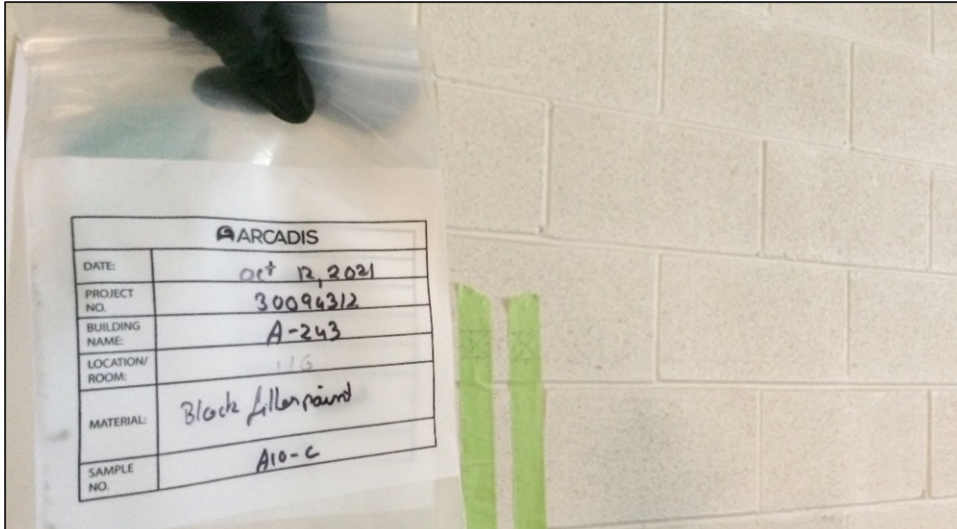
Photo: 13

Room 116/Sample A10-C –
Non-asbestos-containing
block filler paint.

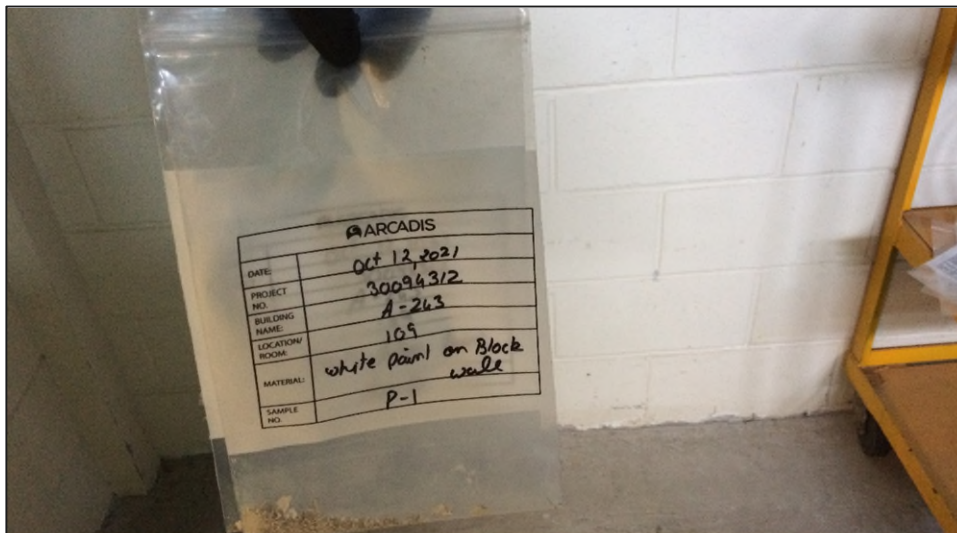
Photo: 14

Room 109/Sample P-1 –
White paint on block wall. No
parameters exceeded.

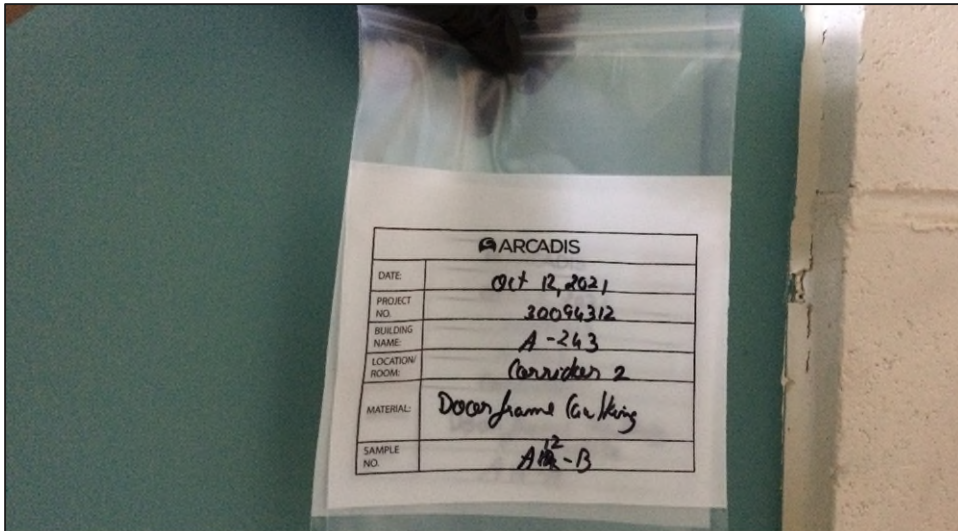
Photo: 16

Corridor-2/Sample A12-B –
Non-asbestos-containing
white door frame caulking.

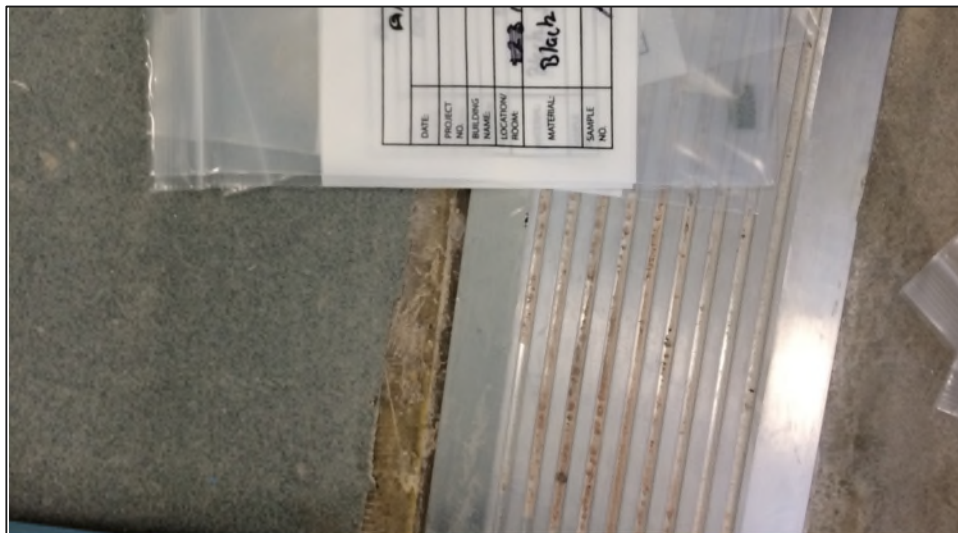
Photo: 17

Room 123/Sample A14-A –
Non-asbestos-containing
mastic behind black vinyl
sheet flooring.

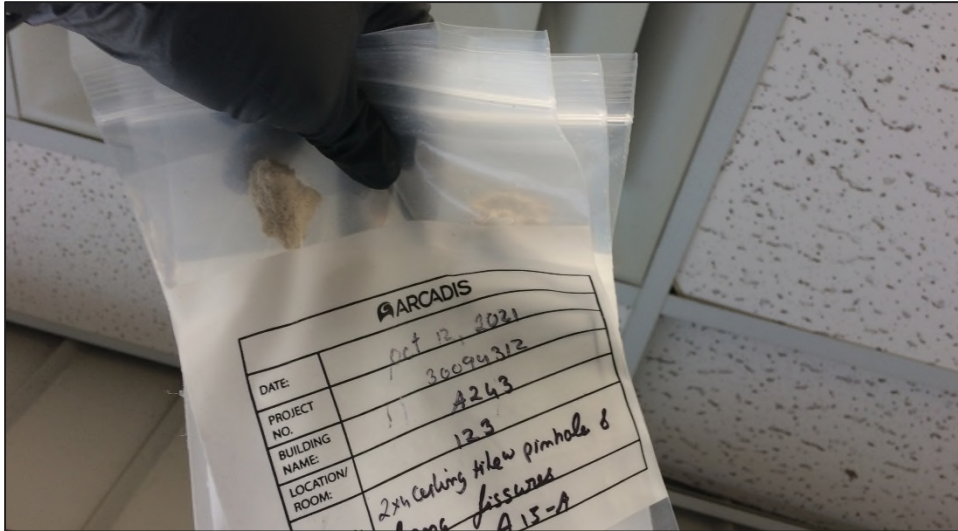
Photo: 19

Room 123/Sample A15-A – Non-asbestos-containing 2'x4' ceiling tile with pinholes and long fissures.

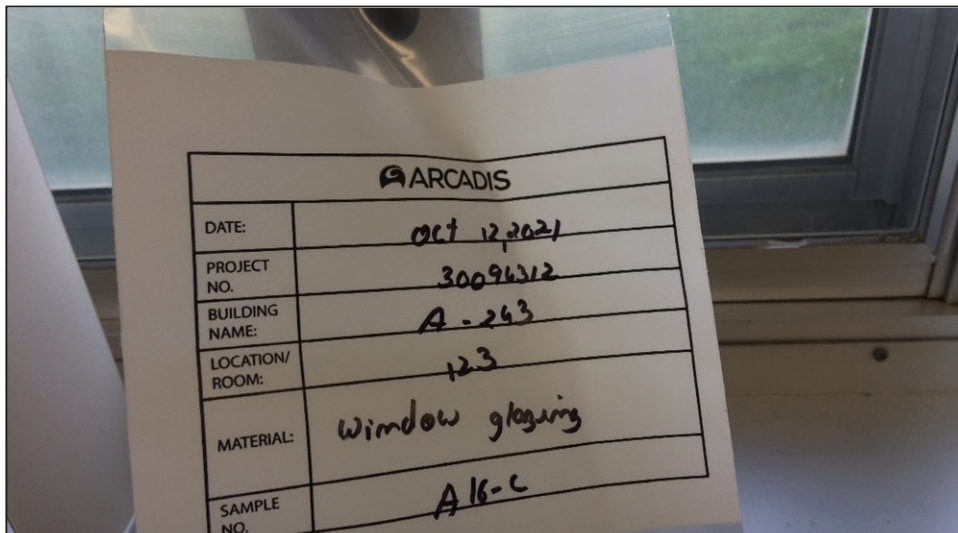
Photo: 20

Room 123/Sample A16-C – Non-asbestos-containing window glazing.

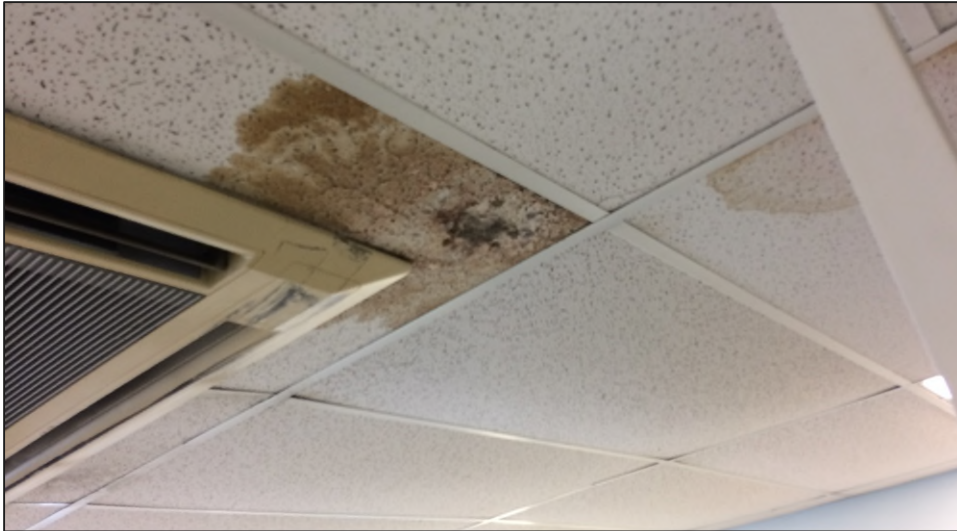
Photo: 22

Room 205/View of suspect mould growth on non-asbestos ceiling tile.

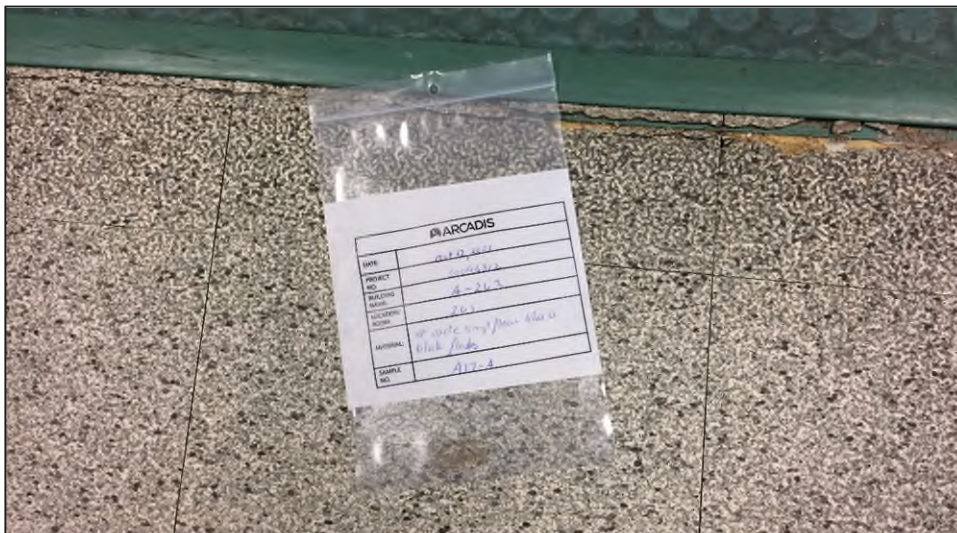
Photo: 23

Room 205/Sample A17-A – Non-asbestos containing 12" vinyl floor tile with black flecks.

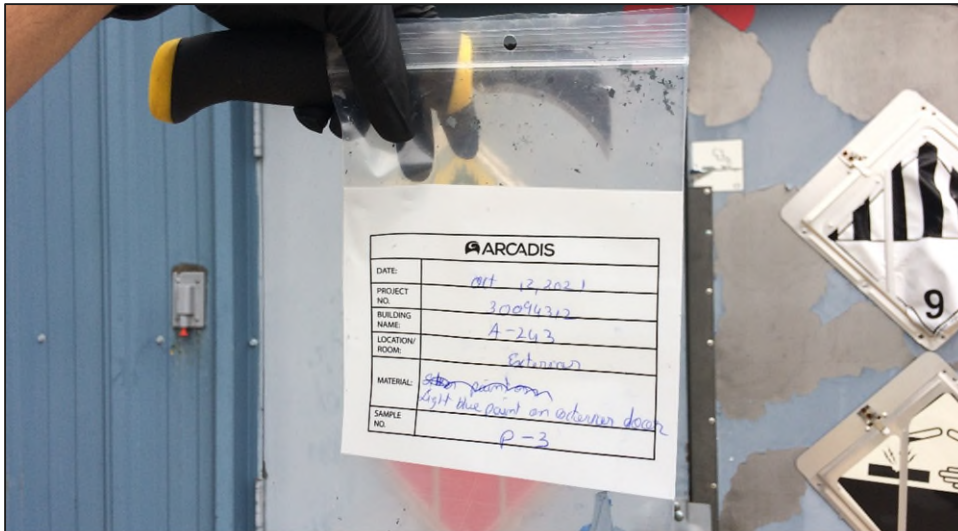
Photo: 25

Exterior/Sample P-3 – Light blue paint on exterior door. No parameters exceeded.

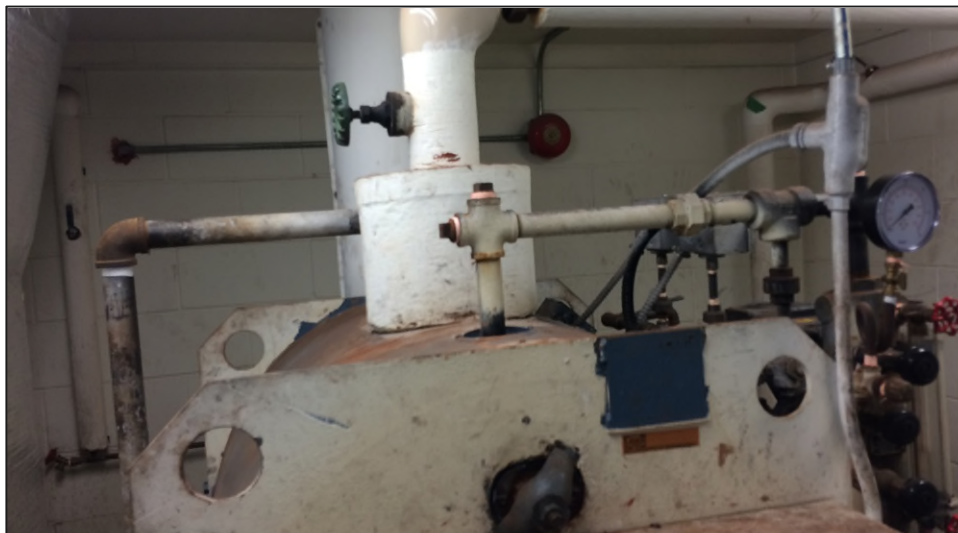
Photo: 26

Potential asbestos-containing materials are materials which could contain asbestos, but which were not sampled as such sampling could cause significant damage. Potential asbestos-containing materials observed at this site include boiler insulation, mortar beds and grout under ceramic floor tiles, exterior window caulking and roofing materials.

Boiler Room/Boiler – May contain asbestos-containing material.
