## Plumbing & HVAC Assessment Waterloo City Centre

265 Lexington Court  
Waterloo, ON  
N2J 4A8

PREPARED BY:

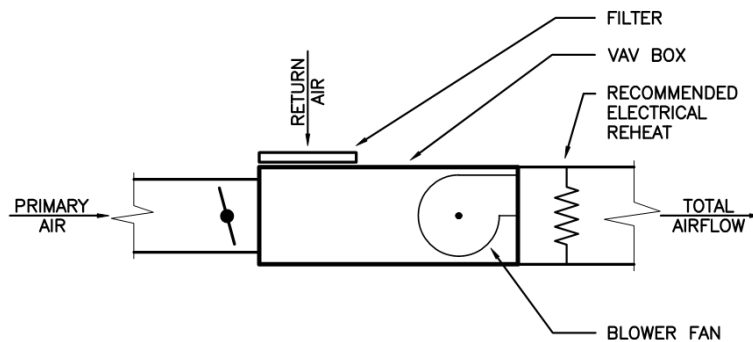
Figure 1 Fan Powered VAV Box

During the preliminary stage of airflow investigation, the filters in the series flow FPVAV boxes were found to be completely blocked. Based on the quantity of dust accumulated, it appears that the filters have not been changed for a substantial time – more than a year. When the dirty filters were removed, total airflow rates increased substantially (up to triple), and total airflow more closely approached design values.

- 1) The filters in all the series fan powered VAVs were very dirty and do not appear to have been changed for a very long time, by appearance, much more than one year. Manufacturers typically recommend filter replacements multiple times per year. Requirement: replace all filters in VAV boxes in the entire building. Add filter replacement for VAV boxes to the maintenance schedule.

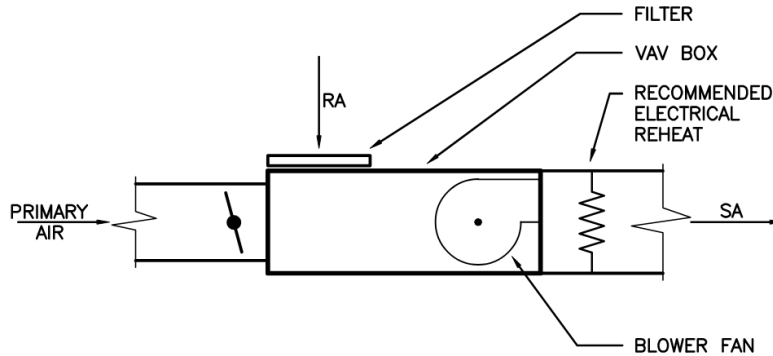
Figure 2 Fan Powered VAV Box

Standard operation for zones served by VAV boxes is for the VAV damper to remain in fully open position only as required for cooling. When cooling demand is low, the damper will move to minimum outdoor air position. This operation is the same for VVT, VAV, or FPAV systems<sup>9</sup>.

To achieve higher primary air and outdoor air changes, the minimum VAV damper position can be increased. Increasing the minimum damper position and primary airflow rate also increases space cooling. Increasing the minimum damper position decreases temperature control and leads to overcooling. The typical method to mitigate overcooling is to add reheat to the VAV box. Electric reheat is recommended because it is available all year round and is not dependent on seasonal gas boiler operation.

**Recommendation:** add electric reheat to zones where delivery of sufficient outdoor air requires higher primary rates. Add approximately 1 kW of electric reheat for every 100 cfm primary airflow.

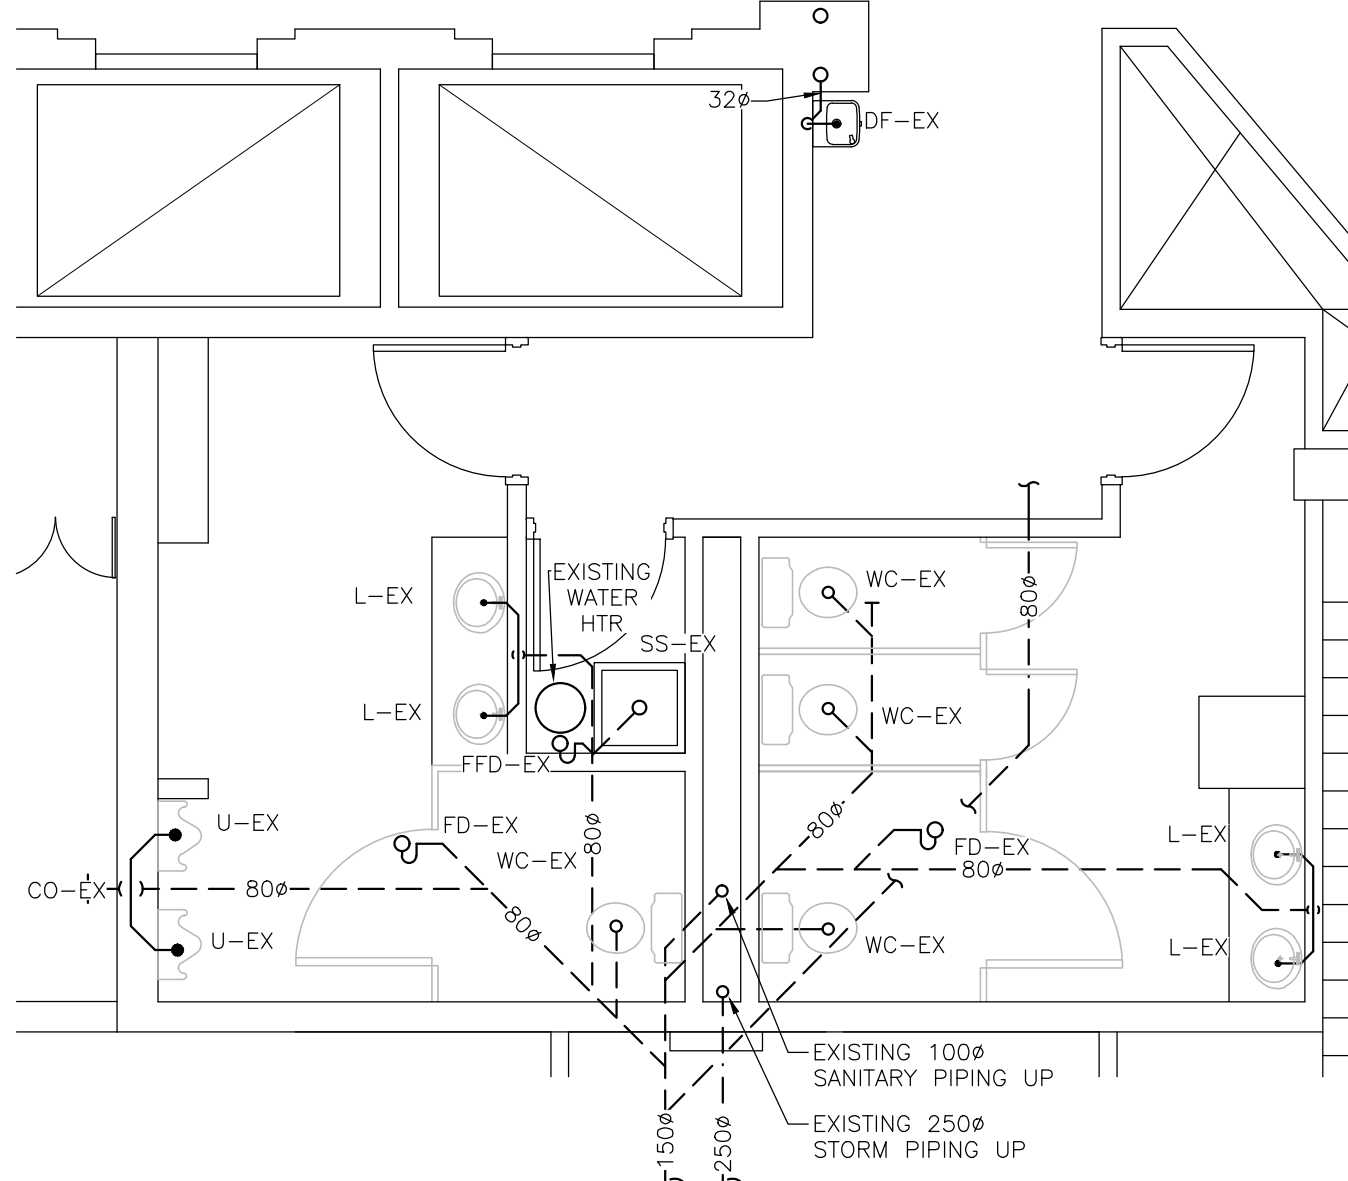
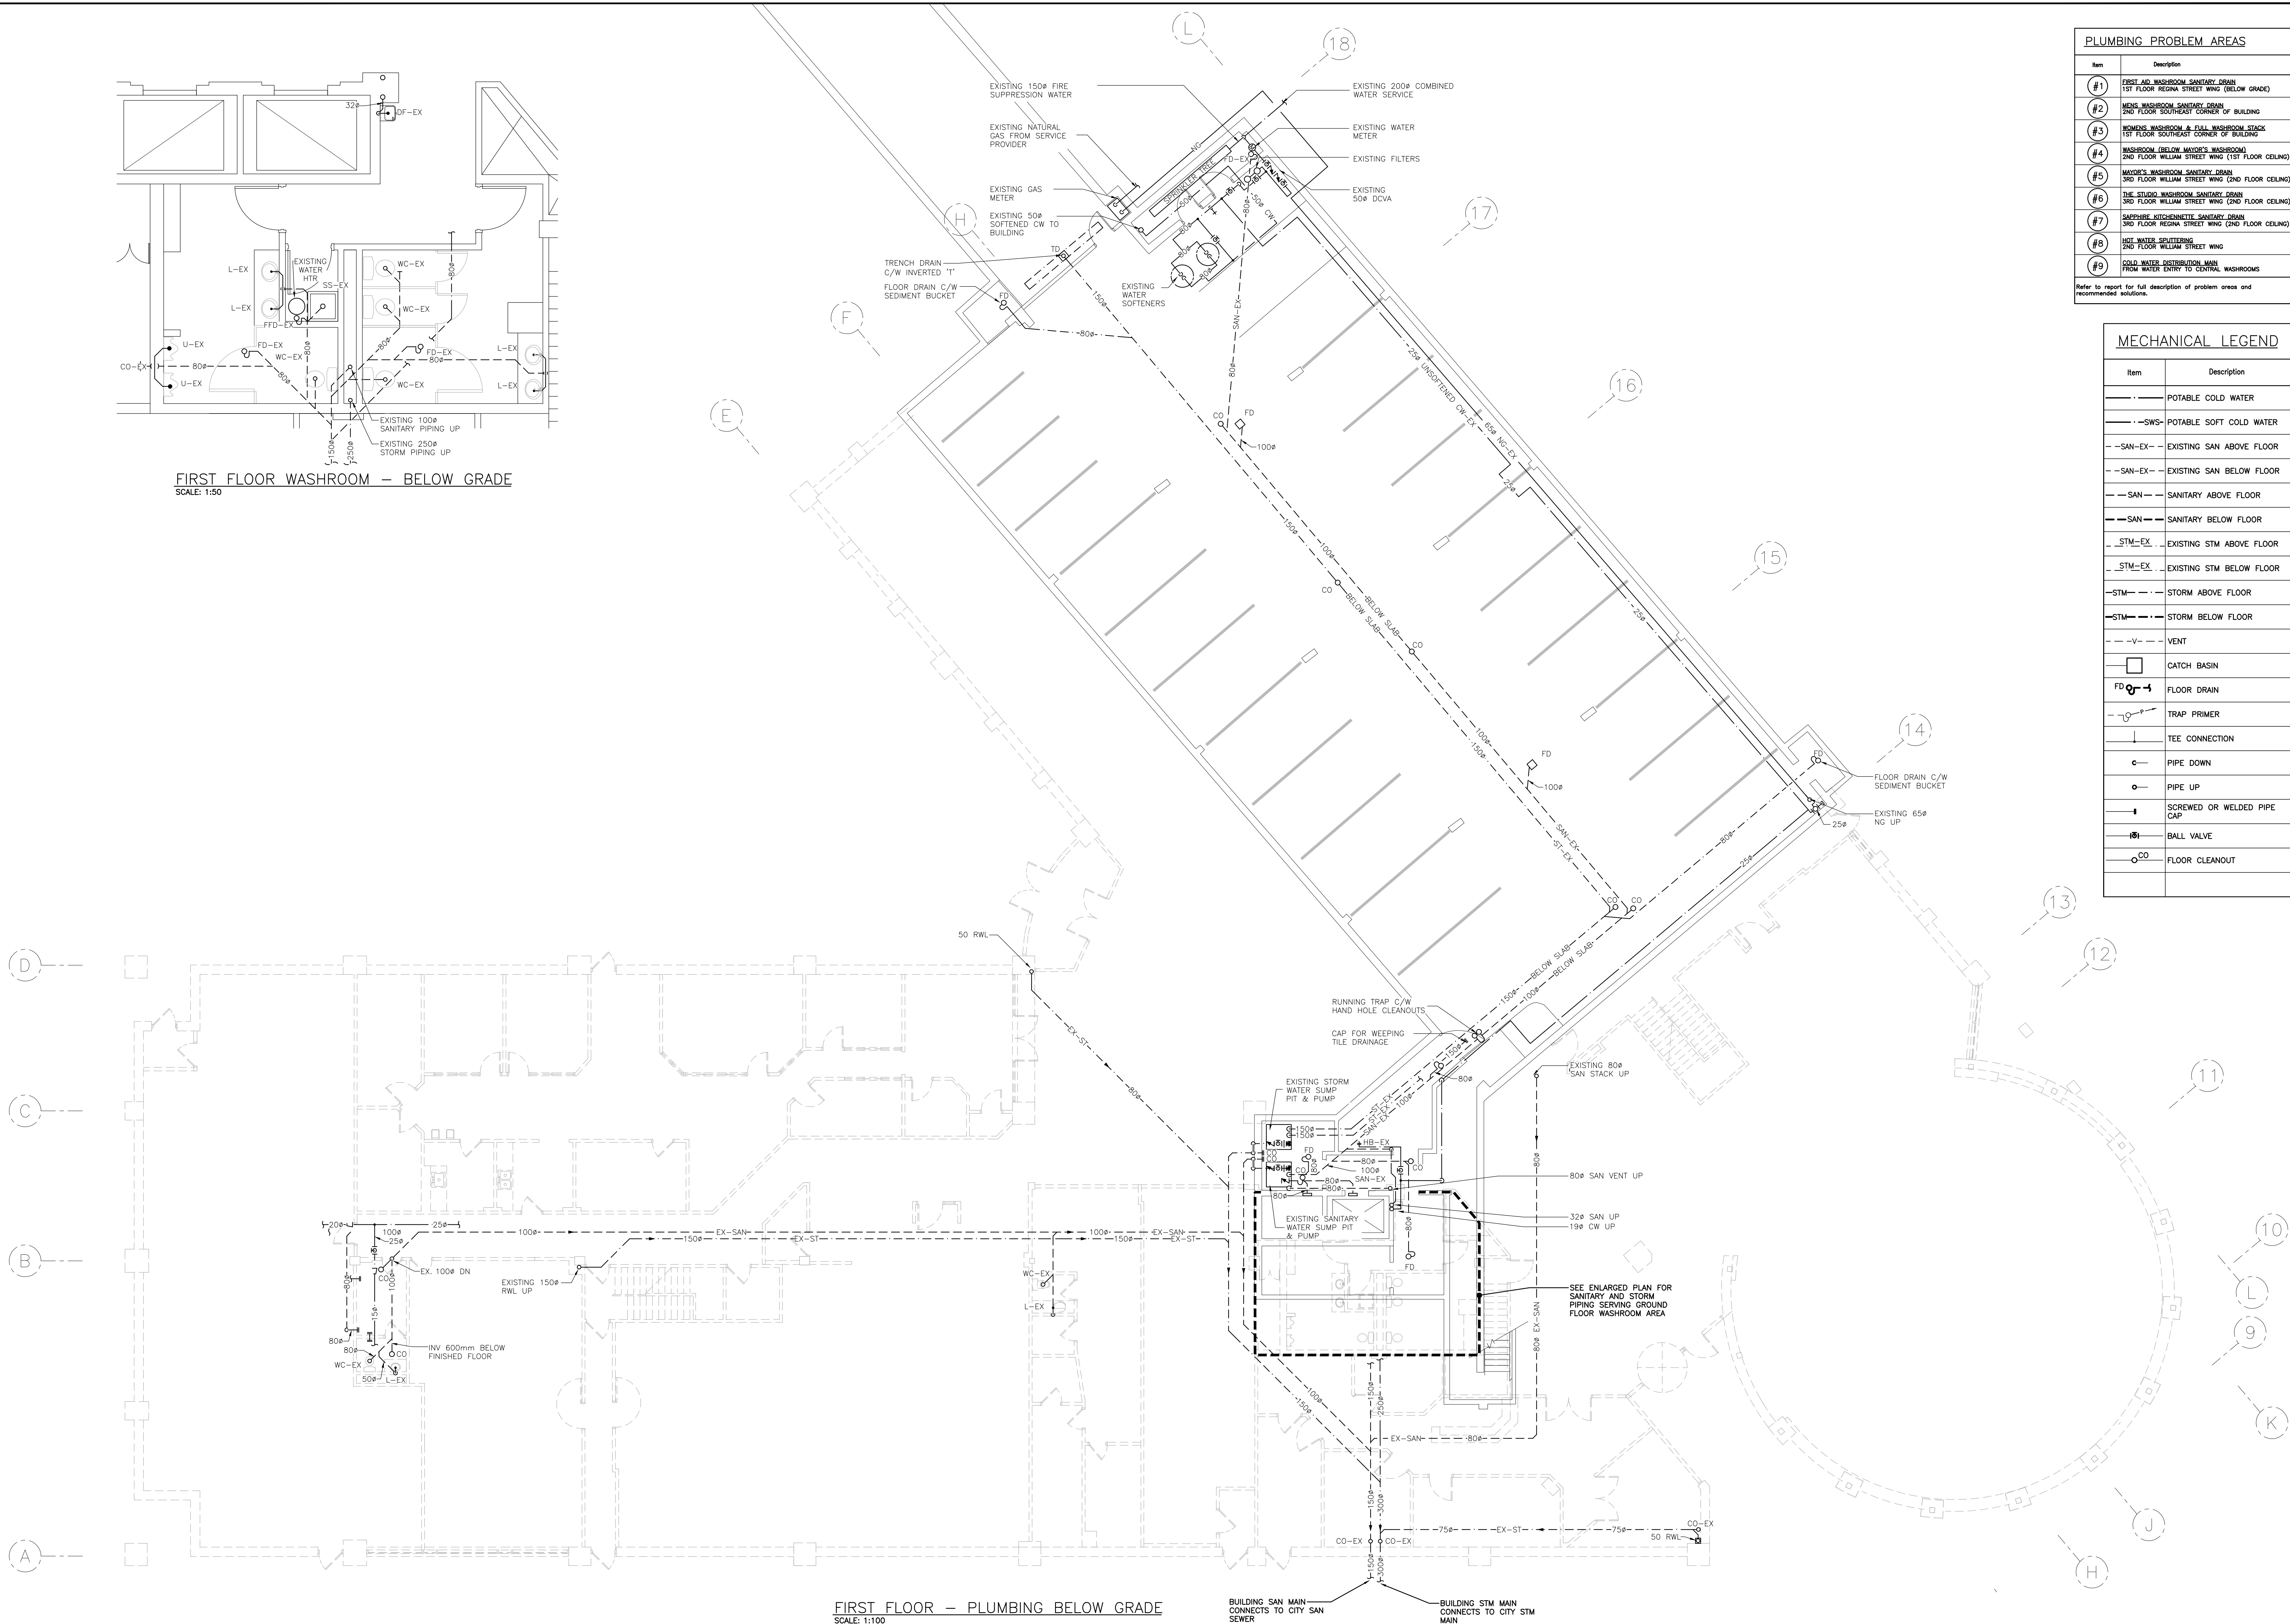
FIRST FLOOR — PLUMBING BELOW GRADE  
SCALE: 1:100

PLUMBING PROBLEM AREAS	
Item	Description
#1	FIRST AD WASHROOM SANITARY DRAIN 1ST FLOOR REGINA STREET WING (BELOW GRADE)
#2	MENS WASHROOM SANITARY DRAIN 2ND FLOOR SOUTHEAST CORNER OF BUILDING
#3	WOMENS WASHROOM & FULL WASHROOM STACK 1ST FLOOR SOUTHEAST CORNER OF BUILDING
#4	WASHROOM (BELOW MAYOR'S WASHROOM) 2ND FLOOR WILLIAM STREET WING (1ST FLOOR CEILING)
#5	MAYOR'S WASHROOM SANITARY DRAIN 3RD FLOOR WILLIAM STREET WING (2ND FLOOR CEILING)
#6	THE STUDIO WASHROOM SANITARY DRAIN 3RD FLOOR WILLIAM STREET WING (2ND FLOOR CEILING)
#7	SAPPHIRE KITCHENETTE SANITARY DRAIN 3RD FLOOR REGINA STREET WING (2ND FLOOR CEILING)
#8	HOT WATER SPILLING 2ND FLOOR WILLIAM STREET WING
#9	COLD WATER DISTRIBUTION MAIN FROM WATER ENTRY TO CENTRAL WASHROOMS

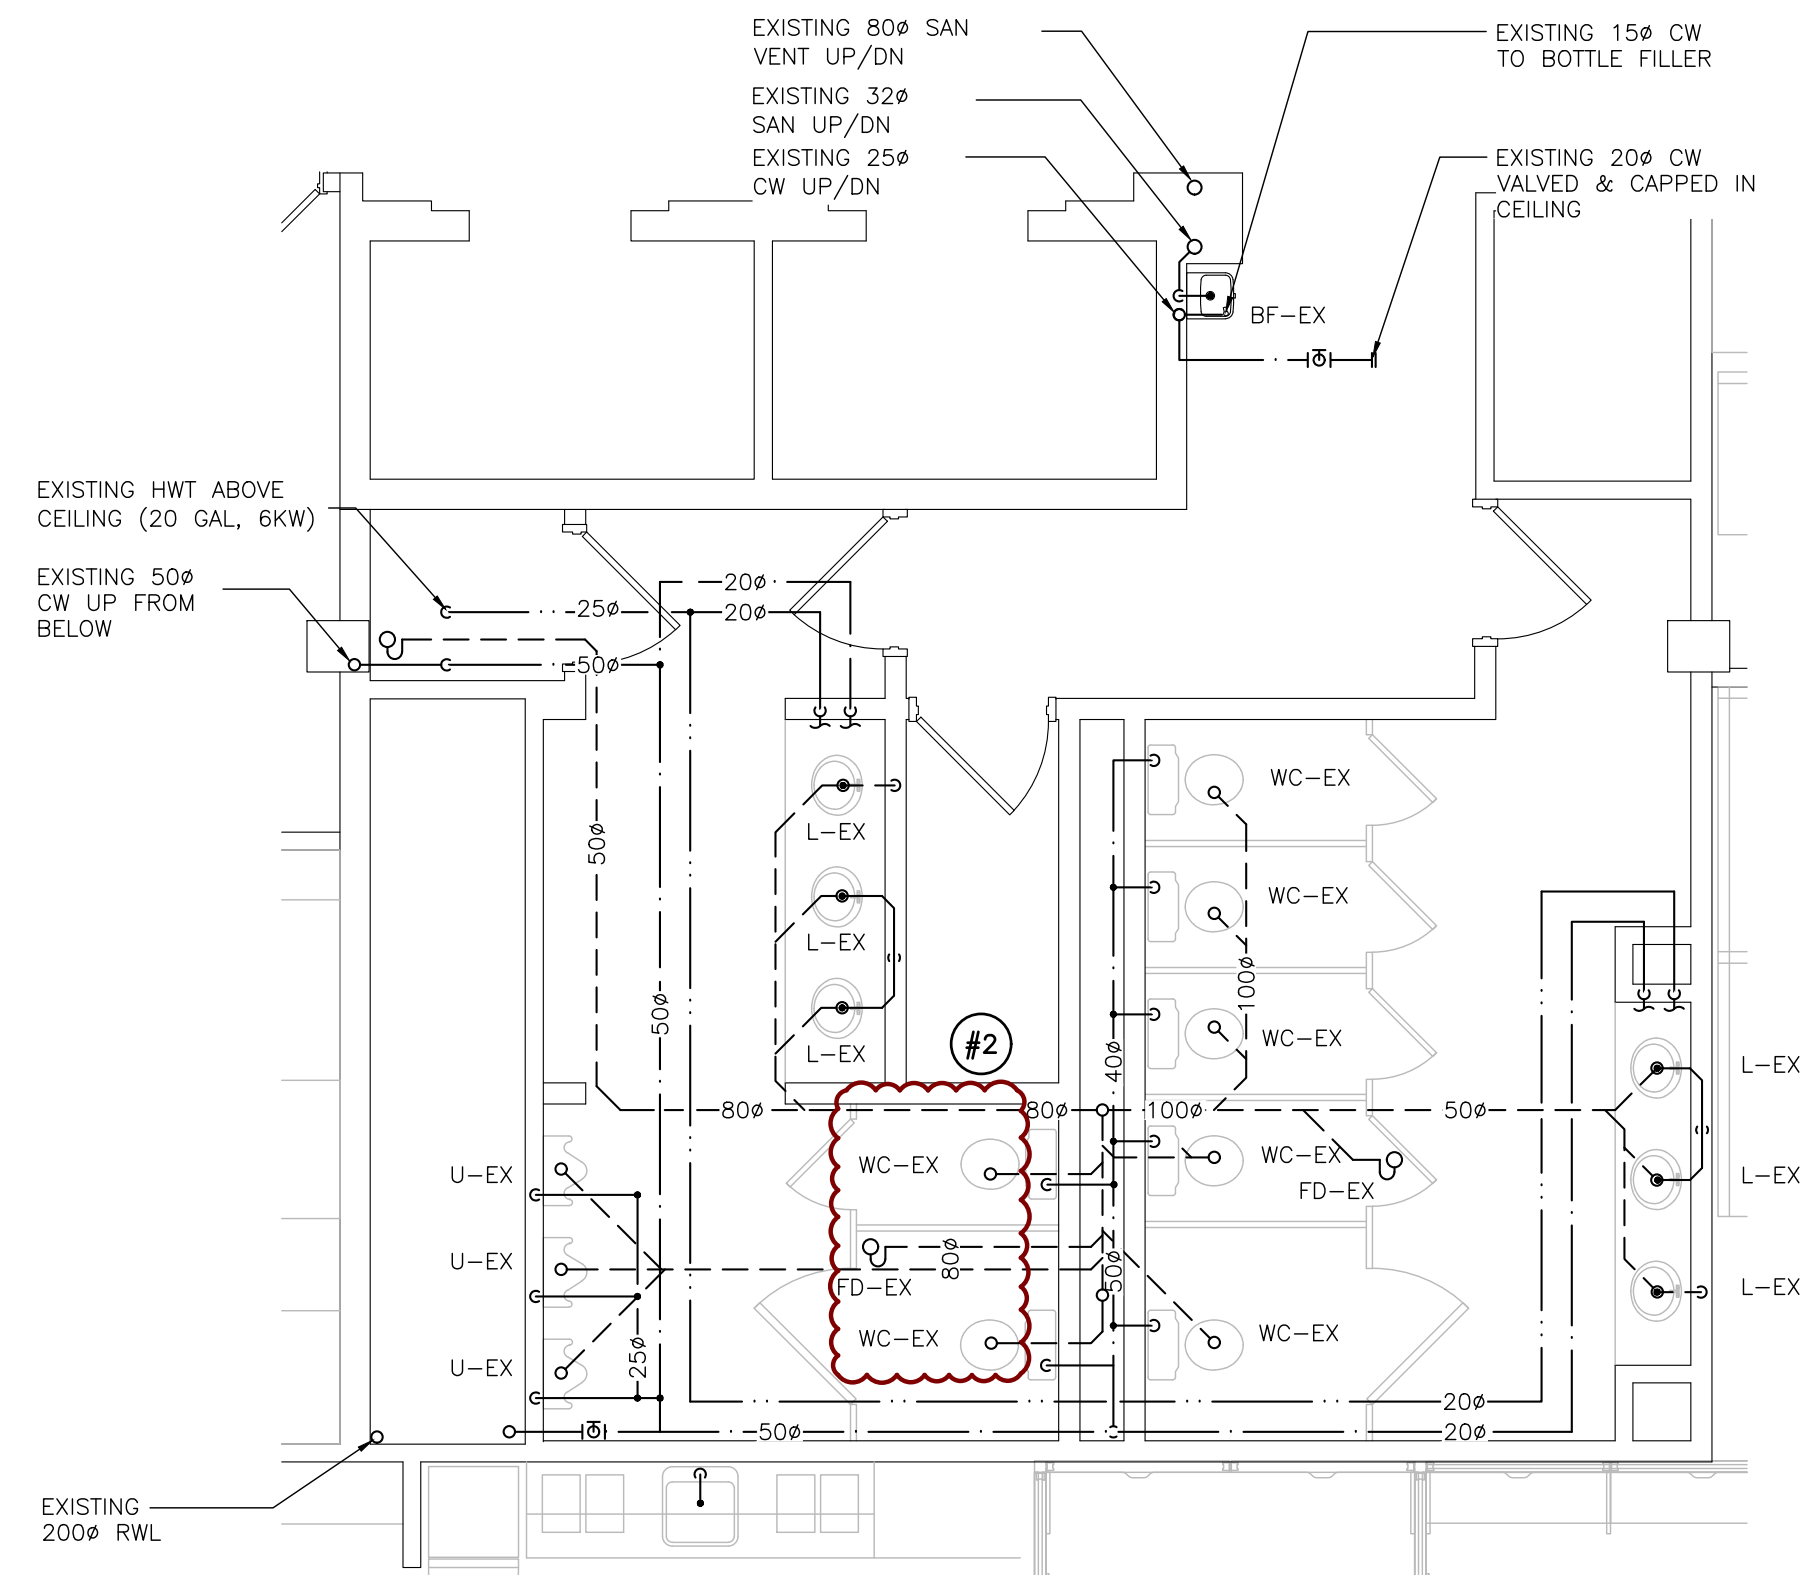
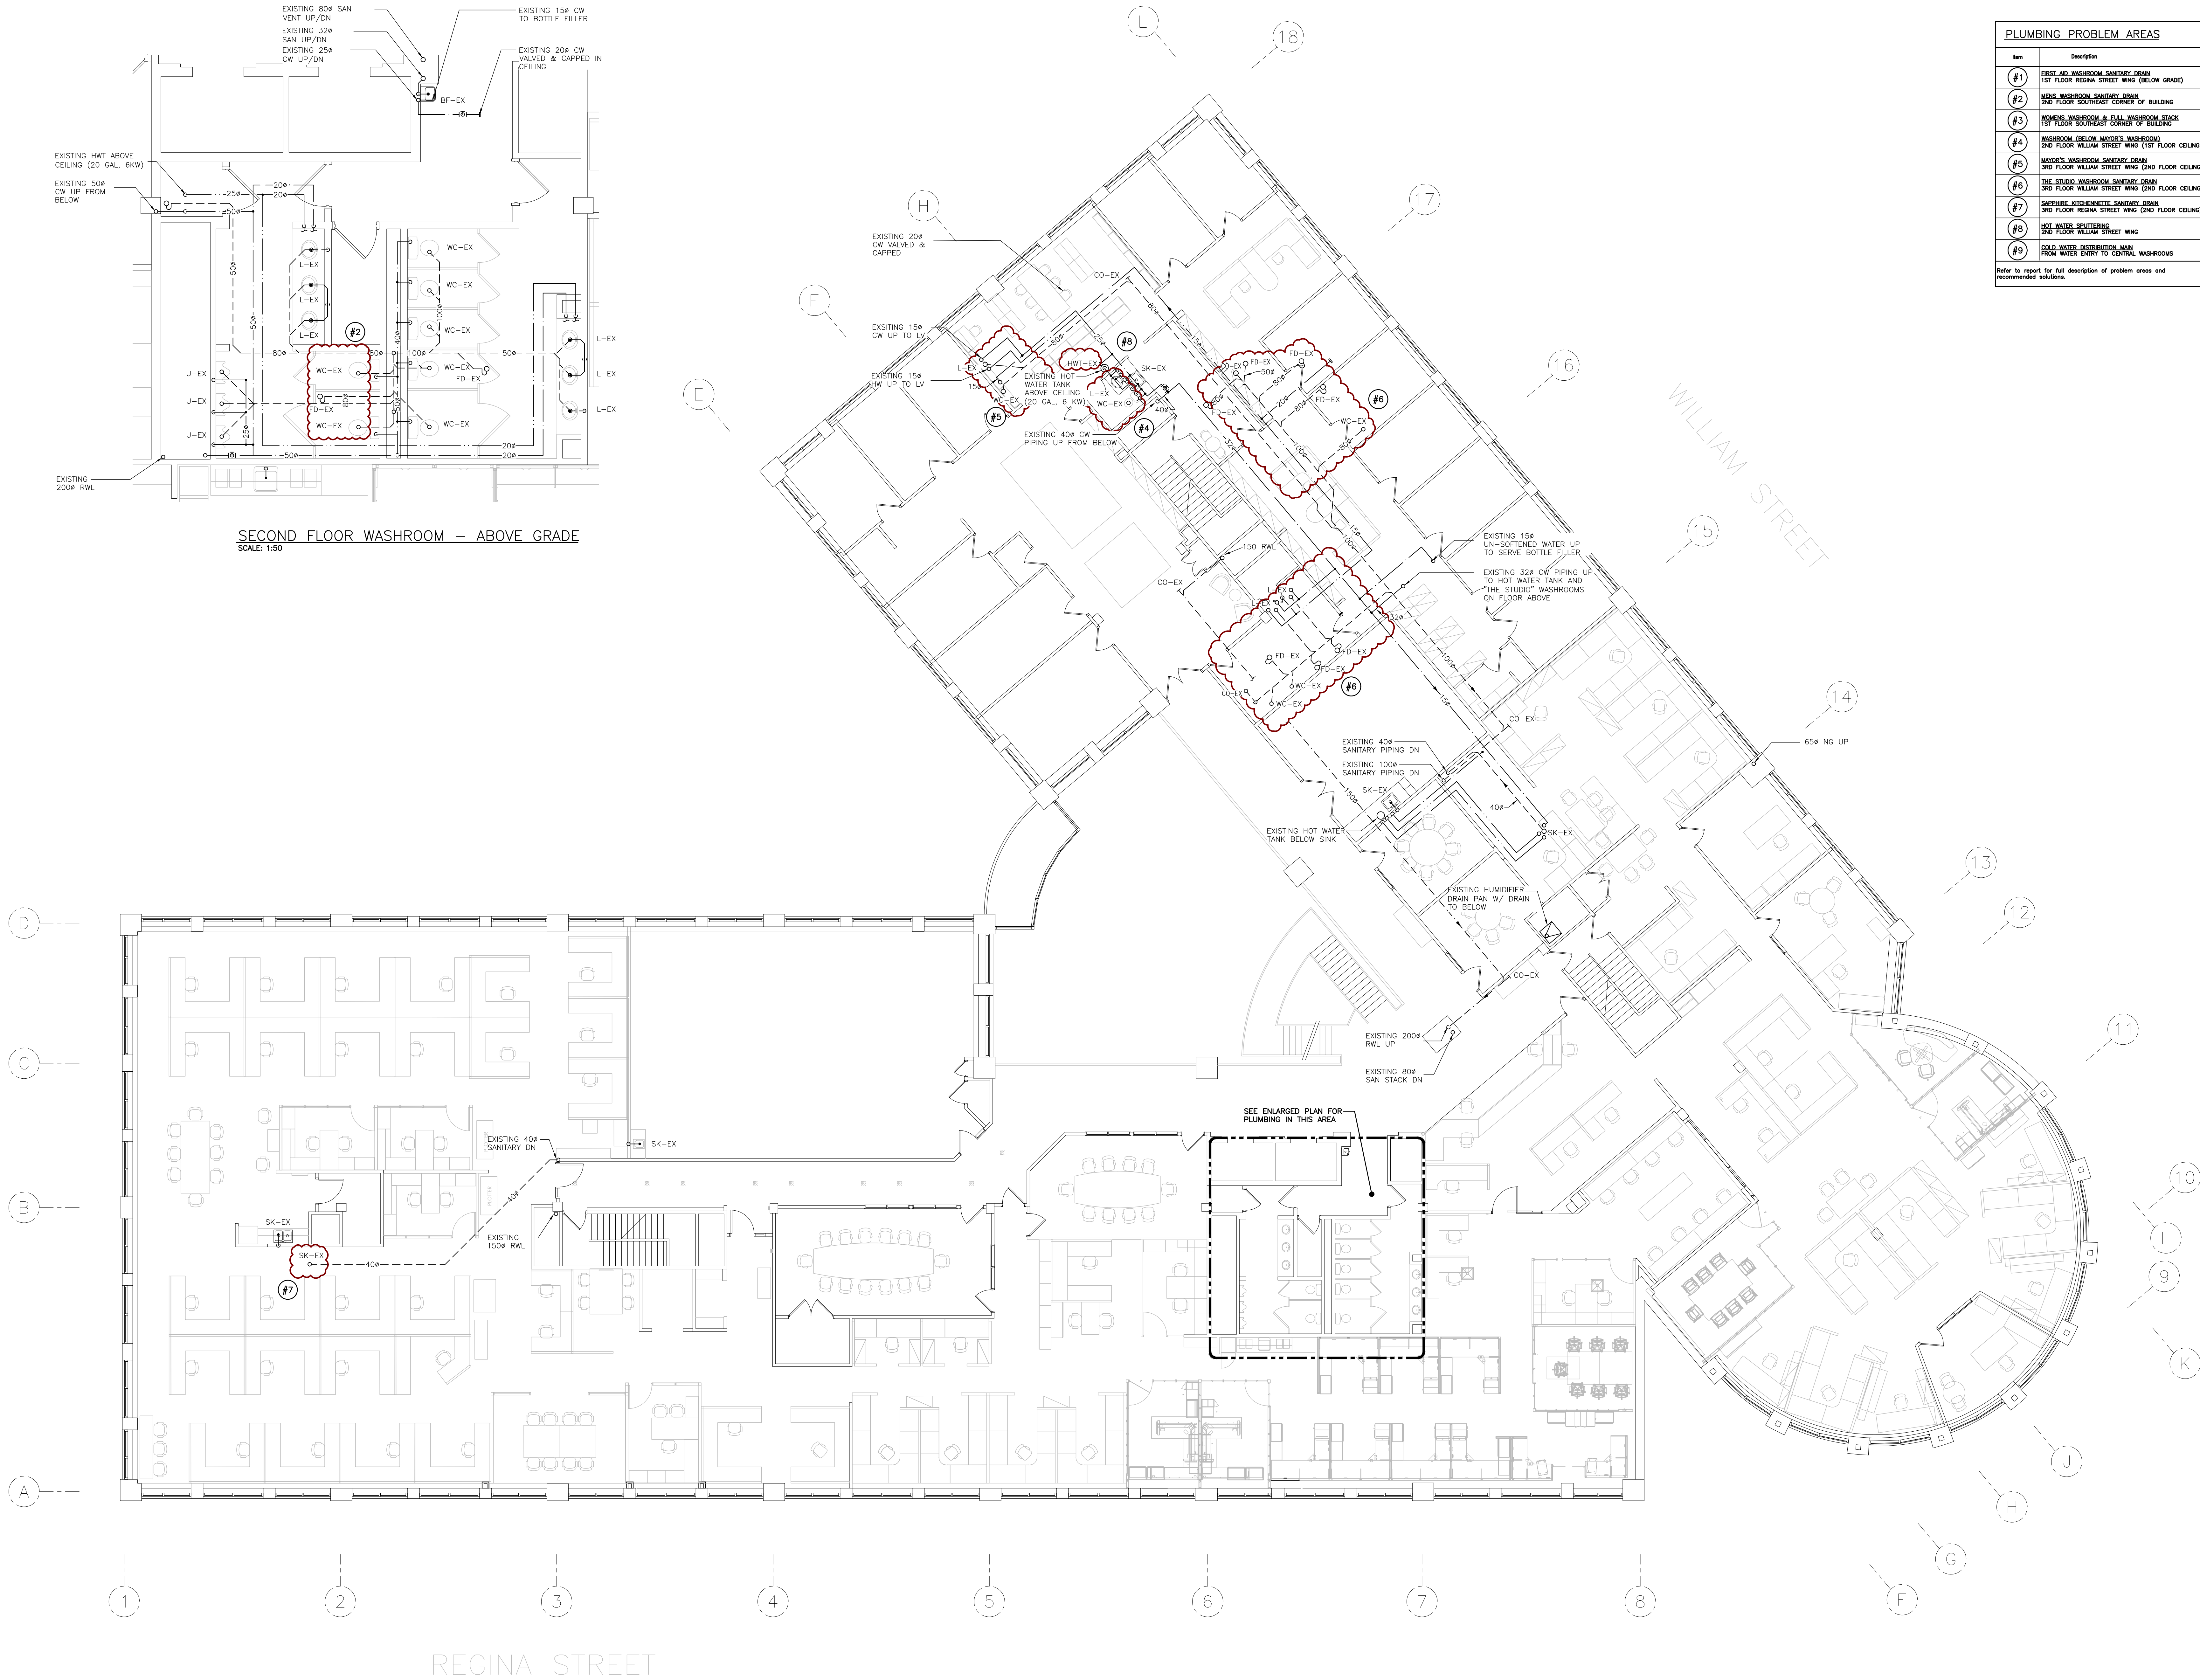
SECOND FLOOR — PLUMBING  
SCALE: 1:100

PLUMBING PROBLEM AREAS	
Item	Description
#1	FIRST AD WASHROOM SANITARY DRAIN 1ST FLOOR REGINA STREET WING (BELOW GRADE)
#2	MENS WASHROOM SANITARY DRAIN 2ND FLOOR SOUTHEAST CORNER OF BUILDING
#3	WOMENS WASHROOM & FULL WASHROOM STACK 1ST FLOOR SOUTHEAST CORNER OF BUILDING
#4	WASHROOM (BELOW MAYOR'S WASHROOM) 2ND FLOOR WILLIAM STREET WING (1ST FLOOR CEILING)
#5	MAYOR'S WASHROOM SANITARY DRAIN 3RD FLOOR WILLIAM STREET WING (2ND FLOOR CEILING)
#6	THE STUDIO WASHROOM SANITARY DRAIN 3RD FLOOR WILLIAM STREET WING (2ND FLOOR CEILING)
#7	SAPPHIRE KITCHENETTE SANITARY DRAIN 3RD FLOOR REGINA STREET WING (2ND FLOOR CEILING)
#8	HOT WATER SPILLING 2ND FLOOR REGINA STREET WING
#9	COLD WATER DISTRIBUTION MAIN FROM WATER ENTRY TO CENTRAL WASHROOMS

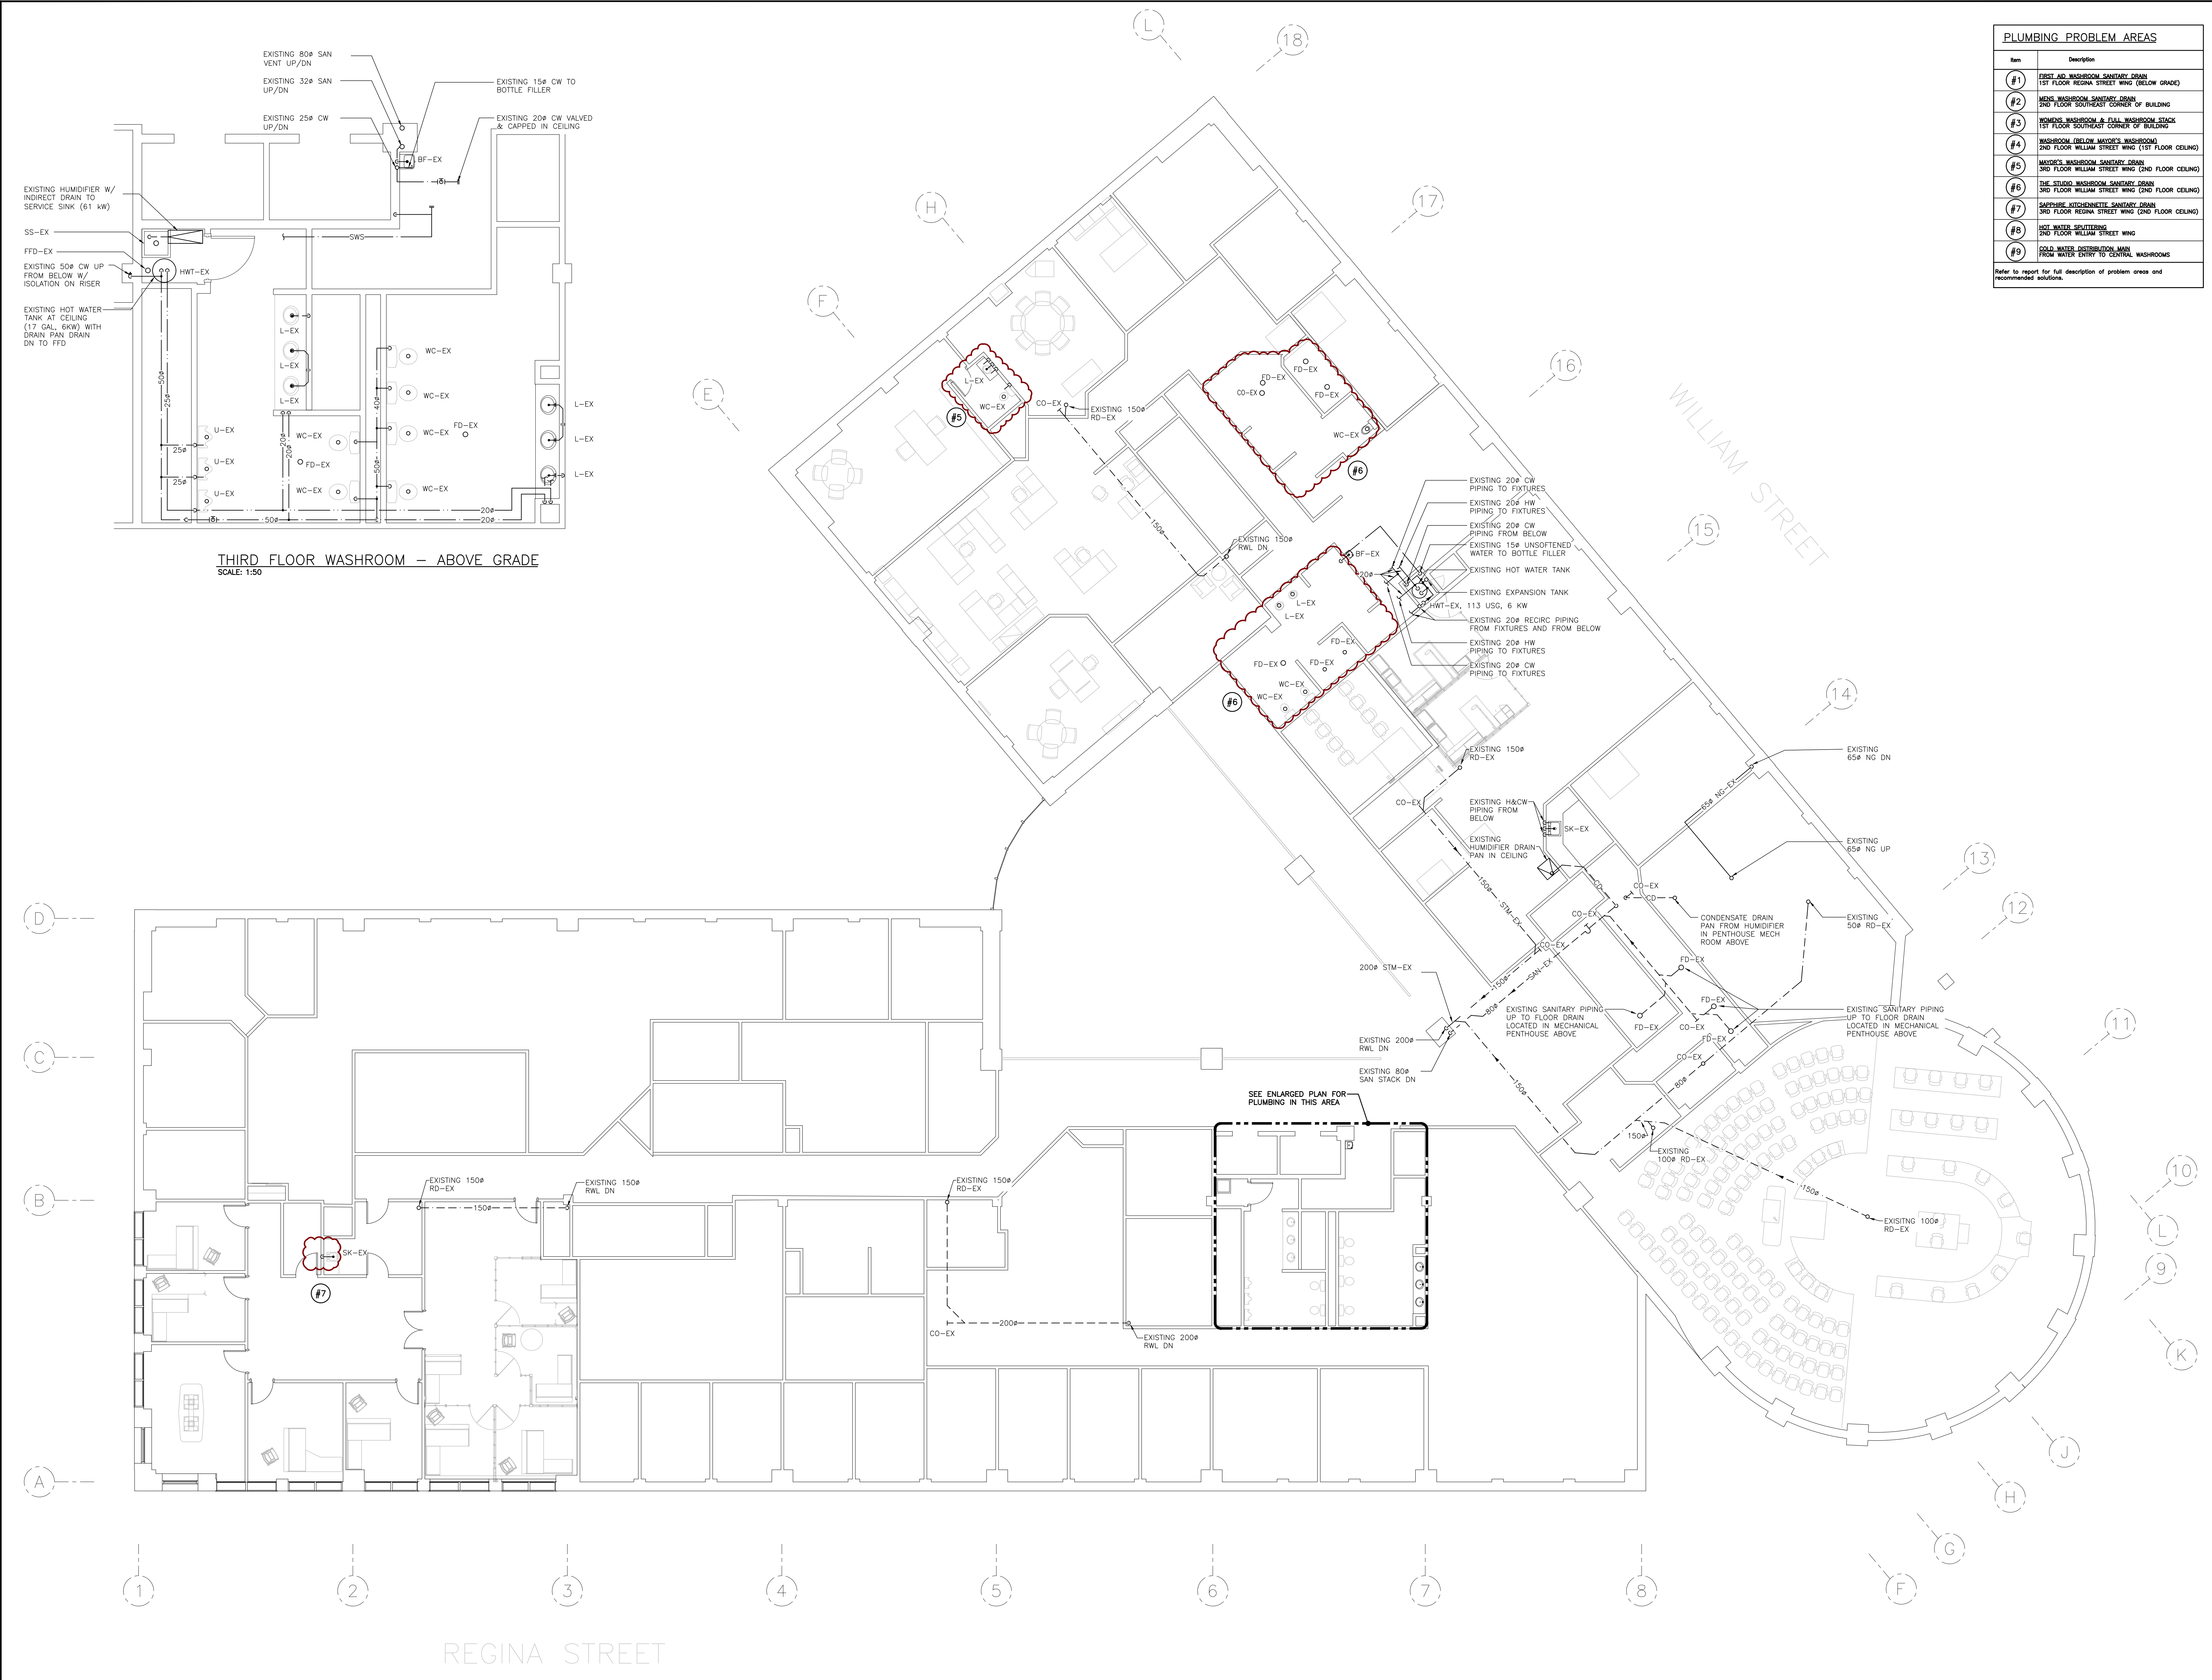
PLUMBING PROBLEM AREAS	
Item	Description
#1	FIRST AD WASHROOM SANITARY DRAIN 1ST FLOOR REGINA STREET WING (BELOW GRADE)
#2	MENS WASHROOM SANITARY DRAIN 2ND FLOOR SOUTHEAST CORNER OF BUILDING
#3	WOMENS WASHROOM & FULL WASHROOM STACK 1ST FLOOR SOUTHEAST CORNER OF BUILDING
#4	WASHROOM (BELOW MAYOR'S WASHROOM) 2ND FLOOR WILLIAM STREET WING (1ST FLOOR CEILING)
#5	MAYOR'S WASHROOM SANITARY DRAIN 3RD FLOOR WILLIAM STREET WING (2ND FLOOR CEILING)
#6	THE STUDIO WASHROOM SANITARY DRAIN 3RD FLOOR WILLIAM STREET WING (2ND FLOOR CEILING)
#7	SAPPHIRE KITCHENETTE SANITARY DRAIN 3RD FLOOR REGINA STREET WING (2ND FLOOR CEILING)
#8	HOT WATER SPILLING 2ND FLOOR WILLIAM STREET WING
#9	COLD WATER DISTRIBUTION MAIN FROM WATER ENTRY TO CENTRAL WASHROOMS
