# DESIGNATED SUBSTANCES AND HAZARDOUS BUILDING MATERIALS ASSESSMENT REPORT

Renovation & Addition Project  
Commercial Building  
Toronto Public Library  
575 Van Horne Avenue  
Toronto, ON  
M2J 4S8

Safetech Project Number: 1-3250245

Date of Site Work: April 14, 2025  
Date of Issue: April 24, 2025

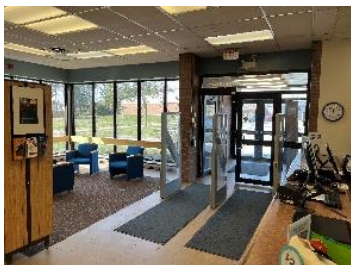
Location/Description	Picture
<p>Beige paint was sampled during our investigation. Results of analysis did not indicate the presence of any detectable concentrations of lead. Therefore, the Beige paint is not considered to be lead-containing. Refer to sample L1 in Table 4.</p>

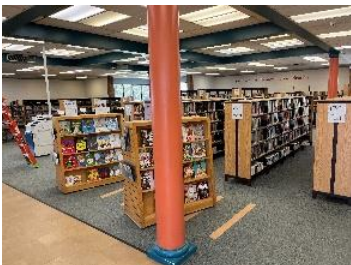
<p>Blue paint was sampled during our investigation. Results of analysis did not indicate the presence of any detectable concentrations of lead. Therefore, the Blue paint is not considered to be lead-containing. Refer to sample L2 in Table 4.</p>
