PROJECT MANUAL – VOLUME 3

Satellite Imaging Renovation
3050 Lawrence Avenue East, Toronto Ontario

Project No. 140023034

April 7, 2025

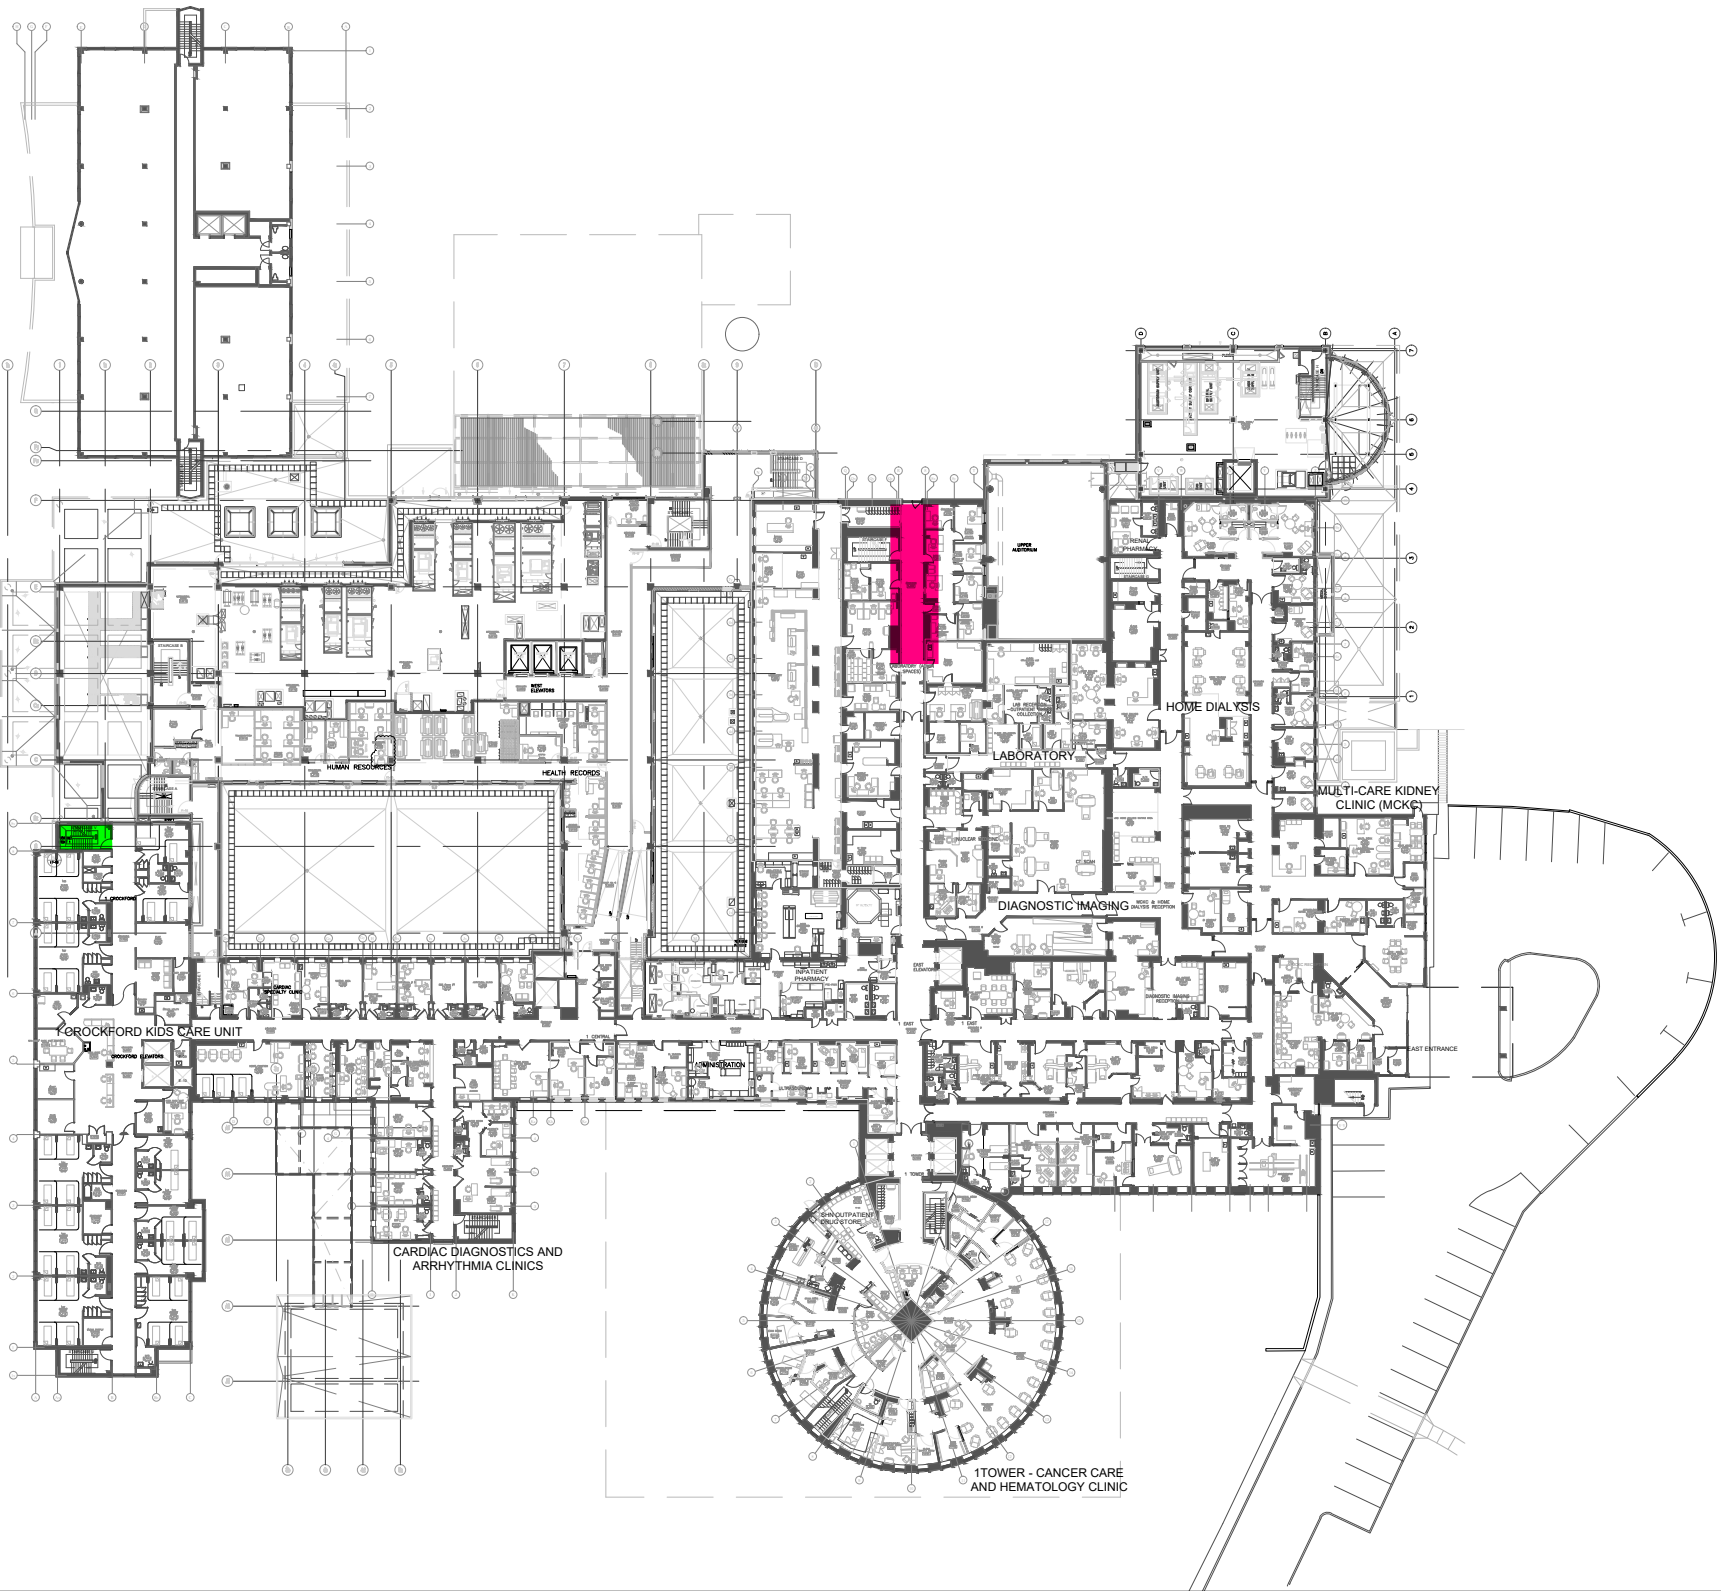
FIRST FLOOR

Friable paring cement, containing chrysotile asbestos is present beneath fibreglass and canvas jacketing at edges, seams and pins on ductwork in Mechanical Room 12A (B.468) and Mechanical Room 19. Ductwork within the ceiling plenum of the First Floor Corridor (1.280) and Office Spaces (1.284, 1.279, 1.279A, 1.279F) is wrapped with a tar-impregnated paper containing chrysotile asbestos. Minor damage was observed to the corner of the duct in the First Floor Corridor (1.280). Please refer to Appendix C, Summary of ACM Occurrences for listing of asbestos-containing duct insulation.

Please note that asbestos-containing vinyl floor tiles previously identified in Hemodialysis Zone A (G.710) and Examination Room 2 (5.105) were not observed at the time of the assessment.

Friable asbestos-containing beige and grey mosaic pattern vinyl sheet flooring is present within the I.S. Device Sign In / Out Room (G.103). This material was noted to be in Good condition at the time of the assessment. Please refer to Appendix C, Summary of ACM Occurrences for listing of asbestos-containing duct insulation.
