Facility Condition Assessment

Toronto Public Libraries

**Pleasant View
575 Van Horne Ave
Toronto, ON**

Date of Report: August 17, 2020

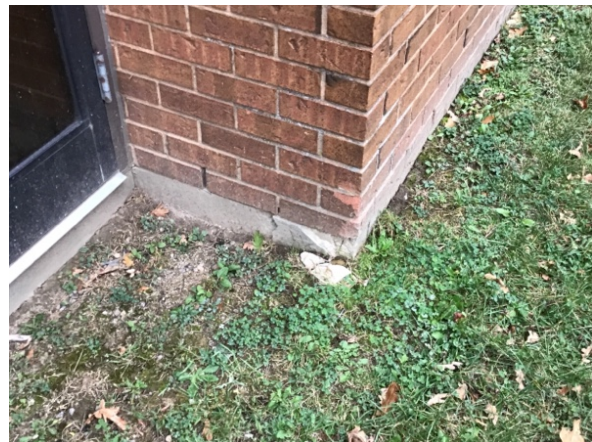
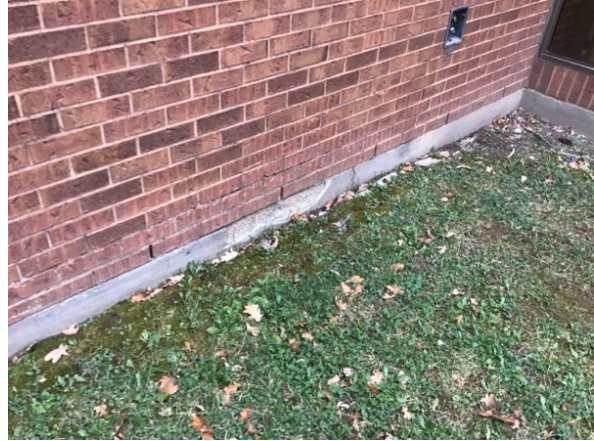
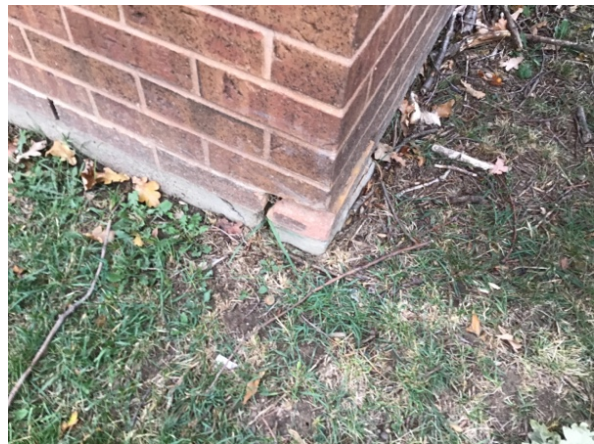
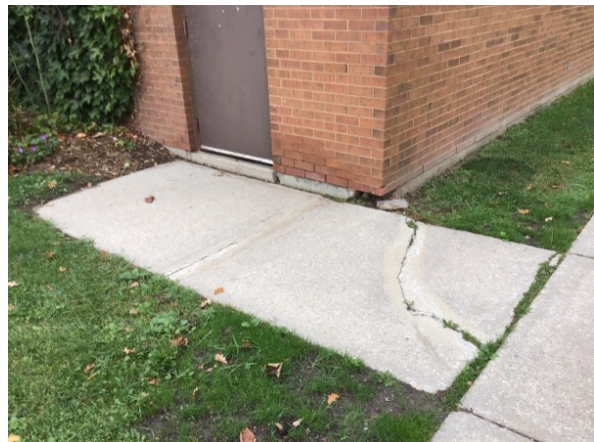
Damaged concrete was observed at the building corners. The site representative reported that the damage was caused by the lawn mower operators on site. Although the concrete foundation walls have been damaged at the corners of the building, it does not appear to have significantly affected the building at this time.

Further deterioration of the foundation walls, particularly at the building corners, may occur. Repair of the foundation wall is recommended to maintain longevity and minimize the potential for unwanted building movement. Construction of bollards at the building corners may also be considered as a guard from additional damage.

Uniformat	Component Description	Quantity	Unit Cost	Plan Type	Priority	Year	Expenditures
A1011	Repair damaged foundations	1 SF	\$20,000.00	MREP	3	2020	\$20,000
A1011	Replace Foundations	1 SF	\$100,000.00	MREP	4	2030	\$100,000

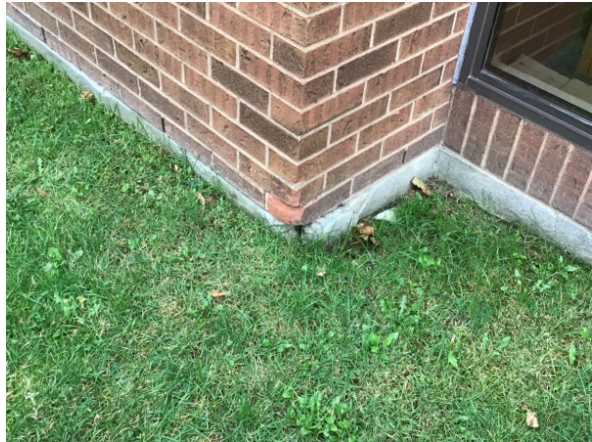
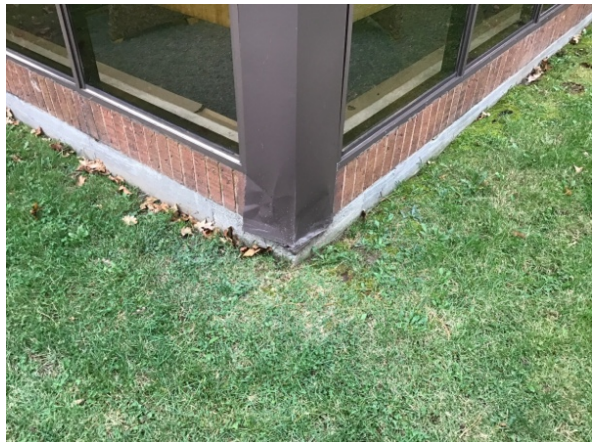
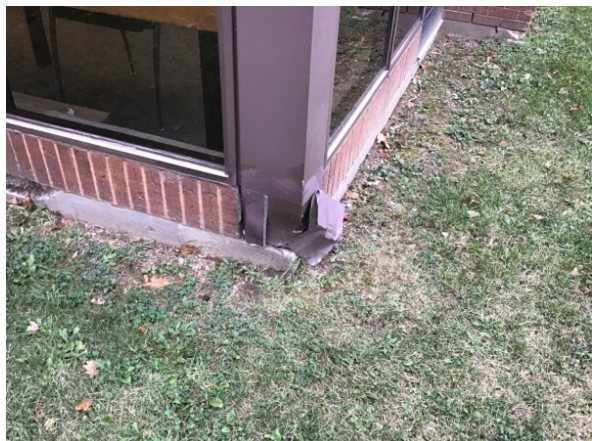
the metal flashing was observed to have damaged corners. the overall condition is fair.

replacement of the damaged flashing in the next year.

Uniformat	Component Description	Quantity	Unit Cost	Plan Type	Priority	Year	Expenditures
B2010	Replace Flashing & Metal Panels	250 SF	\$45.00	LCR	2	2020	\$11,250

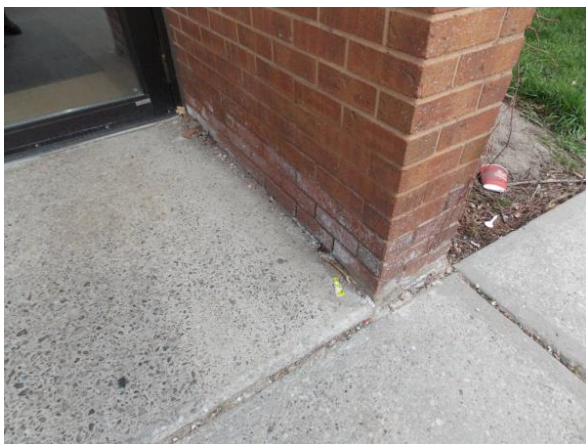
In general the exterior wall system is in good condition overall, with the exception of the spalling brick and efflorescence observed near the main entrance door.

Efflorescence near the main entrance

An allowance has been included for replacement of the spalled masonry in the short term.

Unifomat	Component Description	Quantity	Unit Cost	Plan Type	Priority	Year	Expenditures
B2011	Replace Brick Masonry	1,000 SF	\$85.00	MREP	2	2020	\$85,000

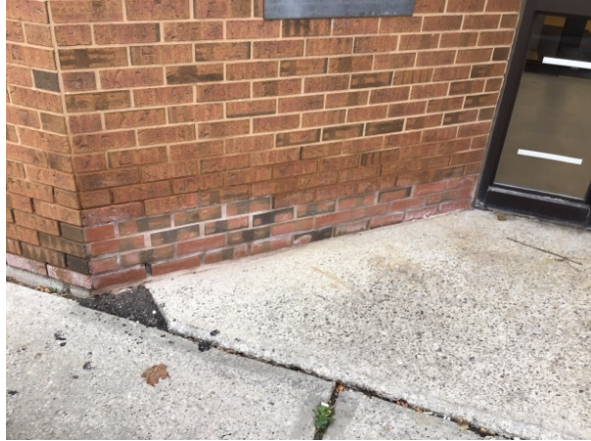
Close-up of spalling brick and efflorescence

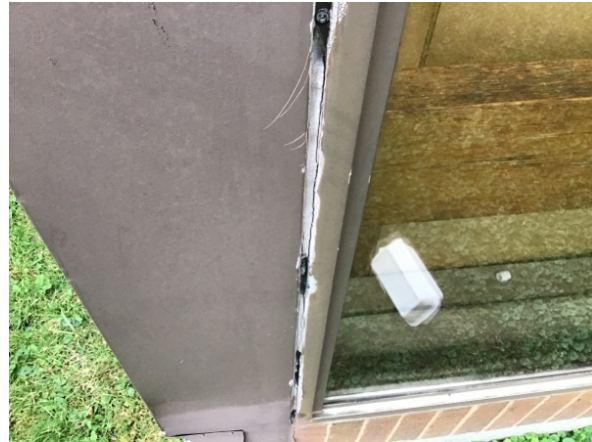
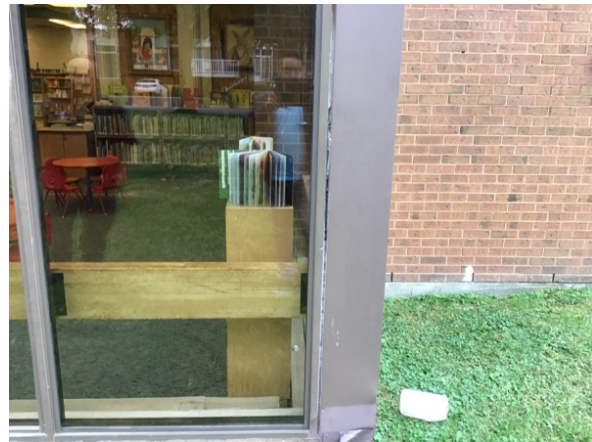
The exterior wall sealant was generally in fair condition. Craziing has begun to form on the sealant, particularly at the window perimeters. Sealants around the metal cap flashings are completely deteriorated.

An allowance is included to replace the sealants in the short term.

Uniformat	Component Description	Quantity	Unit Cost	Plan Type	Priority	Year	Expenditures
B2011.1	Replace Exterior Sealant	1,000 SF	\$12.00	LCR	2	2020	\$12,000

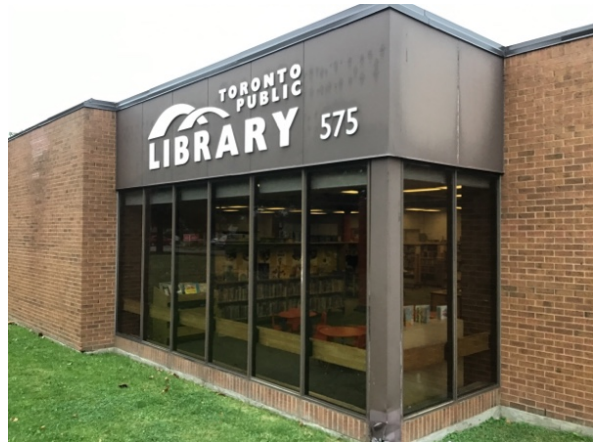
Windows are constructed to provide a life cycle of approximately 32 years, which is consistent with the observed condition. Further deterioration of the windows is anticipated with continued exposure to the elements. A proactive replacement of the 1975 and 1983 windows is recommended to minimize the potential of air/water infiltration, which could cause damage to interior finishes.

Close-up of typical window metal spacer and glazing seal

Uniformat	Component Description	Quantity	Unit Cost	Plan Type	Priority	Year	Expenditures
B2021	Replace Windows	1 LS	\$168,000.00	LCR	2	2020	\$168,000

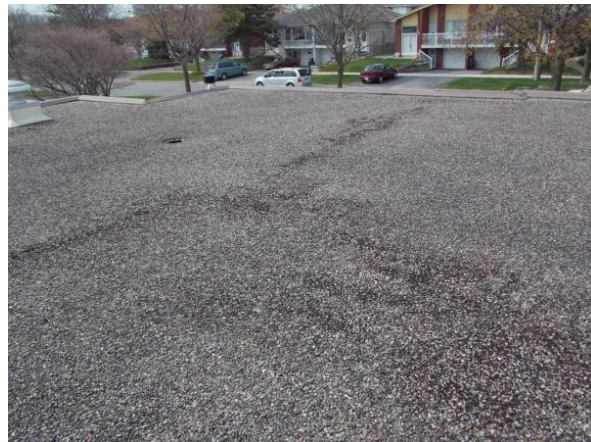
Some asphalt migration on the roof

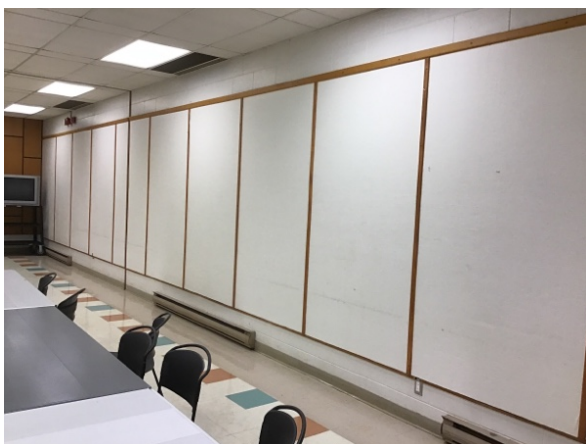
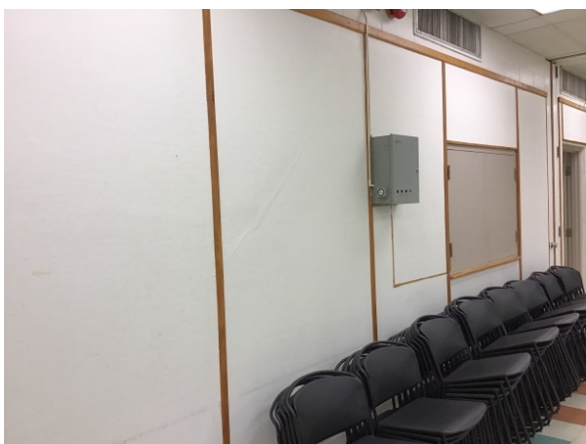
Some damaged paint and gypsum was observed.

Paint covering continues to deteriorate from oxidation and exposure to impurities in the air, and in time the deterioration may progress and could possibly affect the building interior aesthetics. A provision has been allocated for repainting the interior walls and other architectural features (e.g. columns) in the building.

Uniformat	Component Description	Quantity	Unit Cost	Plan Type	Priority	Year	Expenditures
C3012	Replace Paint	7,000 SF	\$2.50	LCR	3	2021	\$17,500
C3012	Replace Paint	7,000 SF	\$2.50	LCR	3	2031	\$17,500

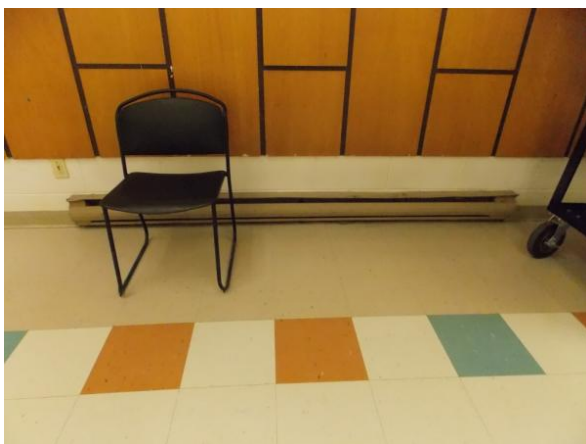
Based on observed condition, replacement of the baseboard heaters is recommended to maintain thermal comfort for building occupants. The removal/decommissioning of the forced flow heater may be considered, as it does not appear to be necessary for heating.

Typical baseboard heater in the Auditorium

Close-up of aged baseboard heater

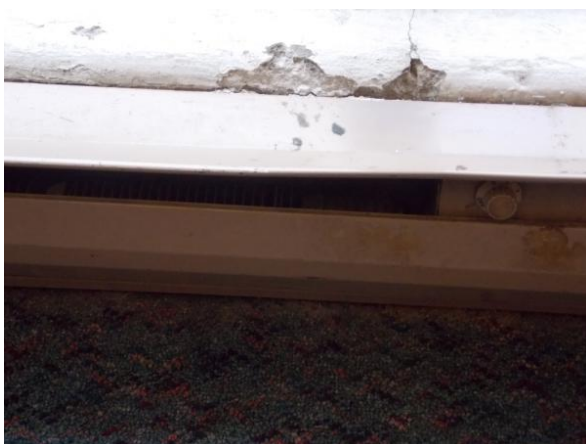
Impact damage on baseboard heater in the open space of the Library

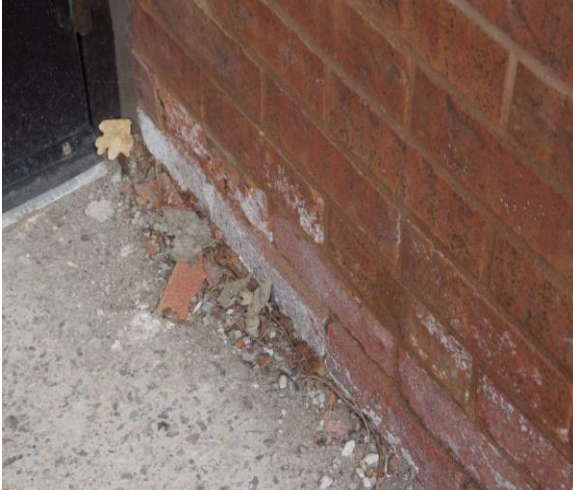
B2011 Exterior Wall Construction:- Close-up of spalling brick and efflorescence

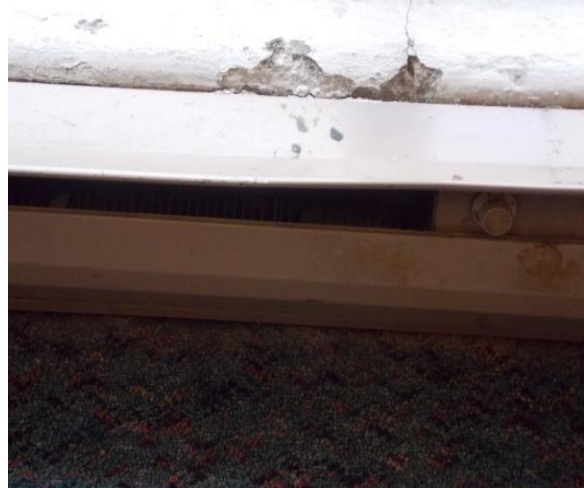
D3050 Heat Transfer Terminal and Packaged Units:- Impact damage on baseboard heater in the open space of the Library
