## **DESIGNATED SUBSTANCES AND HAZARDOUS MATERIALS SURVEY**

**North District Patrol Yard (Building Code G013-B1)  
3525 Baseline Road  
Georgina, Ontario**

**ECO Project No.: 25991-05  
November 2, 2020**

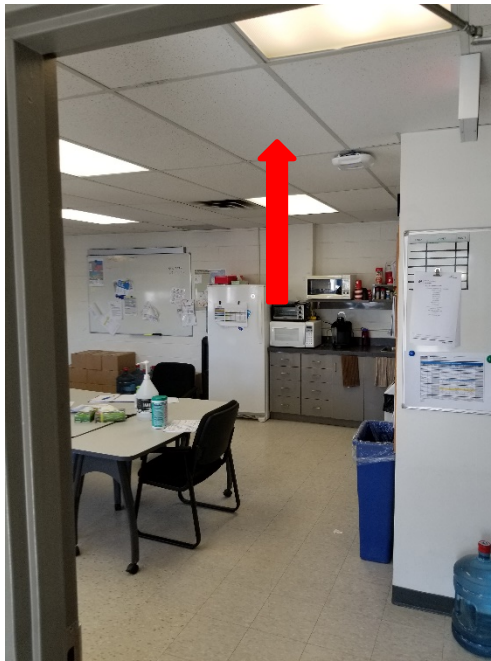
Visually confirmed non-asbestos ceiling tile (CT1 – 2'x4' Small Fissure with pinhole)

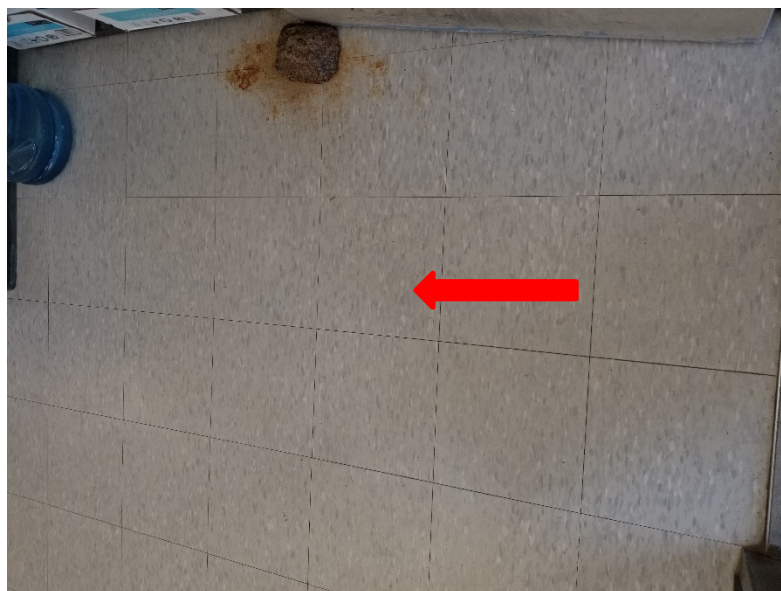
VFT2 – 12'x12"  
Grey with Black  
Specks

This material was  
sampled, and  
results indicate non-  
asbestos.

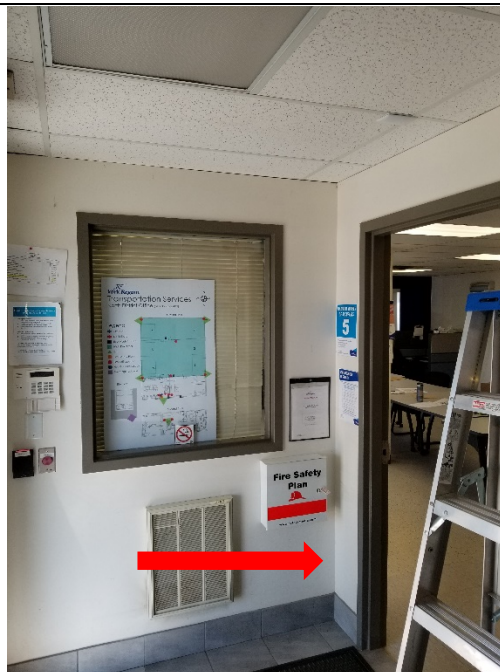
Concrete Block  
Mortar

This material was  
sampled, and  
results indicate non-  
asbestos.
