Addendum #2

**Project Manual
For
The Hospital for Sick Children
Spect CT Room Renovation**

Hazardous Building Materials Assessment (Pre-Construction)

Sick Kids SPEC CT Room
Renovation
555 University Avenue,
Toronto, Ontario

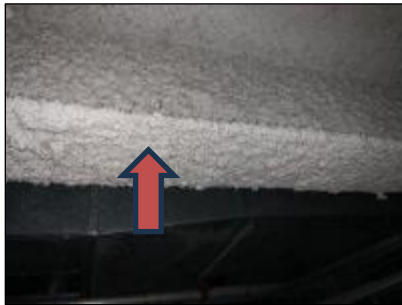
Asbestos-containing light grey/off white fireproofing, Burton Wing Room 2107C (Location 6012).

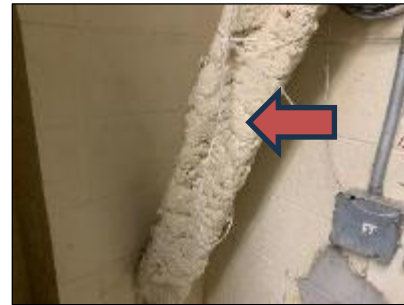
Asbestos-containing white encapsulated fireproofing, Burton Wing Electrical Room 2111 (Location 6058).

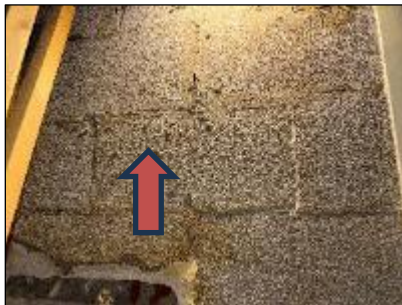
Concrete block wall with asbestos-containing residual fireproofing in pours, Burton Wing Mechanical Shaft/Room S111 (Location 3039).

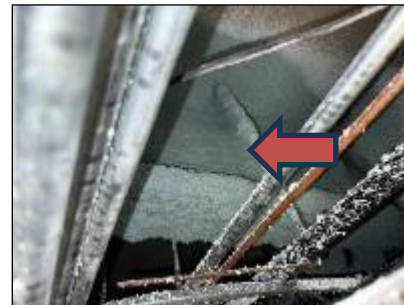
Non-asbestos green fireproofing, Burton Wing 2nd Floor South Corridor (Location 6004).

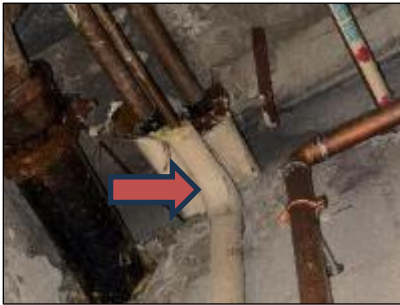
Asbestos-containing parging cement on pipe fitting, Burton Wing Room B111 (Location 2034).

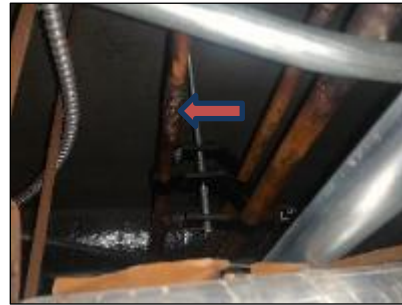
Uninsulated pipes, 2nd Floor Corridor and Elevator Lobby (Location 6001).

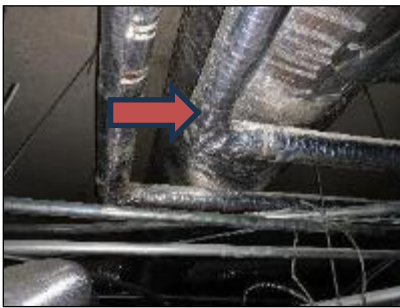
Non-asbestos fiberglass insulated pipes jacketed with foil, Burton Wing Room 2107C (Location 6012).

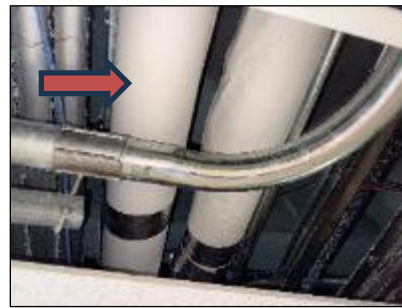
Non-asbestos fiberglass insulated pipes jacketed with paper, Burton Wing 2nd Floor South Corridor (Location 6004).

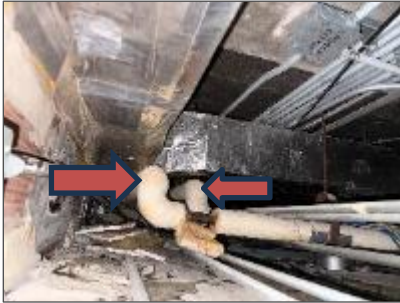
Asbestos-containing paring cement on pipe fittings, Black Wing Service North Floor Corridor (Location 2035).

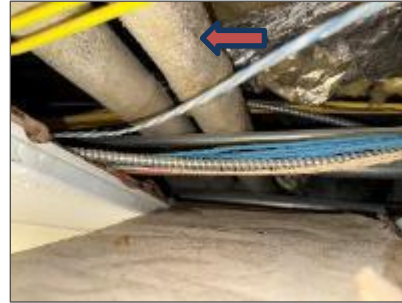
Asbestos-containing aircell pipe insulation, Black Wing Corridor S200B (Location 2079).

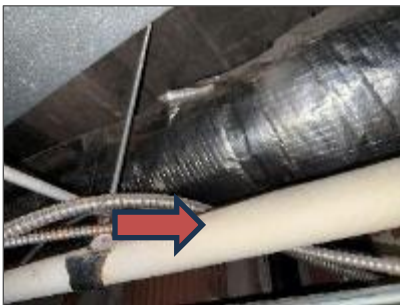
Non-asbestos fibreglass insulated pipes jacketed with paper, Black Wing Corridor S200B (Location 2079).

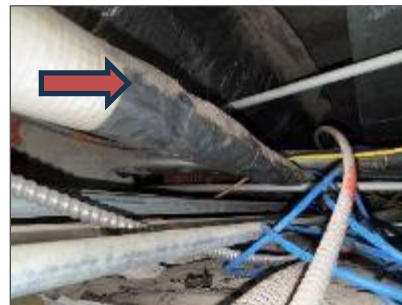
Non-asbestos fibreglass insulated pipe jacketed with foil, Black Wing Corridor S200B (Location 2079).

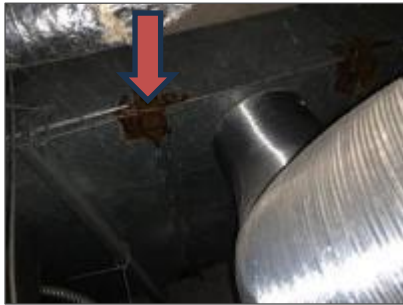
Asbestos-containing reddish brown duct mastic, Room 1172 (Location 5065).

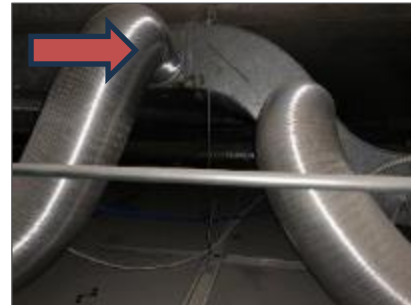
Uninsulated duct, Room 1168 (Location 5063).

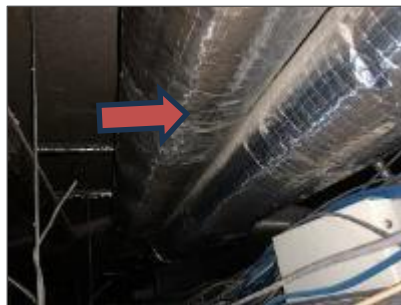
Non-asbestos fibreglass insulated ducts jacketed with foil, 1st Floor South Corridor (Location 5004).

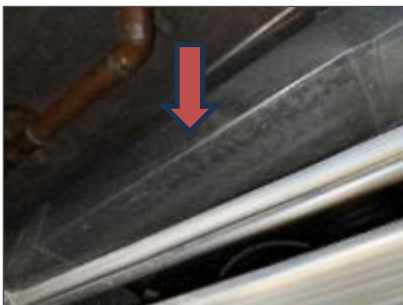
Uninsulated duct, Black Wing Service North Floor Corridor (Location 2035).

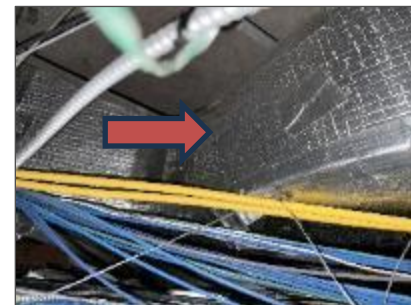
Non-asbestos fibreglass insulated duct jacketed with foil, Black Wing Corridor S200B (Location 2079).

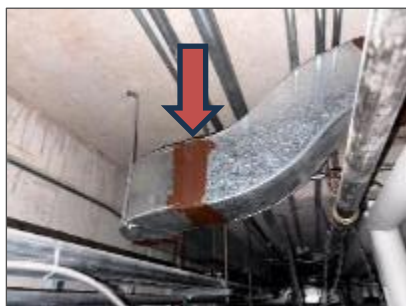
Reddish/brown duct mastic, containing asbestos, is present at seams / joints on the exterior of ducts in Room 2801M and Corridor (Location 204) (samples b298447 S0041A-C). The duct mastic was visually confirmed as the same previously sampled mastic in the Burton Wing and is located where the Slaight Atrium Wing and Burton Wing connect on the 2nd Floor.

Asbestos-containing reddish brown duct mastic, Saight Atrium Wing Room 2810M and Corridor (Location 204).

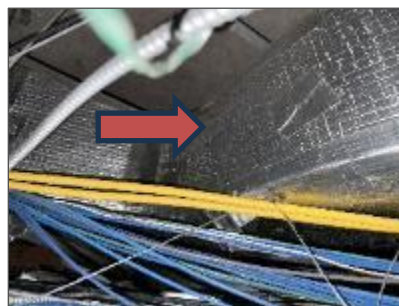
Non-asbestos fibreglass insulated duct jacketed with foil, Saight Atrium Wing Room 2810M and Corridor (Location 204).

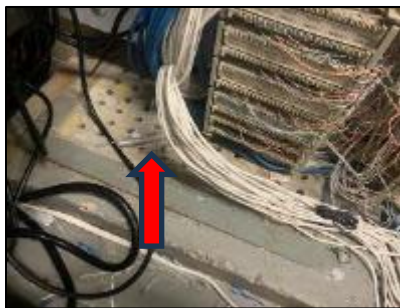
Asbestos-containing Transite cable cover is present in Room 2111-Electrical Room (Location 6058). Transite is visually confirmed to contain asbestos.

Asbestos-containing Transite cable cover, Room 2111 (Location 6058).

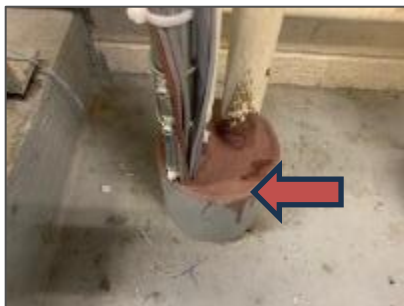
Non-asbestos brownish red firestop caulking, Electrical Room 2111 (Location 6058).

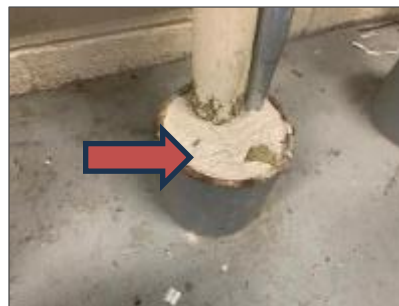
Non-asbestos white firestop caulking, Electrical Room 2111 (Location 6058).

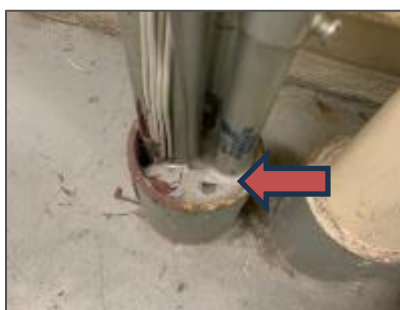
Non-asbestos grey firestop caulking, Electrical Room 2111 (Location 6058).

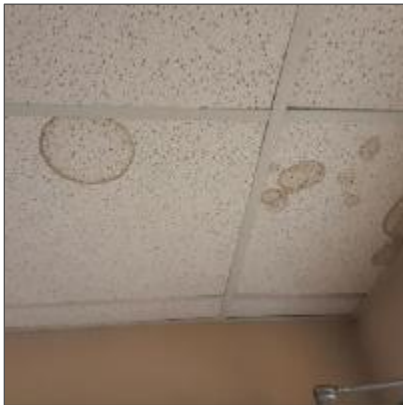
Two water-stained non-asbestos ceiling tiles were observed in Burton Wing 2nd Floor East Corridor (Location 6003).

Water staining on non-asbestos ceiling tiles, 2nd Floor East Corridor (Location 6003).

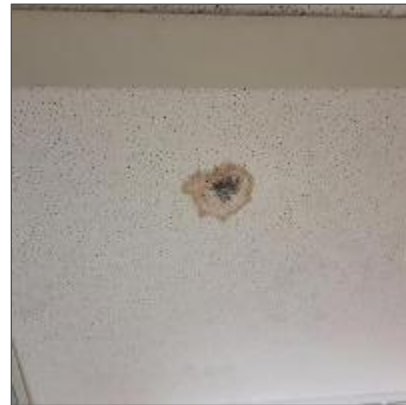
Visible mould was observed on a non-asbestos ceiling tile in the Burton Wing 2nd Floor South Corridor (Location 6004).

Mould on non-asbestos ceiling tile in the 2nd Floor South Corridor (Location 6004)
