Designated Substance Study

370 William Street - Warton, ON

GMBP File: 220089-1

April 29, 2020

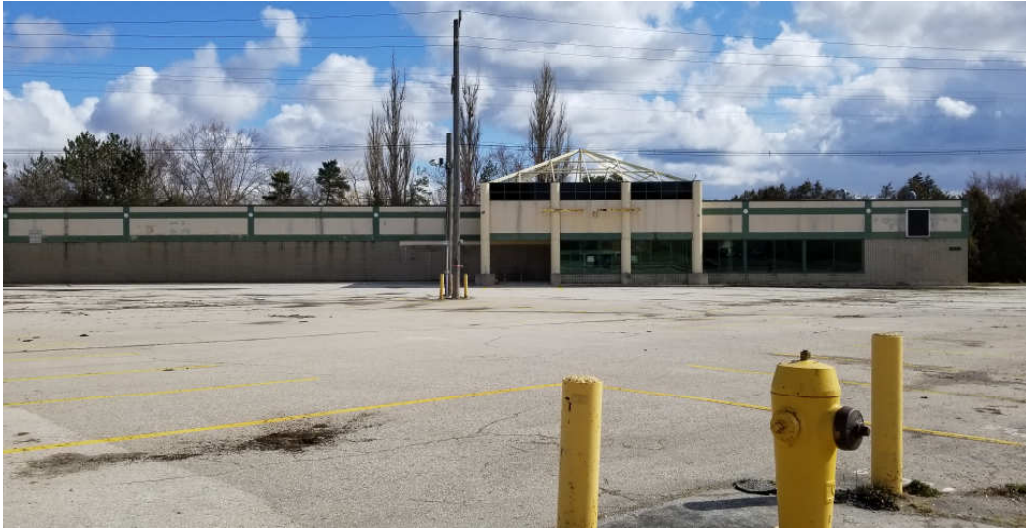
Photo 1: Image of the front (SW) Side of the former Foodland building.

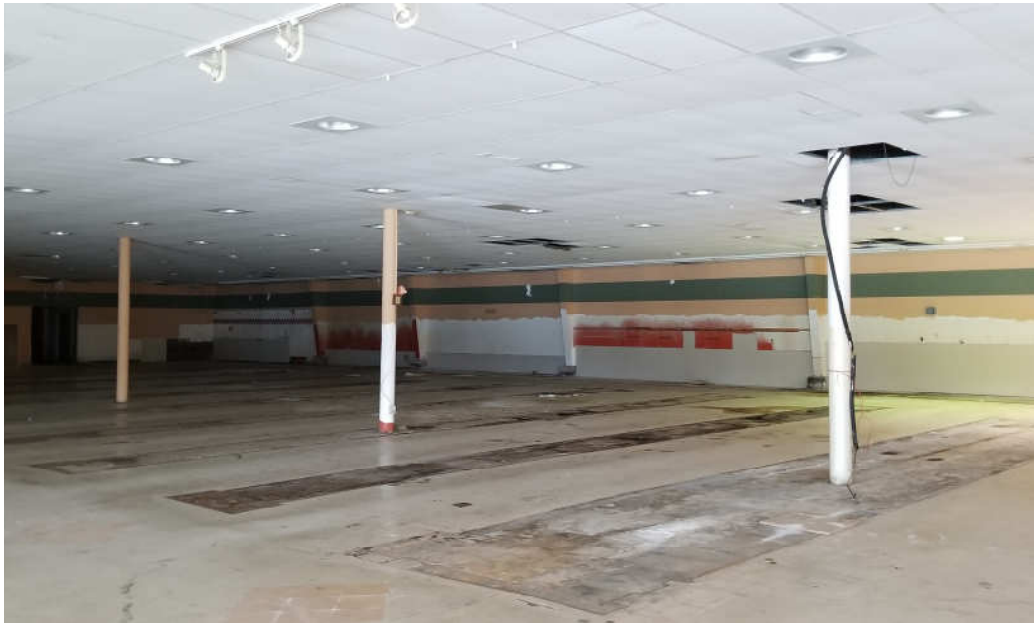
The retail floor was observed to consist of painted wallboard, a drop ceiling with acoustic ceiling tiles, and vinyl floor tiles overlying the concrete floor slab. Fibreglass batt insulation was identified between the wallboard and the concrete block walls.

Photo 2: View of former retail floor.

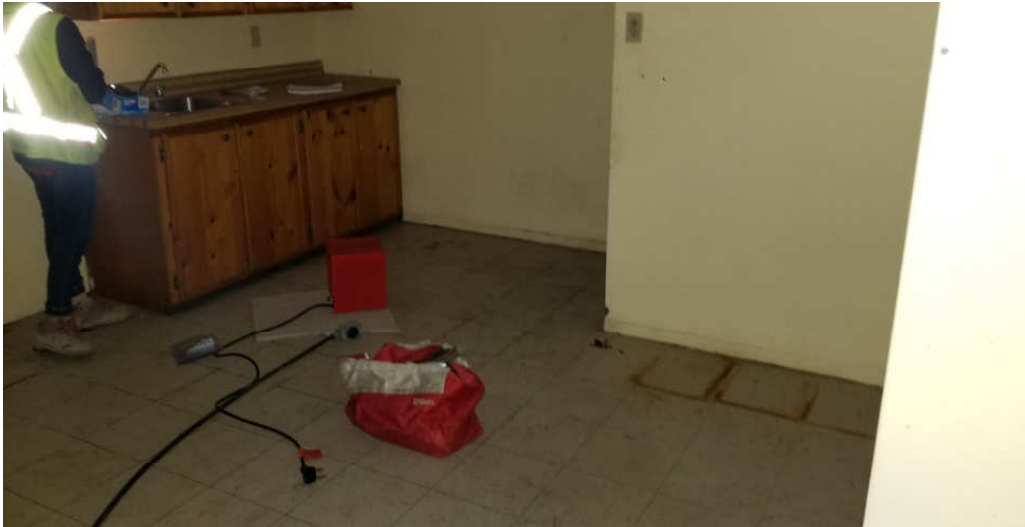
Photo 3: View of vinyl floor tiles in the NW Upper Kitchen (and throughout this area of the building) [i.e. S-6]

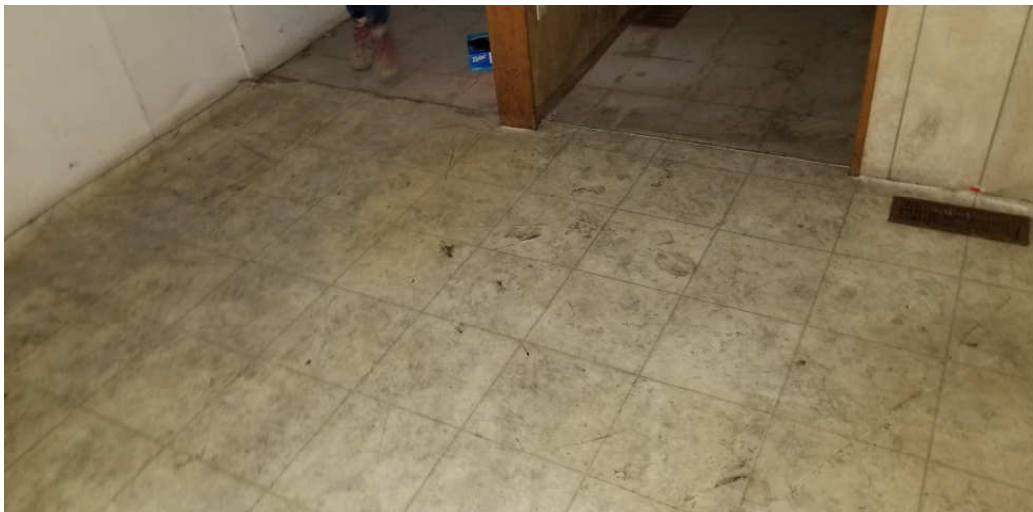
Photo 4: View of the rolled sheet flooring in the second office in the upper NW portion of the building [i.e. S-10]

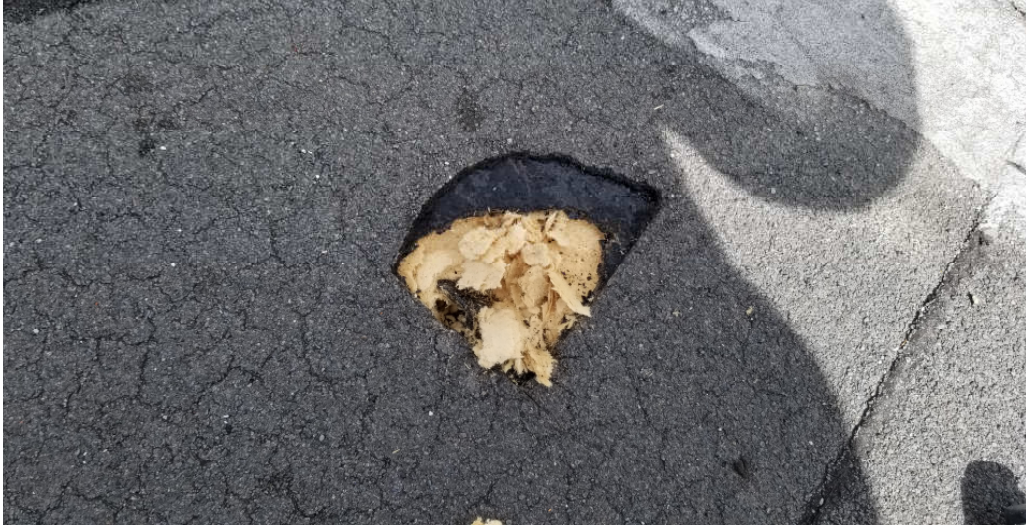
Photo 5: View of modified bitumen roof membrane on a portion of the roof [i.e. S-12].

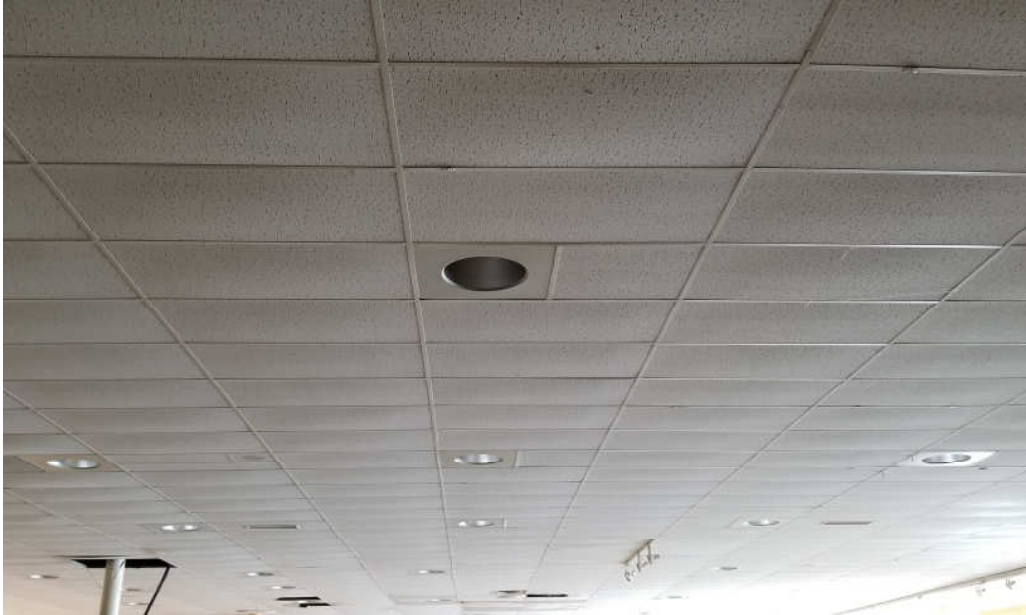
Photo 6: View of acoustic ceiling tiles in the retail floor [i.e. S-3]
