SURVEY FOR DESIGNATED SUBSTANCES AND HAZARDOUS MATERIALS

**WEST SCARBOROUGH NEIGHBOURHOOD COMMUNITY CENTRE
313 PHARMACY AVENUE
TORONTO, ONTARIO**

ECOH Project No.: 25715-B077
November 27, 2020

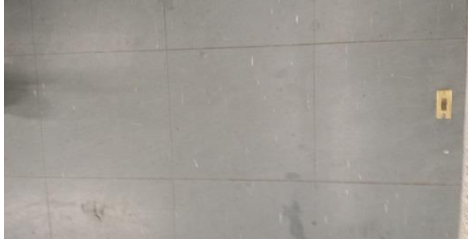
<i>MIN</i>	<i>Material</i>	<i>Photo</i>	<i>Material Description</i>	<i>Size (if applicable)</i>
VFT 4	Mastic

Blue with white marks (ACM Assumed)	12" x 12"
VFT 7	Mastic

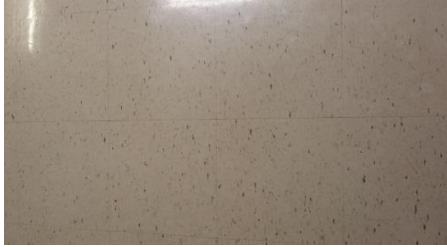
Mastic beneath VFT - White with black marks (ACM Assumed)	12'x12'
VFT 7	Levelling Compound

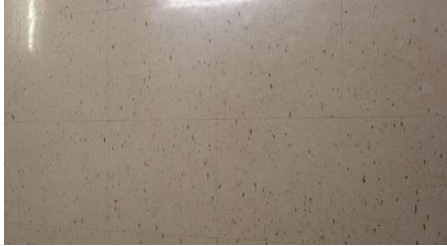
Levelling compound beneath VFT - White with black marks (ACM Assumed)	12'x12'
