PROJECT: **MOUNT HOPE ELEMENTARY SCHOOL
RENOVATION & ADDITION**

BINDER: **C** ARCHITECTURAL DETAILS,
DESIGNATED SUBSTANCE REPORT &
GEOTECHNICAL REPORT

REVISED
Hazardous Building
Materials Assessment
(Pre-Construction)

Additions and Renovations
Project

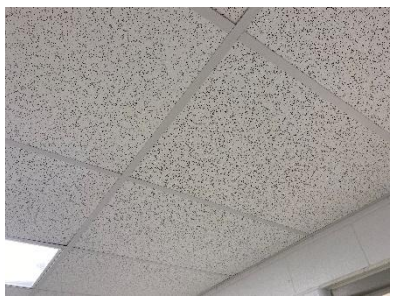
Description	Sample Location	Sample Number or Date Code	Asbestos	Photo
2' x 4', lay-in, pinholes and short fissures	Not sampled	02/03/17	None*

*Ceiling tiles are presumed to be non-asbestos based on the date of manufacture determined from the date stamp applied to the top of the tiles. The tiles were manufactured after asbestos stopped being used in acoustic ceiling tiles.

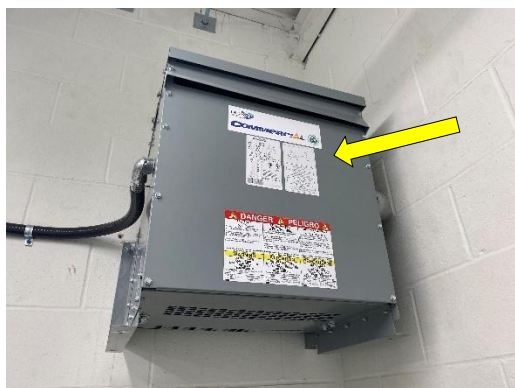
Photo 1

All transformers in the building are dry type transformers and do not contain PCB-containing dielectric fluids; however, may contain capacitors, which could not be assessed for PCBs as the equipment was in service (photo 1).

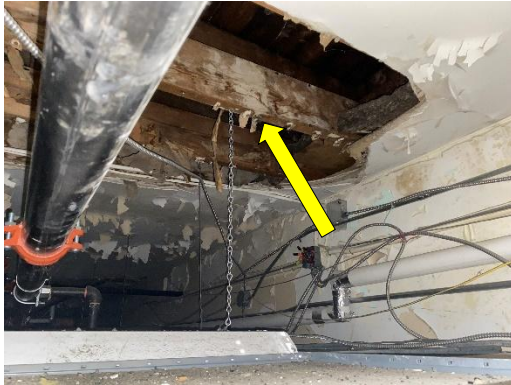
Photo 1

Visible mould growth and water damage is present on the wood structure and plaster ceilings above acoustic ceiling tiles in Corridor 118 (Location 8764, photo 1).

Mould growth was noted in areas affected by the planned work. Retain a qualified consultant to perform an intrusive investigation to determine the full extent of hidden mould growth.

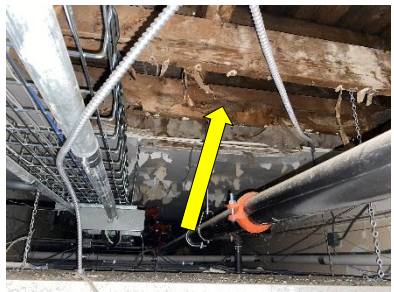
Material, Quantity & Condition	Location	Recommended Procedure	Photo
Plaster ceiling, 100 square feet, poor condition	Corridor 118 (Location 8764)	Consider conducting an intrusive investigation for potential of mould growth.

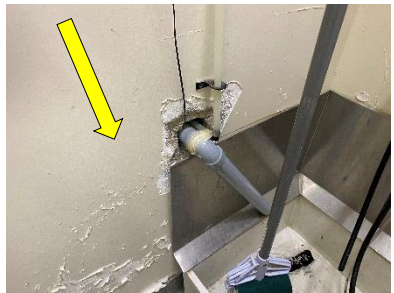
Lead-containing paint, 10 square feet, poor condition	Resource Room 132A (Location 8749)	Remove flaking paint in accordance with EACC Class 2A lead procedures.

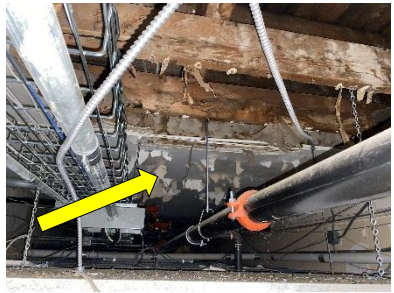
Lead-containing paint and debris, 120 square feet, poor condition	Corridor 118 (Location 8764)	Remove flaking paint in accordance with EACC Class 2A lead procedures.
