**Re: Hazardous Materials Assessment (Preconstruction)**  
2960 Teston Road, Vaughan, Ontario  
Pinchin File: 346087.000

The Regional Municipality of York (Client) retained Pinchin Ltd. (Pinchin) to conduct a hazardous materials assessment of the vacant parking lot located at 2960 Teston Road, Vaughan, Ontario.

The objective of the assessment was to identify specified hazardous materials in preparation for removal of asphalt paving in advance of the new construction of a paramedic station on the property as per an email sent by the Client on July 30, 2024.

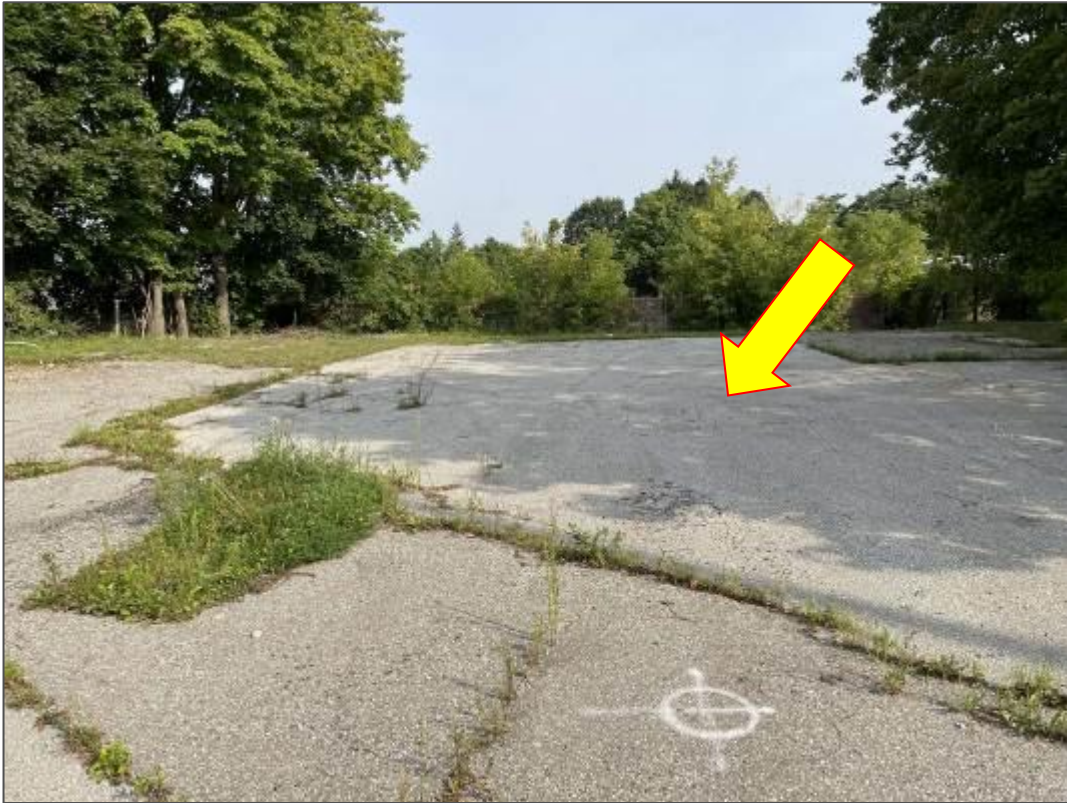
1. <0.5% Chrysotile asbestos was detected in samples S0001B and S0003C. As this is below the regulatory threshold of 0.5%, this material is determined not to be asbestos-containing. Asbestos procedures are not required when disturbing this material.

S0001A (None), Light Asphalt, Floor, Asphalt, Exterior (Location #: 1).  
North.

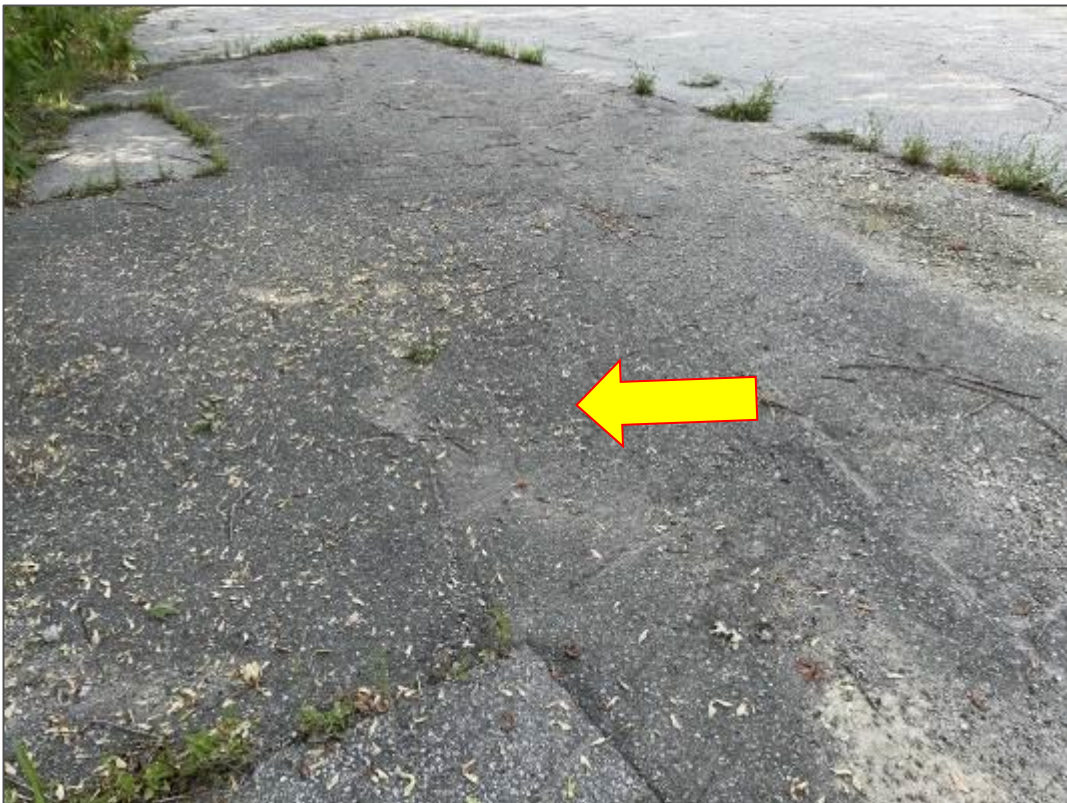
S0002A (None), Dark Asphalt, Floor, Asphalt, Exterior (Location #: 1)  
Middle.

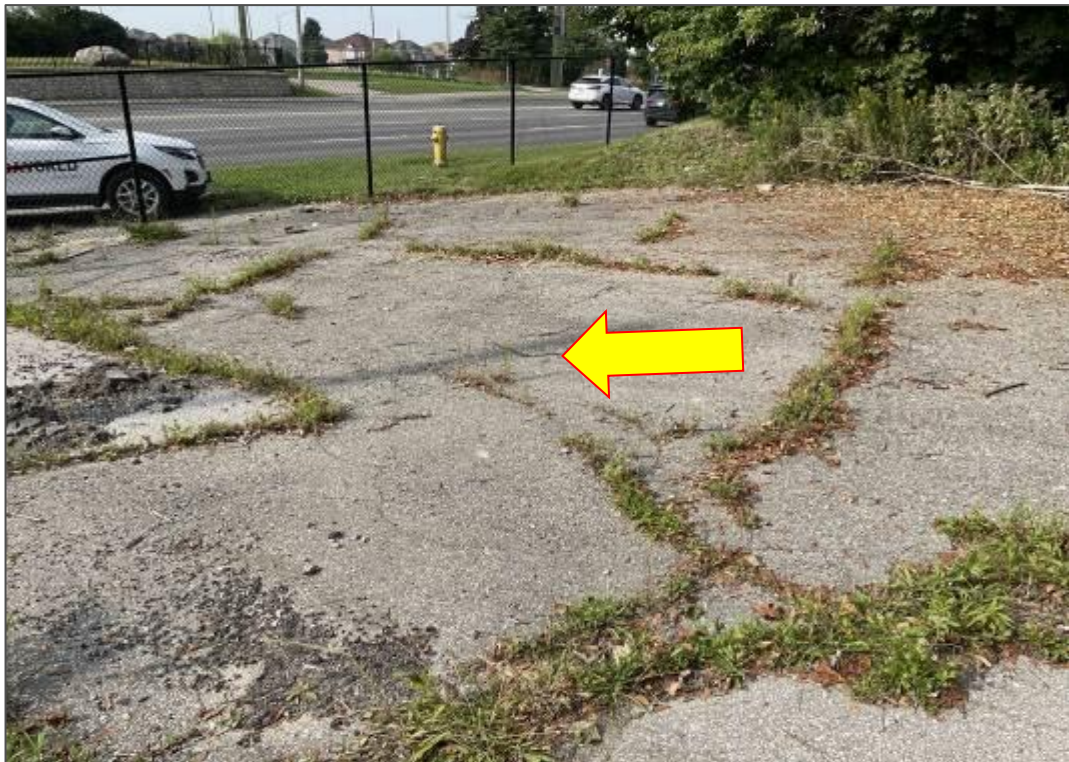
S0003A (None), Floor, Asphalt, Exterior (Location #: 1).
