Comprehensive Drain & Storm Investigation Report

Issued October 30<sup>th</sup>, 2025, by Element Building Systems

**Project:** 1116 King Street West – Buildings 8 & 9

**Client:** City of Toronto / IBI Group

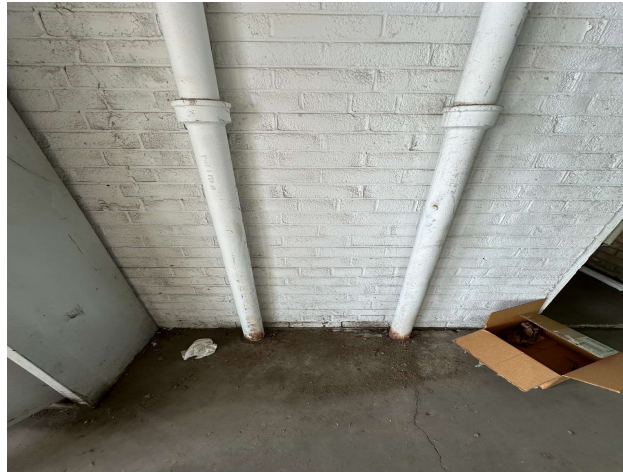
unit 9 unknown \_vent\_

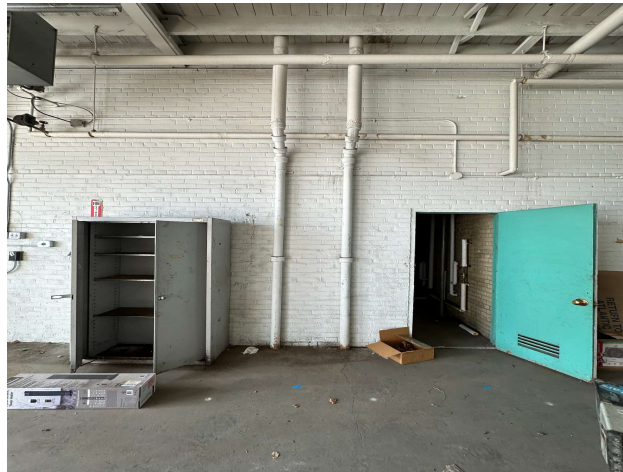
unit 9 unknown no access vent

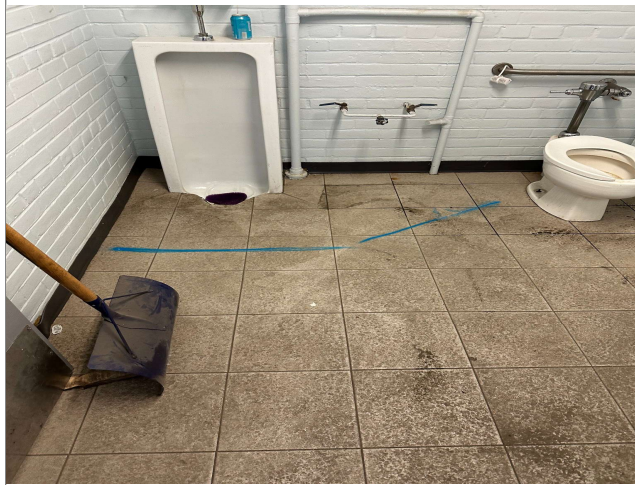
unit 9 washroom sewer pipe location

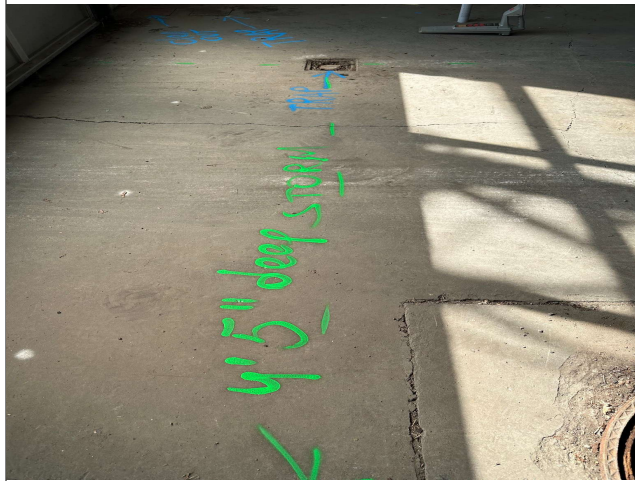
unit9 storm pipe cast 4

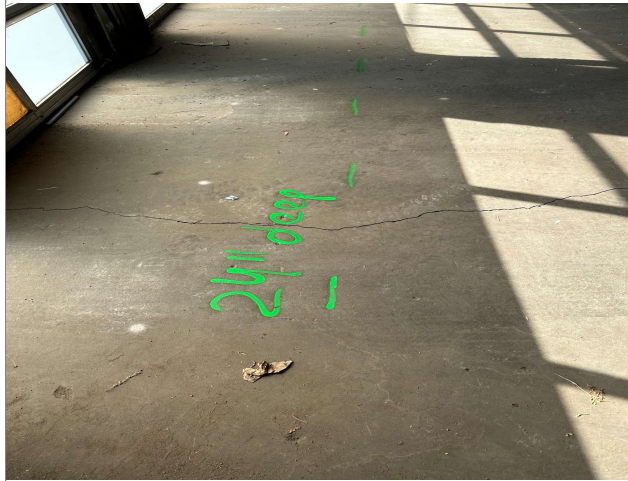
unit 9 branch from RD to storm

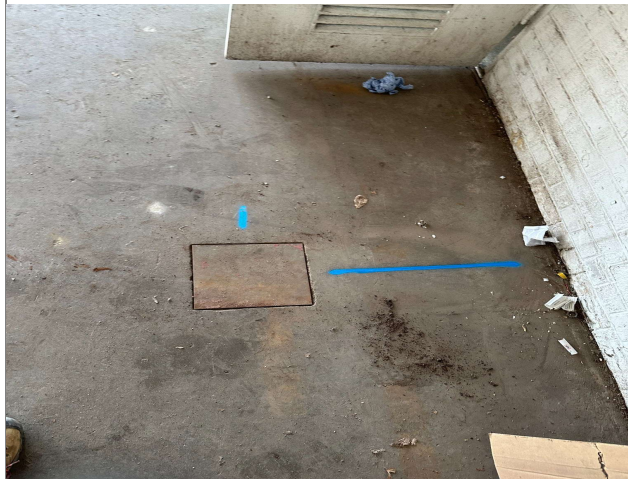
unit 9 cleanout from washroom to main

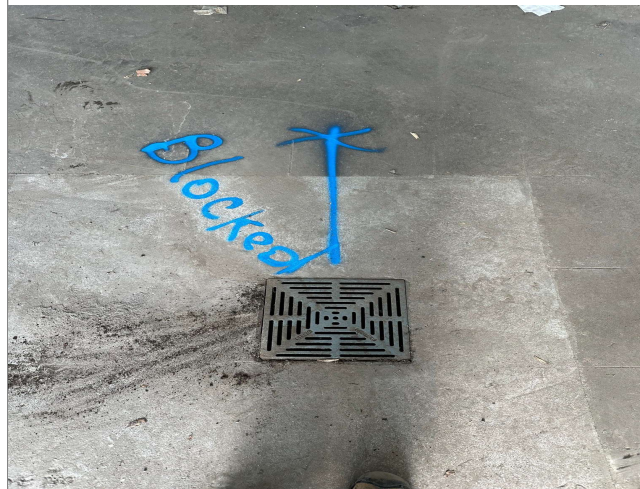
Unit 9 point 93 Full blocked floor drain

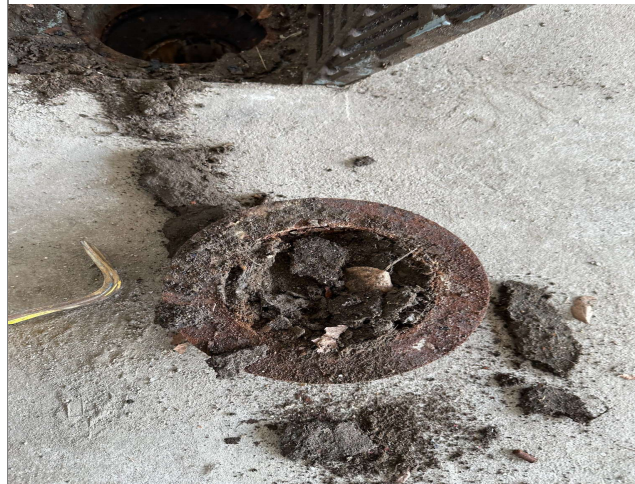
unit 9 point 93 protector net

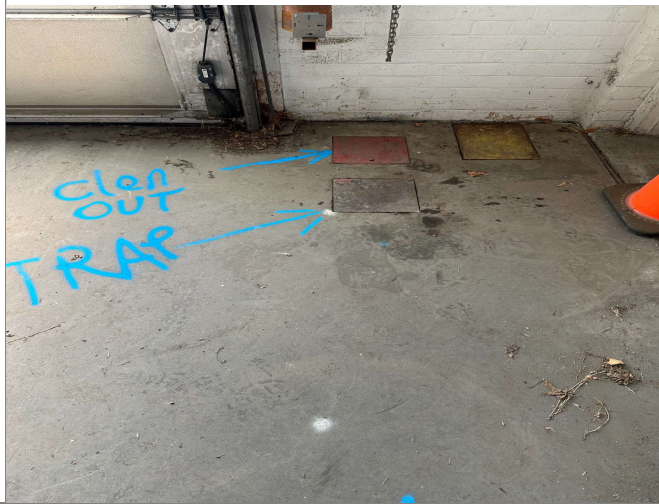
unit 9 sewer trap leading to outside

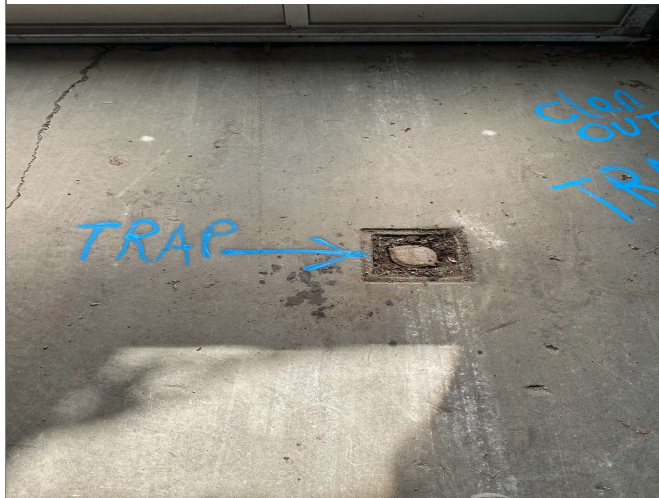
unit 9 sewer trap

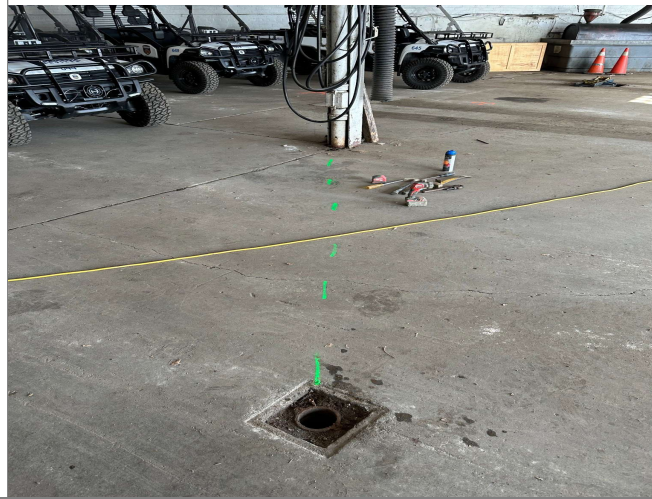
unit 9 SS with clean out

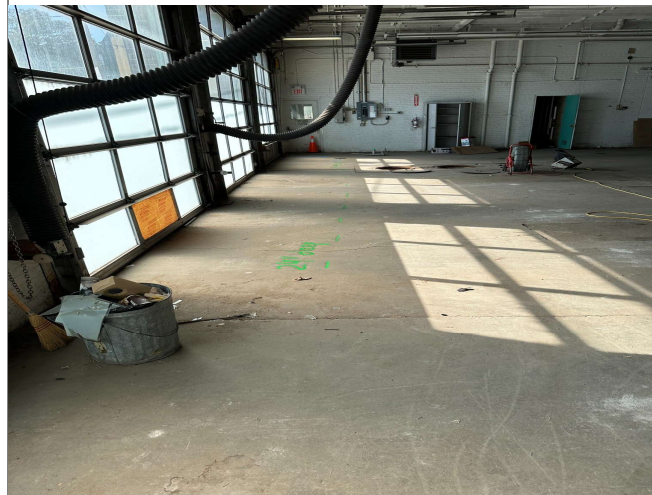
unit 9 storm pipe

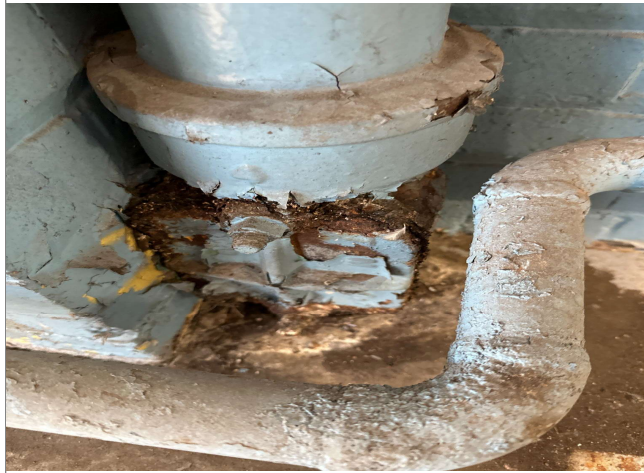
Trap Assembly - Corroded Connection

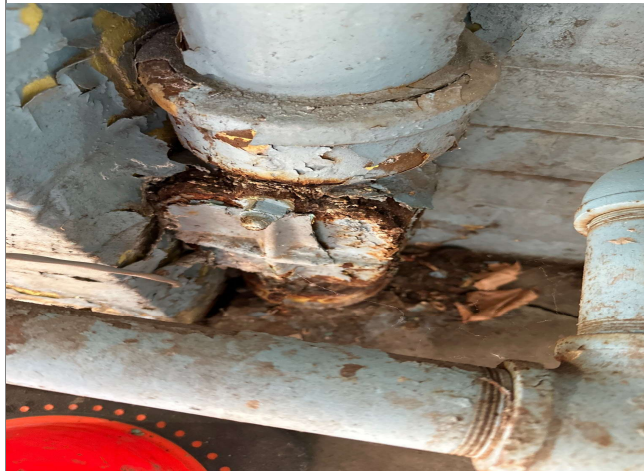
Trap Assembly - Side View

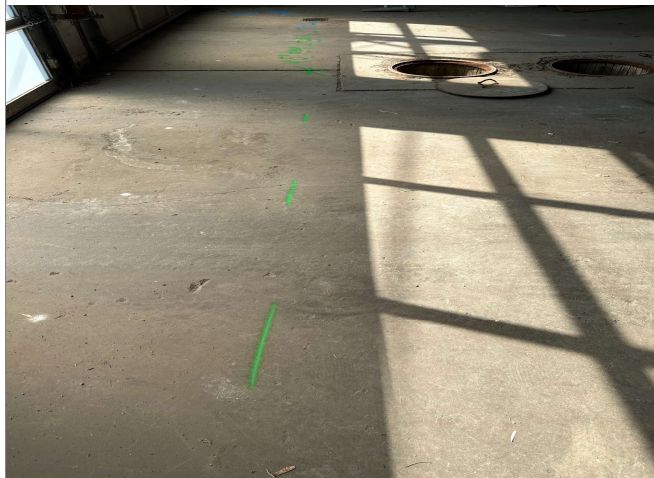
Storm Pipe - Unit 9 Alignment (Green markings)

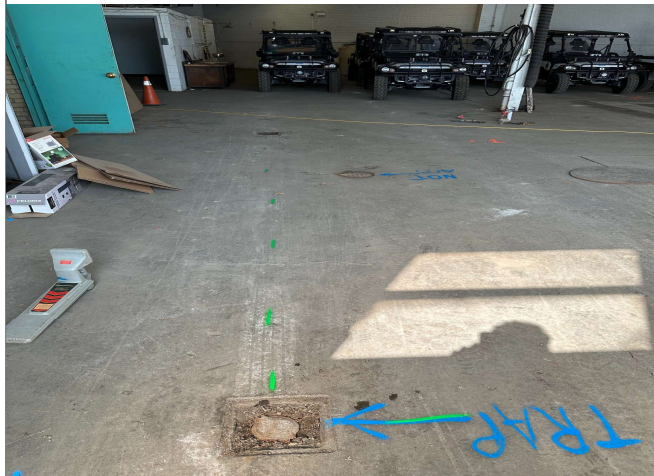
Trap Unit 9 - Marked on Floor

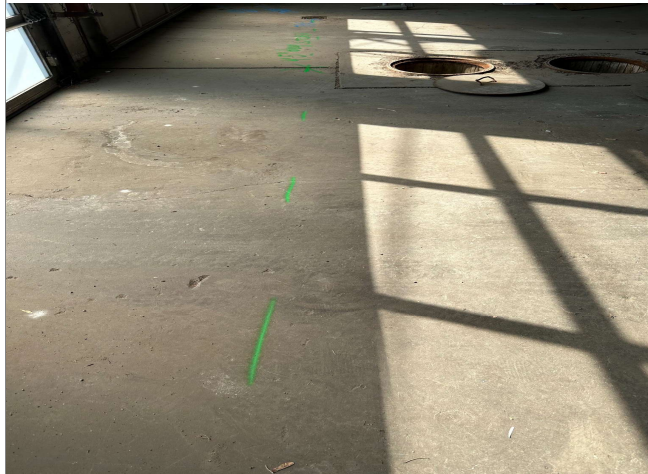
Storm Pipe - Unit 9 Alignment (Green markings)

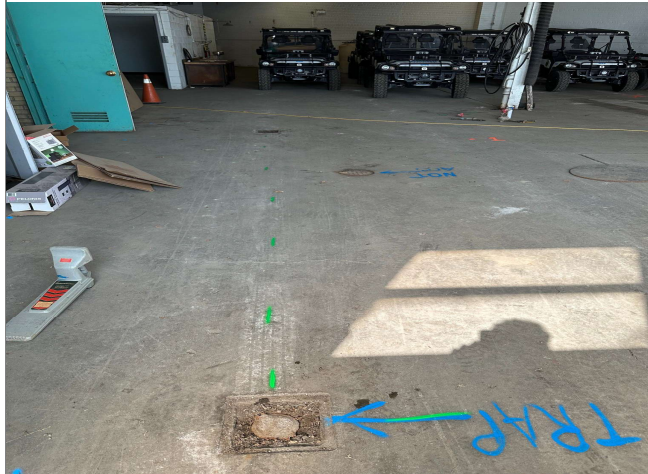
Trap Unit 9 - Marked on Floor

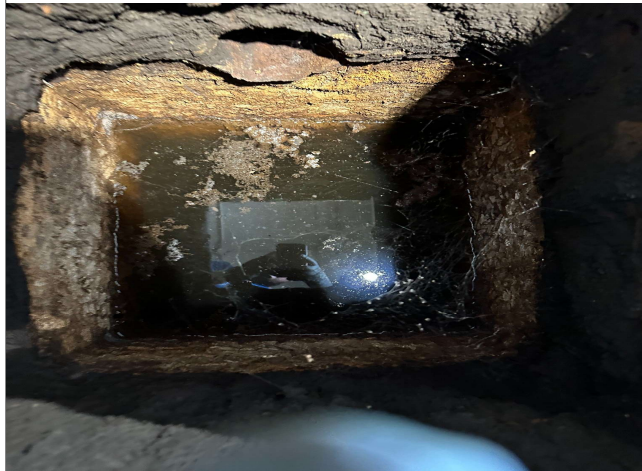
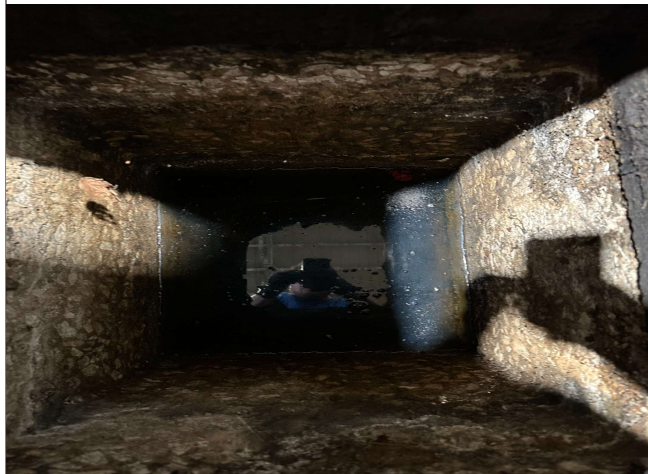
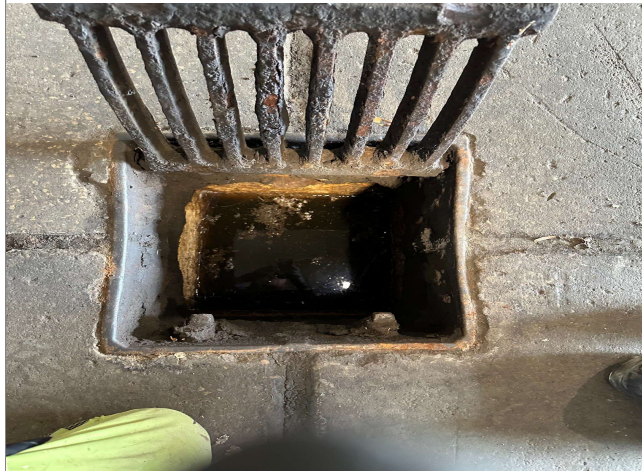
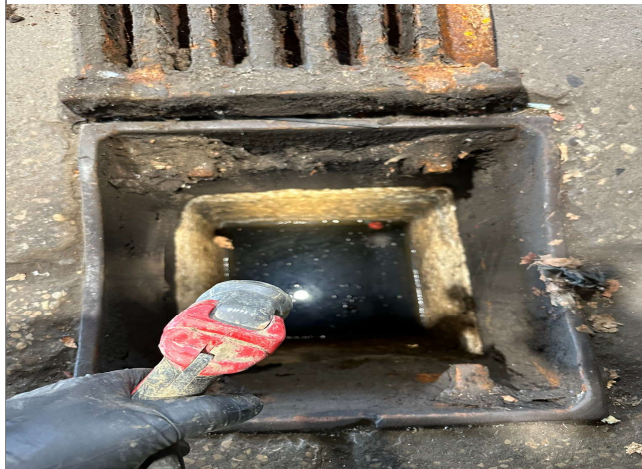
Unit 8 Catch Basin 1 (View 1)

Unit 8 Catch Basin 1 (View 2)

Unit 8 Catch Basin 1 (View 3)

Unit 8 Catch Basin 1 (Wide View)

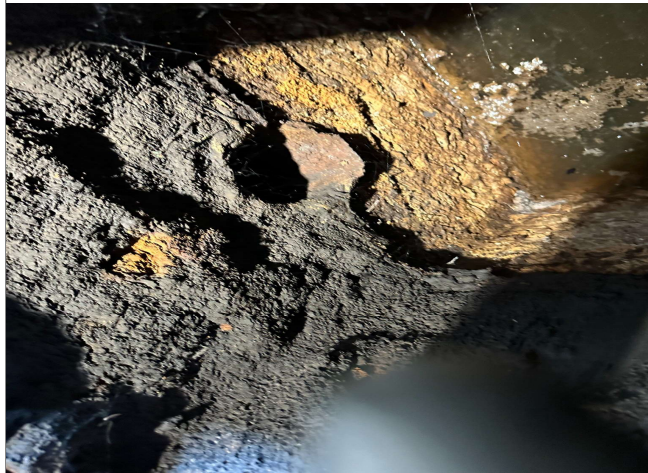
Unit 8 Catch Basin 2 - Outlet

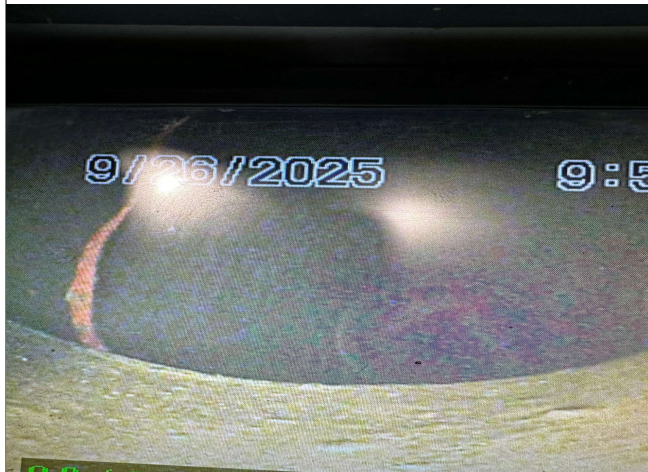
Unit 8 Inspection Point 81

Location	Pipe Material	Approx. Diameter	Invert (from Finished Floor)	Condition	Remarks
Unit 8 – Storm (Point 81)	Clay	6 in	6.8 ft	Broken/Shifted	Pipe extends north toward exterior; U-trap located immediately beyond break.
Unit 9 – Storm (Internal)	Cast Iron	4 in	N/A	Blocked	Trap filled with debris; flow toward north side confirmed by camera direction.
Catch Basins (CB1, CB2)	Clay	6 in	5–6 ft	Blocked	Sediment accumulation prevented camera entry.
Roof Drains (RD2–RD6)	Cast Iron	4 in	N/A	Limited access	Connections visually confirmed from surface conditions.
Exterior Storm Outlet	Clay	6 in	6–7 ft (assumed)	Good	Route inferred to connect to municipal storm main on north side.

System Component	Observed Issue	Impact	Recommended Action
Hydro Pole Area (Unit 9 Sewer)	Fractured pipe at 7 ft depth	Potential leakage and infiltration	Repair section during construction.
Storm Line (Point 81)	Broken and shifted clay pipe	Restricted storm flow	Replace damaged segment prior to reuse.
Oil Interceptor	Completely blocked	Non-functional / environmental risk	Replace unit with new separator.
Catch Basins	Sediment buildup	Reduced drainage capacity	Clean and restore access.
Roof Drains	Limited access	Potential ponding risk	Inspect and clear during facility upgrades.

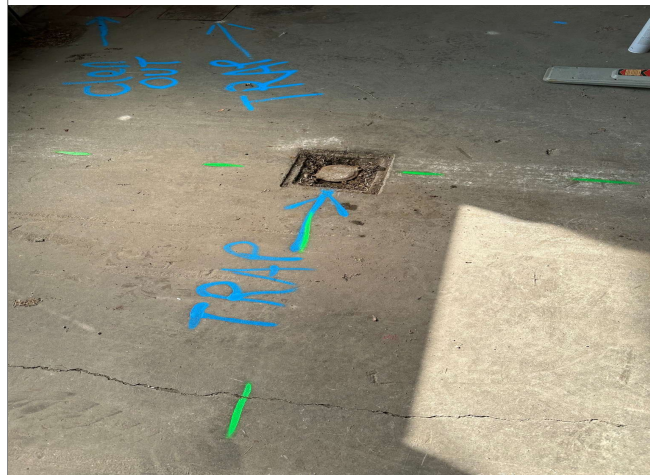
Blocked Trap

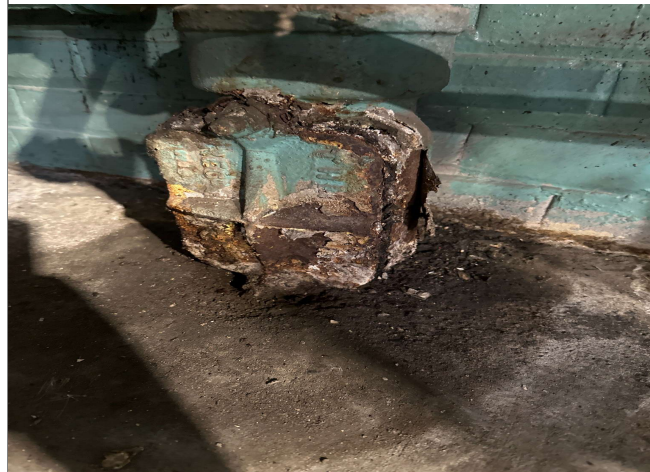
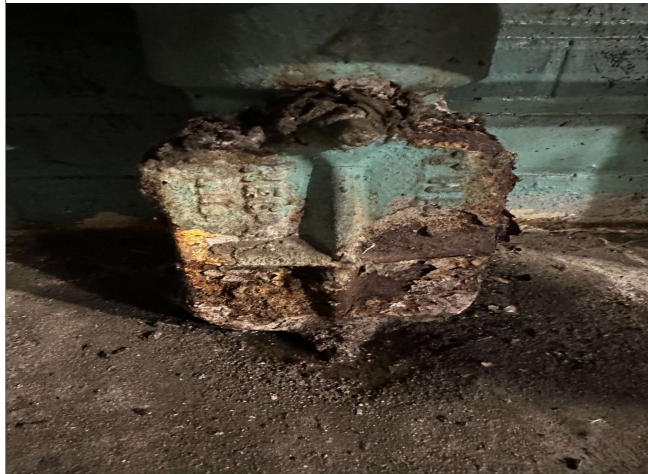
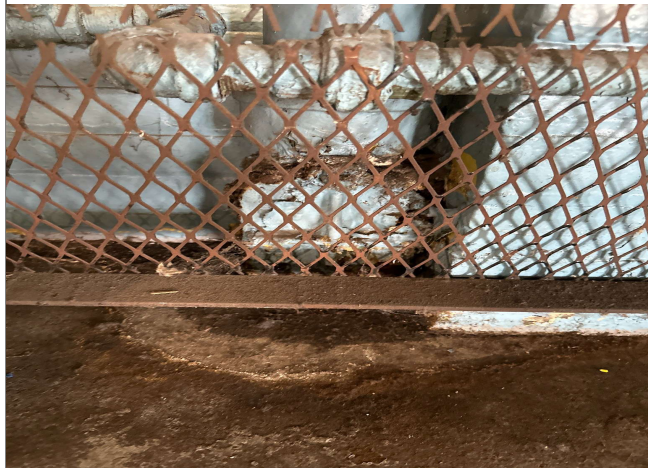
Clean Out

Clean Out (alternate view)

Clean Out (labeled)

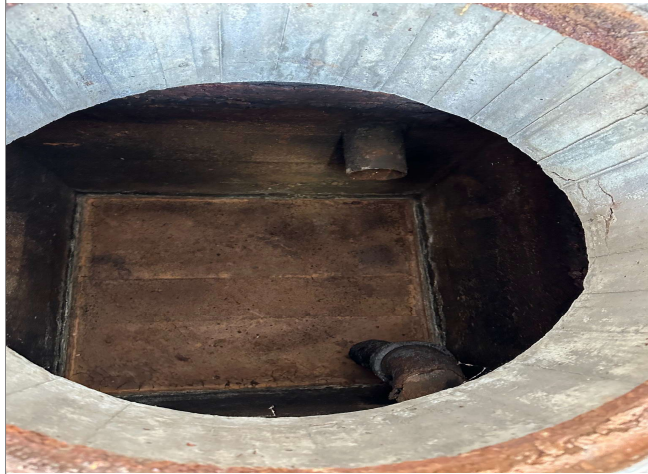
Downstream Chamber

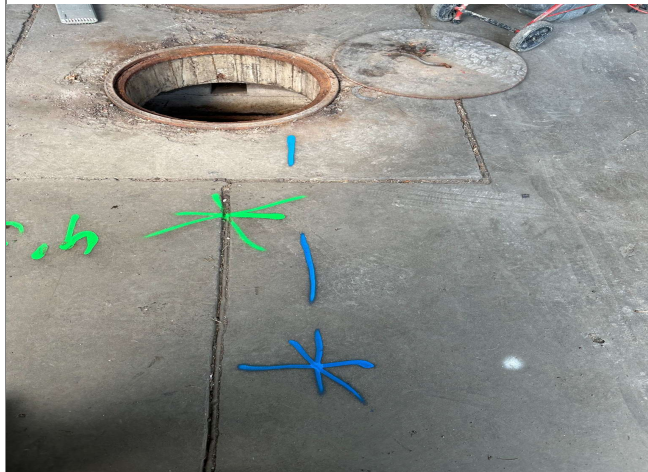
- **Type:** Three-chamber unit located in Unit 9.
- **Condition:** Both inlet and outlet completely blocked with hardened oil and debris.
- **Status:** Non-functional and at end-of-life condition.
- **Recommendation:** Power washing is not effective; mechanical clean-out or replacement is required before reuse or system integration.
- **Invert Depth:** Approximately 7 ft below finished floor based on camera readings.

Oil Separator Chamber

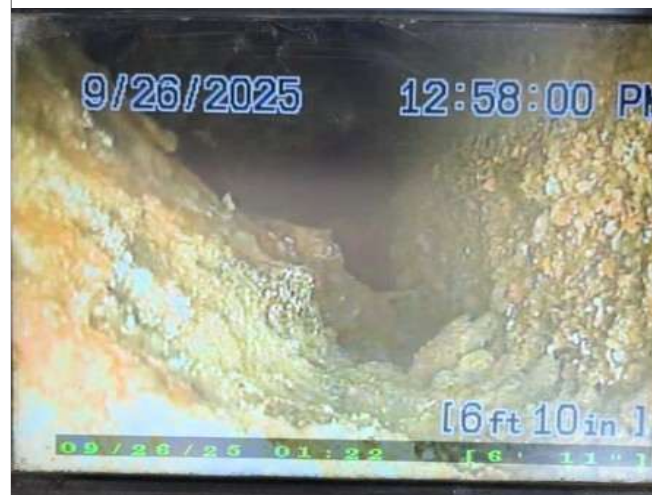
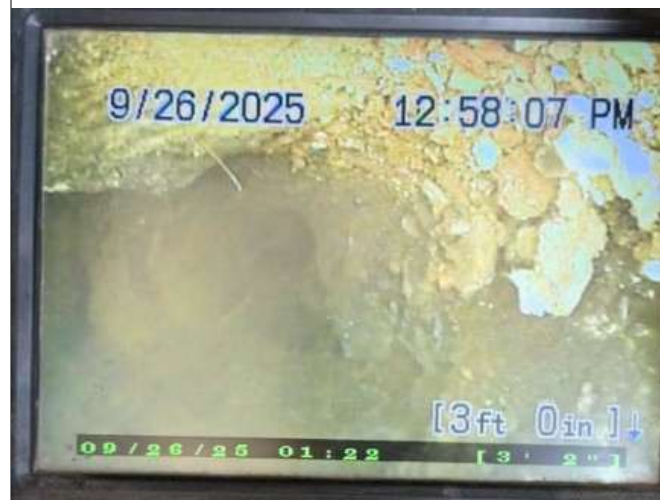
Oil Separator Inlet Pipe Upstream PC2

Oil Separator Inlet Pipe Upstream PC3

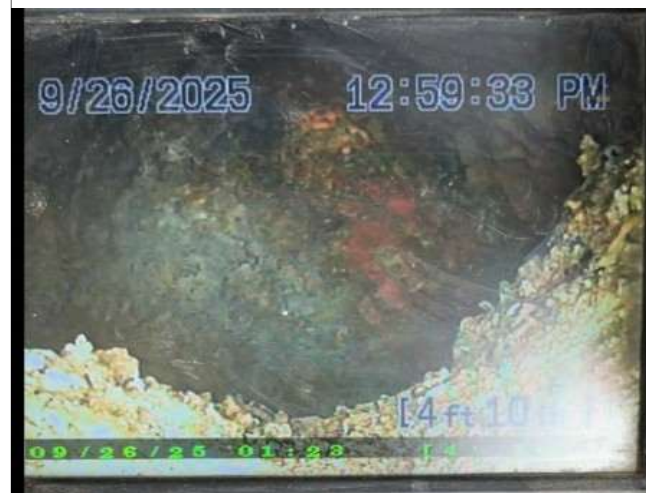
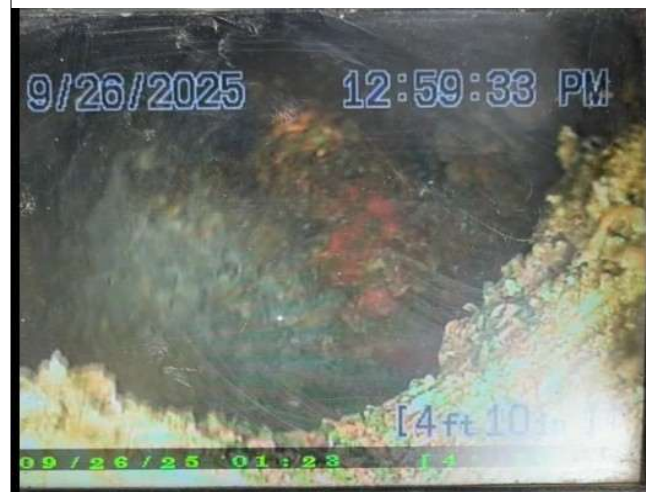
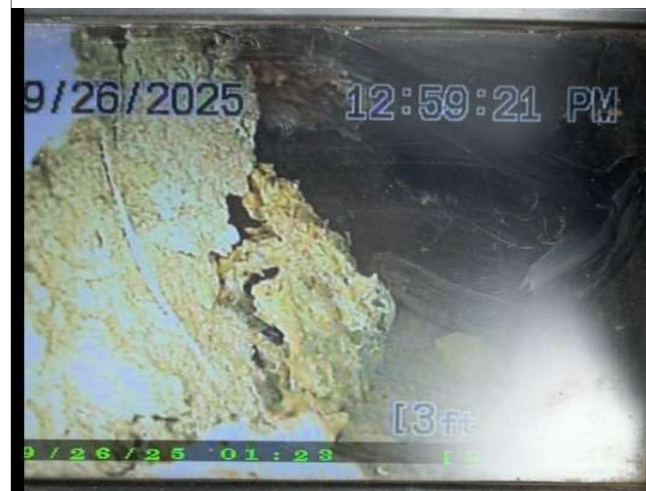
Point 92 Unit 9 PC1

Point 92 Unit 9 PC2

Point 92 Unit 9 PC3

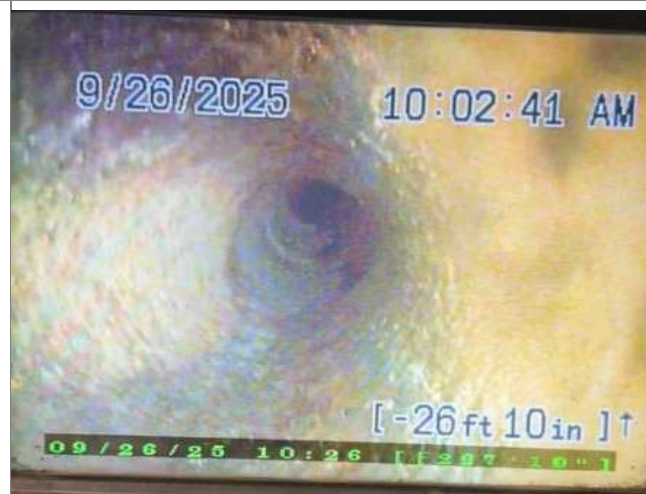
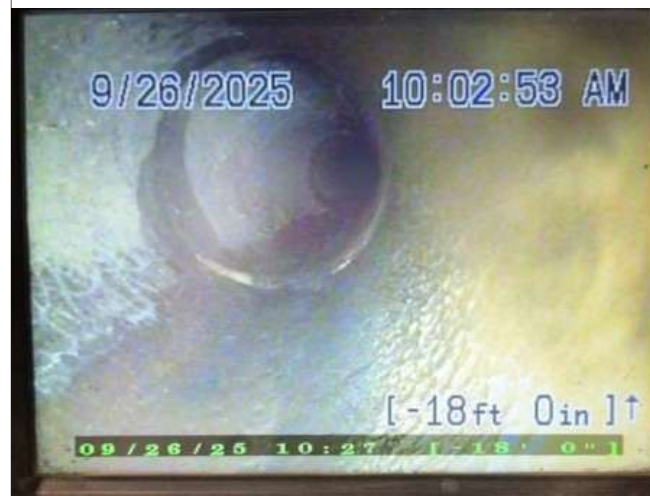
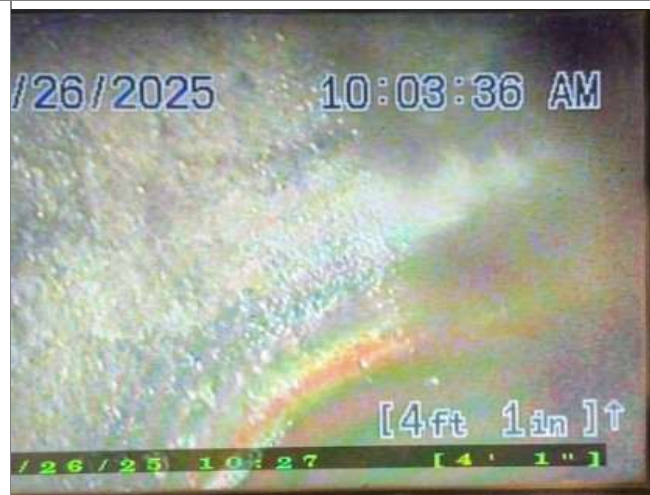
RD1\_and\_branch PC1

RD1\_and\_branch PC2

RD1\_and\_branch PC3

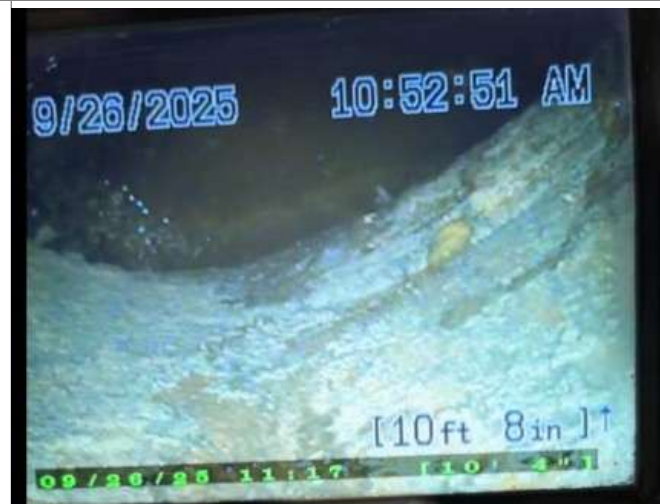
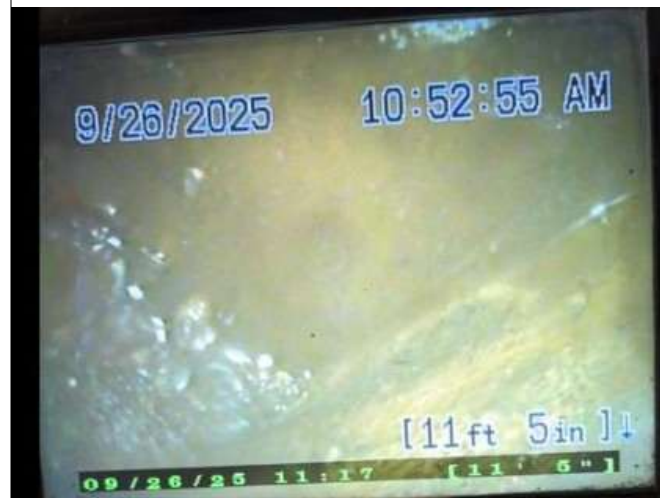
Unit 8 CB1 PC1

Unit 8 CB1 PC2

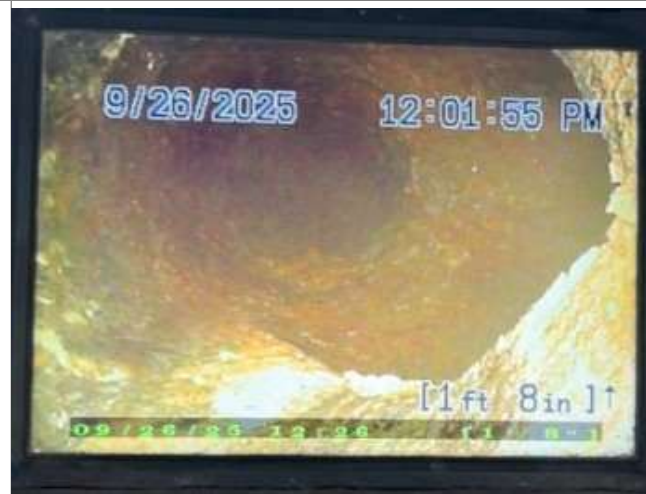
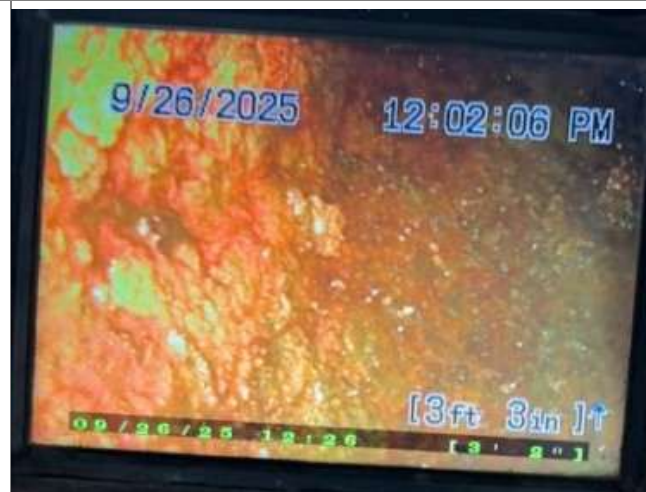
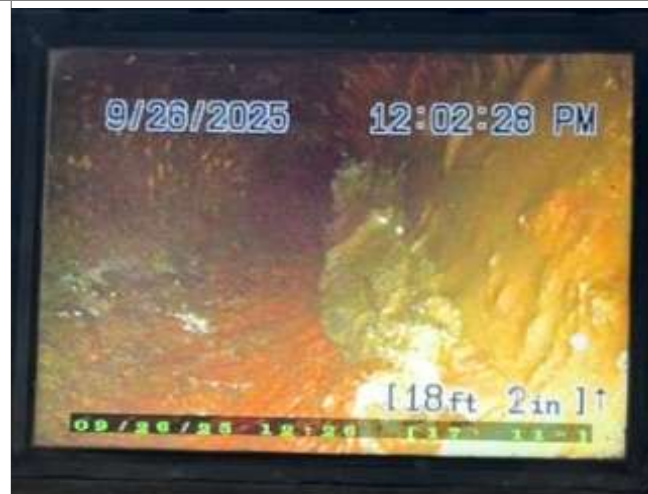
Unit 9 CO3 PC1

Unit 9 CO3 PC2

Unit 9 CO3 PC3

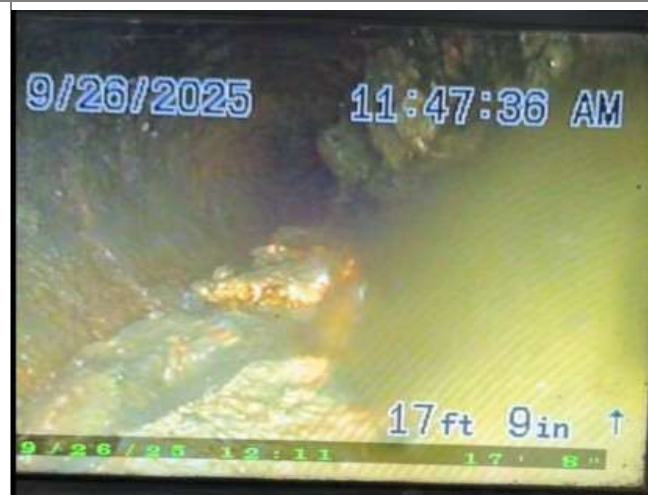
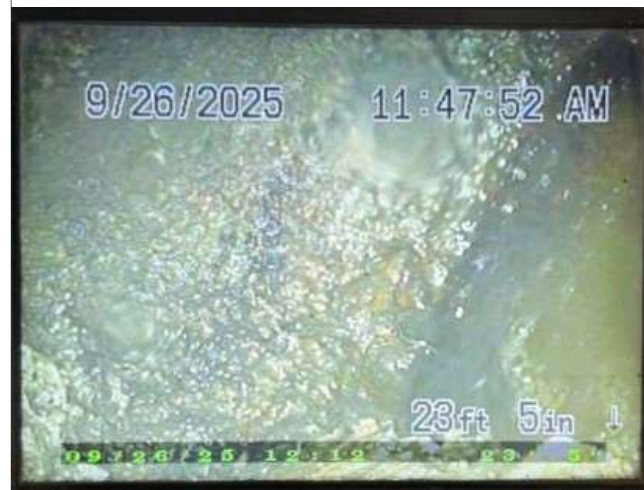
Unit 9 RD91 PC1

Unit 9 RD91 PC2

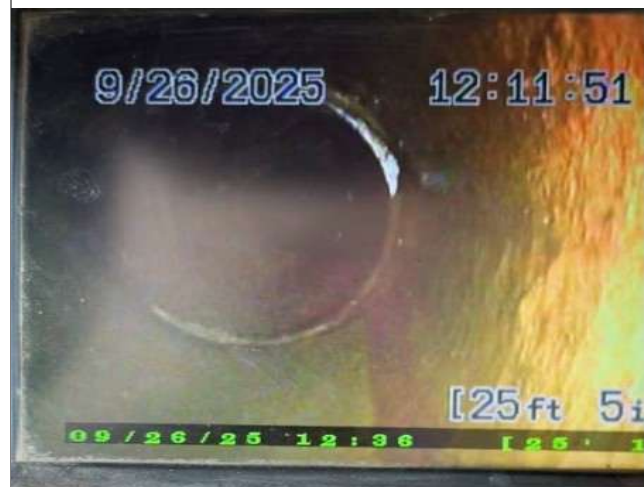
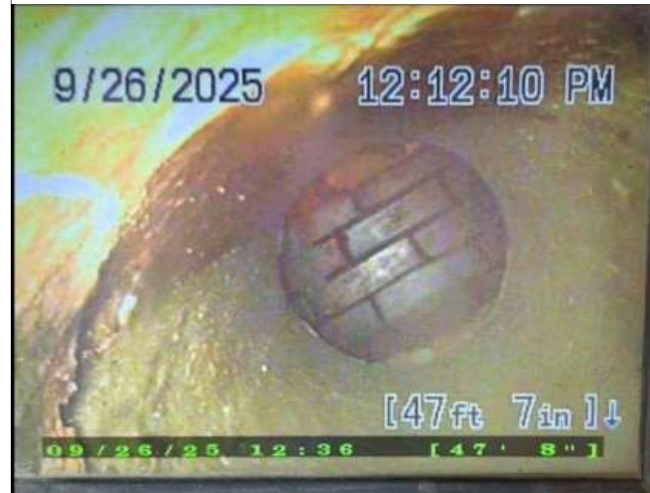
Location	Pipe Material	Approx. Diameter	Invert (from Finished Floor)	Condition	Remarks
Unit 8 – Main Sewer (CO81 to Exterior)	Clay	6 in	7.2 ft	Fair	Traced to municipal sewer; flow verified via camera run.
Unit 9 – Main Sewer	Clay / Cast Iron	4–6 in	7.0 ft	Damaged	Localized fracture and shift at Hydro Pole location (7 ft depth).
Floor Drains – Unit 9	Cast Iron	4 in	N/A	Fully blocked	Non-functional; replacement required.
Interior Branches	Clay	4 in	5–6 ft typ.	Corroded	Offset joints and partial blockages observed.
Oil Interceptor Outlet	Cast Iron	4 in	N/A	Sealed	Outlet completely solidified with oil residue.

Unit 9 sewer pipe leading to hydro pole section  
PC 1

Unit 9 sewer pipe leading to hydro pole section  
PC 2
