ASBESTOS SURVEY 2023 ANNUAL UPDATE REPORT

Queensway Health Centre
150 Sherway Drive
Toronto, Ontario
M9C 1A5

March 2023

OHE Project No.: 28418

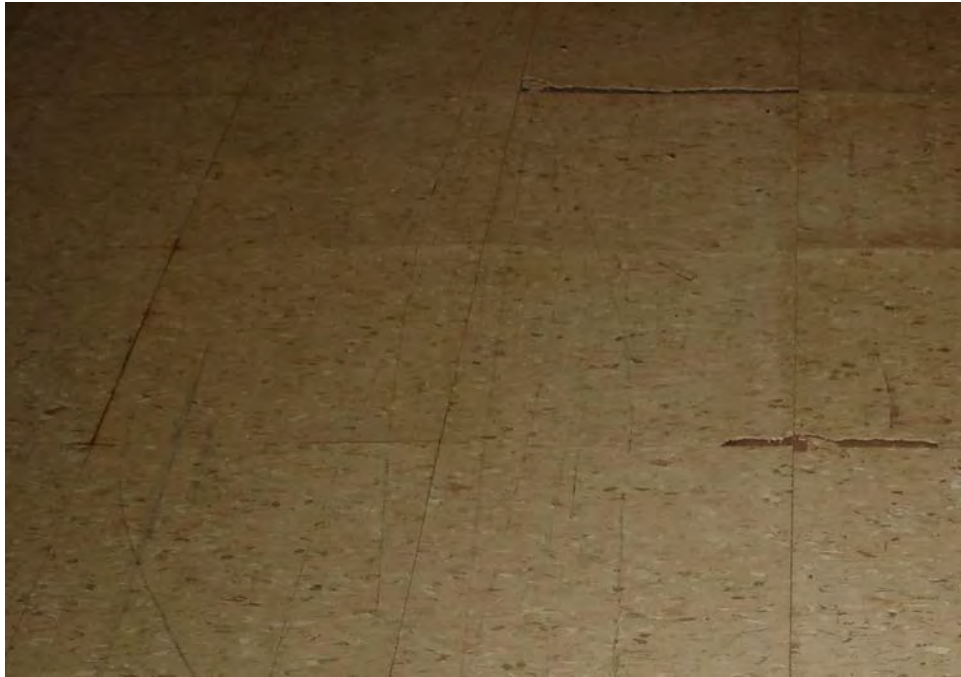
Vinyl Floor Tiles (VFTs) were observed throughout the subject location. Twenty four (24) samples of VFTs were collected as part of the survey. OHE Sample MA1014-25A, collected in Room B333 in the basement, was found to contain 1% Chrysotile asbestos. Sample MA1014-26A, collected in Room B333 in the basement, was found to contain 1% Chrysotile asbestos. Sample MA1014-28A, collected in Room 305 in the basement, was found to contain 8% Chrysotile asbestos. Sample MA1014-30A, collected in Room 338 in the basement, was found to contain 3% Chrysotile asbestos. No asbestos was detected in any of the remaining VFTs samples collected and analyzed.

Photograph 1: View of asbestos-containing floor tile identified in the basement, hallway B113 (OHE Sample MA1014-25B).

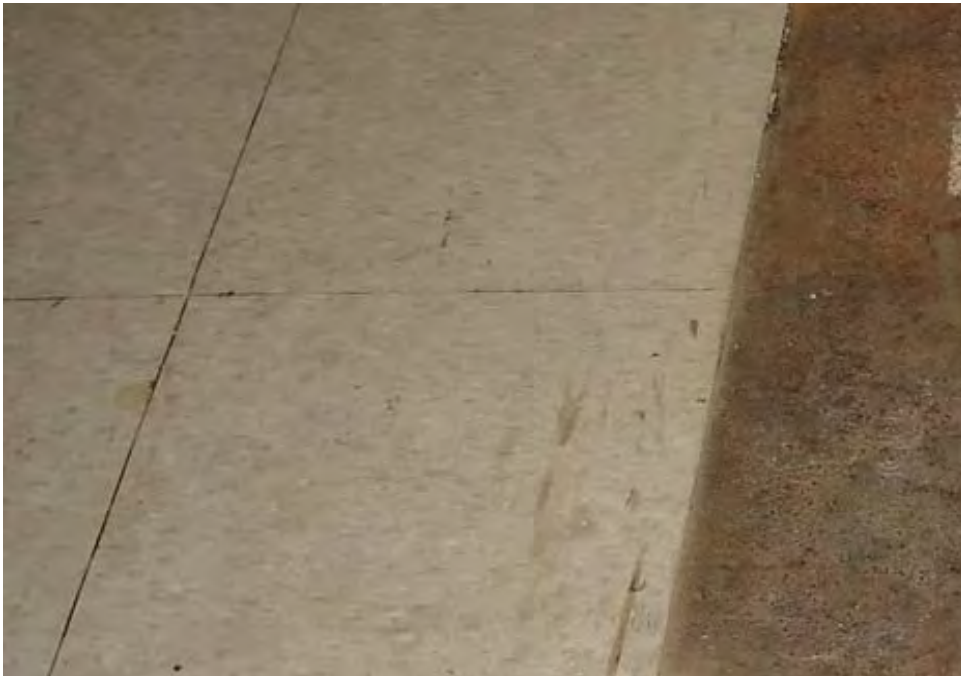
Photograph 2: View of additional type of asbestos-containing floor tile identified in the basement, hallway B113 (OHE Sample MA1014-26B).

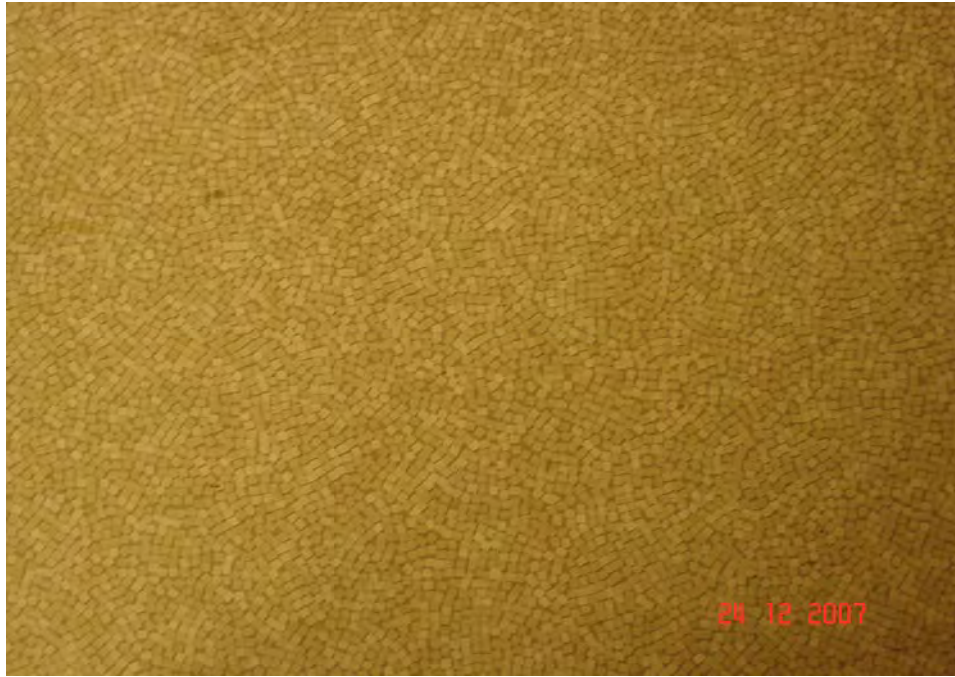
Vinyl sheet flooring was observed throughout the subject location. Twenty four (24) samples of vinyl sheet flooring were collected as part of the survey. OHE Sample MA1014-2A, collected in Room 1657A on the main floor, was found to contain 15% Chrysotile asbestos. No asbestos was detected in any of the remaining vinyl sheet flooring samples collected and analyzed.

Photograph 3: View of asbestos-containing vinyl sheet flooring identified on the Main floor, room 1657A (OHE Sample MA1014-2A).

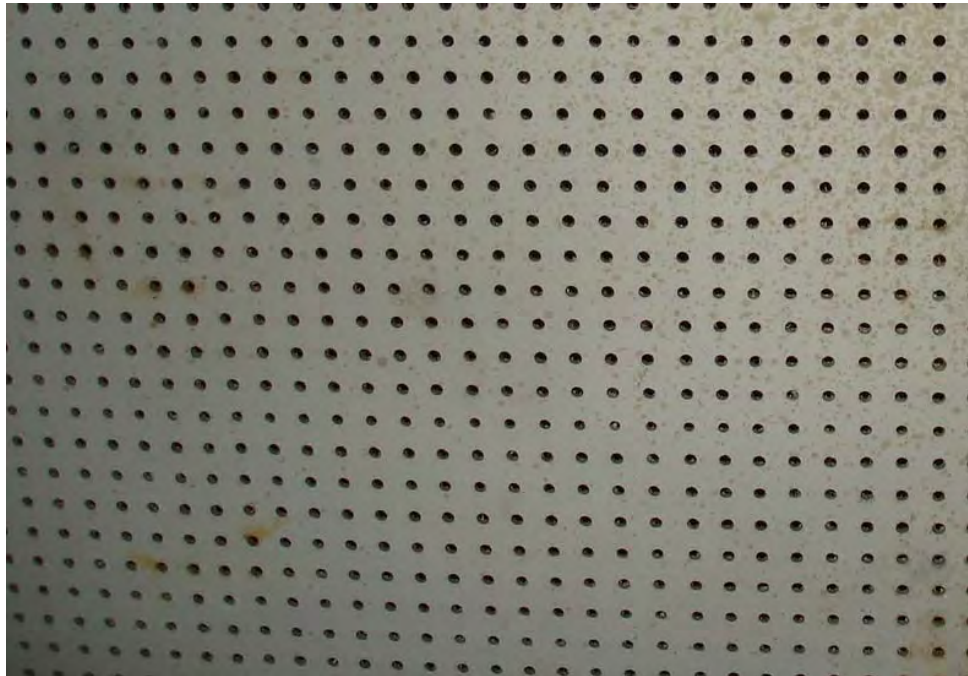
Asbestos cement products (in the form of transite boards and transite pipes) were observed throughout the basement and the main floor in the subject location. Three samples (3) of transite board were collected during the survey. OHE Sample #MA1014-22A collected in Room 310B in the basement, was found to contain 20% Chrysotile asbestos. The other samples in this sample set were not analyzed as per O. Reg. 278/05. Transite pipes were also observed during the survey. No samples were collected of transite pipes to avoid damaging the material.

Photograph 4: View of asbestos-containing transite board identified on the Main floor, 1211A (OHE Sample MA1014-22C).

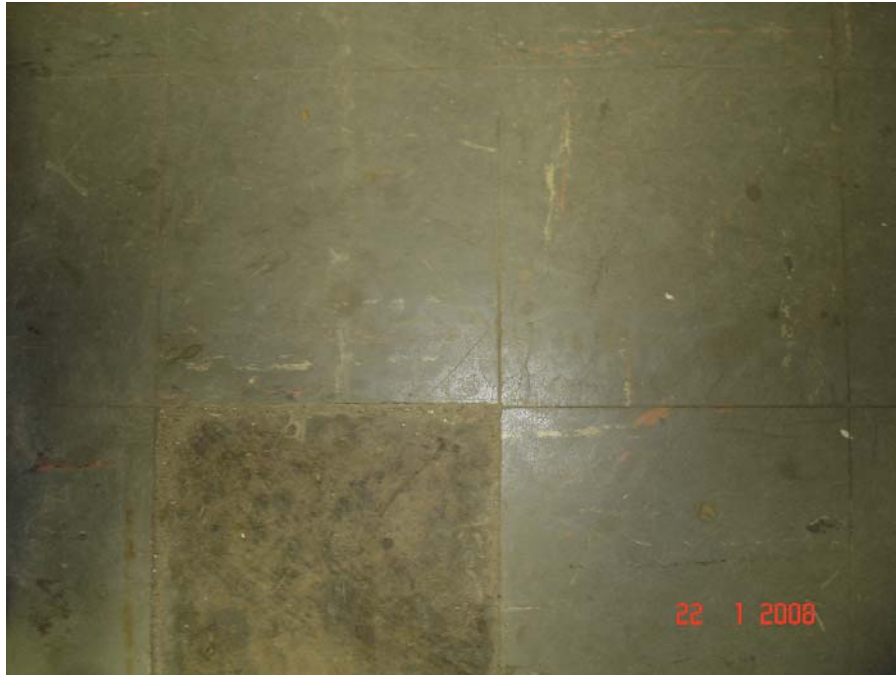
Photograph 5: View of asbestos-containing floor tile identified in the basement, Room 305 (OHE Sample MA1014-28A).

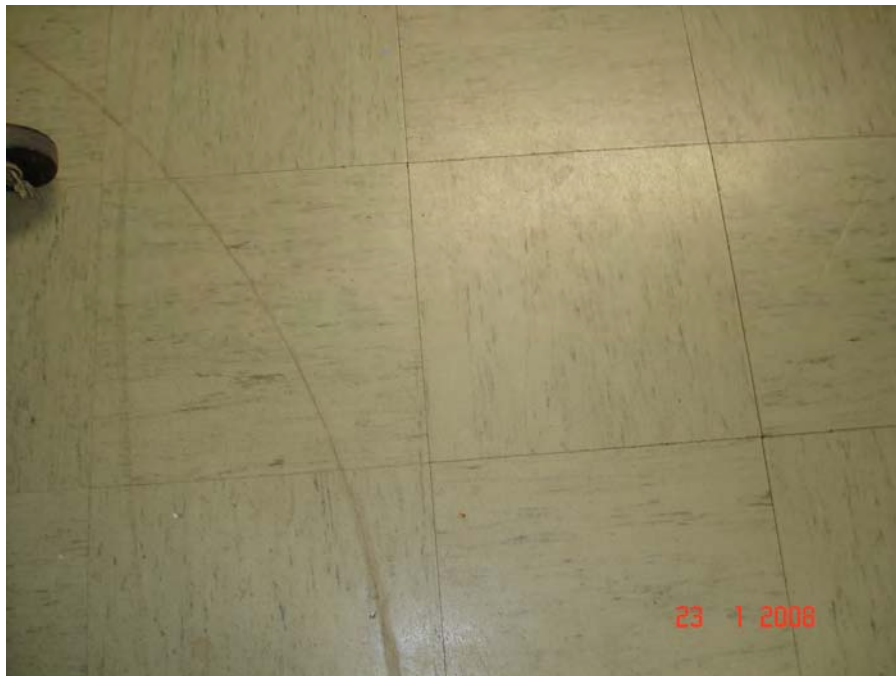
Photograph 6: View of asbestos-containing floor tile identified in the basement, room 338 (OHE Sample MA1014-30A).

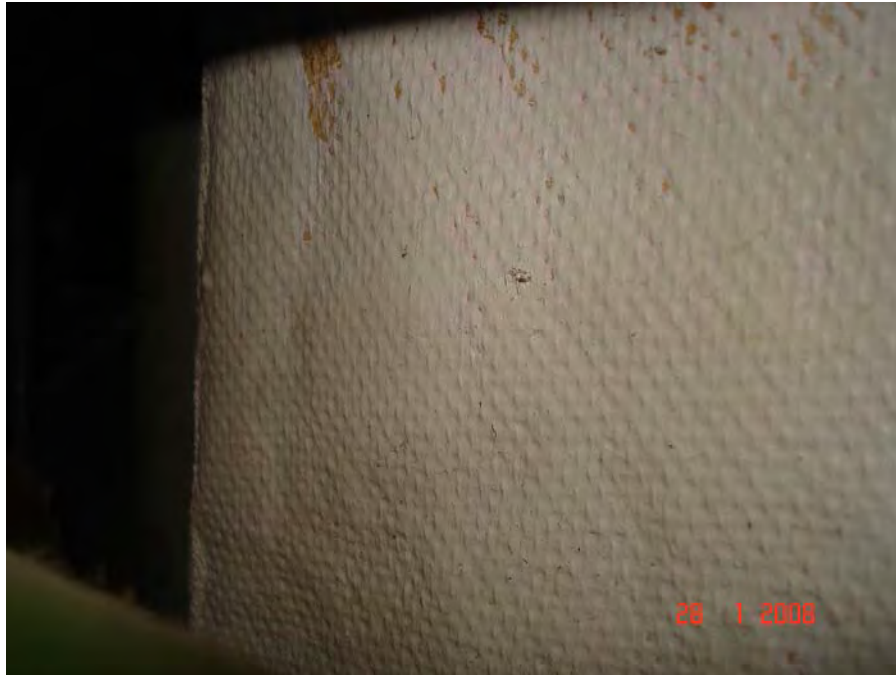
Mechanical Air Duct Insulation (MADI) (in the form of paper rap and parging cement) was observed in the basement of the subject location. One sample of MADI was collected as part of the survey. OHE Sample MA1014-38A, collected from the duct wrap in hallway 279C in the basement, was found to contain 15% Chrysotile asbestos. All other mechanical duct insulation are considered asbestos-containing as per data from past sampling and analysis by other parties. Therefore, additional MADI was not resampled to avoid duplication of efforts.

Photograph 7: View of asbestos-containing mechanical air duct insulation identified in the basement, hallway 279C (OHE Sample MA1014-37).

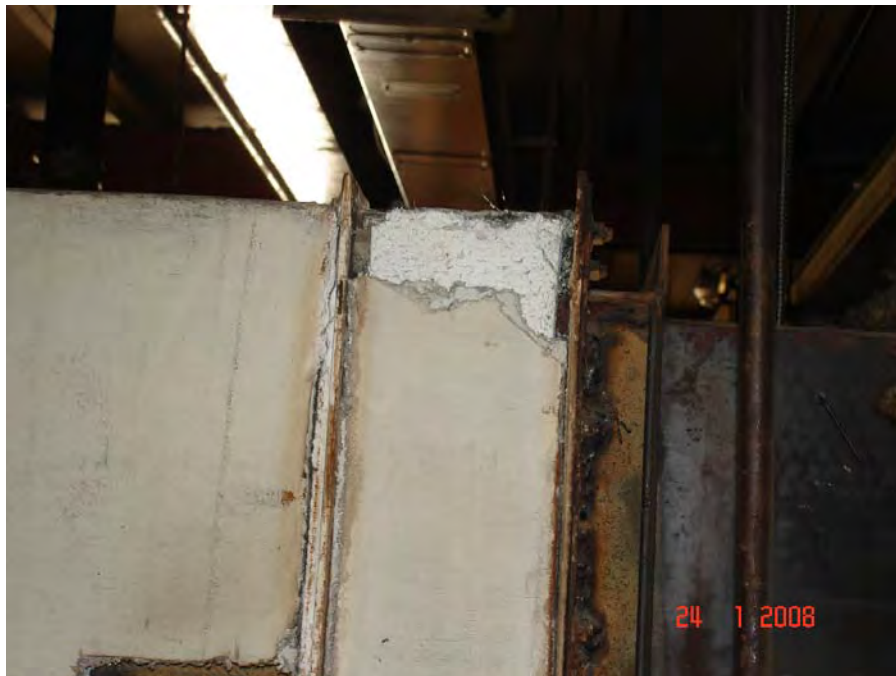
Boiler Breeching (BB) was observed in the basement of the subject location. Three (3) samples of BB were collected as part of the survey. OHE Sample MA1014-38A, collected from the boiler in BH-2 in the basement, was found to contain 30% Amosite and 10% Chrysotile asbestos. The other samples in this sample set were not analyzed as per O. Reg. 278/05.

Photograph 8: View of asbestos-containing mechanical insulation on boiler breeching identified in the basement, BH-2 (OHE Sample MA1014-38A).

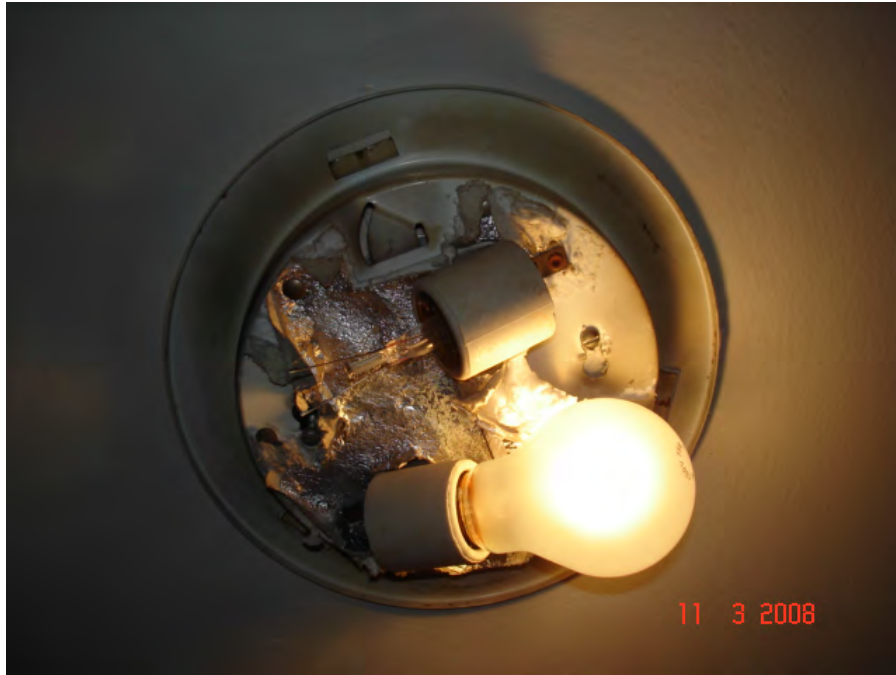
Heat Shields in incandescent light fixtures were observed in the subject location. One sample of a representative heat shield was collected during the survey. OHE Sample #MA1014-51 collected in Room 4014 on the fourth floor, was found to contain 20% Chrysotile asbestos.

Photograph 9: View of asbestos-containing heat shield on an incandescent light fixture identified on the fourth floor, room 4014 (OHE Sample MA1014-51).

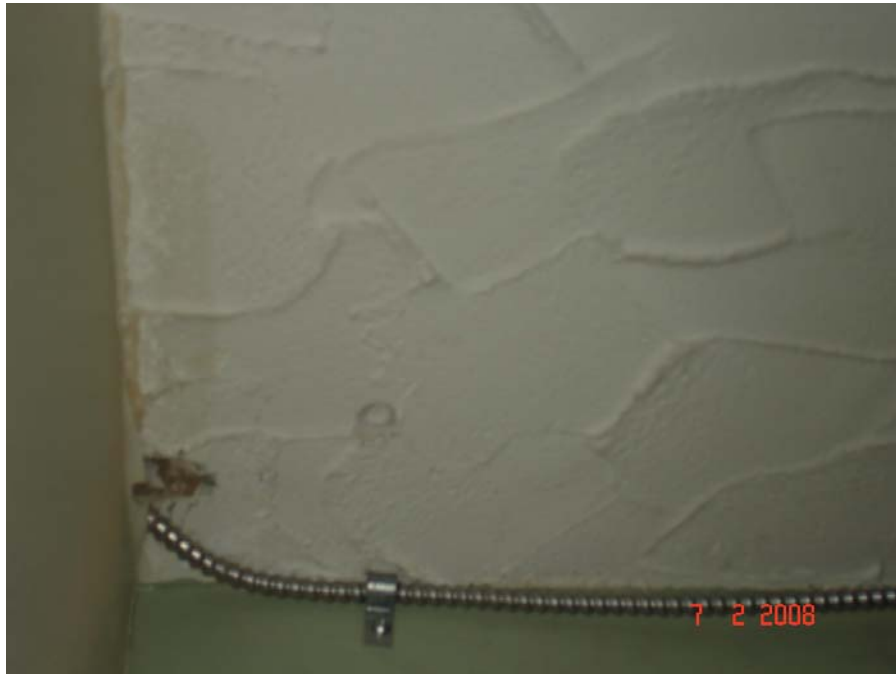
Texture coat was observed throughout the subject location. Nine (9) samples of texture coat were collected as part of the survey. OHE Sample MA1014-43A, collected in Hallway 1108 on the main floor, was found to contain 2% Chrysotile asbestos. No asbestos was detected in any of the remaining texture coat samples collected and analyzed.

Photograph 10: View of asbestos-containing texture coat on ceiling identified on the main floor, hallway 1108 (OHE Sample MA1014-43A).
