**Re: Asbestos Reassessment**

Georgian Bay General Hospital, 1112 St. Andrews Drive, Midland, Ontario  
Pinchin File: 366479.000

Georgian Bay General Hospital (Client) retained Pinchin Ltd. (Pinchin) to conduct an asbestos-containing materials (ACM) reassessment of Georgian Bay General Hospital located at 1112 St. Andrews Drive, Midland, Ontario.

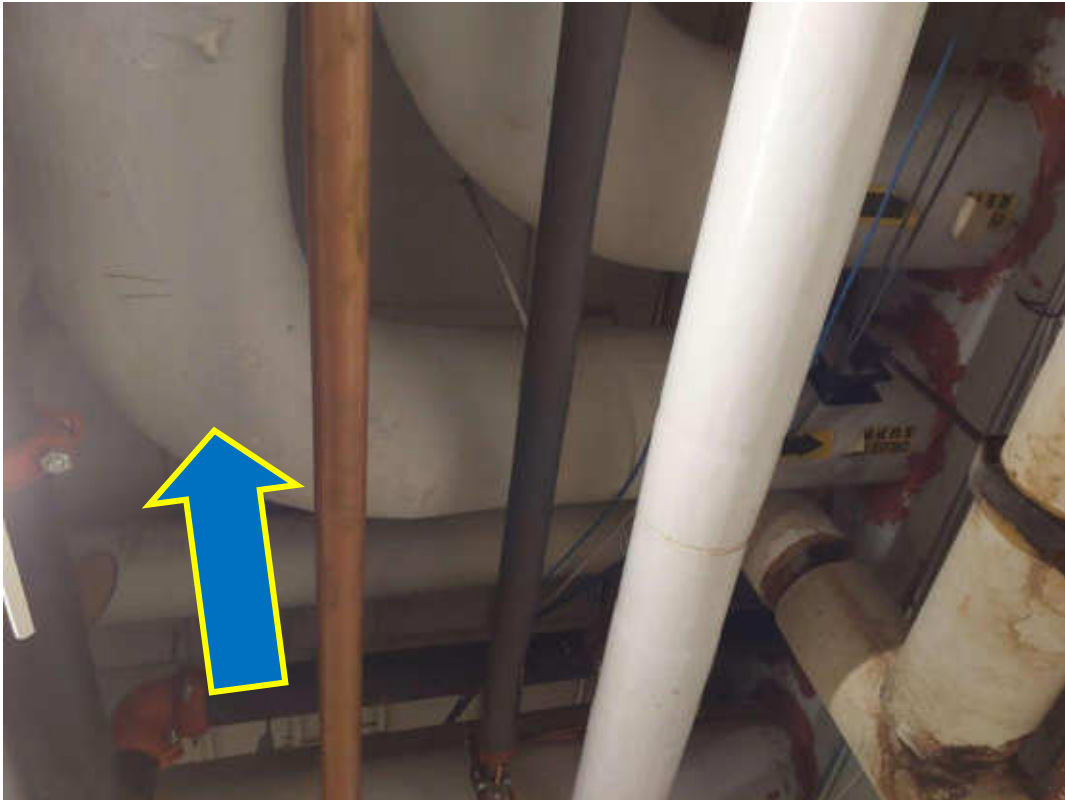
V0001 (Confirmed Asbestos), Piping, Domestic Cold Water, Parging Cement, Corridor (Location #: 10)

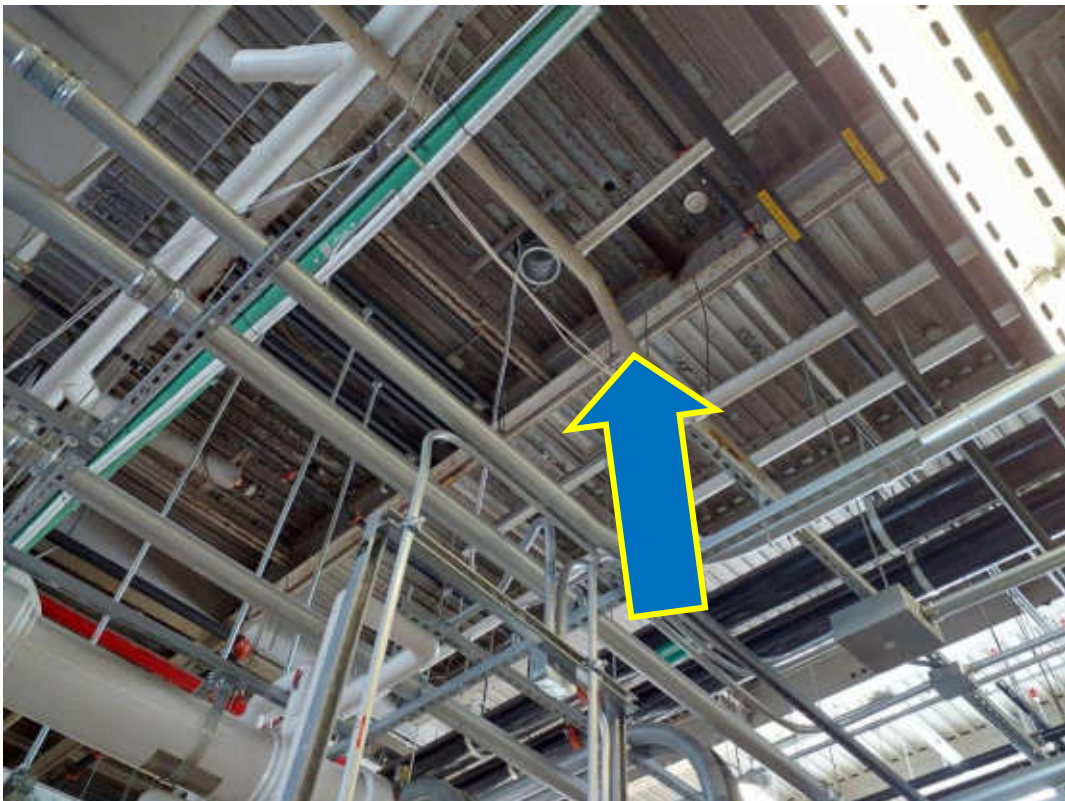
S0002 (Confirmed Asbestos), Piping, Parging Cement, Boiler Room (Location #: 1)

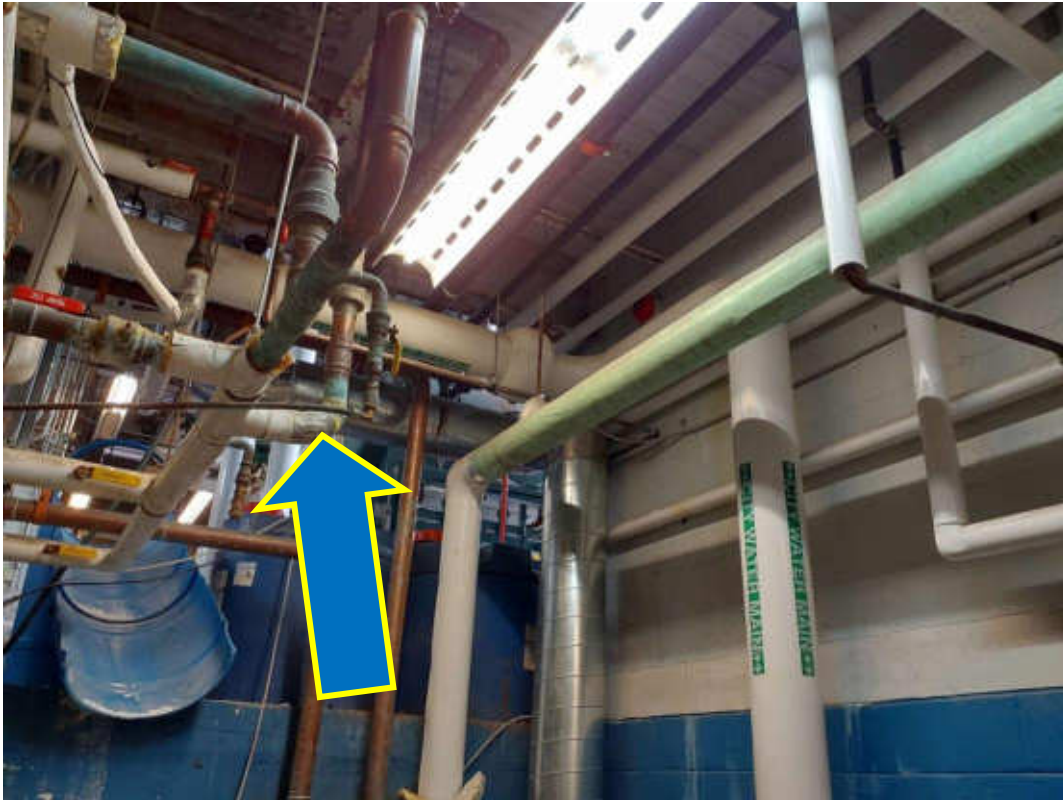
V0002 (Confirmed Asbestos), Piping, Parging Cement, Lower Boiler Pits (Location #: 8)

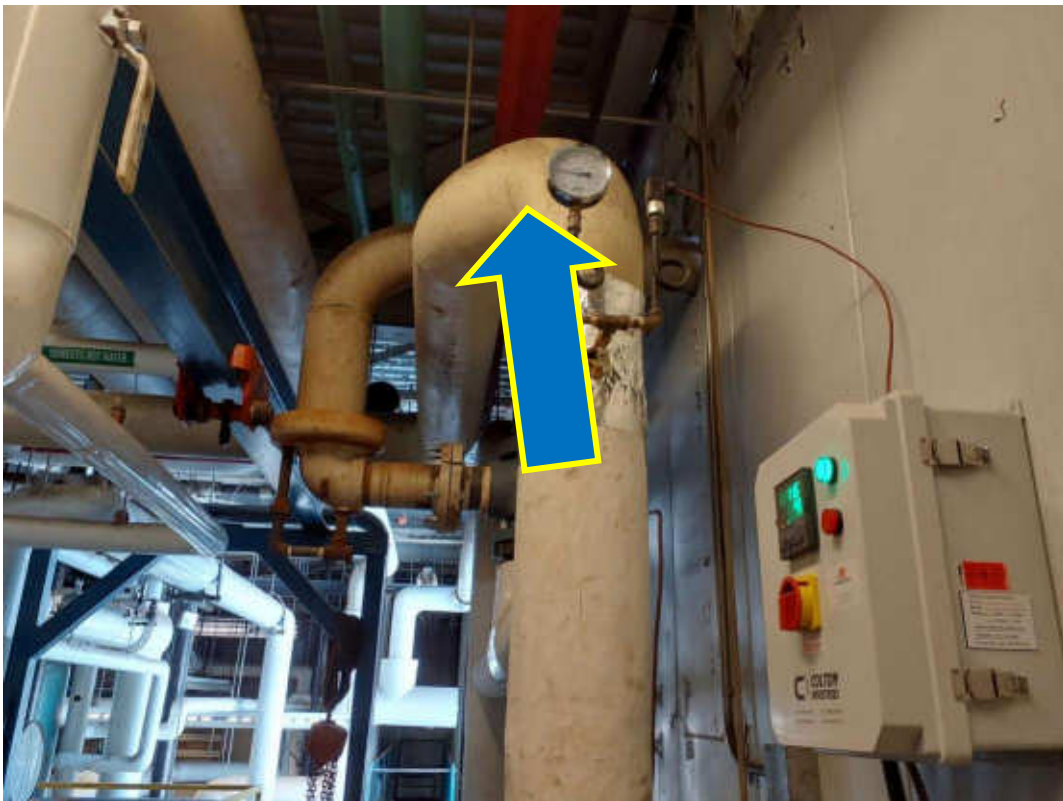
V0006 (Confirmed Asbestos), Piping, Parging Cement, Upper Boiler Room (Location #: 6)

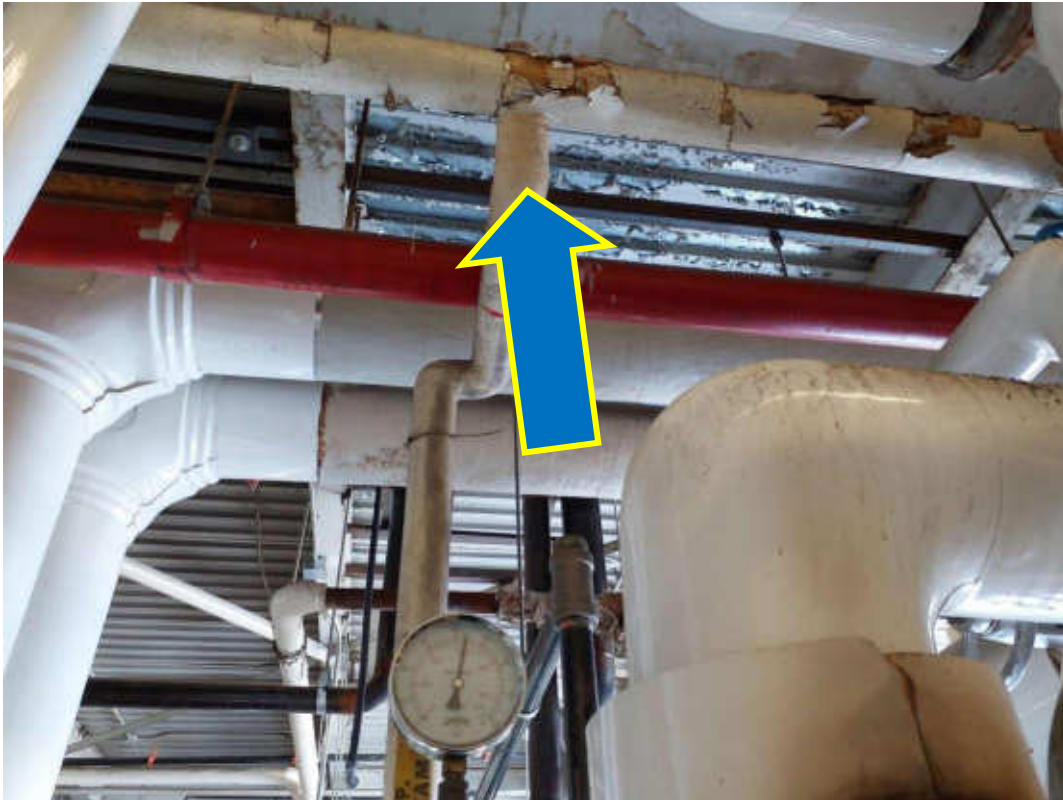
V0006 (Confirmed Asbestos), Piping, Parging Cement, Upper Boiler Room (Location #: 6)

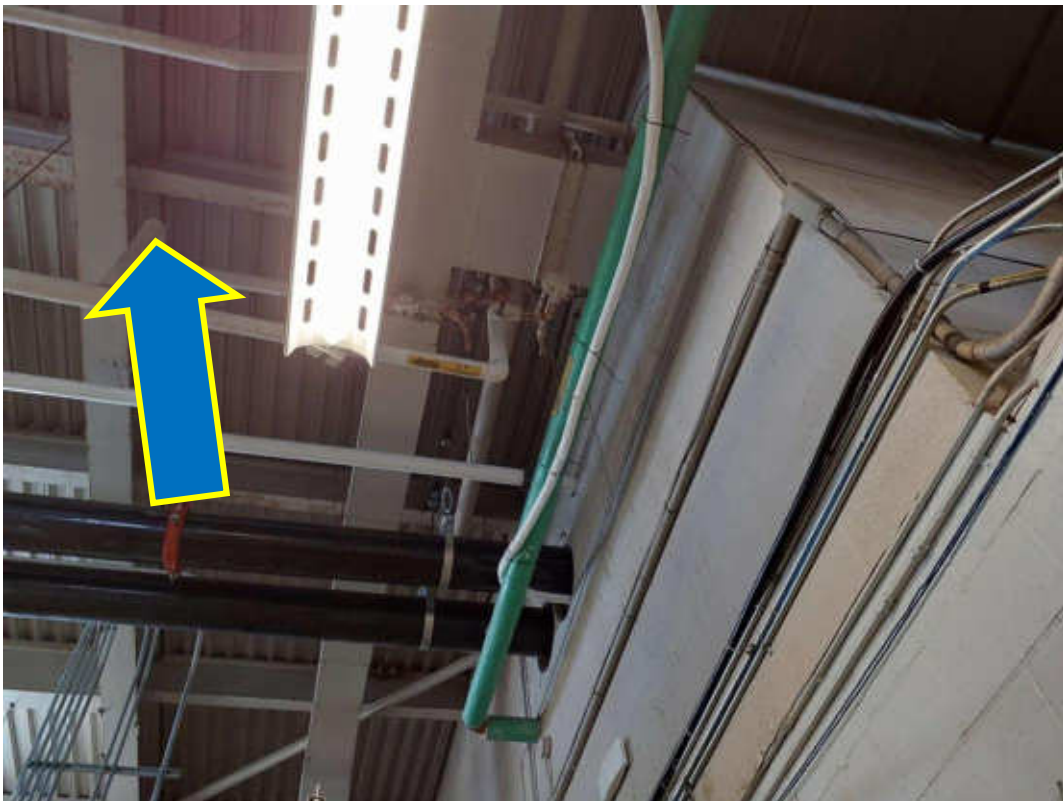
S0007 (Confirmed Asbestos), Piping, Parging Cement, Boiler Room (Location #: 1)

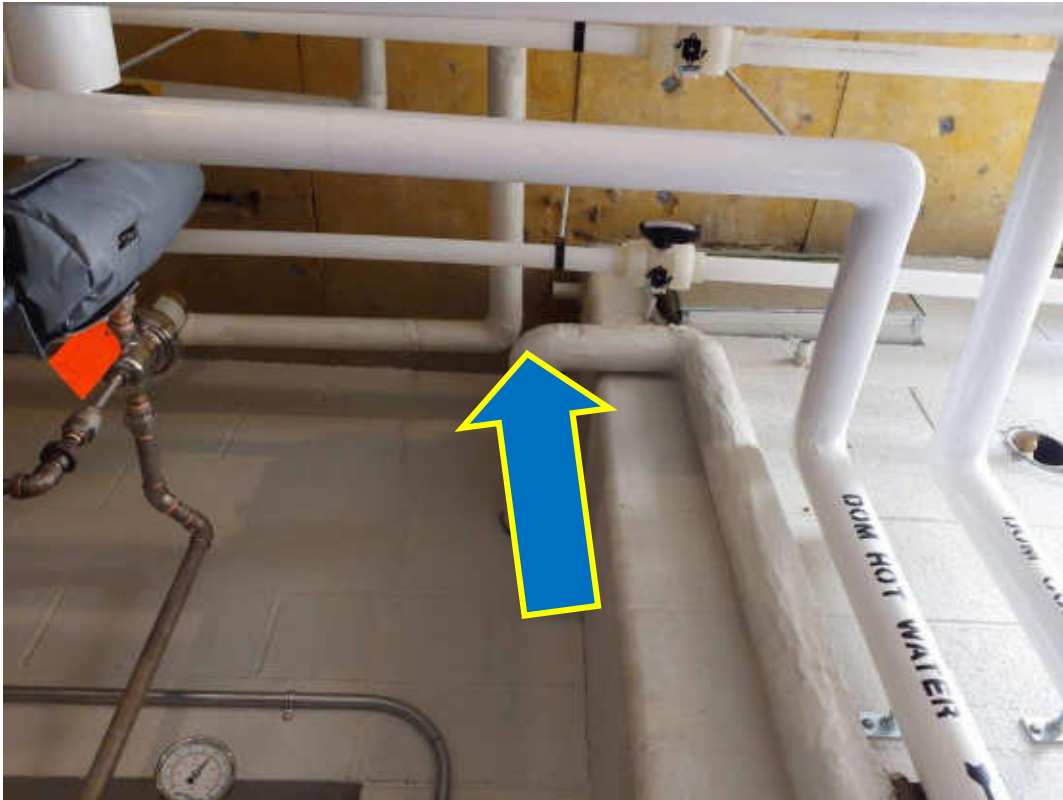
V0007 (Confirmed Asbestos), Piping, Parging Cement, Auto Clave Service Area (Location #: 47)

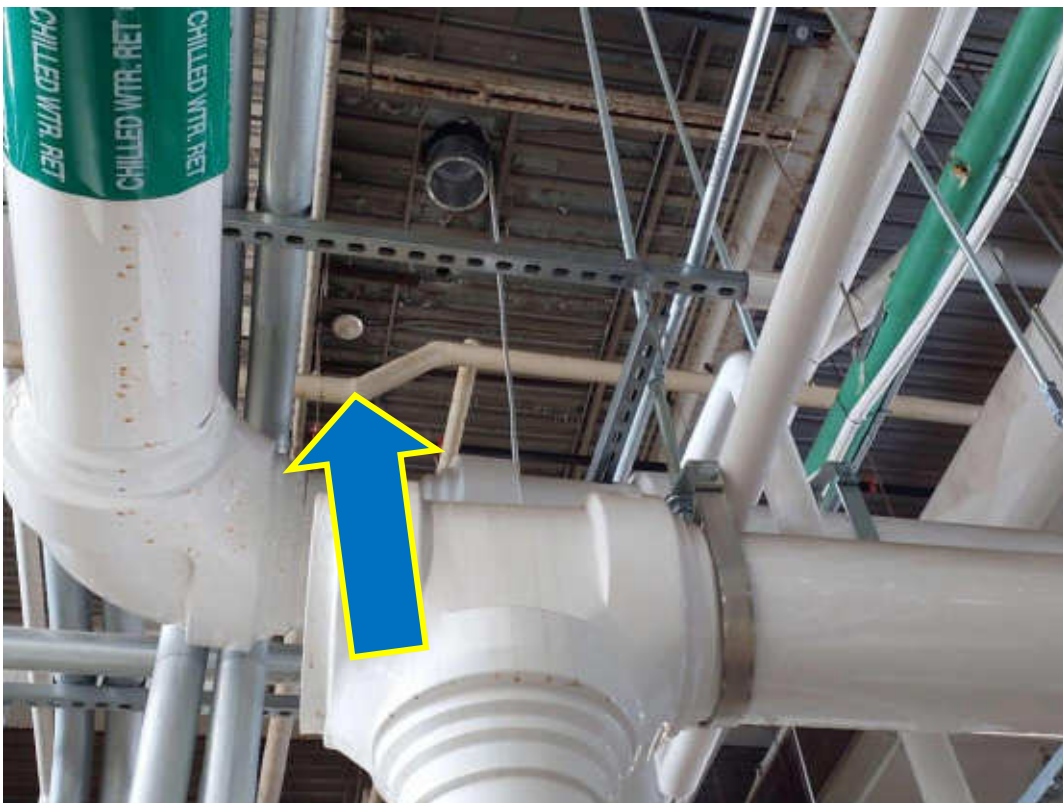
S0008 (Confirmed Asbestos), Piping, Parging Cement, Boiler Room (Location #: 1)

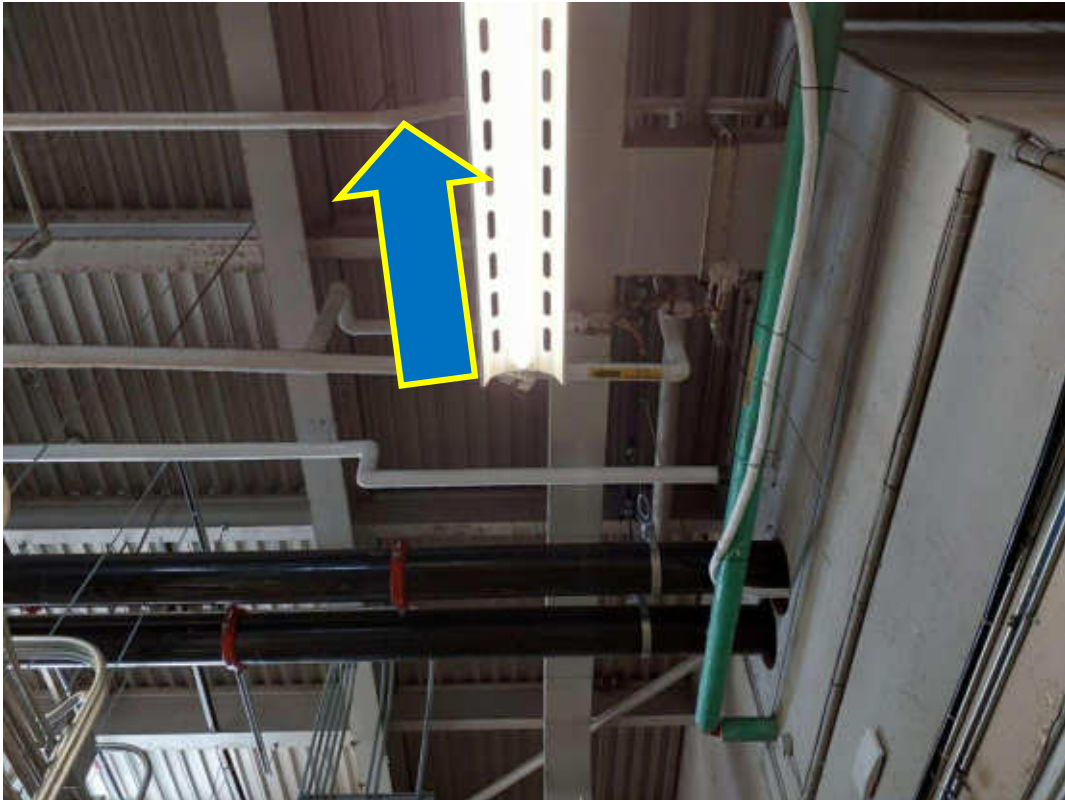
S0009 (Confirmed Asbestos), Piping, Parging Cement, Boiler Room (Location #: 1)

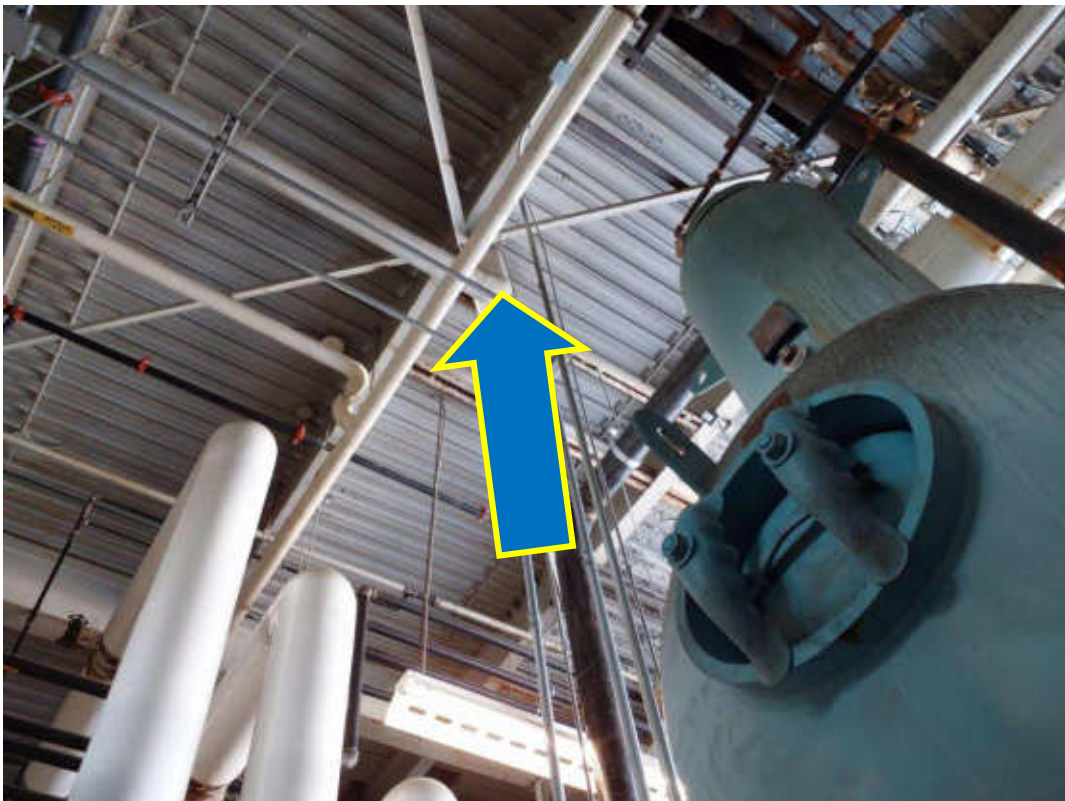
S0010 (Confirmed Asbestos), Piping, Parging Cement, Boiler Room (Location #: 1)

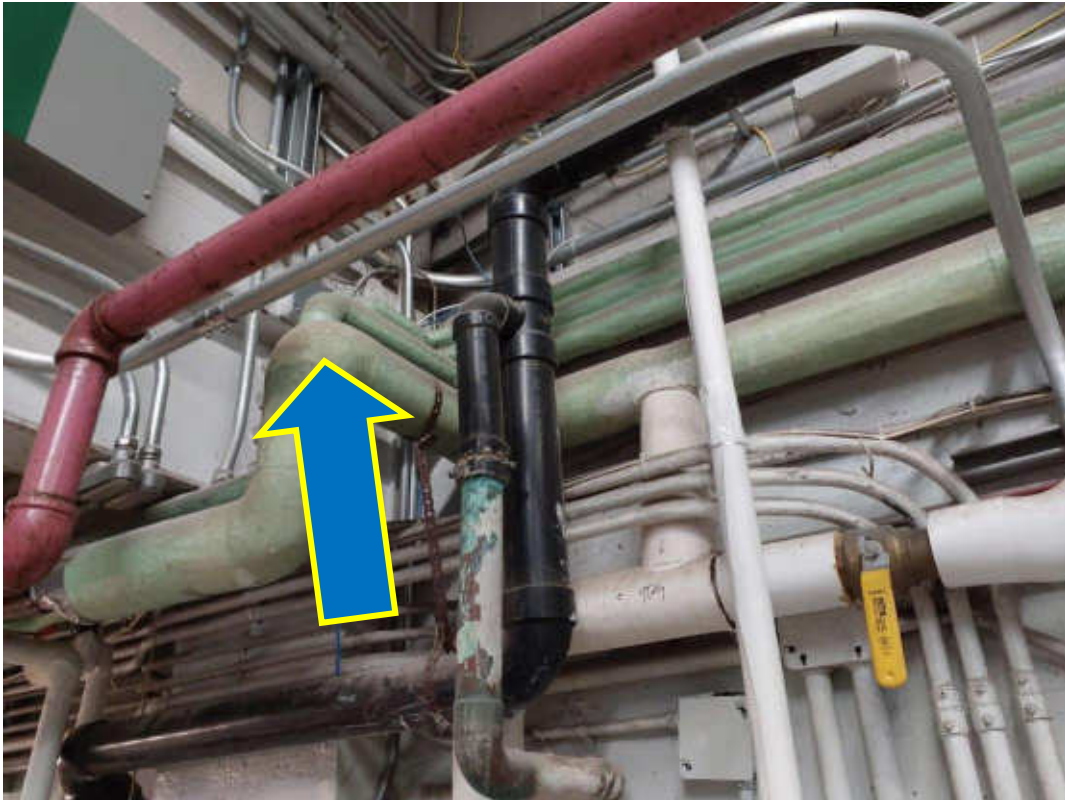
S0014 (Confirmed Asbestos), Piping, Parging Cement, Lower Boiler Pits (Location #: 8)

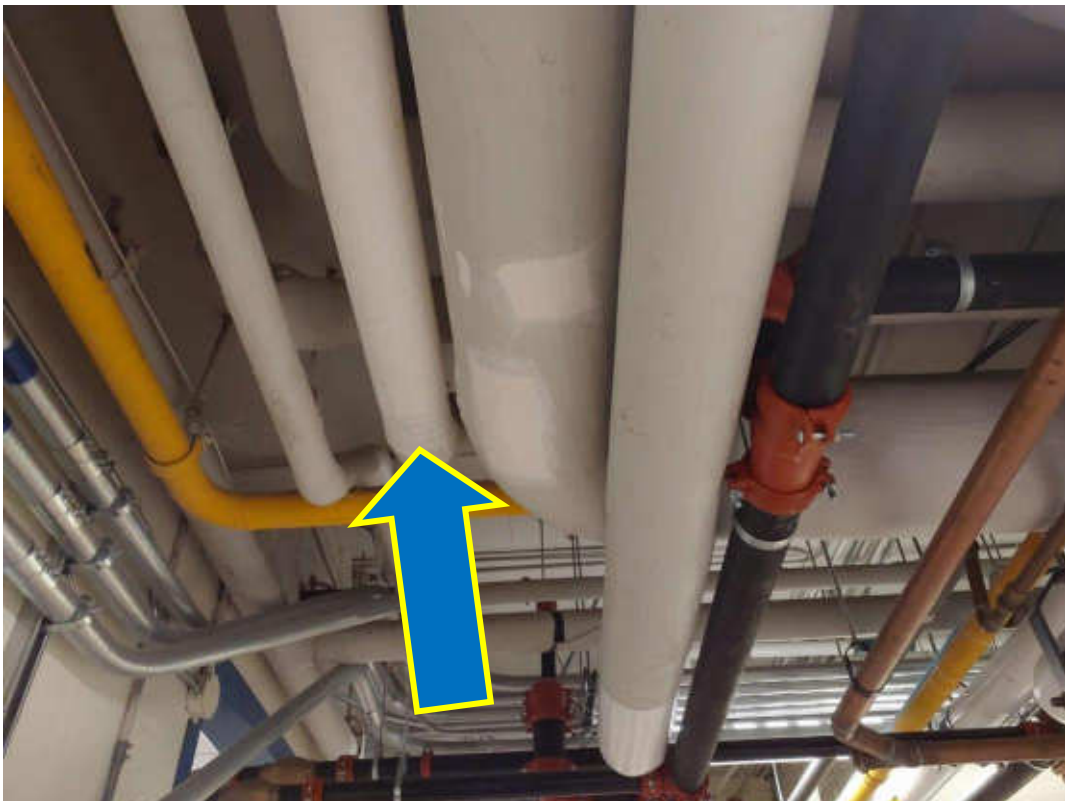
V0015 (Confirmed Asbestos), 12", Piping, High Pressure Steam, Parging Cement, Corridor (Location #: 10)

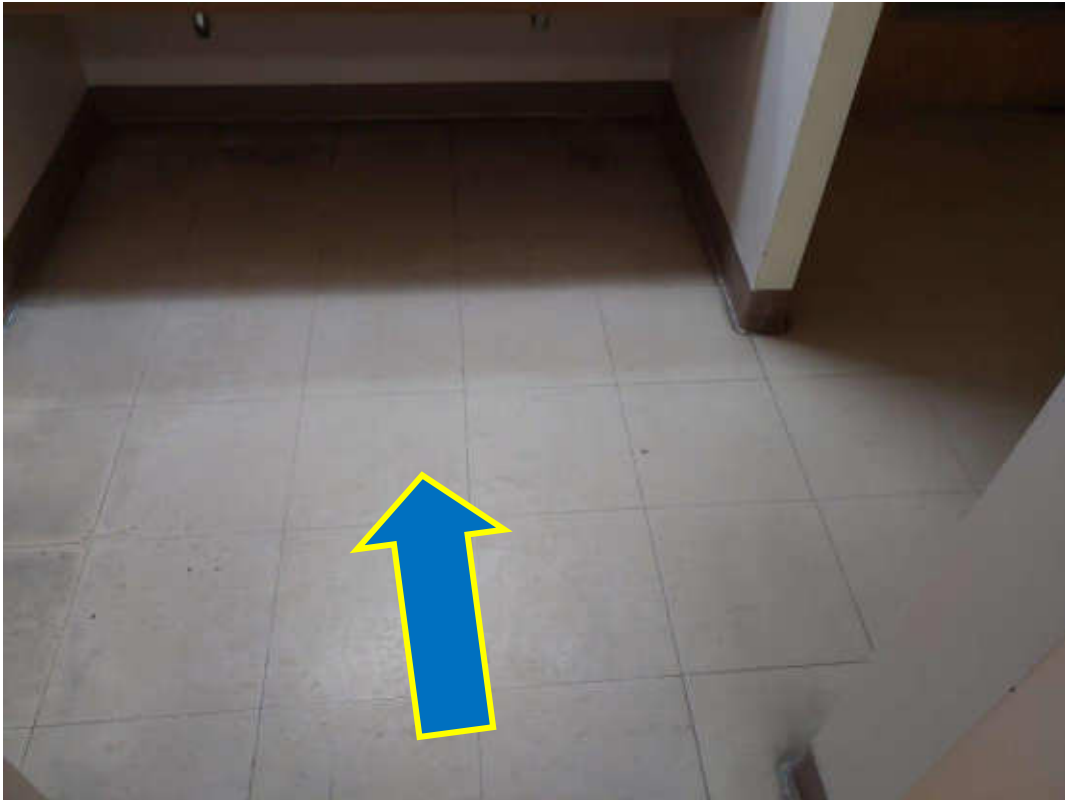
V0023 (Confirmed Asbestos), Floor, Vinyl Floor Tile and Mastic, Women's Washroom (Location #: 194)

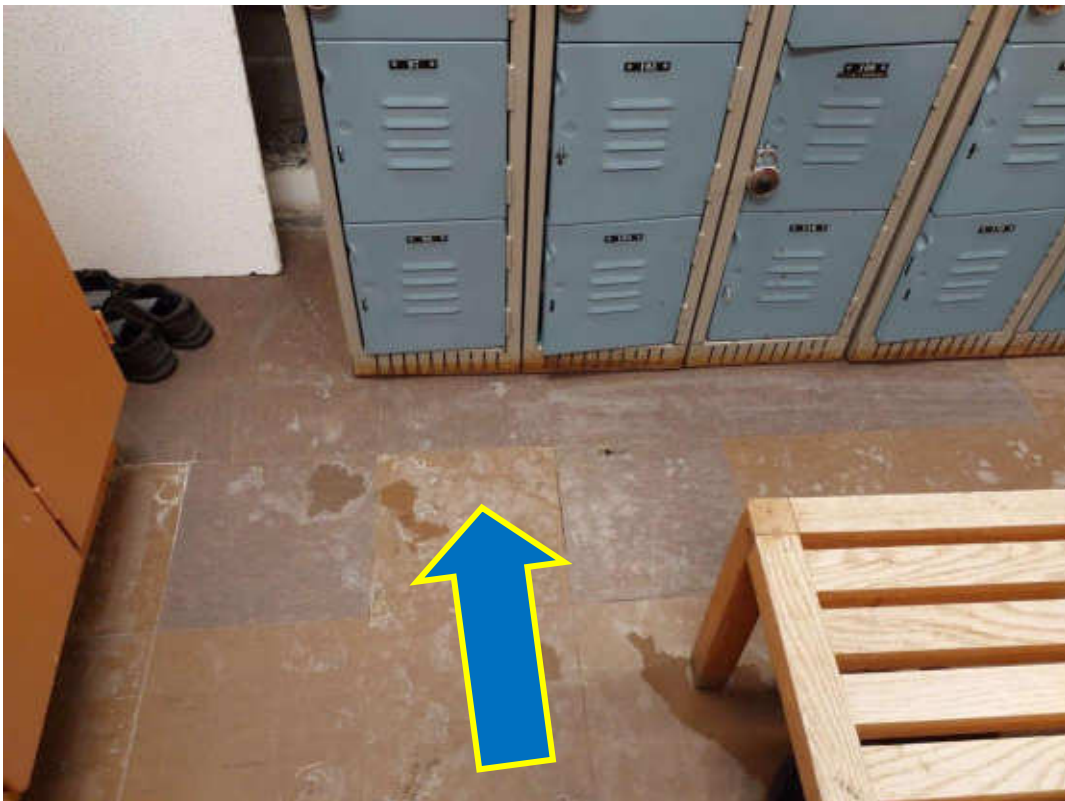
S0027 (Confirmed Asbestos), Floor, Vinyl Floor Tile and Mastic, Woman's Locker Room (Location #: 58)  
10 sf abated as of 2025

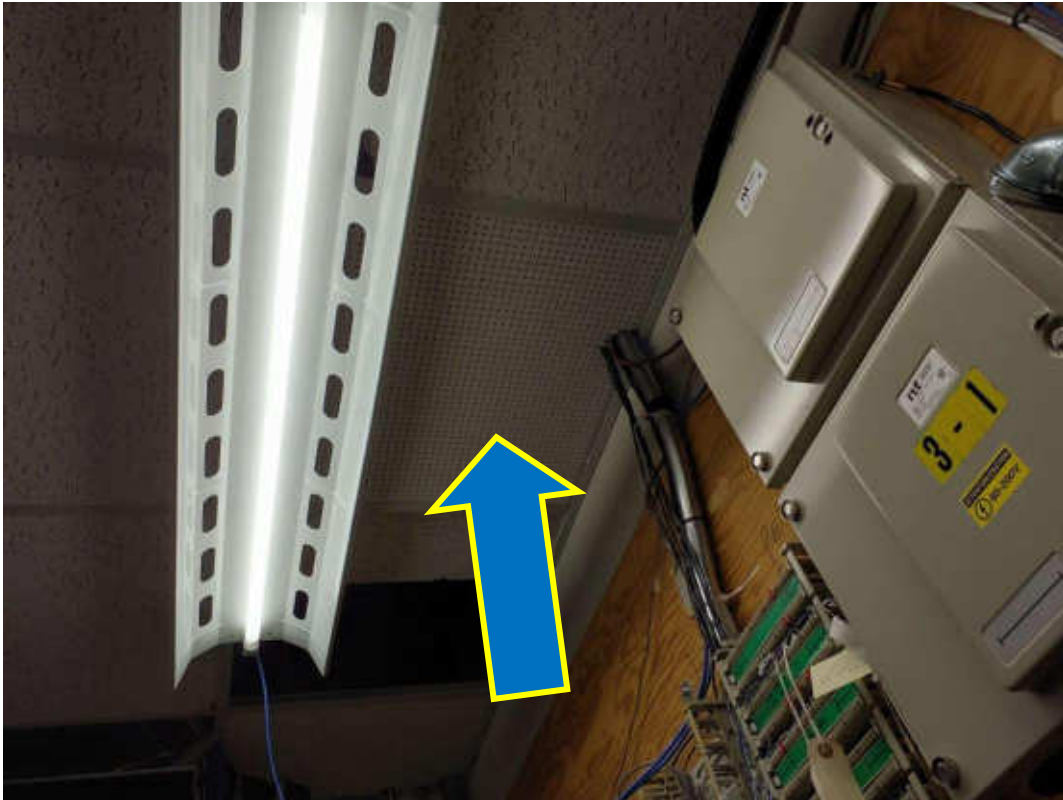
V0029 (Confirmed Asbestos), Transite, Ceiling, Ceiling Tiles (lay-in), Mechanical P/House (Location #: 295)

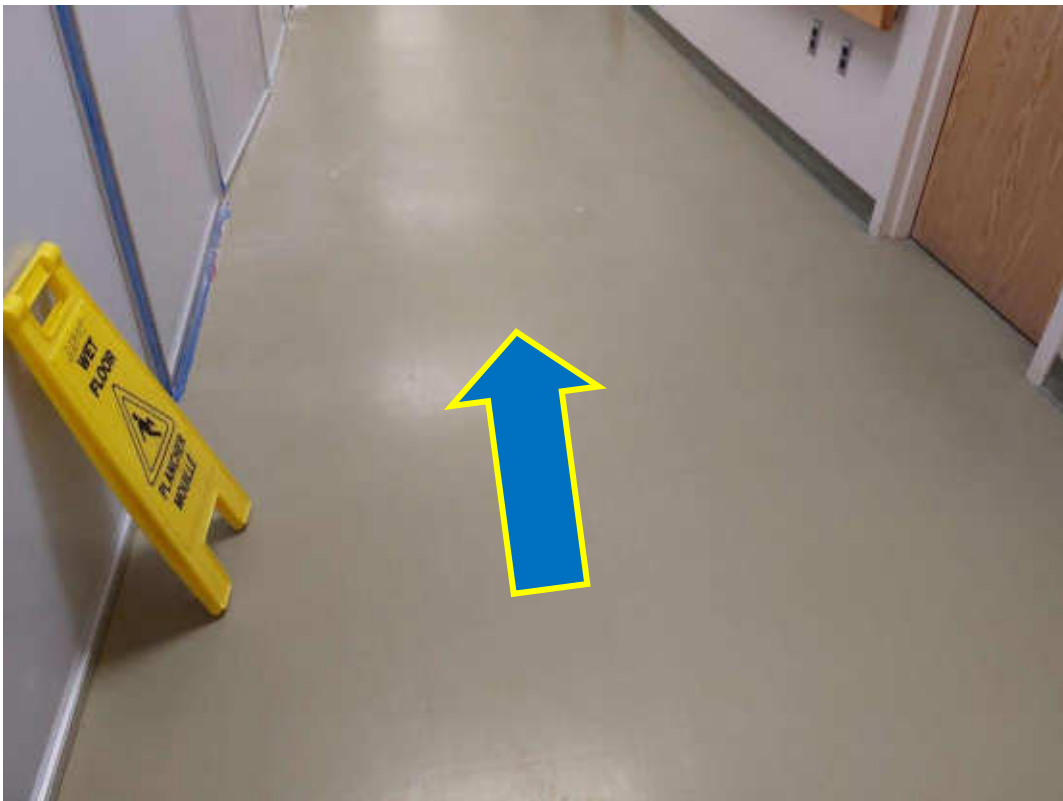
S0055 (Confirmed Asbestos), Floor, Vinyl Floor Tile and Mastic, Corridor (Location #: 184)

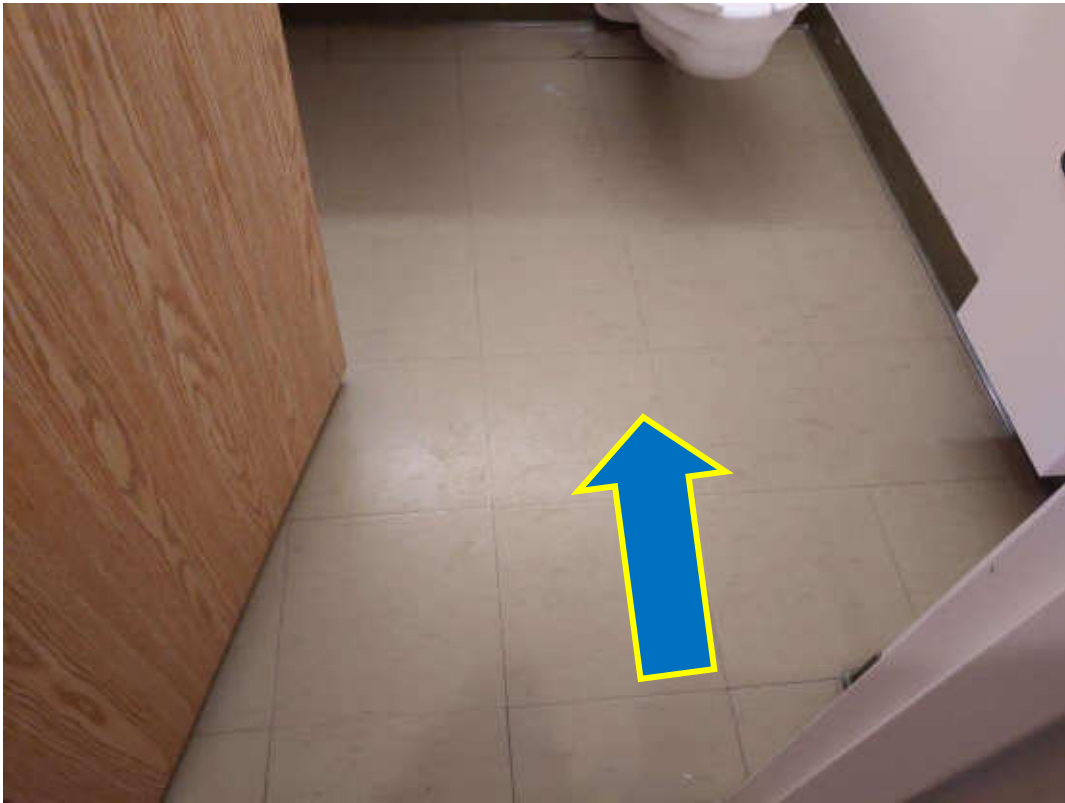
V0071 (Confirmed Asbestos), Green with black striations, Floor, Vinyl Floor Tile, Office (Location #: 292)

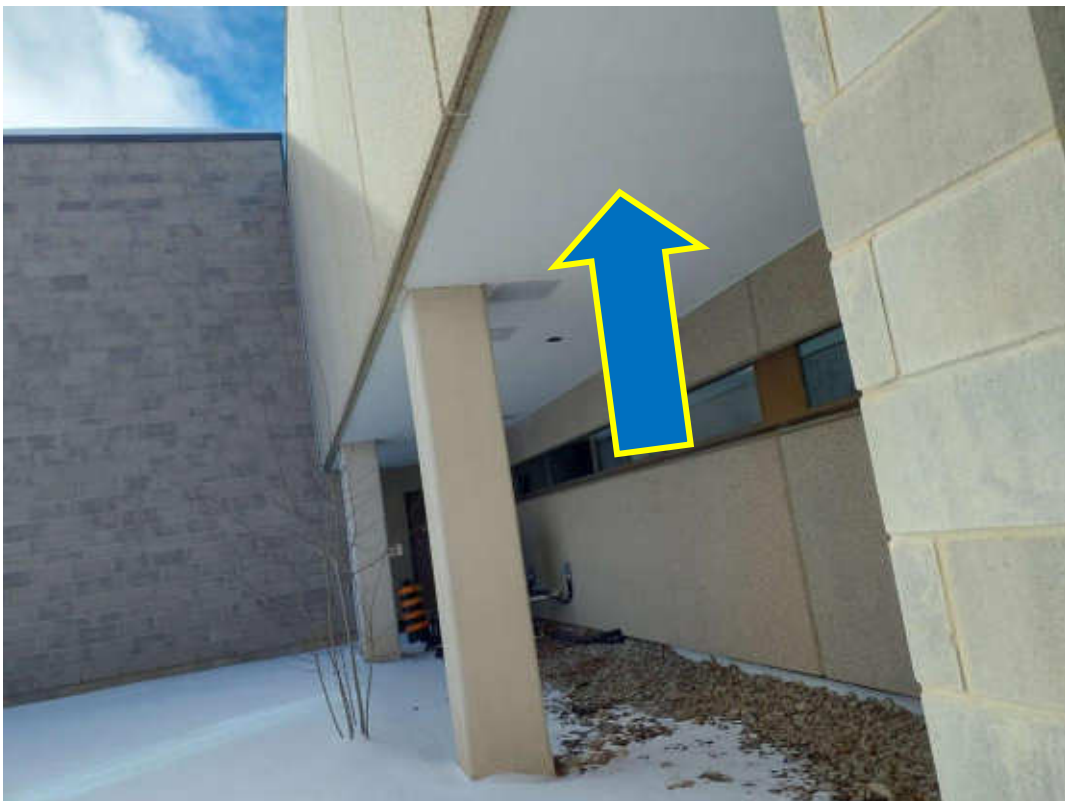
S0073 (Confirmed Asbestos), Ceiling, Texture Coat, Exterior Soffit (Location #: 296)

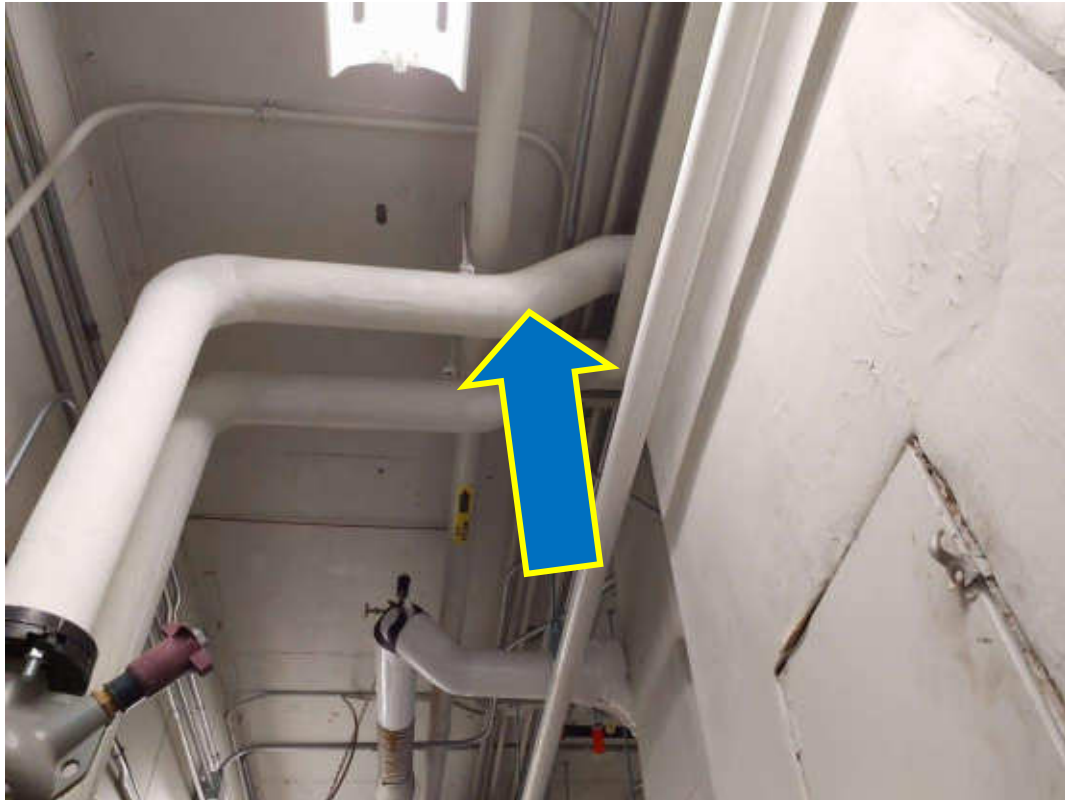
S0075 (Confirmed Asbestos), Piping, Parging Cement, Mechanical P/House (Location #: 295)

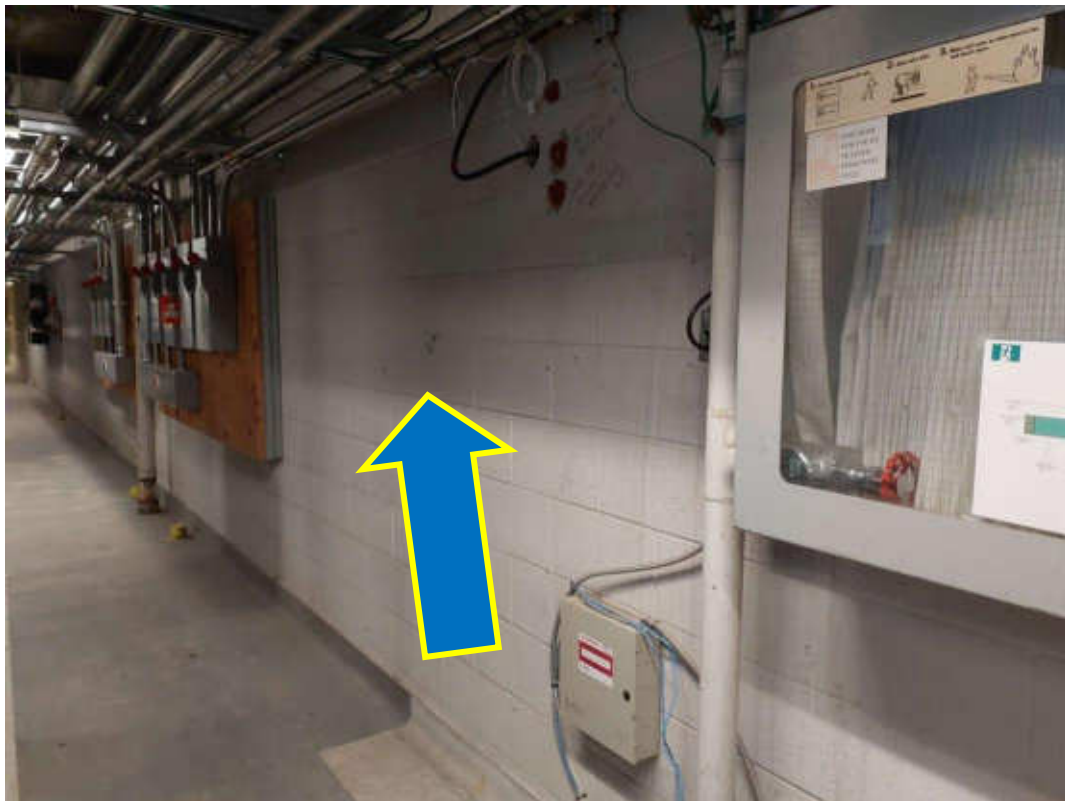
S0107G (Confirmed Asbestos), Paint on block walls, Wall, Paint, Mechanical P/House (Location #: 295)  
West Penthouse

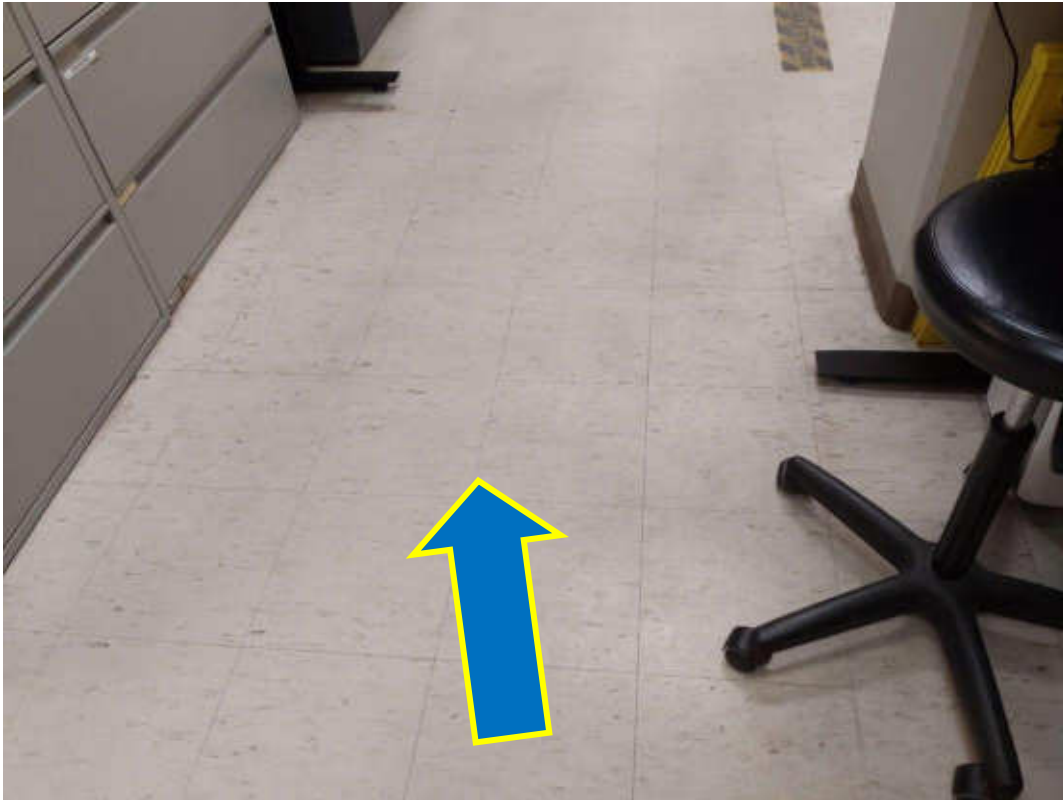
S1101A (Confirmed Asbestos), 12"x12" grey with grey streaks, Floor, Vinyl Floor Tile and Mastic, Pharmacy (Location #: 38)

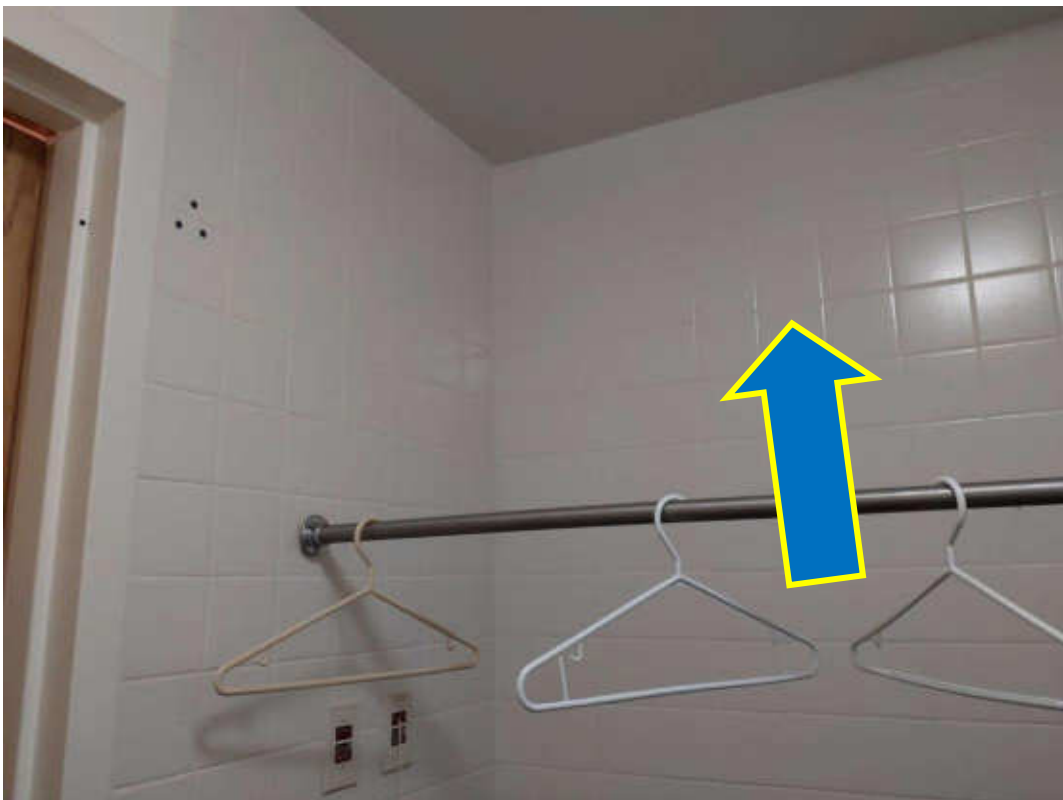
V9500 (Presumed Asbestos), Wall, Mortar, Storage (Location #: 125)

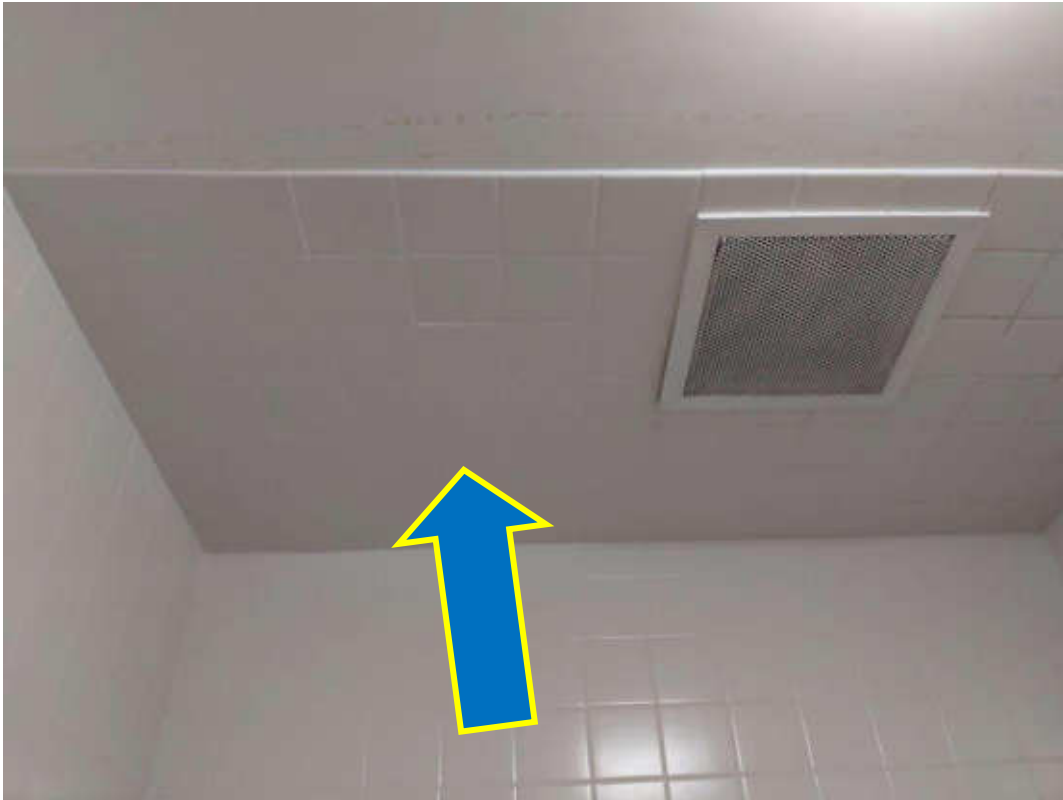
V9500 (Presumed Asbestos), Ceiling, Mortar, Storage (Location #: 125)

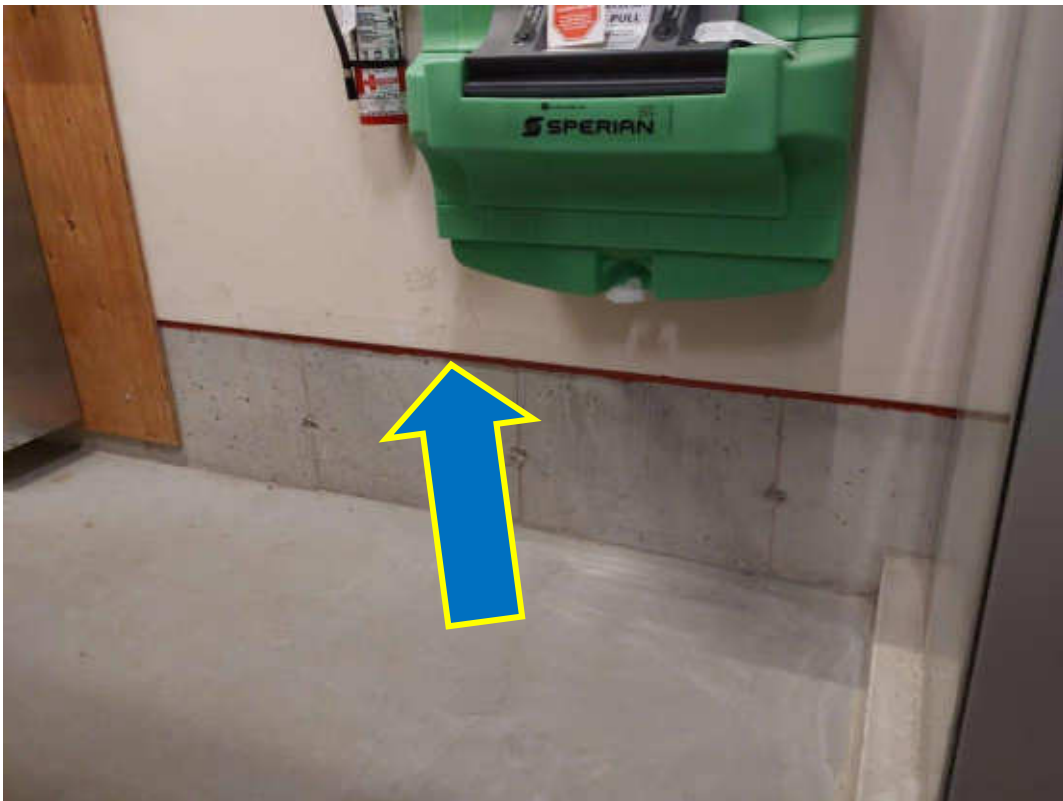
V9500 (Presumed Asbestos), Red at drywall wall edges and pipe penetrations, Other, Firestopping (mastic), Mechanical P/House (Location #: 295)

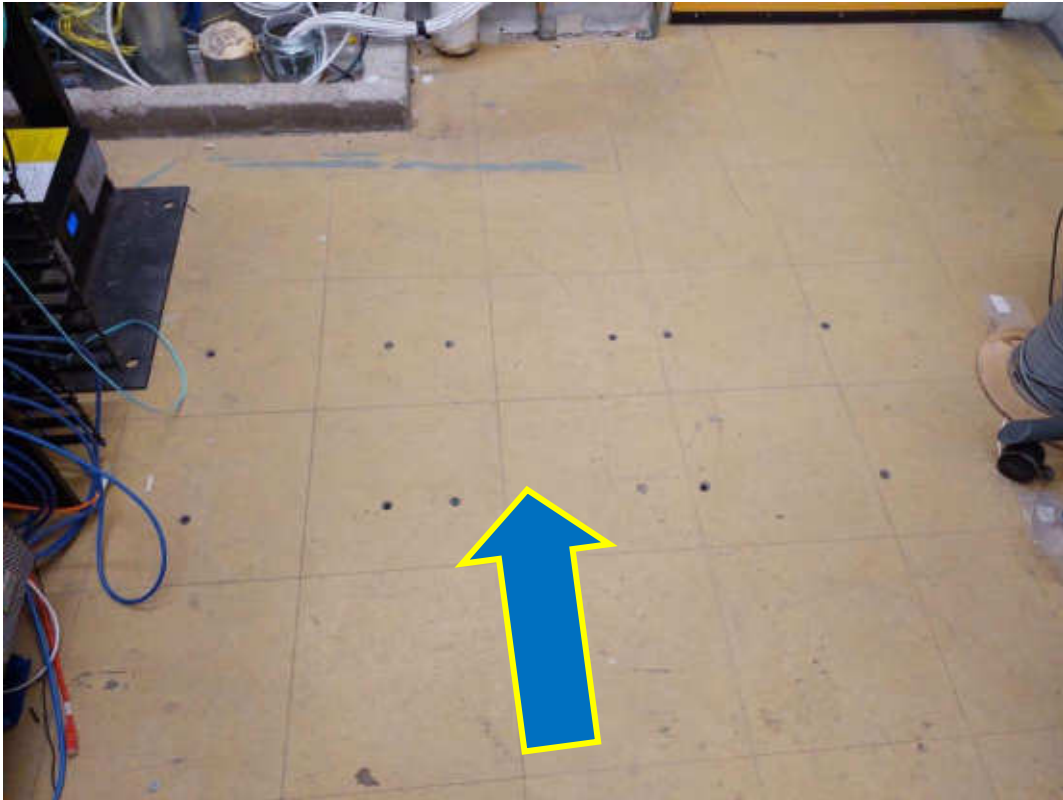
V9500 (Presumed Asbestos), 12x12 yellow, Floor, Vinyl Floor Tile, Mechanical P/House (Location #: 295)  
Server room

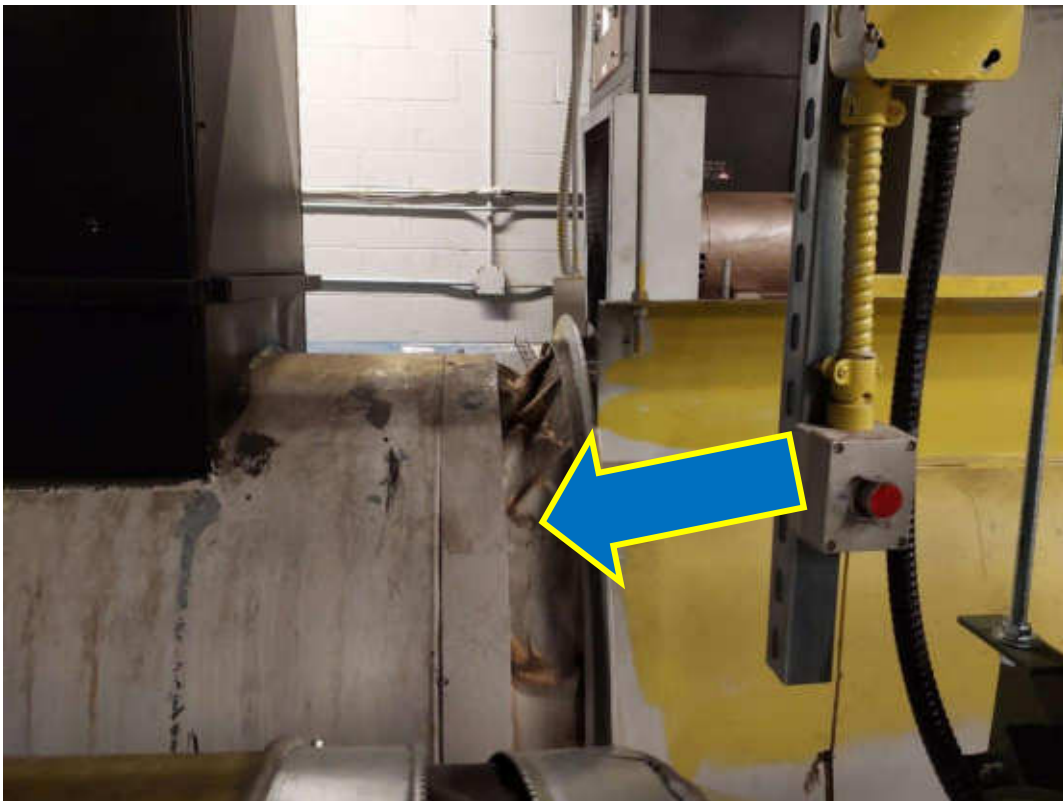
V9500 (Presumed Asbestos), Duct, Textile, Mechanical P/House (Location #: 295)
