**Re: Asbestos Reassessment**

Georgian Bay General Hospital, 1112 St. Andrews Drive, Midland, Ontario  
Pinchin File: 366479.000

Georgian Bay General Hospital (Client) retained Pinchin Ltd. (Pinchin) to conduct an asbestos-containing materials (ACM) reassessment of Georgian Bay General Hospital located at 1112 St. Andrews Drive, Midland, Ontario.

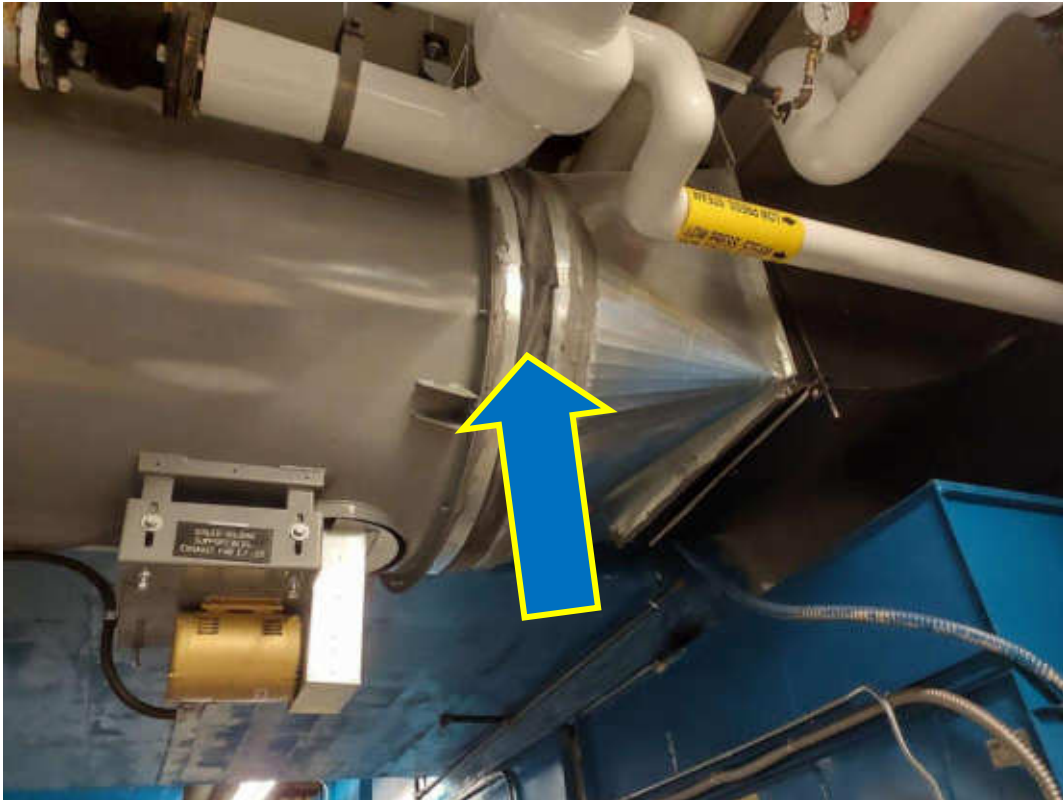
V9500 (Presumed Asbestos), Black, Duct, Textile, Mechanical P/House (Location #: 295)

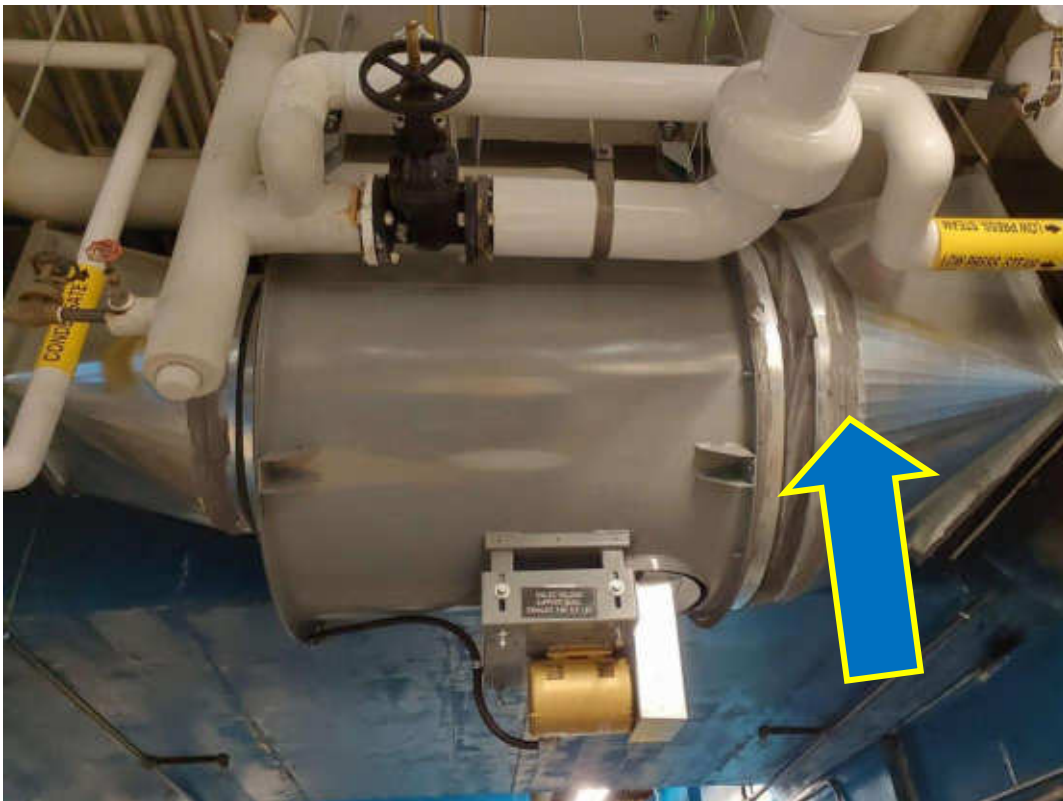
V9500 (Presumed Asbestos), Dark Grey, Duct, Mastic, Mechanical P/House (Location #: 295)

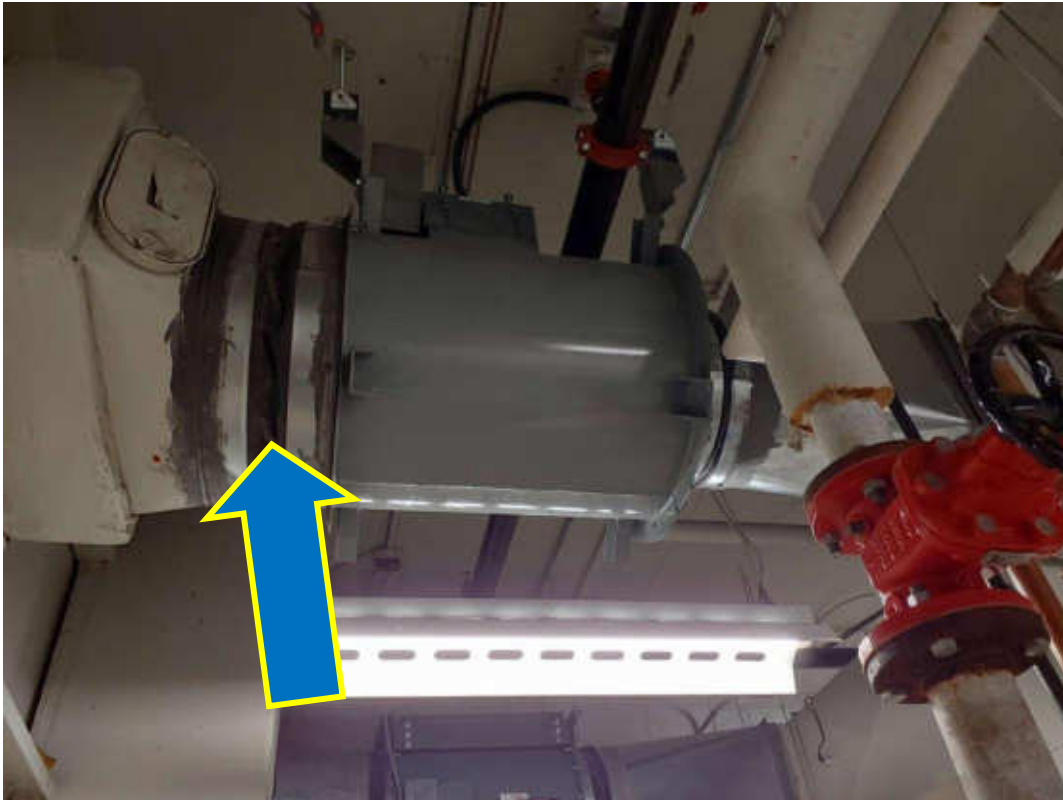
V9500 (Presumed Asbestos), Grey, Duct, Mastic, Mechanical P/House (Location #: 295)  
Penthouse north

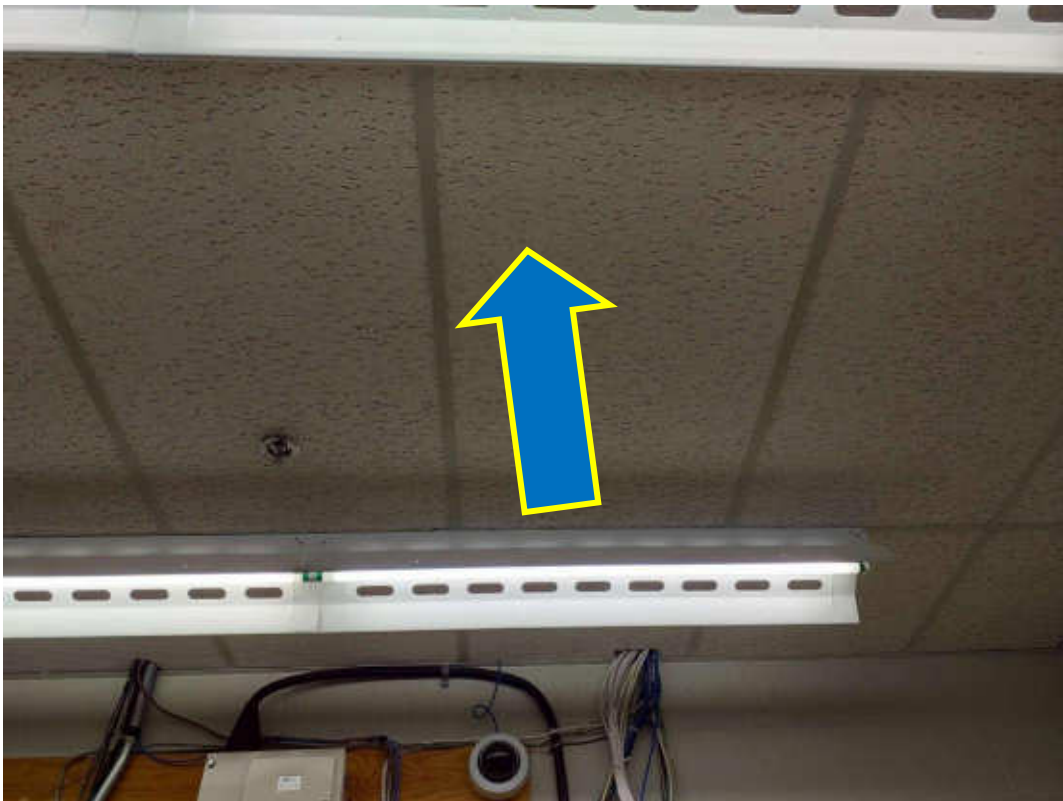
V9500 (Presumed Asbestos), 24x48 long widthwise fissure, Ceiling, Ceiling Tiles (lay-in), Mechanical P/House (Location #: 295)  
Server room

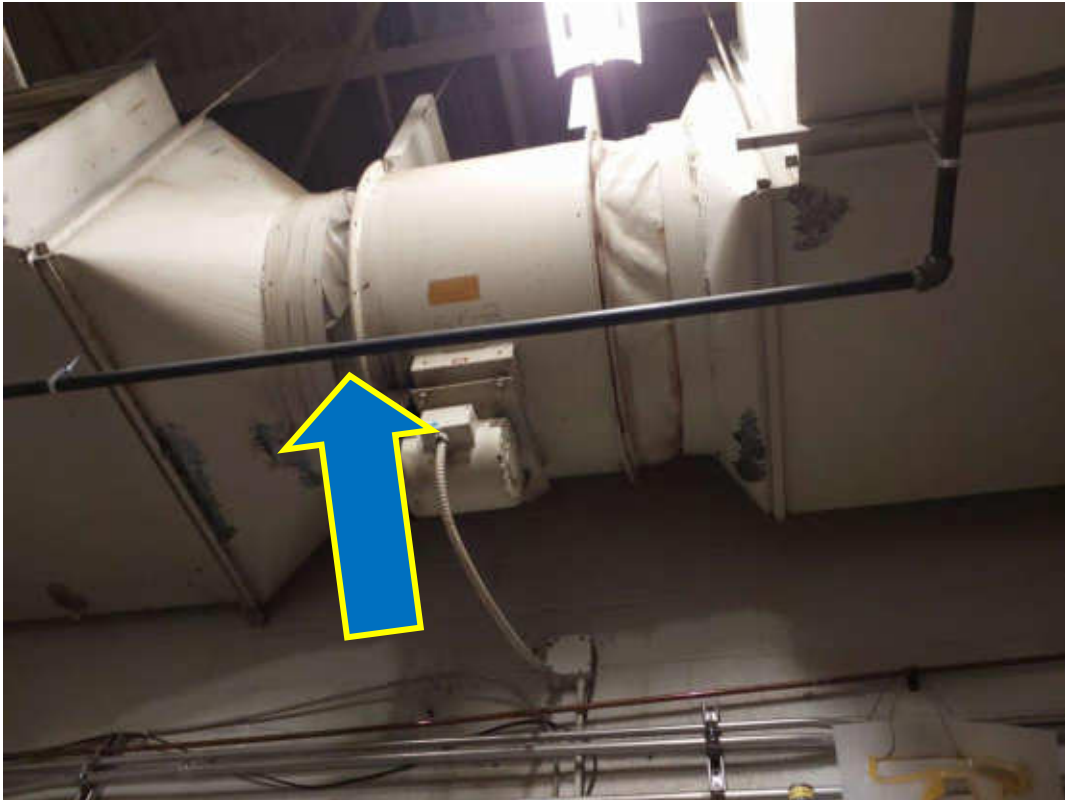
V9500 (Presumed Asbestos), Duct, Textile, Garage (Location #: 3)

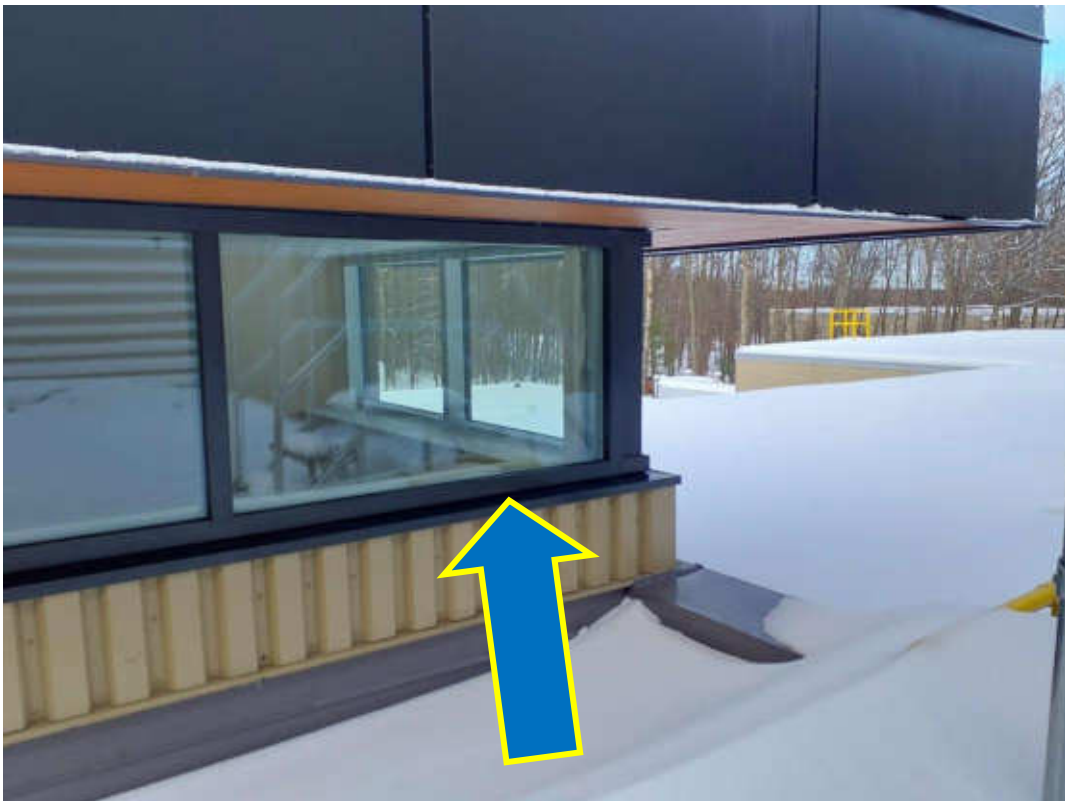
V9500 (Presumed Asbestos), Black on window base plate, Wall, Caulking, Roof Section D2 (Location #: 315)

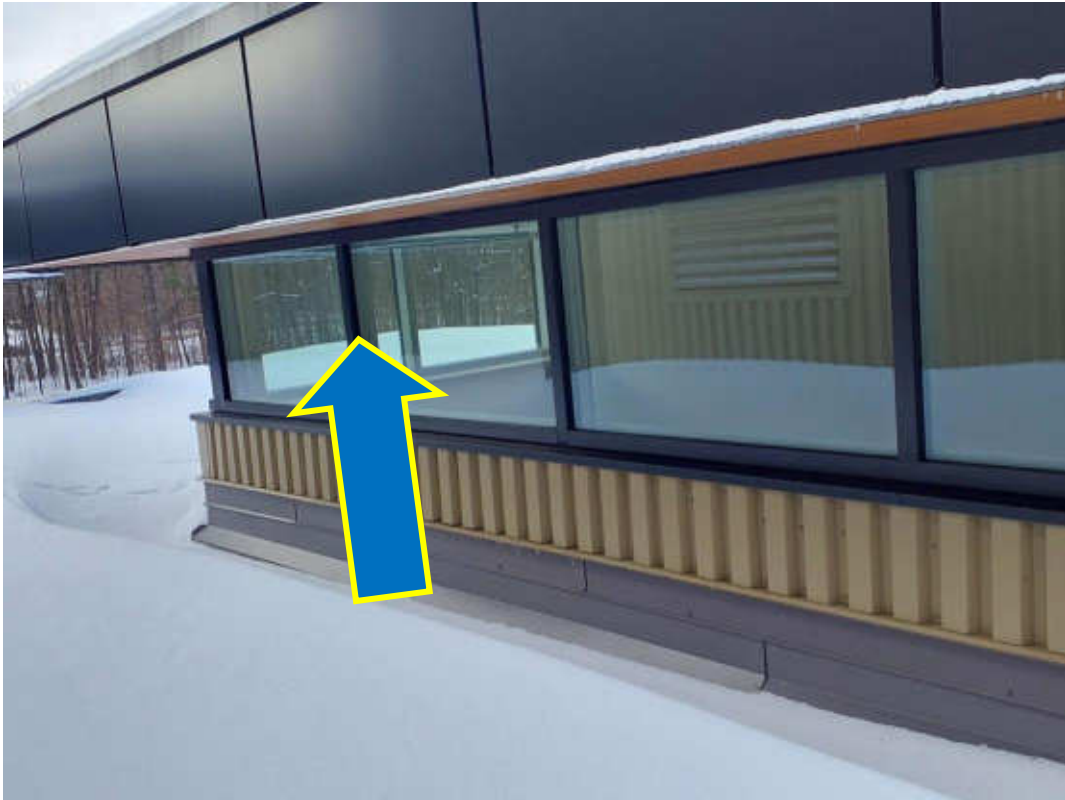
V9500 (Presumed Asbestos), Black butyl sealant, Other, Window Liner, Caulking, Roof Section D2 (Location #: 315)
