December 4, 2025

Re: Hazardous Building Materials Assessment (Pre-construction)
Kitchen and Office Renovations
Georgian Bay General Hospital, 1112 St. Andrews Drive, Midland, ON
Pinchin File: 367199.000

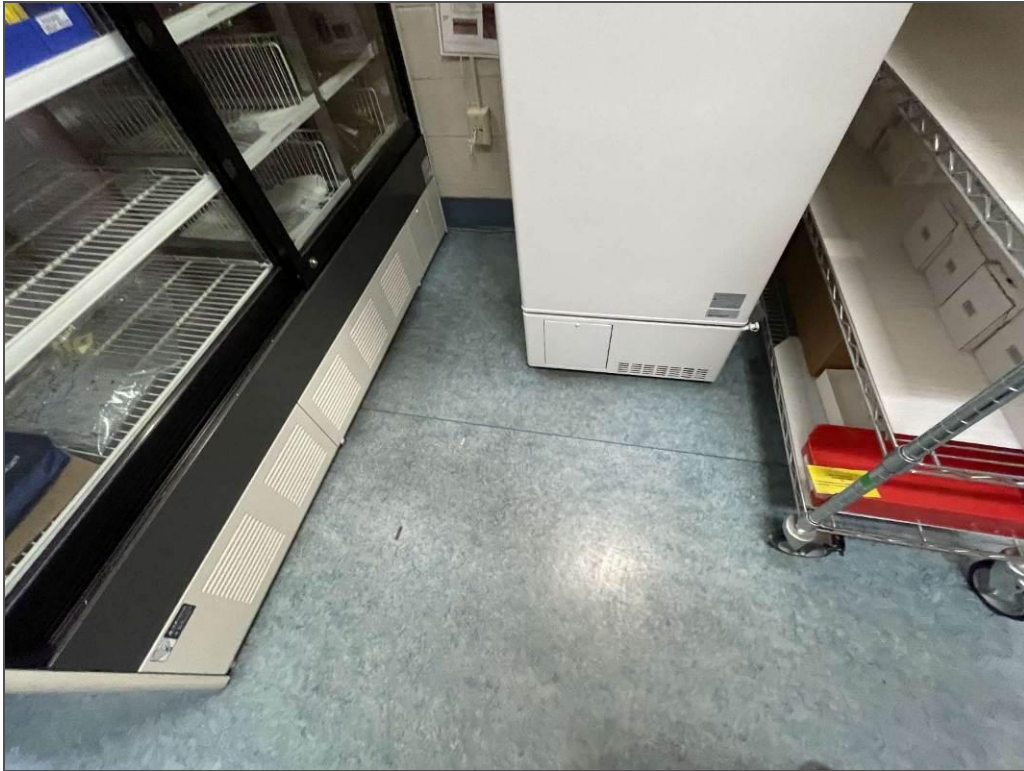
V0048 (None), Blue mottled, Floor, Vinyl Sheet Flooring, Printer Room (Location #: 40)

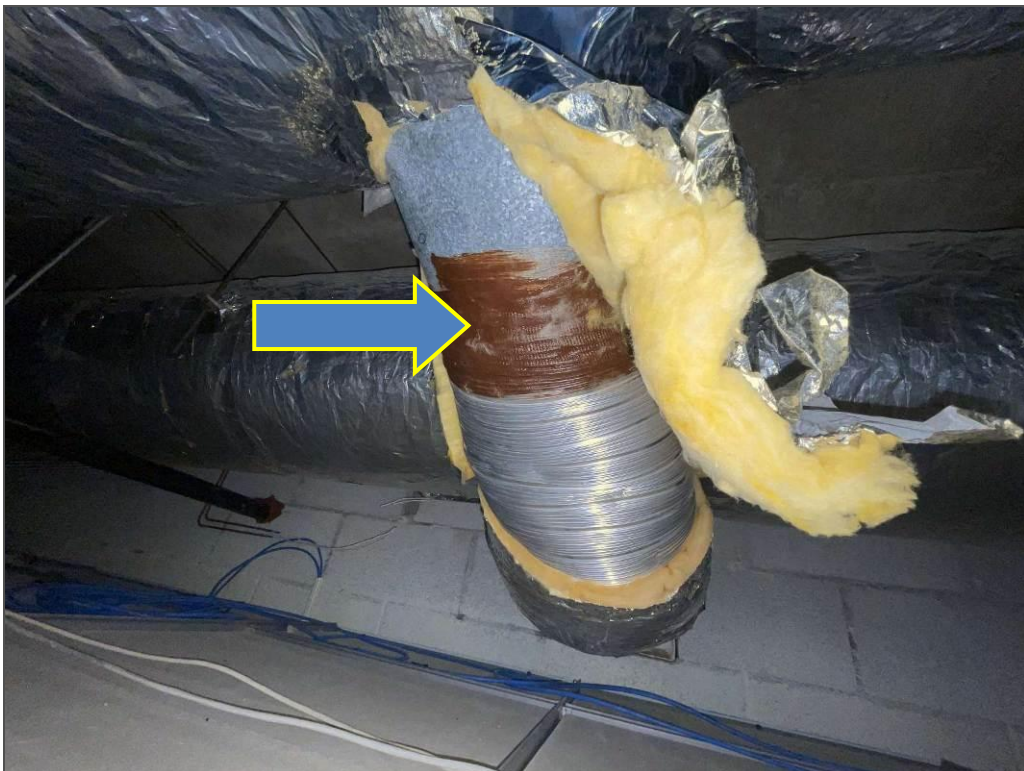
V1092 (Confirmed Asbestos), Duct, Mastic, Pharmacy (Location #: 38)

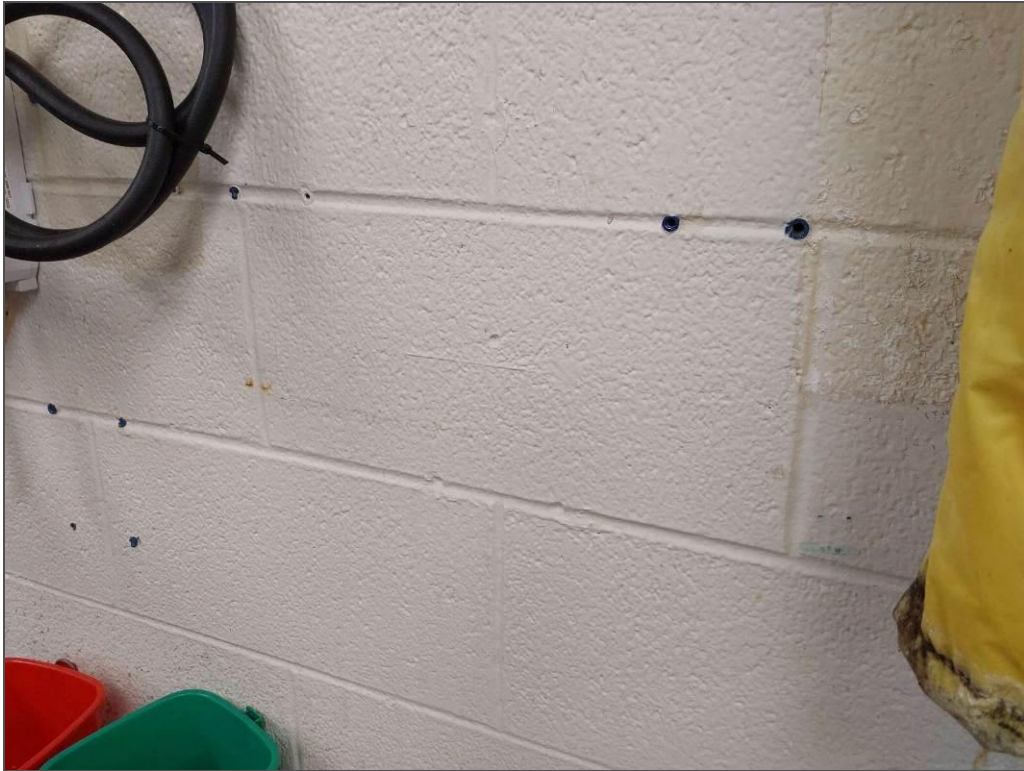
S1096A (Confirmed Asbestos), Paint on block walls, Wall, Paint, Dishwashing Area (Location #: 318)

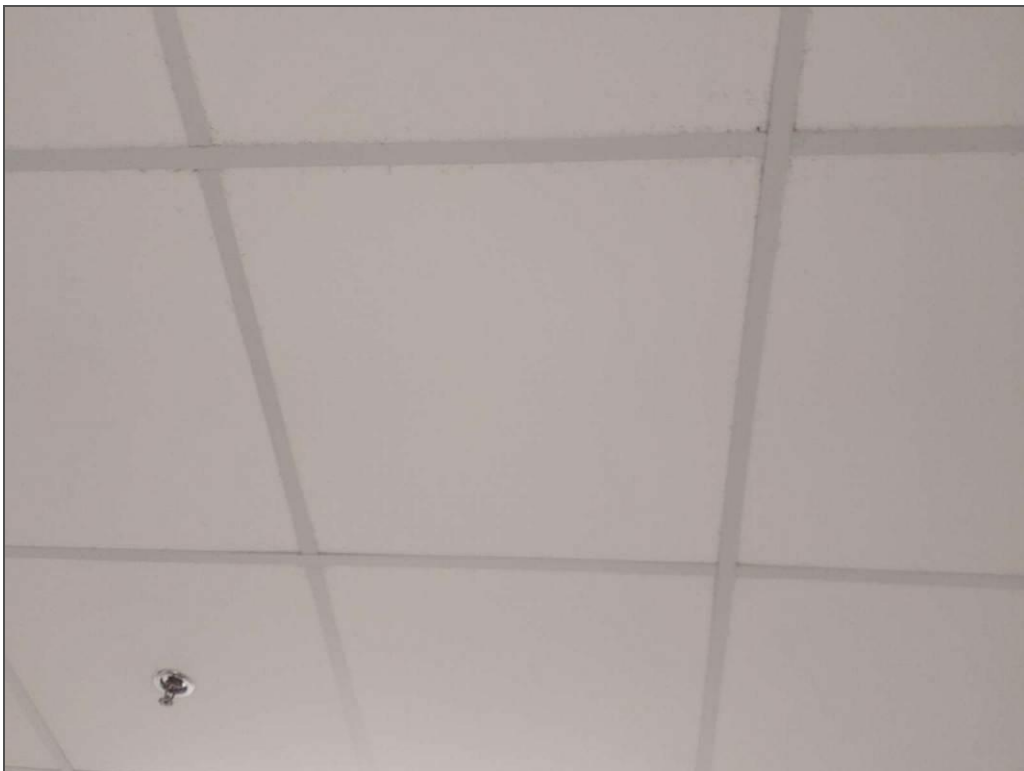
S1097A (None), 24"x24" white textured, Ceiling, Ceiling Tiles (lay-in), Dishwashing Area (Location #: 318)

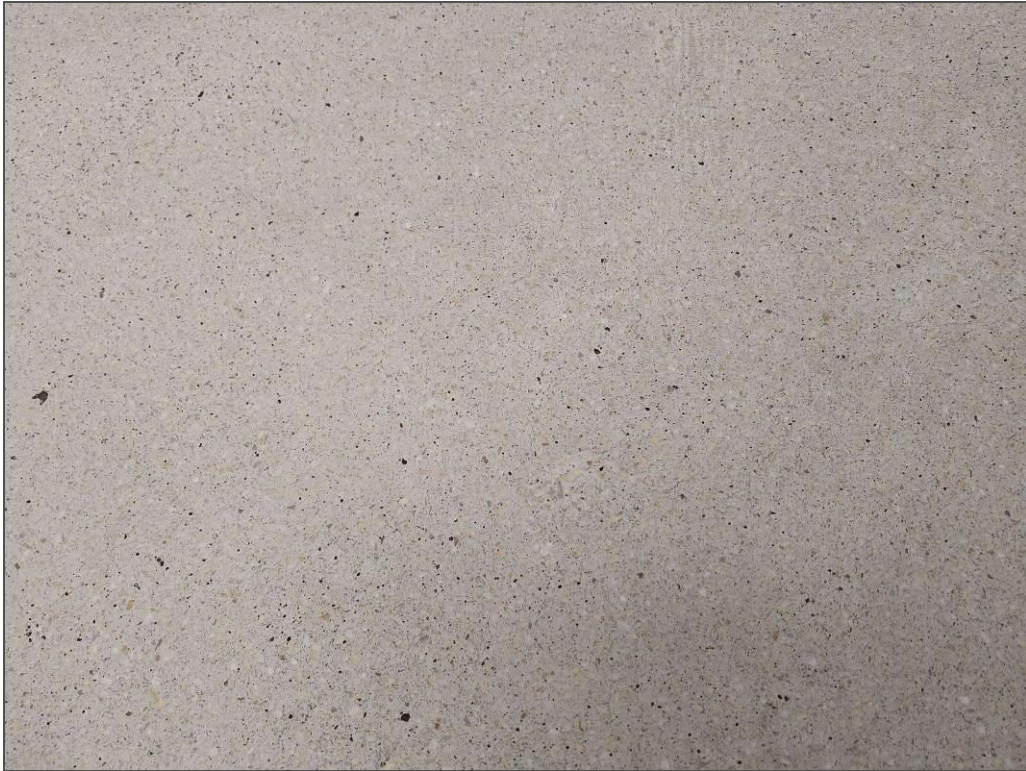
S1098A (None), Thinset under terrazzo, Floor, Thin-set, Dishwashing Area (Location #: 318)

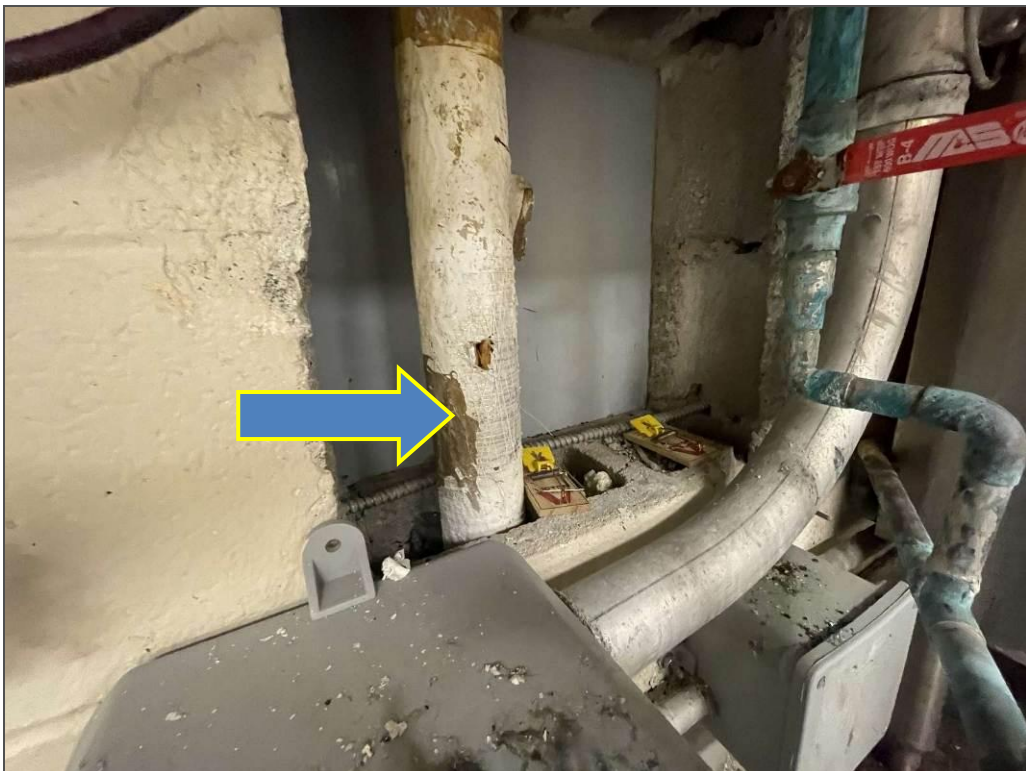
S1099A (None), Piping, Mastic, Dishwashing Area (Location #: 318)

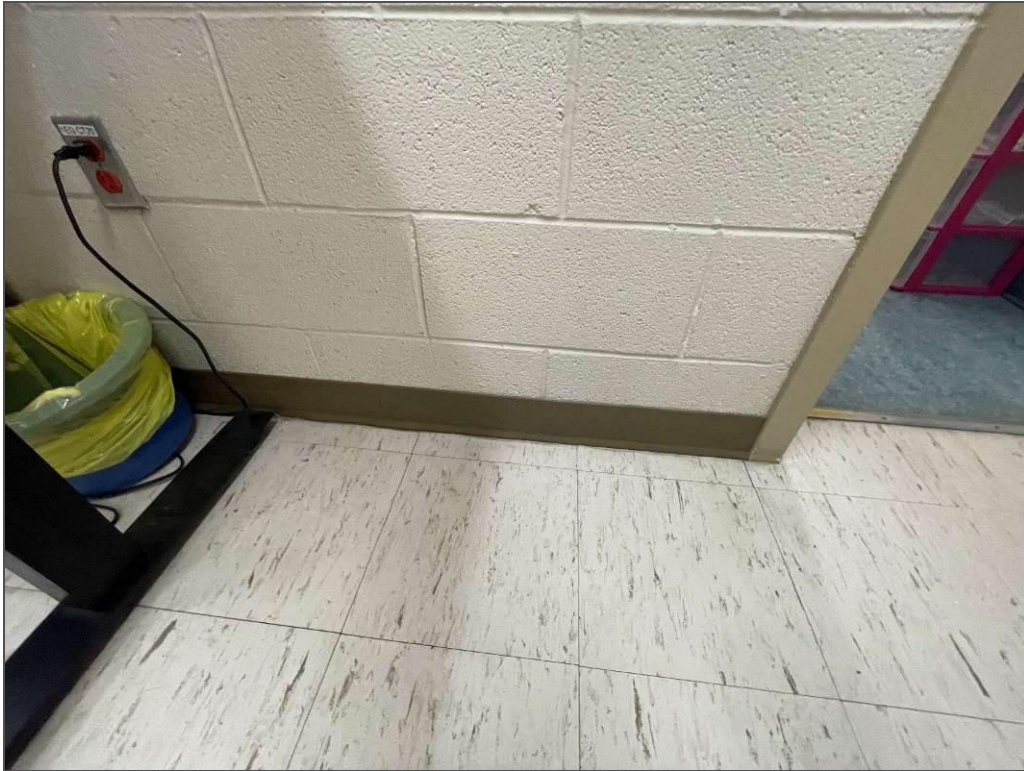
S1100A (None), Paint on block walls, Wall, Paint, Pharmacy (Location #: 38)

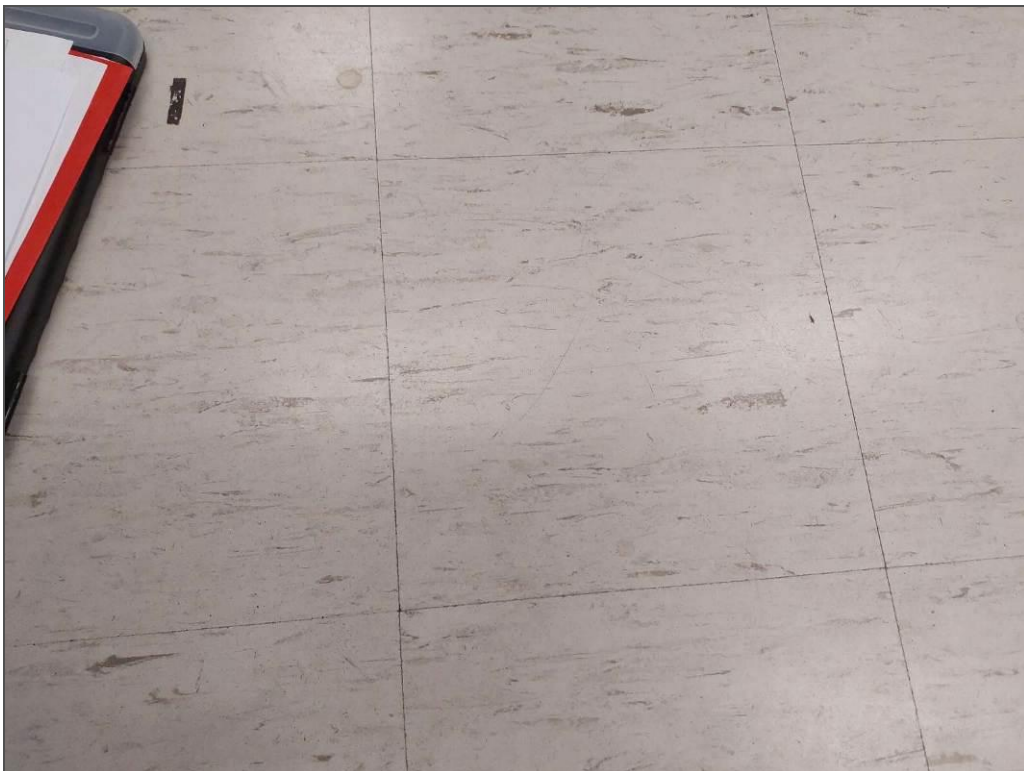
S1101A (Confirmed Asbestos), 12"x12" grey with grey streaks, Floor, Vinyl Floor Tile and Mastic, Pharmacy (Location #: 38)
Possible 23

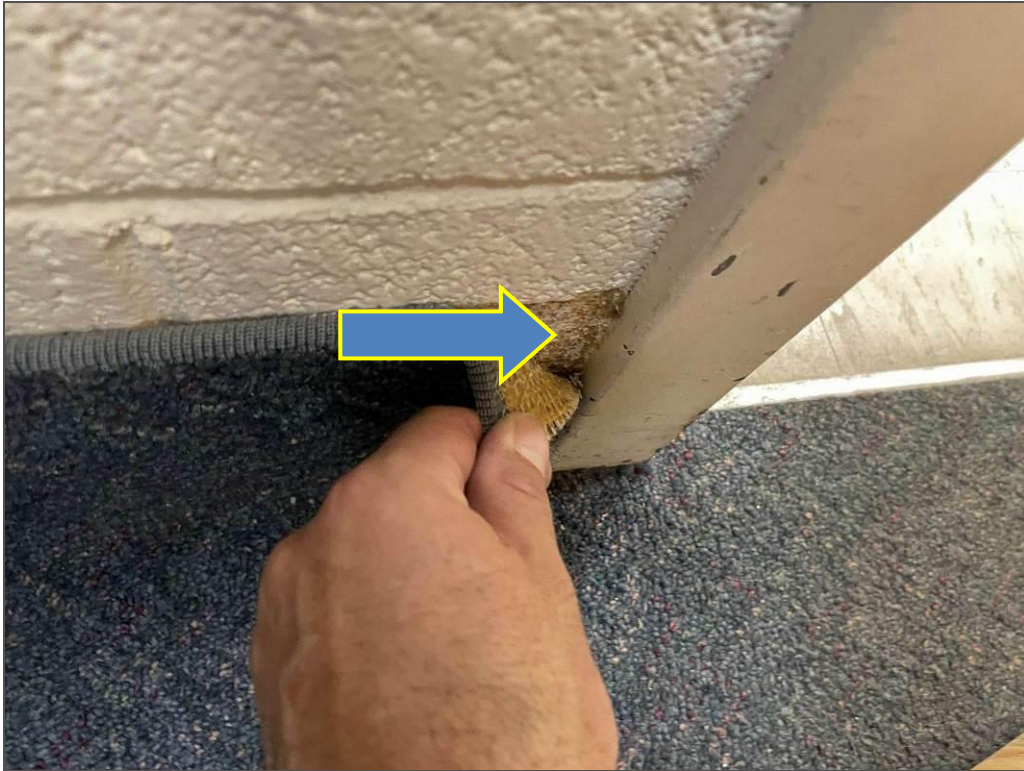
S1103A (None), Brown behind carpet baseboard, Wall, Base, Mastic, Office (Location #: 320)

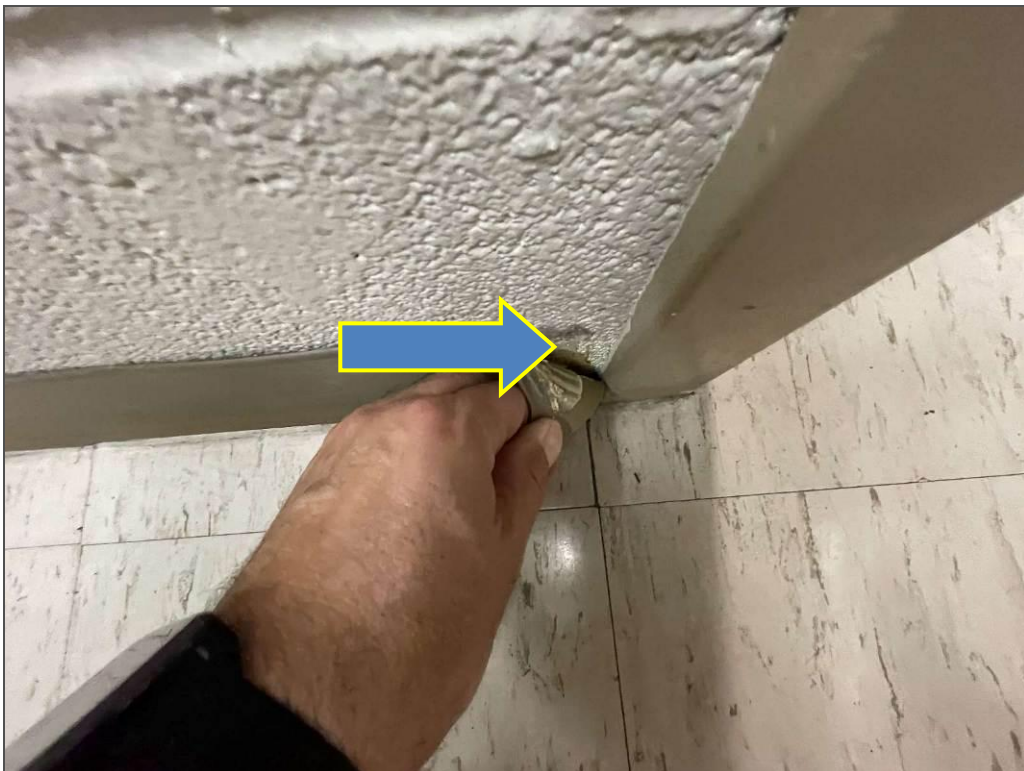
S1104B (None), Brown mastic behind rubber baseboard, Wall, Base, Mastic, Central Dispatch (Location #: 37)

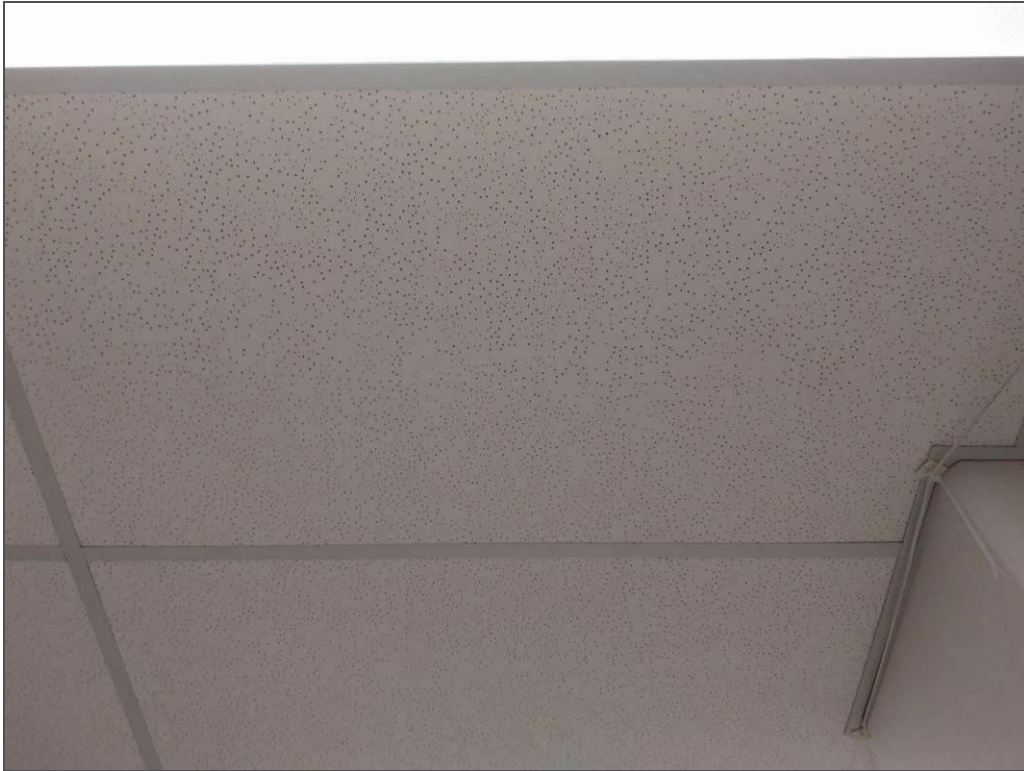
S1105B (None), 24"x48" large pinhole, Ceiling, Ceiling Tiles (lay-in), Pharmacy (Location #: 38)

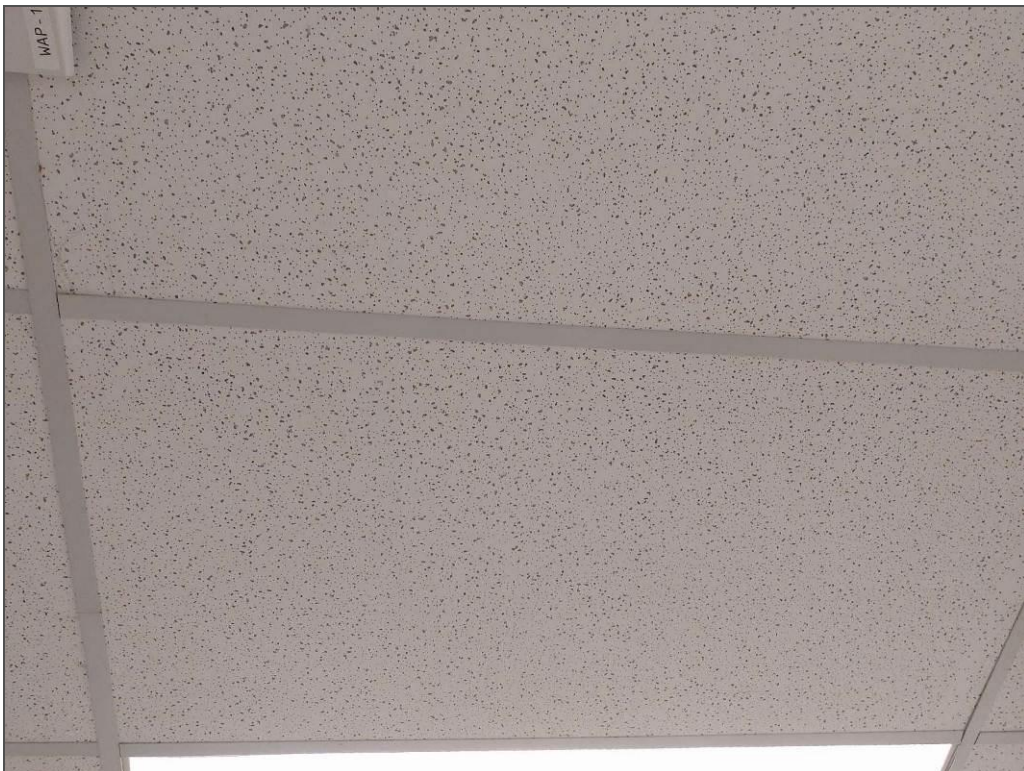
V0000 (None), 24"x48" pinhole and fleck, Ceiling, Ceiling Tiles (lay-in), Central Dispatch (Location #: 37)
2007 date stamp

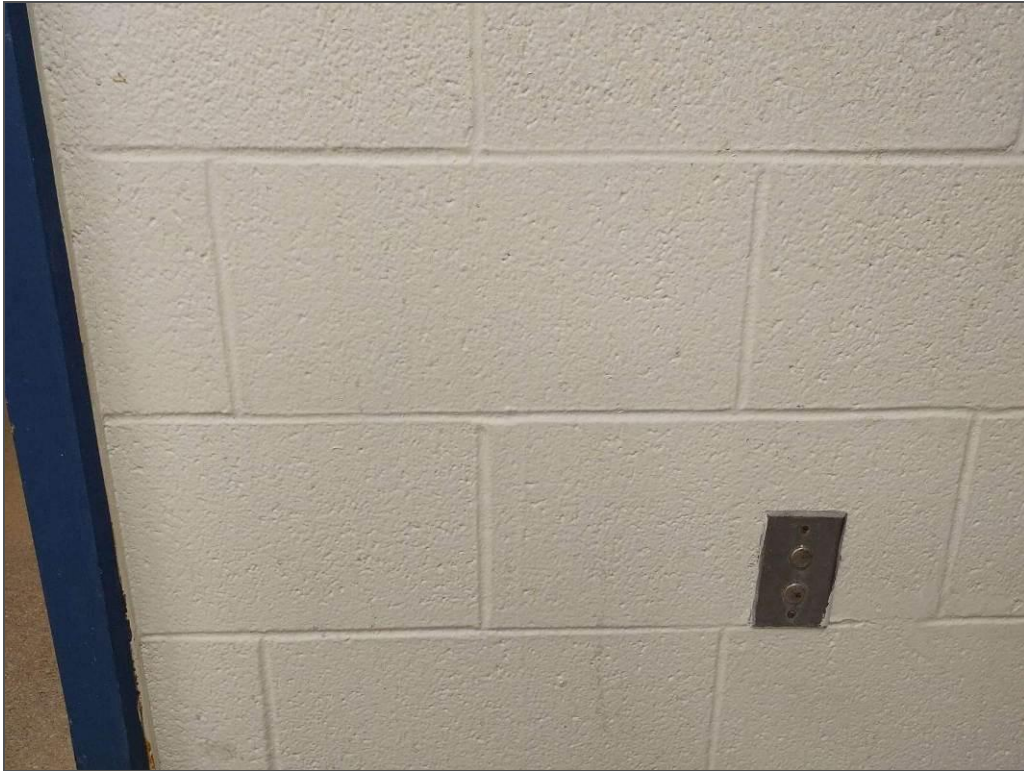
Sample Number	Material Description	Concentration	Confirmed Hazard	Total Quantity Present	Material Specific Notes
L0018	Wall Concrete (precast) Paint on block walls	0.0015%	No	1200 SF

L0018(Lead, None), Paint on block walls, Wall, Dishwashing Area (Location #: 318)

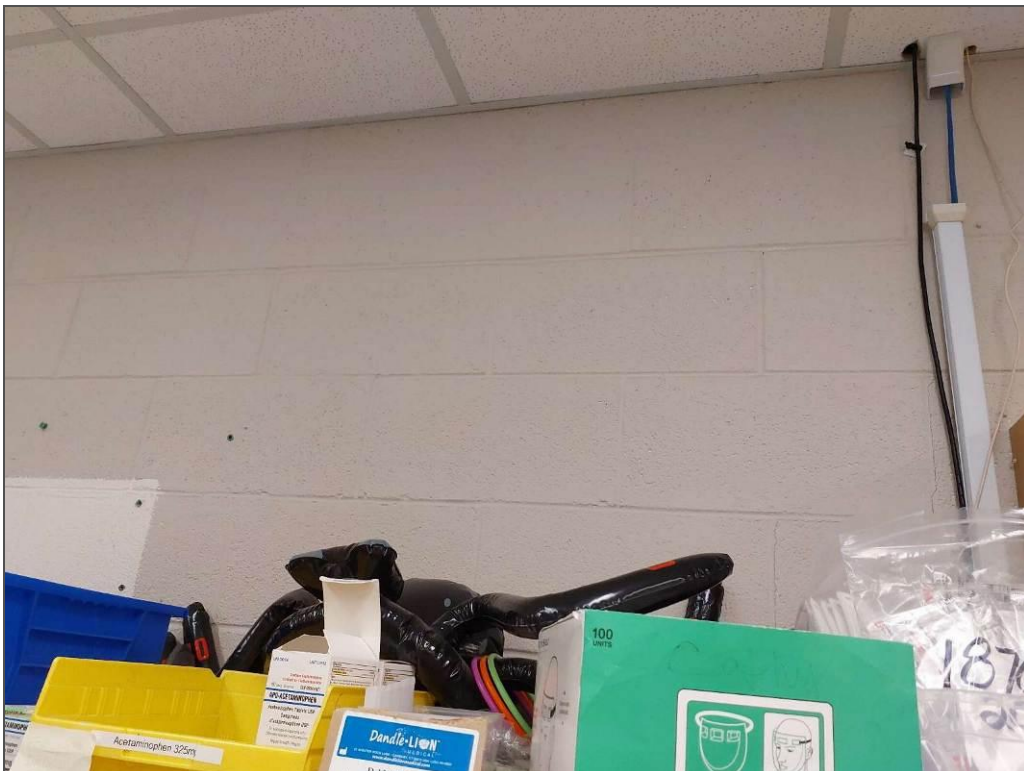
Sample Number	Material Description	Concentration	Confirmed Hazard	Total Quantity Present	Material Specific Notes
L0019	Wall Concrete (precast) Paint on block walls	0.00046%	No	2080 SF	
L0020	Wall Drywall and joint compound White and grey	0.00018%	No	2520 SF

L0019(Lead, None), Paint on block walls, Wall, Pharmacy (Location #: 38)

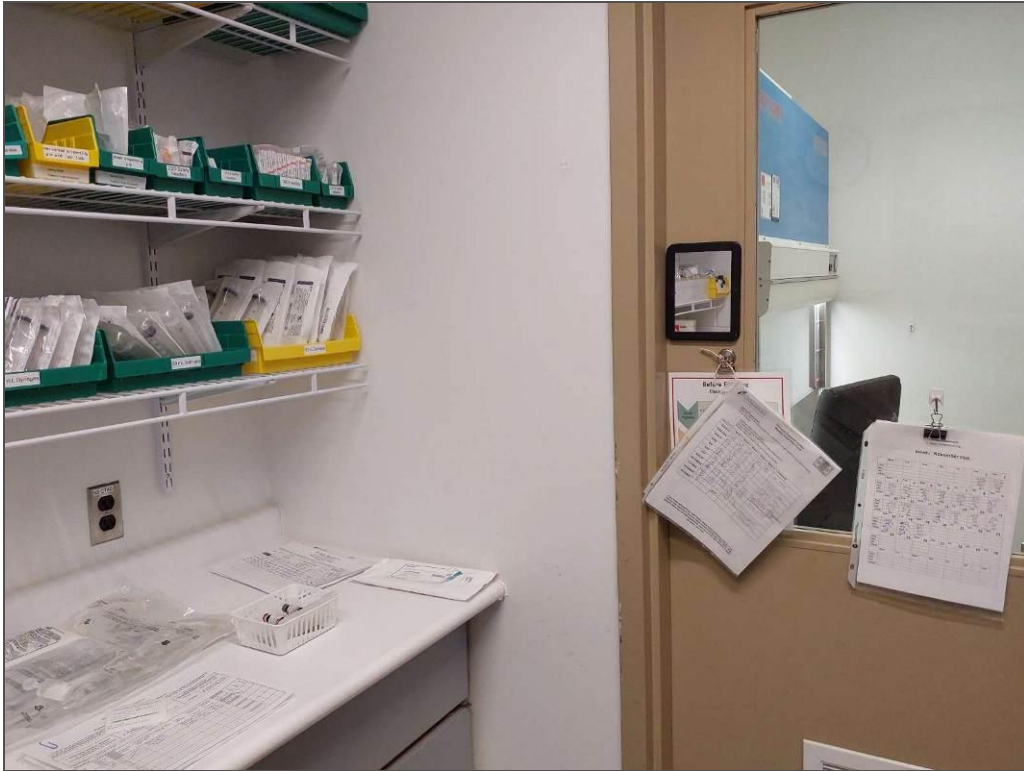
L0020(Lead, None), White and grey, Wall, Pharmacy (Location #: 38)

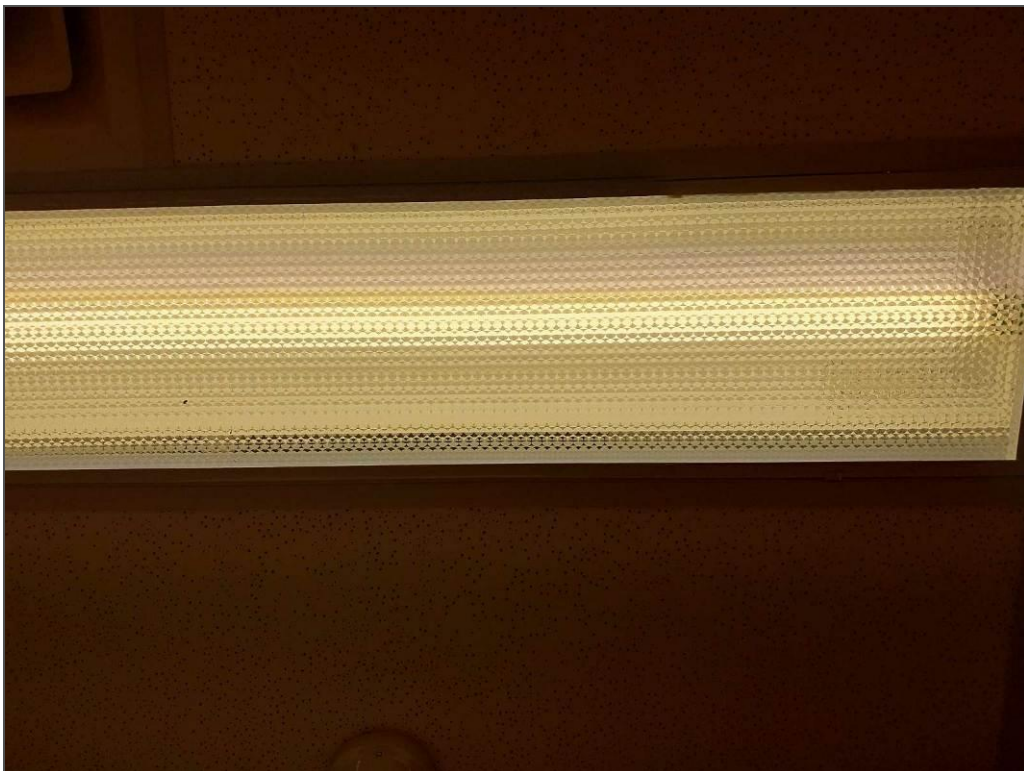
Sample Number	Material Description	Confirmed Hazard	Total Quantity Present	Material Specific Notes
V9500	Light Fixture	Yes	100%

Items identified as Sample Number V9500 were observed to be present but could not be definitively determined to contain mercury (e.g., inaccessible lamps and thermostats).

Mercury, V9500(Presumed), Light Fixture, T8, File Storage (Location #: 39)

Do not break lamps. Recycle and reclaim mercury from fluorescent lamps when taken out of service. Mercury is classified as a hazardous waste and must be disposed of in accordance with applicable regulations.
