**Scope of Work – Designated Substances Abatement/Procedures**  
**Faculty of Information Relocation – Project# P164-25-078**  
**481 Spadina Avenue (Building # 164A) 481 Spadina Avenue, Toronto M5S 2G7**

Further to your request, F&S Hazardous Construction Materials Group (HCMG) is pleased to provide the University Planning, Design & Construction (UPDC) this final report summarizing the observations made during a review of available reports, abatement records, bulk sampling records and current investigations/sampling for accessible designated substances in building materials for the above captioned project at the University of Toronto building located at 481 Spadina Avenue, Toronto.

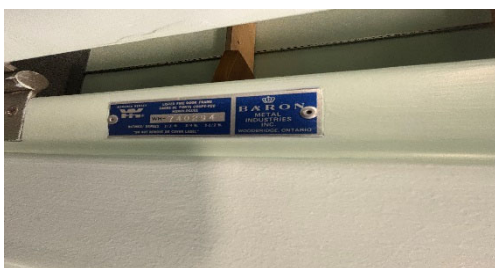
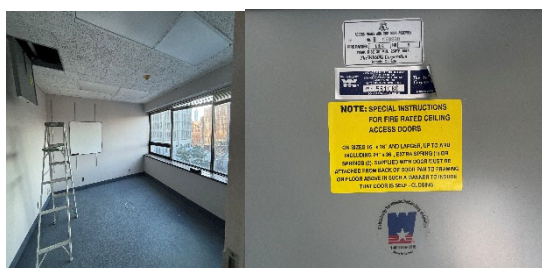
Fire-rated doors/hatches are present within the current project locations. Due to the destructive nature of sampling, the fire-rated door/hatch infill material was not examined. All fire-rated doors/hatches in this facility shall be considered to contain friable asbestos infill material.

No removal or disturbance of this material shall proceed without following the appropriate asbestos procedures listed below:

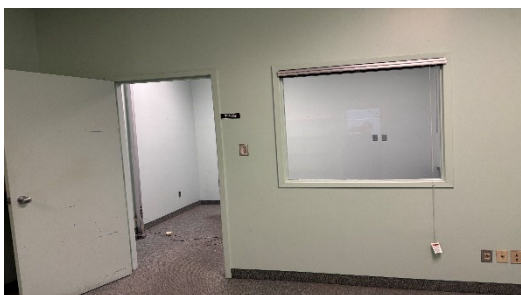
Caulking at frame of interior window between Room T207 and T208 (image shown below) does not contain asbestos based on laboratory analytical results of bulk asbestos samples of this homogeneous material.

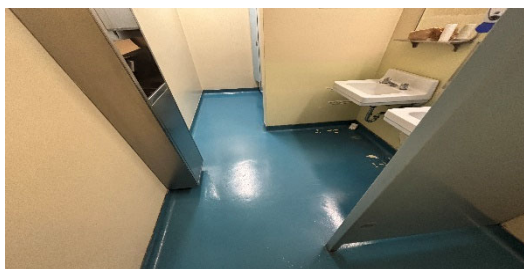
Based on laboratory analytical results of samples of this homogeneous material obtained during the current investigation, all epoxy flooring (image shown below) present within the current project locations can be considered not to contain asbestos.

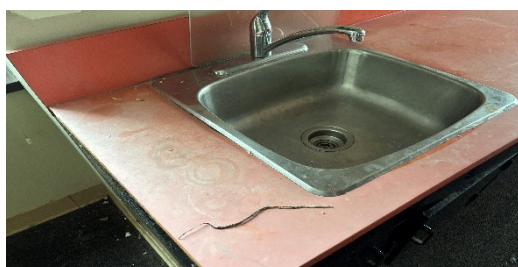
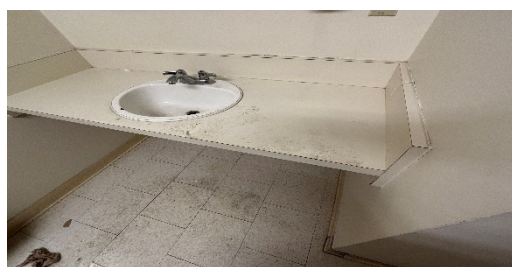
Based on laboratory analytical results of samples of sink and countertop caulking (image shown below) obtained during the current investigation, all sink/countertop caulking within the current project locations can be considered not to contain asbestos.
