# DESIGNATED SUBSTANCES AND HAZARDOUS BUILDING MATERIALS ASSESSMENT REPORT

Accessibility Upgrades Project  
Downsview Public School  
2829 Keele Street  
North York, Ontario  
M3M 2G4

Safetech Project Number: 1-3260212

Date of Site Work: March 6, 2026  
Date of Issue: March 19, 2026

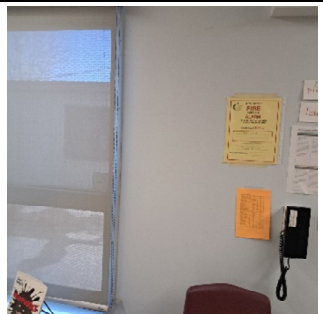
Plaster Finishes	Plaster walls were observed in the project specific areas. Bulk samples were collected during the assessment and results of analysis confirmed that this building material is not asbestos-containing. Refer to sample set 1 in Table 2.

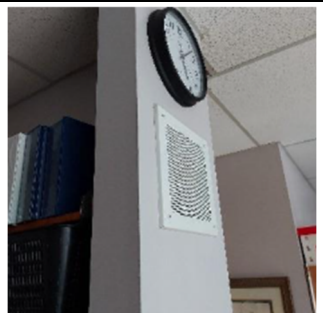
Drywall Joint Compound	Drywall joint compound was observed in the project specific areas. Bulk samples were collected during the 2022 survey assessment and results of analysis confirmed that this building material is not asbestos-containing.

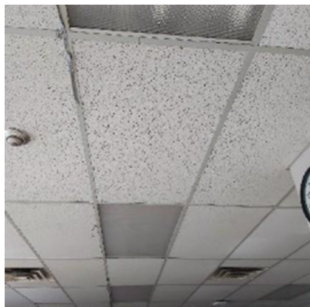
Lay-in Acoustic Ceiling Tiles	During the 2022 survey, 2x4 fissure and pinhole lay-in ceiling tiles were observed in the project specific areas. This building material was noted to contain a manufacturer's date stamp following the year 2000. Therefore, the material is not suspected to contain asbestos.

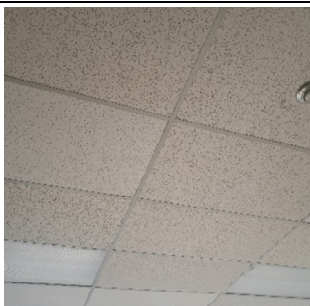
2'x4' Pinhole lay-in ceiling tiles were observed in the project specific areas. Bulk samples were collected during the assessment and results of analysis confirmed that this building material is not asbestos-containing. Refer to sample set 7 in Table 2.

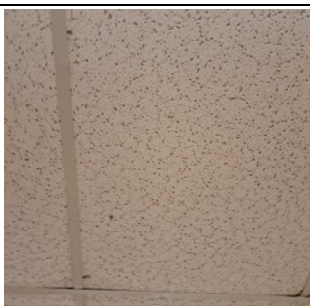
2'x4' Large fissure lay-in ceiling tiles were observed in the project specific areas. Bulk samples were collected during the assessment and results of analysis confirmed that this building material is not asbestos-containing. Refer to sample set 8 in Table 2.

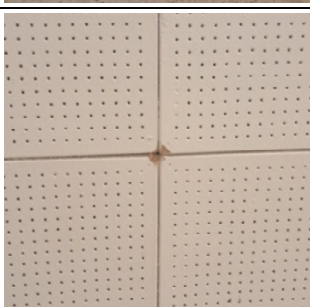
Glued-on Acoustic Ceiling Tiles	1'x1' Pinhole glued-on ceiling tiles were observed in the project specific areas. This material was confirmed to be made of fiberboard and is not expected to contain asbestos.

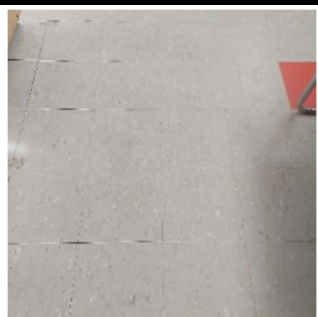
Vinyl Floor Tiles	Various patterns of 1'x1' Vinyl Floor Tiles were observed within the subject areas. Samples were not collected during our assessment as this material is not expected to be disturbed as the part of this project. This material is presumed to contain asbestos until proven otherwise.

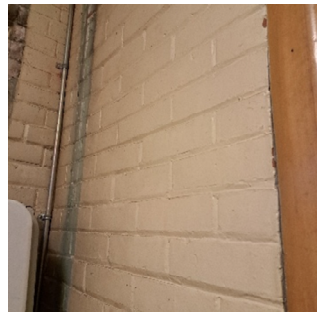
Vinyl Sheet Flooring	None identified in project specific areas.	
Mastic	Mastic pertaining to 1'x1' vinyl floor tiles may be present within the subject areas. This material is not expected to be disturbed as the part of this project. Mastic associated with vinyl floor tiles is presumed to contain asbestos until proven otherwise.	
<b>Asbestos Cement Products</b>	<b>Location/Description</b>	
Piping	None identified in subject area.	
Roofing, Siding, Wallboard	None identified in project specific areas.	
Mortar	Interior brick mortar was observed in the project specific areas. Bulk samples were collected during the assessment and results of analysis confirmed that this building material is not asbestos-containing. Refer to sample set 1 in Table 2.

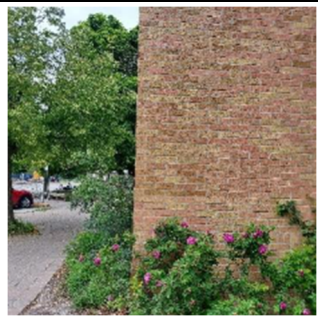
Exterior brick mortar was observed in the project specific areas. Bulk samples were collected during the 2022 assessment and results of analysis confirmed that this building material is not asbestos-containing.

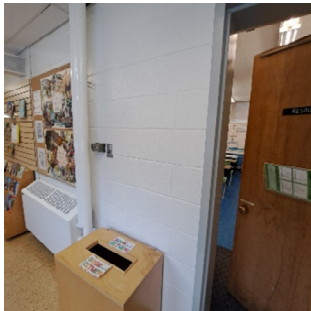
Mortar	Concrete block mortar was observed in the project specific areas. Bulk samples were collected during the assessment and results of analysis confirmed that this building material is not asbestos-containing. Refer to sample set 2 in Table 2.

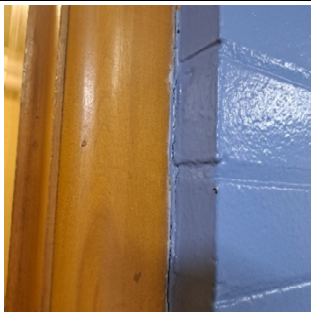
<b>Exterior Building Materials</b>	<b>Location/Description</b>	
Caulking	White door frame caulking was observed in the project specific areas. Bulk samples were collected during the assessment and results of analysis confirmed that this building material is not asbestos-containing. Refer to sample set 3 in Table 2.

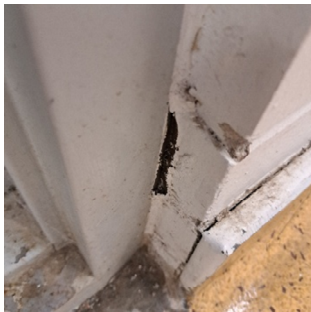
Brown door frame caulking was observed in the project specific areas. Bulk samples were collected during the assessment and results of analysis confirmed that this building material is not asbestos-containing. Refer to sample set 4 in Table 2.

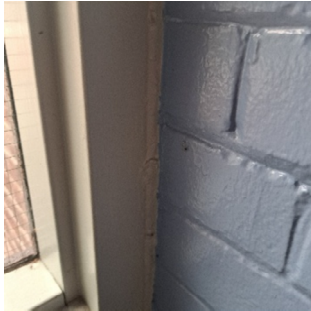
Grey interior door frame caulking was observed in the project specific areas. Bulk samples were collected during the assessment and results of analysis confirmed that this building material is not asbestos-containing. Refer to sample set 5 in Table 2.

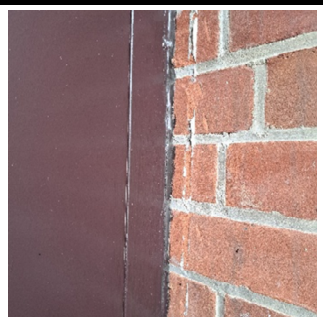
Caulking	Black exterior door frame caulking was observed in the project specific areas. Bulk samples were collected during the assessment and results of analysis confirmed that this building material is not asbestos-containing. Refer to sample set 6 in Table 2.

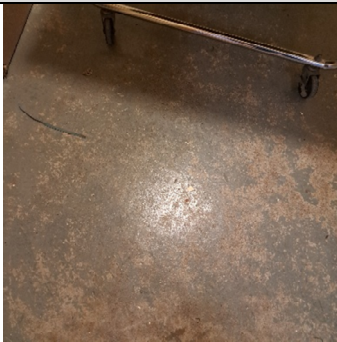
Location/Description	Picture
<p>Grey paint associated with concrete floor in storage room (3845) was sampled during our investigation. Results of analysis indicated the presence of 0.34% concentrations of lead. Therefore, the grey paint is considered to be lead-containing. Refer to sample L1 in Table 4.</p>

At this time the method of disturbance, if any, of lead-containing materials is unknown. It is recommended that any contractor whose work requires lead-containing materials to be disturbed consult the EACC or Ontario MLITSD guidelines prior to the start of work to determine the Class/Type of operation(s) and the corresponding control measures (engineering controls, work/hygiene practices, protective clothing and equipment and worker training) necessary to conduct the work in a manner that will prevent worker

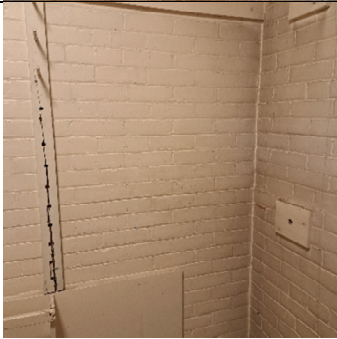
<p>Cream paint associated with brick walls in storage room (3845) was sampled during our investigation. Results of analysis indicated the presence of 0.11% concentrations of lead. Therefore, the cream paint is considered to be lead-containing. Refer to sample L2 in Table 4.</p>

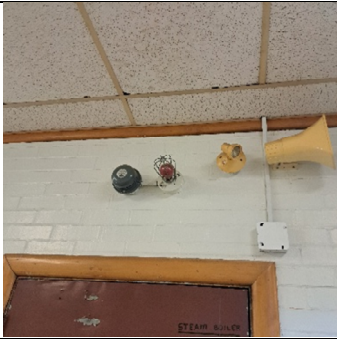
<p>Light grey paint associated block walls in boiler room (3859) was sampled during our investigation. Results of analysis indicated the presence of 0.11% concentrations of lead. Therefore, the light grey paint is considered lead-containing. Refer to sample L3 in Table 4.</p>

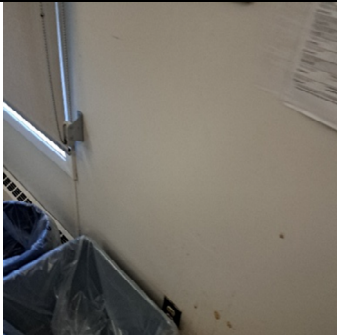
<p>White paint associated with walls in portable 5 was sampled during our investigation. Results of analysis did not indicate the presence of any detectable concentrations of lead. Therefore, the white paint is not considered to be lead-containing. Refer to sample L4 in Table 4.</p>
