**HAZARDOUS MATERIALS SURVEY**  
**Downsview Secondary School**  
**7 Hawksdale Road**  
**Toronto, Ontario**  
**M3K 1W3**

**Issued: June 6, 2024**

**THEM Project #: T26-52809**

**RE: TDSB – Downsview Secondary School – Accessibility Upgrades**  
7 Hawksdale Road, Toronto, Ontario, M3K 1W3  
THEM Project: 52809

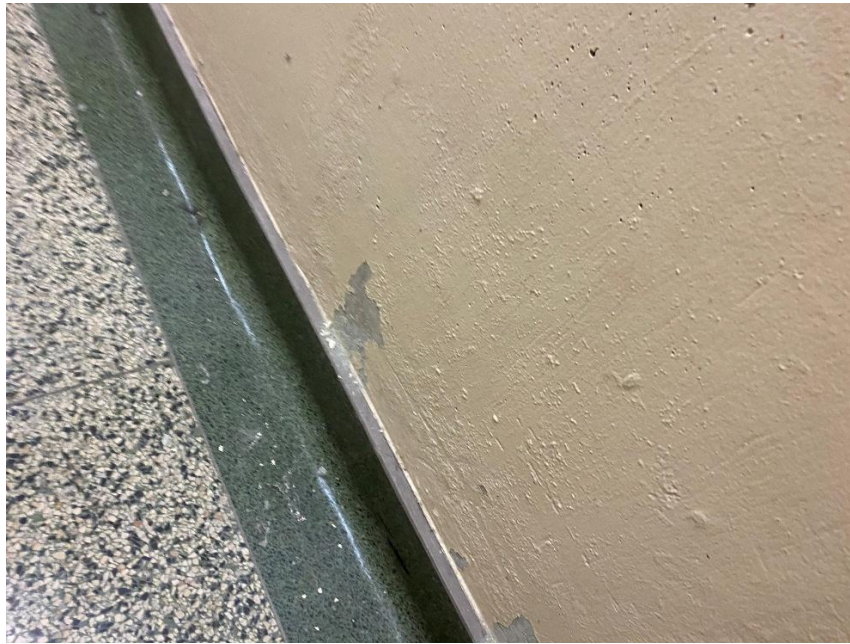
Concentrations of lead were identified in the cream and off-white paint within the project specific areas. All paints sampled was observed to be in good condition. Materials containing less than or equal to 0.1% lead by weight are considered low-level lead materials. A summary of the materials and their associated lead concentrations can be found in **Table V** below. Paints observed in the surveyed area that are similar in colour to other paints listed in **Table V**, should be assumed to have the same lead concentrations unless proven otherwise. Materials containing a lead concentration greater than 0.1% are bolded and highlighted in yellow. Lead is suspected to be present as a component in pipes and in solder used in pipe fittings.

**Photograph 1:** View of cream paint containing high concentration of lead within Corridor (53631).

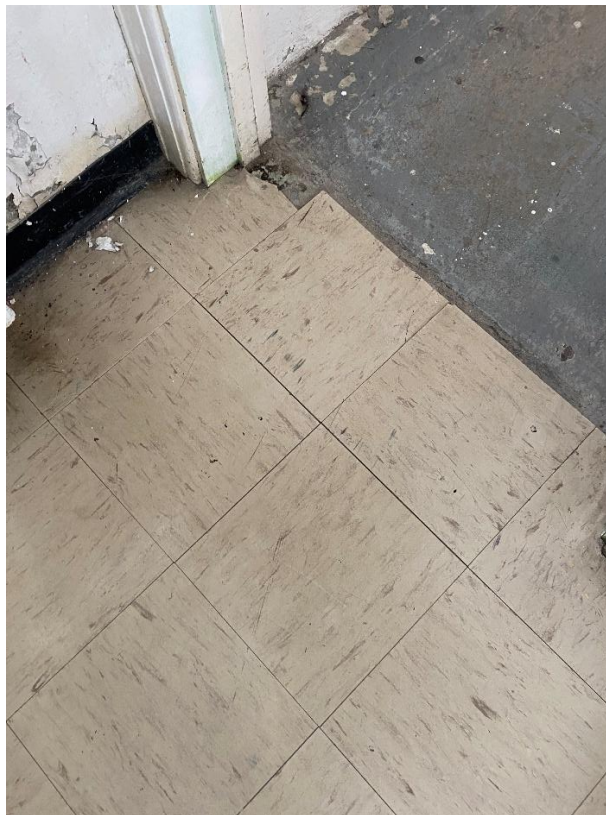
Vinyl floor tiles were observed in the surveyed area. Materials were previously tested and determined to contain **5% Chrysotile** asbestos.

**Photograph 2:** View of asbestos containing vinyl floor tile within Backstage (5364).

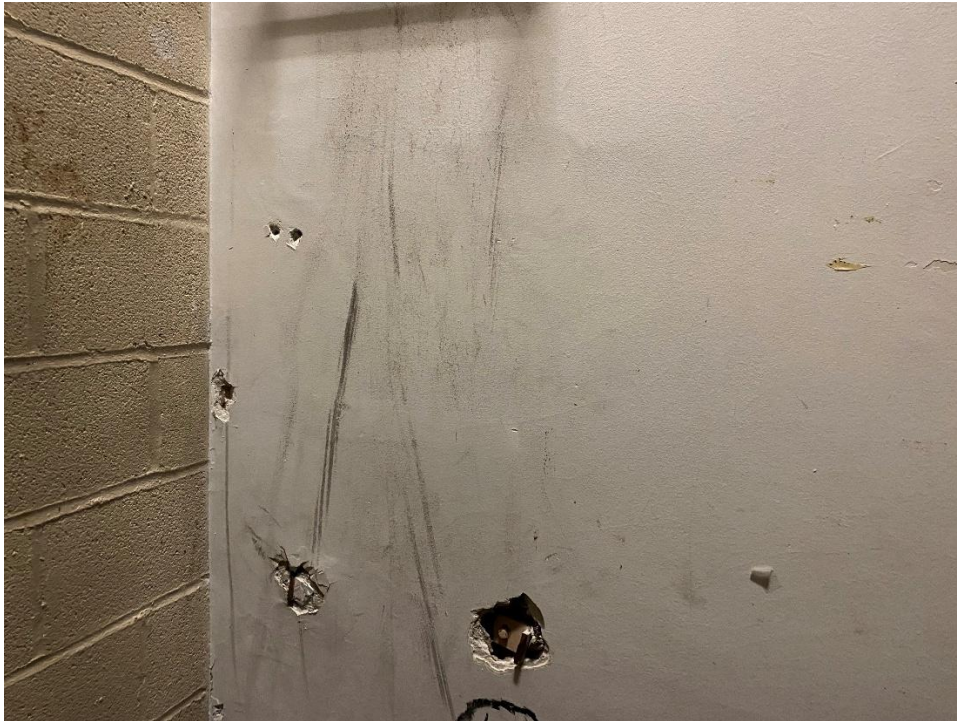
**Photograph 3:** View of off-white paint containing high concentration of lead within Stage (5513).

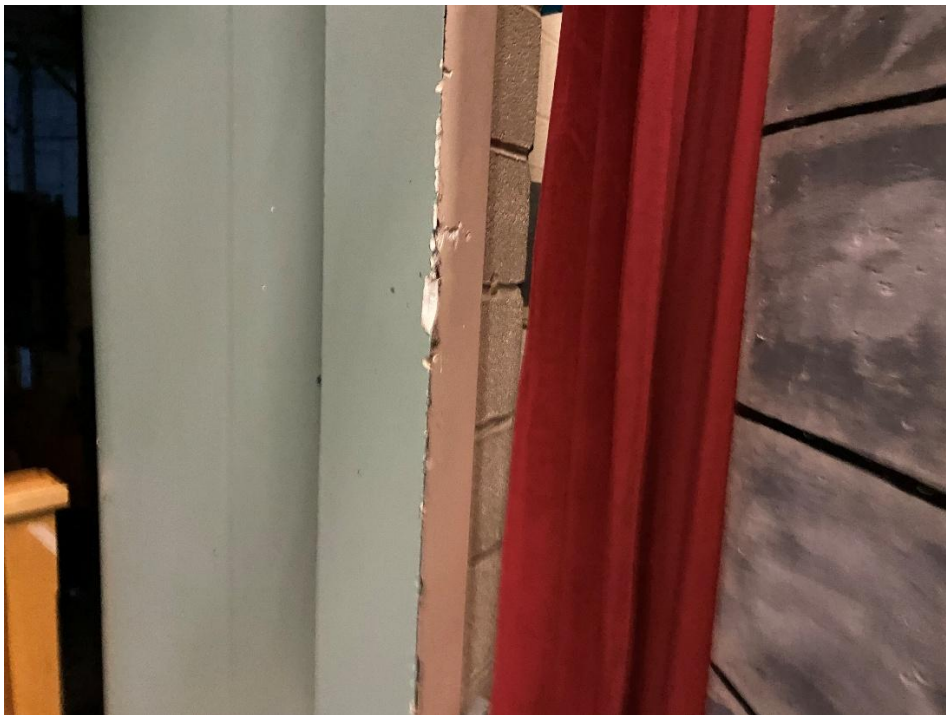
Plasters were observed in the surveyed area. Material was sampled (sample set - 2.1 – 2.3), tested and determined to contain no asbestos.

**Photograph 4:** View of plaster sampling location within Stage (5513).
