DESIGNATED SUBSTANCES AND HAZARDOUS BUILDING MATERIALS ASSESSMENT REPORT

**Accessibility Upgrades Project
Downsview Public School
2829 Keele Street
North York, Ontario
M3M 2G4**

Safetech Project Number: 1-3260212

**Date of Site Work: March 6, 2026
Date of Issue: March 19, 2026**

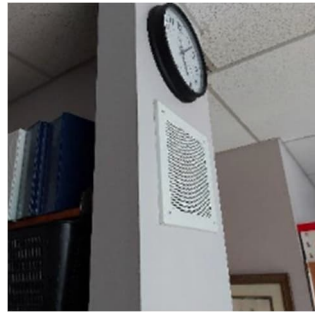
HVAC Duct Insulation	None identified in project specific areas.	
Breeching / Exhaust Insulation	None identified in project specific areas.	
Tank Insulation	None identified in project specific areas.	
Boiler Insulation	None identified in project specific areas.	
Other Mechanical Equipment Insulation	None identified in project specific areas.	
Architectural Finishes & Finishing Materials	Location/Description	
Sprayed Texture / Stucco Finishes	None identified in project specific areas.	
Plaster Finishes	None identified in project specific areas.	
Drywall Joint Compound	Drywall joint compound was observed in the project specific areas. Bulk samples were collected during the 2022 survey assessment and results of analysis confirmed that this building material is not asbestos-containing.

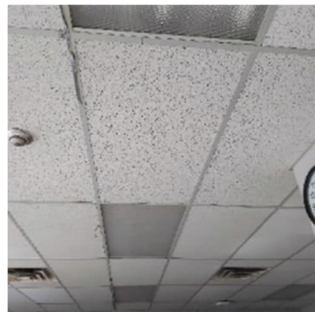
Ceiling Tiles	Location/Description	
Lay-in Acoustic Ceiling Tiles	During the 2022 survey, 2x4 fissure lay-in ceiling tiles were observed in the project specific areas. This building material was noted to contain a manufacturer's date stamp following the year 2000. Therefore, the material is not suspected to contain asbestos.

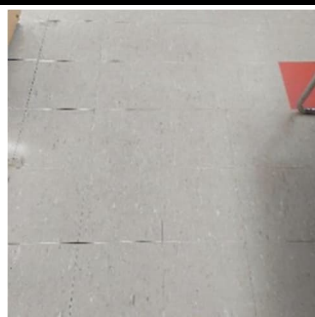
Vinyl Floor Tiles	Various patterns of 1'x1' Vinyl Floor Tiles were observed within the subject areas. Samples were not collected during our assessment as this material is not expected to be disturbed as the part of this project. This material is presumed to contain asbestos until proven otherwise.

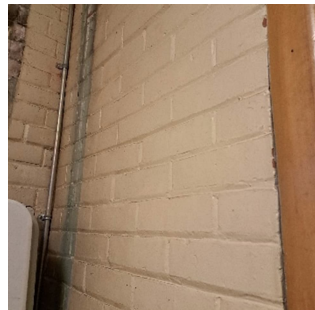
Vinyl Sheet Flooring	None identified in project specific areas.	
Mastic	Mastic pertaining to 1'x1' vinyl floor tiles may be present within the subject areas. This material is not expected to be disturbed as the part of this project. Mastic associated with vinyl floor tiles is presumed to contain asbestos until proven otherwise.	
Asbestos Cement Products	Location/Description	
Piping	None identified in subject area.	
Roofing, Siding, Wallboard	None identified in project specific areas.	
Mortar	Interior brick mortar was observed in the project specific areas. Bulk samples were collected during the assessment and results of analysis confirmed that this building material is not asbestos-containing. Refer to sample set 1 in Table 2.

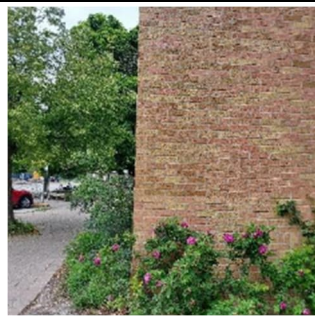
Exterior brick mortar was observed in the project specific areas. Bulk samples were collected during the 2022 assessment and results of analysis confirmed that this building material is not asbestos-containing.

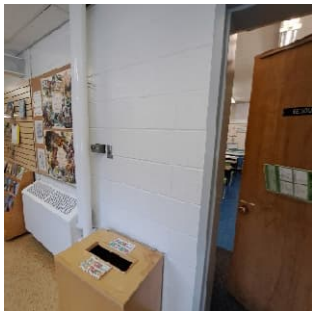
Mortar	Concrete block mortar was observed in the project specific areas. Bulk samples were collected during the assessment and results of analysis confirmed that this building material is not asbestos-containing. Refer to sample set 2 in Table 2.

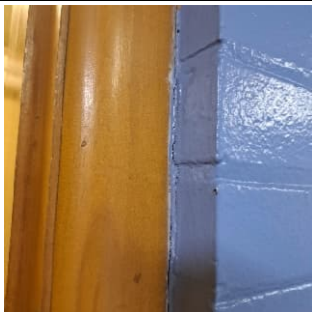
Exterior Building Materials	Location/Description	
Caulking	White door frame caulking was observed in the project specific areas. Bulk samples were collected during the assessment and results of analysis confirmed that this building material is not asbestos-containing. Refer to sample set 3 in Table 2.

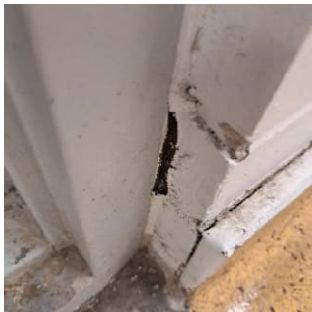
Brown door frame caulking was observed in the project specific areas. Bulk samples were collected during the assessment and results of analysis confirmed that this building material is not asbestos-containing. Refer to sample set 4 in Table 2.

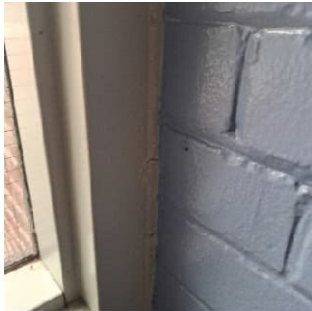
Grey interior door frame caulking was observed in the project specific areas. Bulk samples were collected during the assessment and results of analysis confirmed that this building material is not asbestos-containing. Refer to sample set 5 in Table 2.

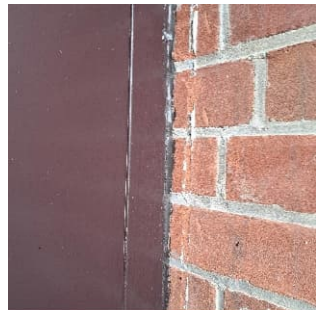
Caulking	Black exterior door frame caulking was observed in the project specific areas. Bulk samples were collected during the assessment and results of analysis confirmed that this building material is not asbestos-containing. Refer to sample set 6 in Table 2.

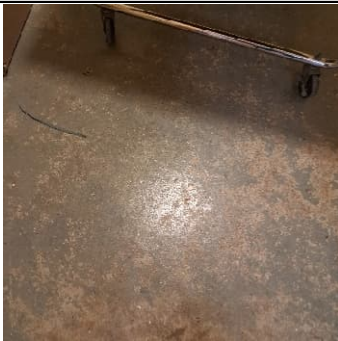
Location/Description	Picture
<p>Grey paint associated with concrete floor in storage room (3845) was sampled during our investigation. Results of analysis indicated the presence of 0.34% concentrations of lead. Therefore, the grey paint is considered to be lead-containing. Refer to sample L1 in Table 4.</p>

At this time the method of disturbance, if any, of lead-containing materials is unknown. It is recommended that any contractor whose work requires lead-containing materials to be disturbed consult the EACC or Ontario MLITSD guidelines prior to the start of work to determine the Class/Type of operation(s) and the corresponding control measures (engineering controls, work/hygiene practices, protective clothing and equipment and worker training) necessary to conduct the work in a manner that will prevent worker overexposure to lead. The following table outlines the classification of lead disturbance based on the EACC guideline.

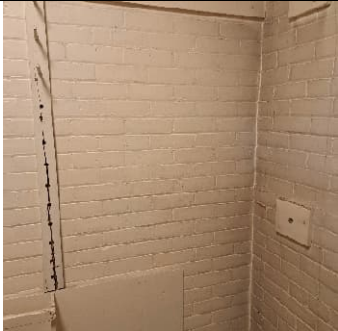
<p>Cream paint associated with brick walls in storage room (3845) was sampled during our investigation. Results of analysis indicated the presence of 0.11% concentrations of lead. Therefore, the cream paint is considered to be lead-containing. Refer to sample L1 in Table 4.</p>
