# **DESIGNATED SUBSTANCES AND HAZARDOUS BUILDING MATERIALS ASSESSMENT REPORT**

**Accessibility Upgrade Project  
Sir Oliver Mowat Collegiate Institute  
5400 Lawrence Avenue East  
Scarborough, Ontario  
M1C 2C6**

**Toronto District School Board  
15 Oakburn Crescent  
Toronto, Ontario  
M2N 2T5**

**Date of Site Work: March 6, 2026  
Date of Issue: March 20, 2026**

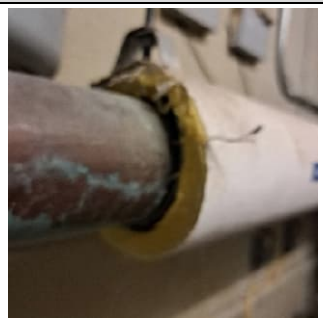
Loose Fill / Vermiculite Insulation	None identified in project specific areas. Interior portions of concrete block walls could not be assessed. However, it is not expected that these walls are insulated with loose fill or vermiculite insulation	
Thermal System Insulation	Location/Description	
Mechanical Pipe Insulation – Straights	Mechanical pipe insulation in the project specific areas was observed to be made of fiberglass which is known to be not asbestos-containing.

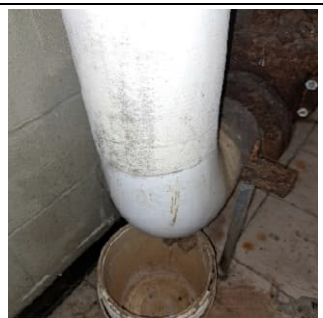
<p><b>Preformed Block On Straight Run Pipe</b> was previously observed in the subject building. Bulk samples were previously collected and results of analysis confirmed that this building material contains <b>50% chrysotile</b> asbestos. Refer to the location, condition, friability, and estimated quantity in Appendix A.</p> <p>The material is not expected to be disturbed under the scheduled project.</p>	
Mechanical Pipe Insulation – Fittings (elbows, valves, tees, hangars, etc.)	Pipe fitting insulation in the project specific areas was observed to be made of fiberglass or PVC which are known to be not asbestos-containing.

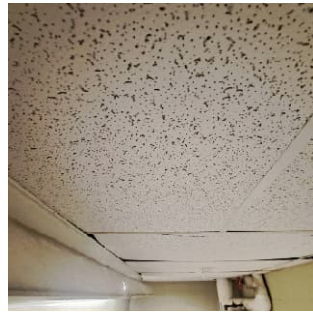
<b>Ceiling Tiles</b>	<b>Location/Description</b>	
Lay-in Acoustic Ceiling Tiles	<p>2x4 Fissure and pinhole lay-in ceiling tiles were observed in the project specific areas. This building material was noted to contain a manufacturer's date stamp following the year 2000 and is therefore not suspected to contain asbestos.</p>

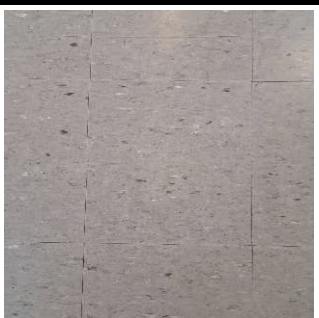
Vinyl Floor Tiles	<p>Grey with black &amp; white specks vinyl floor tiles were observed in the project specific areas. Bulk samples were collected during the assessment and results of analysis confirmed that this building material is not asbestos-containing. Refer to sample set 1 in Table 2.</p>

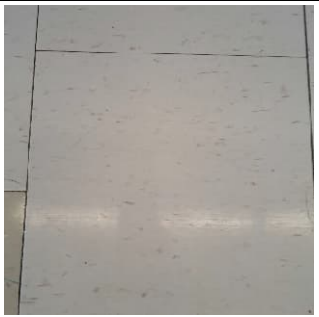
<p>White with beige specks vinyl floor tiles were observed in the project specific areas. Bulk samples were collected during the assessment and results of analysis confirmed that this building material is not asbestos-containing. Refer to sample set 2 in Table 2.</p>

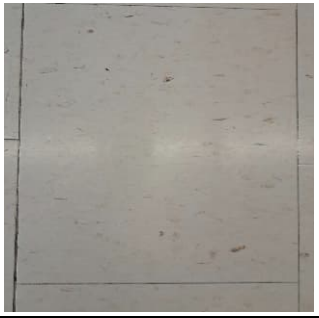
<p>Cream with beige specks vinyl floor tiles were observed in the project specific areas. Bulk samples were collected during the assessment and results of analysis confirmed that this building material is not asbestos-containing. Refer to sample set 3 in Table 2.</p>

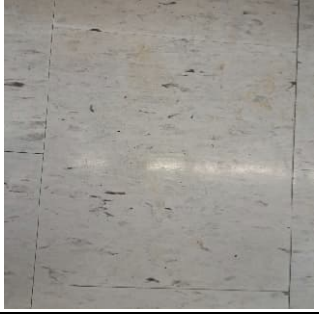
<p>White with faint streaks vinyl floor tiles were observed in the project specific areas. Bulk samples were collected during the assessment and results of analysis confirmed that this building material is not asbestos-containing. Refer to sample set 4 in Table 2.</p>

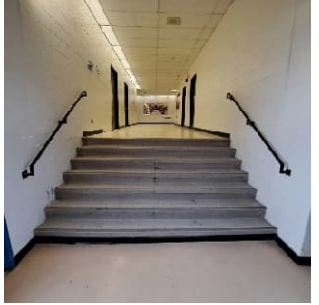
Vinyl Sheet Flooring	<p>Light pink vinyl sheet flooring was observed in the project specific areas. Bulk samples were collected during the assessment and results of analysis confirmed that this building material is not asbestos-containing. Refer to sample set 5 in Table 2.</p>

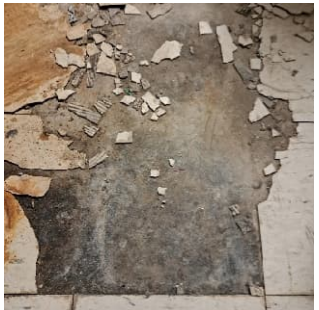
Mastic	Mastic associated with vinyl floor tiles was observed in the project specific areas. Bulk samples were collected during the assessment and results of analysis confirmed that this building material is not asbestos-containing. Refer to sample set 4 in Table 2.

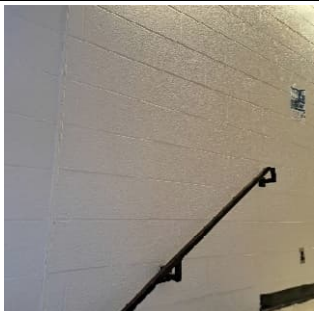
<b>Asbestos Cement Products</b>	<b>Location/Description</b>	
Piping	None identified in subject area.	
Roofing, Siding, Wallboard	None identified in project specific areas.	
Other Cement Products	Concrete block mortar was observed in the project specific areas. Bulk samples were collected during the assessment and results of analysis confirmed that this building material is not asbestos-containing. Refer to sample set 6 in Table 2.

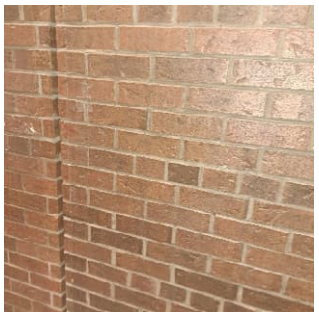
Brick mortar was observed in the project specific areas. Bulk samples were collected during the assessment and results of analysis confirmed that this building material is not asbestos-containing. Refer to sample set 7 in Table 2.

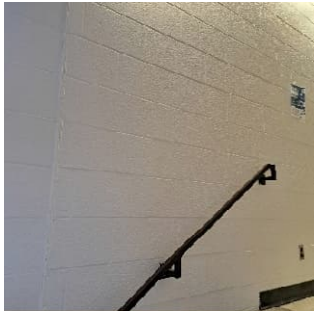
During the 2023 Safetech survey, <b>Block filler</b> was observed in the subject building. Bulk samples were collected during the assessment and results of analysis confirmed that this building material contains <b>1% chrysotile</b> asbestos. Refer to Appendix A for the location, condition, friability, and estimated quantity.

**Block Filler Paint:** The block filler paint is considered to be a non-friable ACM. As per O. Reg. 278/05, removal of non-friable ACM can be conducted following Type 1 operations; as long as the material can be removed without being broken, cut, drilled or otherwise similarly disturbed. If the material cannot be removed without it breaking or being similarly disturbed then the work should be conducted using non-powered hand tools and the material should be wetted to control the spread of dust. If the material cannot be wetted or if power tools attached to dust-collecting devices equipped with HEPA (high efficiency particulate aerosol) filters are used during removal or disturbance, then work should be performed following Type 2 operations. If non-friable materials are removed or disturbed using power tools that are not attached to dust-collecting devices that are equipped with HEPA filters then work should be conducted following Type 3 operations.

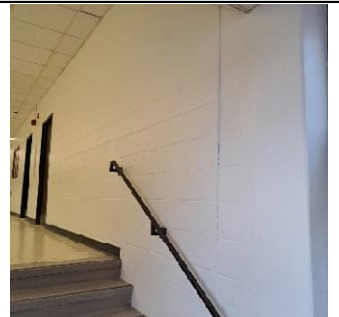
Location/Description	Picture
White paint associated with concrete block walls in corridor adjacent to door 5 (17125) was sampled during our investigation. Results of analysis did not indicate the presence of any detectable concentrations of lead. Therefore, the white paint is not considered to be lead-containing. Refer to sample L1 in Table 4.

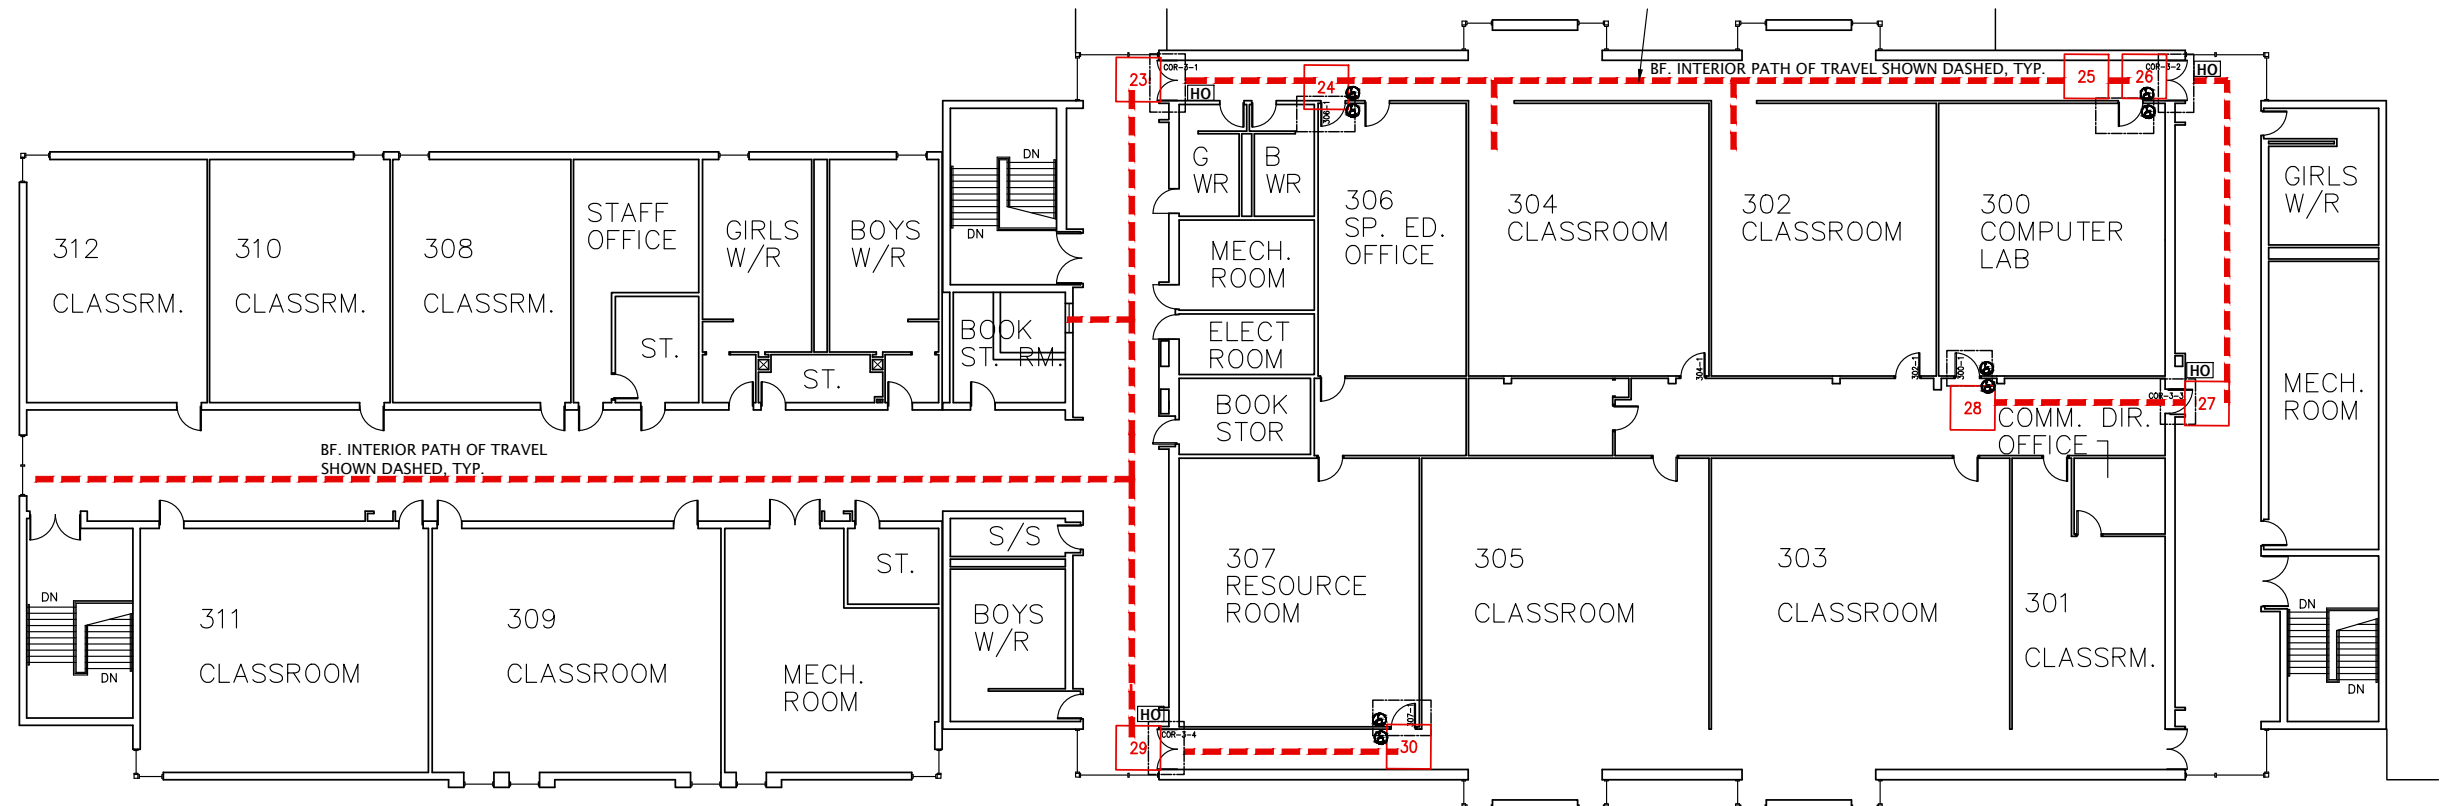
ASBESTOS CONTAINING  
CONCRETE BLOCK FILLER  
COAT WAS IDENTIFIED  
THROUGHOUT THE PROJECT  
SPECIFIC AREAS

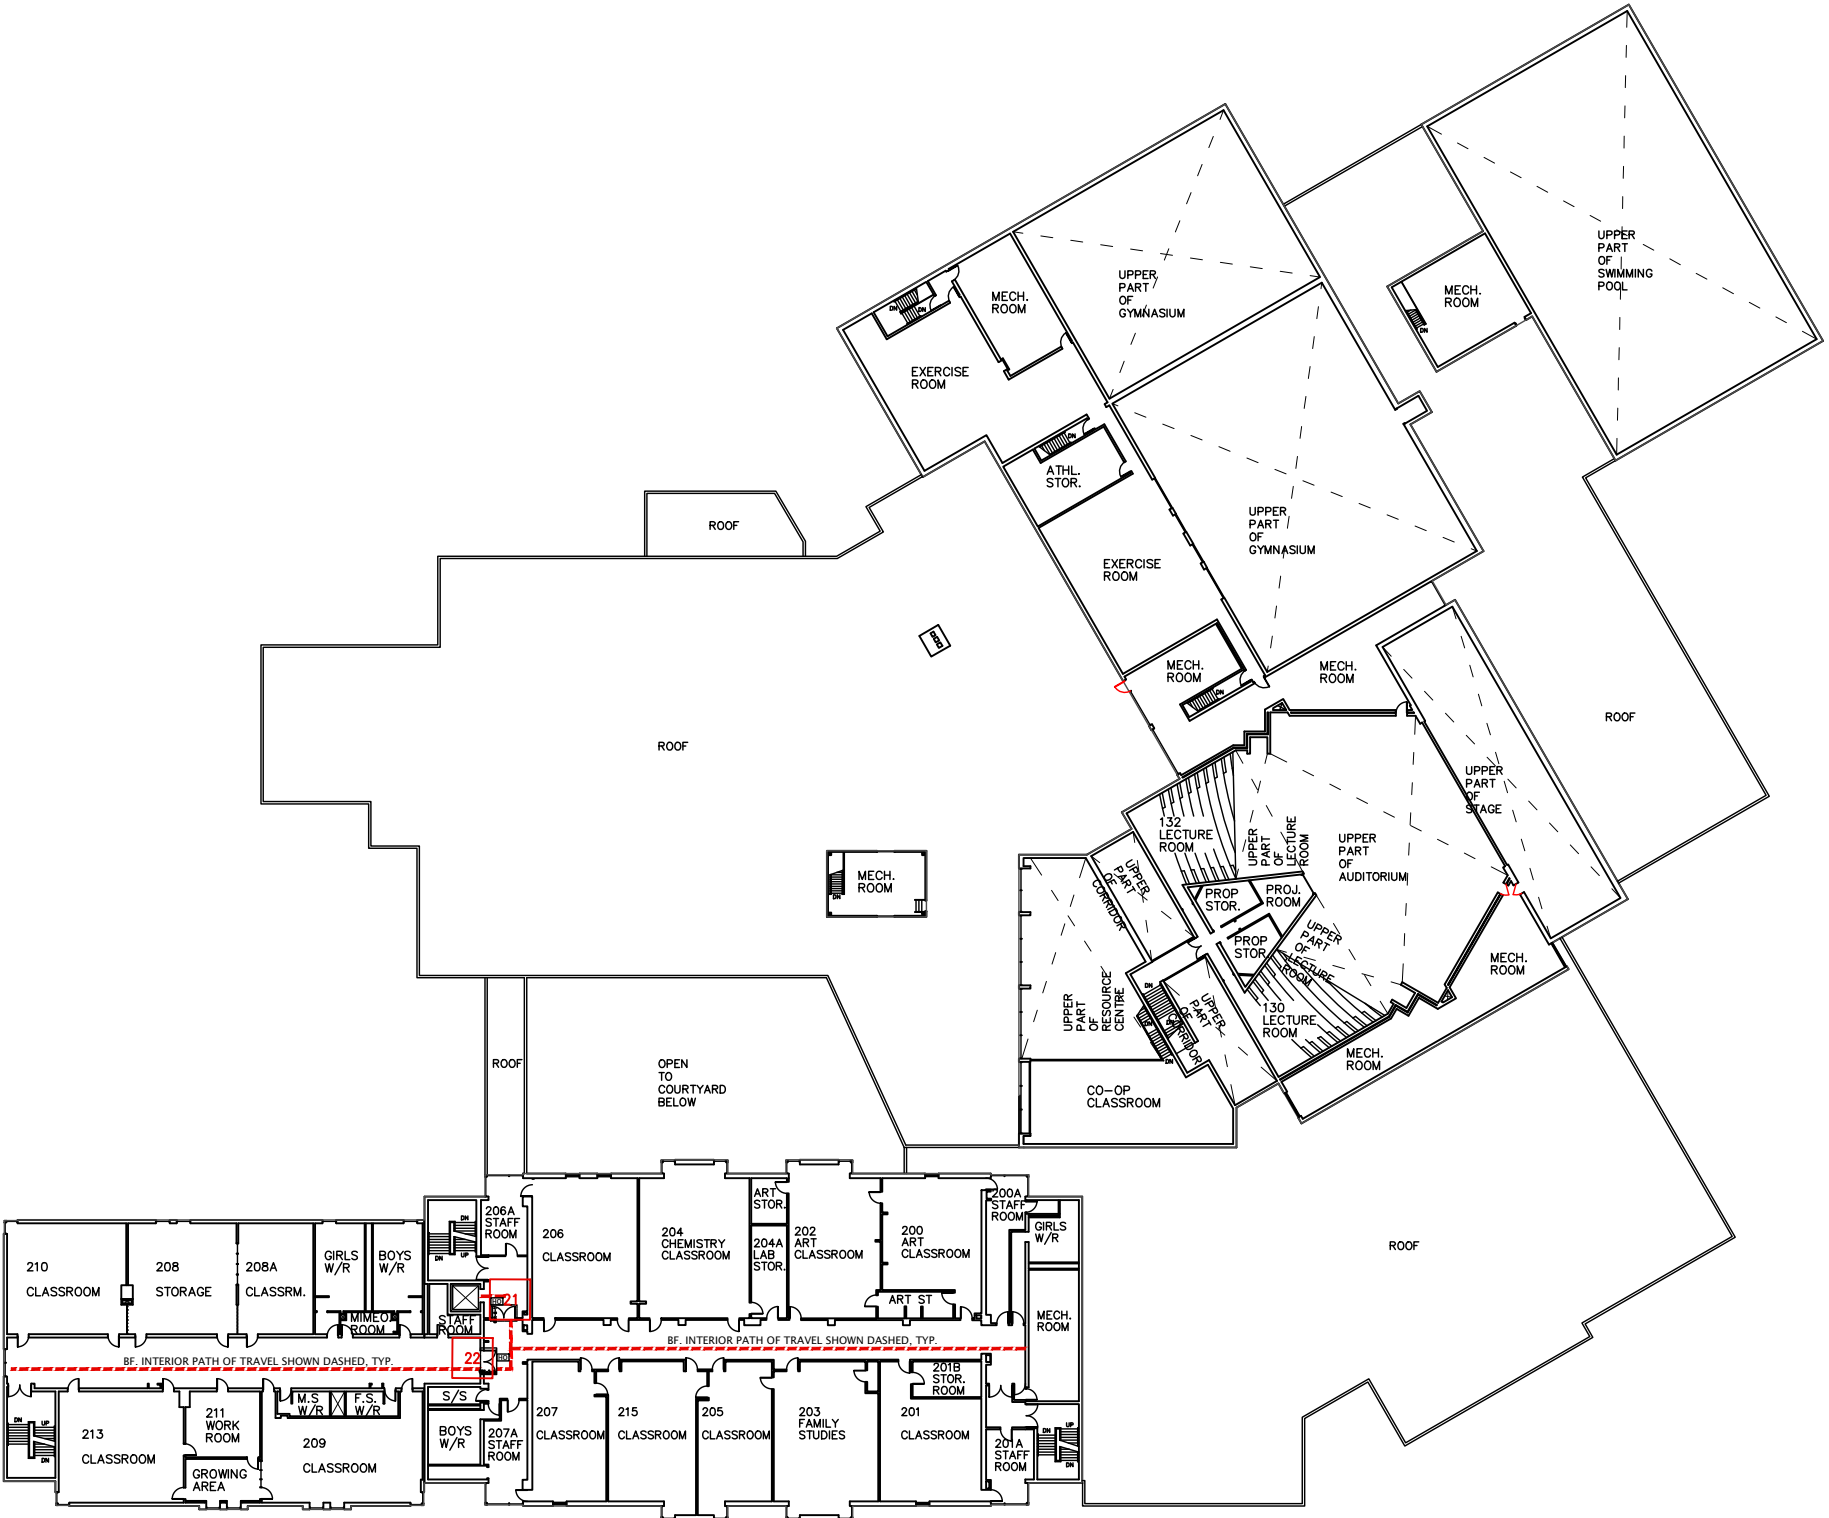
LEVEL 2

ASBESTOS CONTAINING  
CONCRETE BLOCK FILLER  
COAT WAS IDENTIFIED  
THROUGHOUT THE PROJECT  
SPECIFIC AREAS

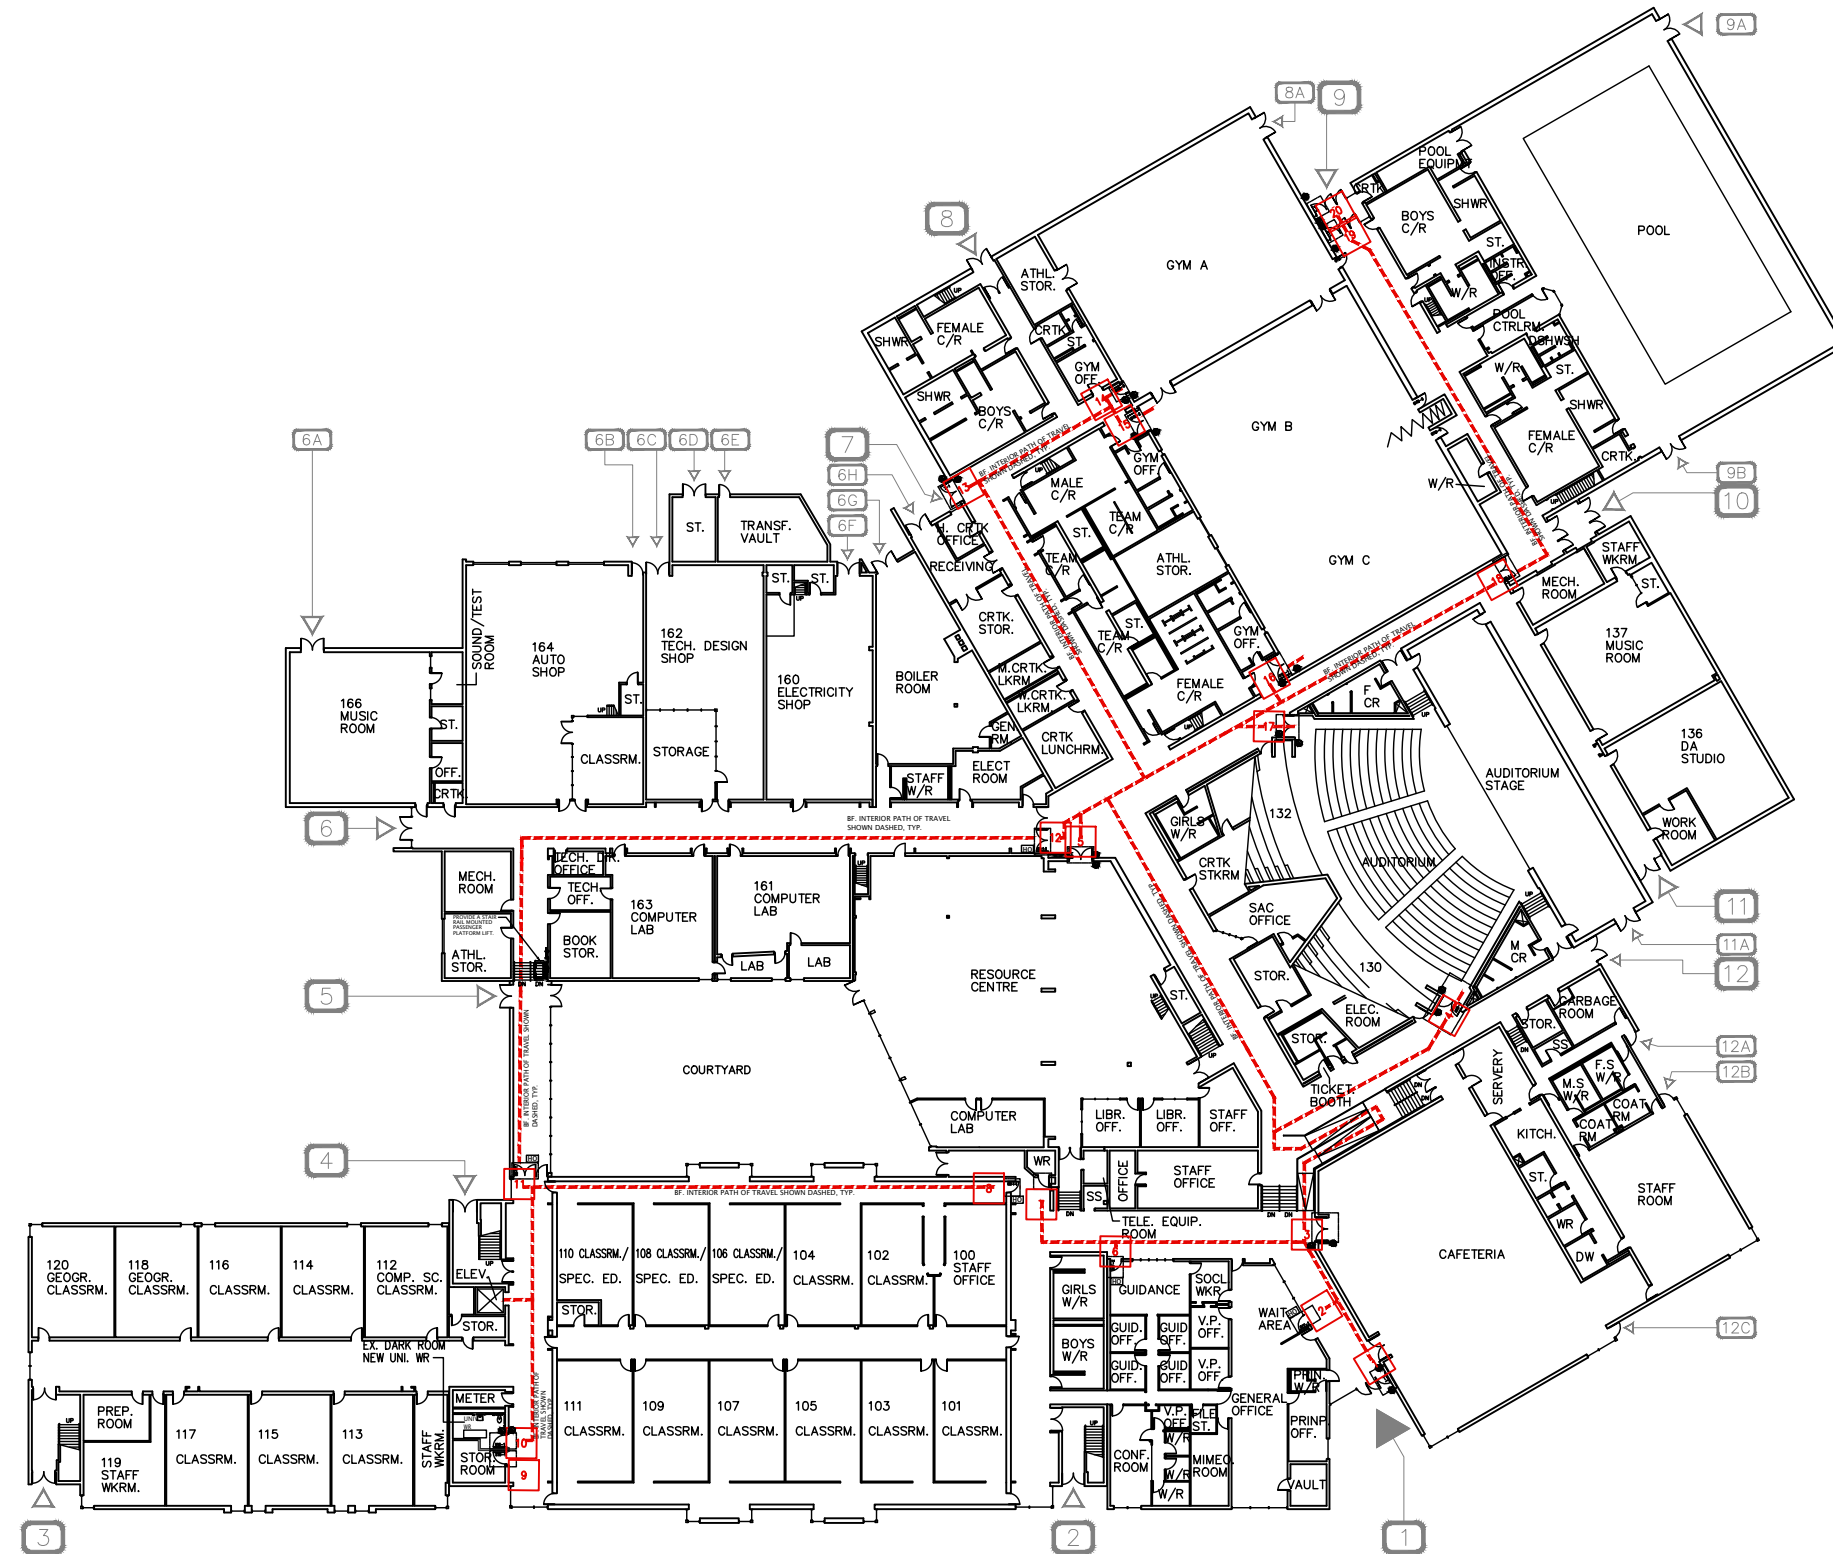
LEVEL 1

ASBESTOS CONTAINING  
CONCRETE BLOCK FILLER  
COAT WAS IDENTIFIED  
THROUGHOUT THE PROJECT  
SPECIFIC AREAS
