Designated Substances Survey

SAP # 3605 -Keele Street Public School -
Accessibility Project Work Locations
99 Mountview Ave
Toronto, Ontario

April 17, 2026
Project No. 32459

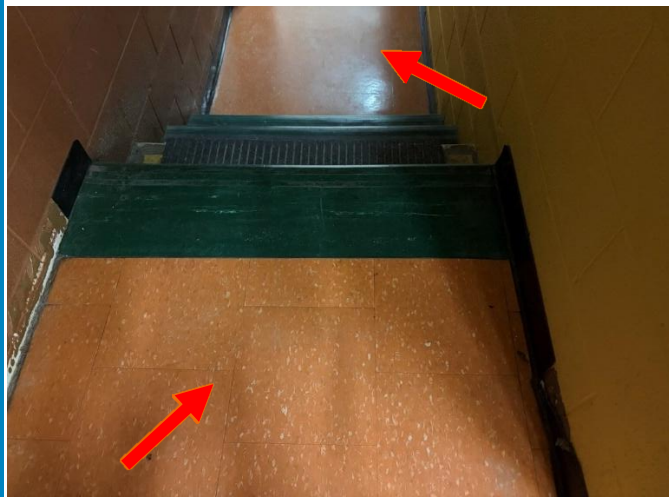
Photo 1: View of the asbestos-containing 12"x12" orange with dark orange, light orange and white flecks vinyl floor tiles (see arrows), with underlying non-asbestos-containing brown floor mastic observed within the basement stage area (Loc# 73832)

- 4) It is recommended that asbestos containing 12"x12" orange with dark/light orange and white flecks vinyl floor tiles in the Stage (Loc#73832) and 2'x4' small holes and pinholes in circular pattern in Entrance Vestibule (Loc# 48777) be removed following Type 1 asbestos work procedures as per O. Reg. 278/05 (as amended) where such materials are to be disturbed or impacted by the accessibility project work.

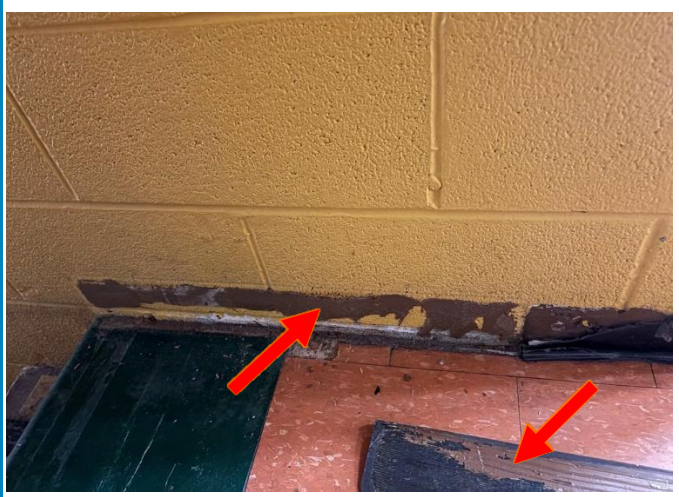
Photo 2: View of a portion of the non-asbestos-containing brown baseboard mastic (see arrows) observed within the basement stage area (Loc# 73832)

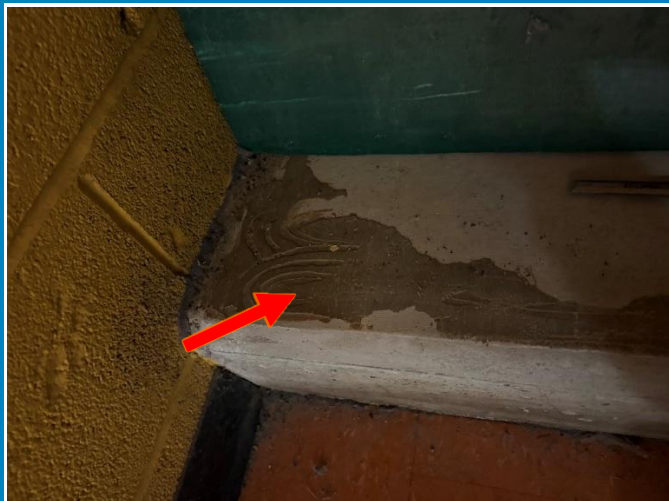
Photo 3: View of the non-asbestos-containing brown mastic (see arrow) observed under green vinyl sheet flooring on the stair within the basement stage area (Loc# 73832).

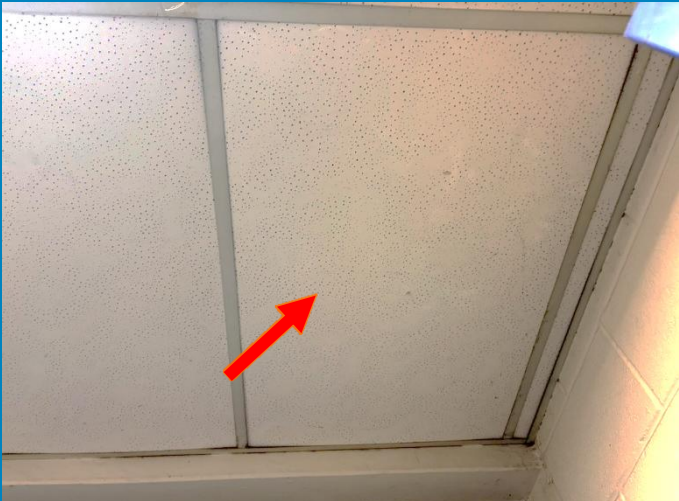
Photo 4: View of the asbestos-containing 2'x4' small holes and pinholes in circular pattern (see arrow) observed within the 2nd floor entrance vestibule (Loc# 48777)

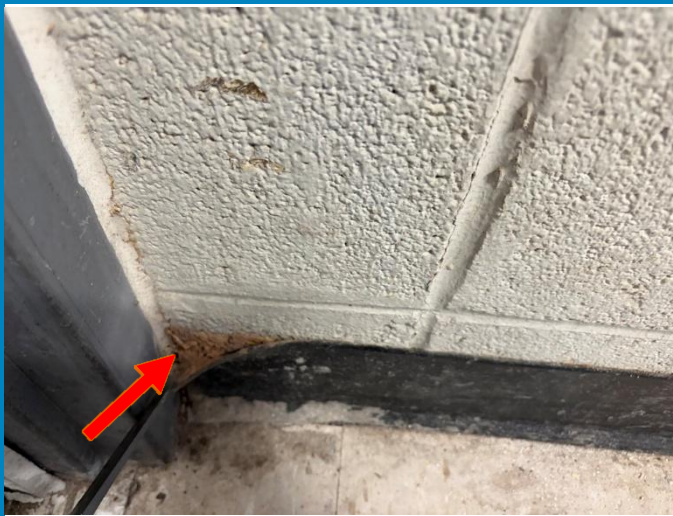
Photo 5: View of a portion of the non-asbestos-containing yellow baseboard mastic (see arrow) observed within the 2nd floor entrance vestibule (Loc# 48777)

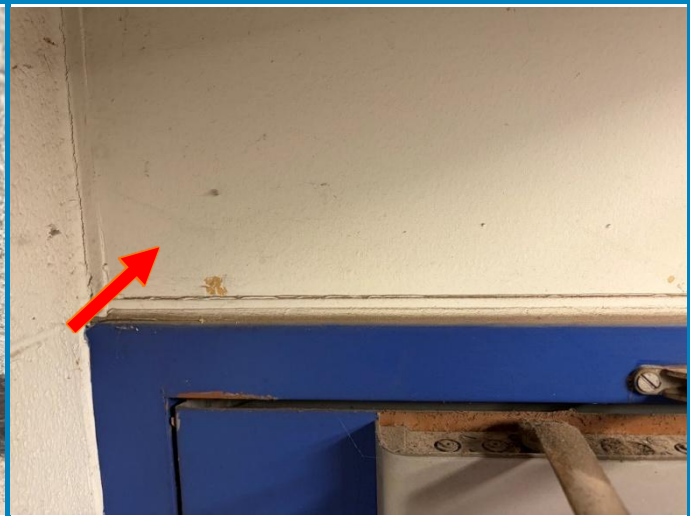
Photo 6: View of a wood panel, without joint compound, observed above the door within the 2nd floor entrance vestibule (Loc# 48777).

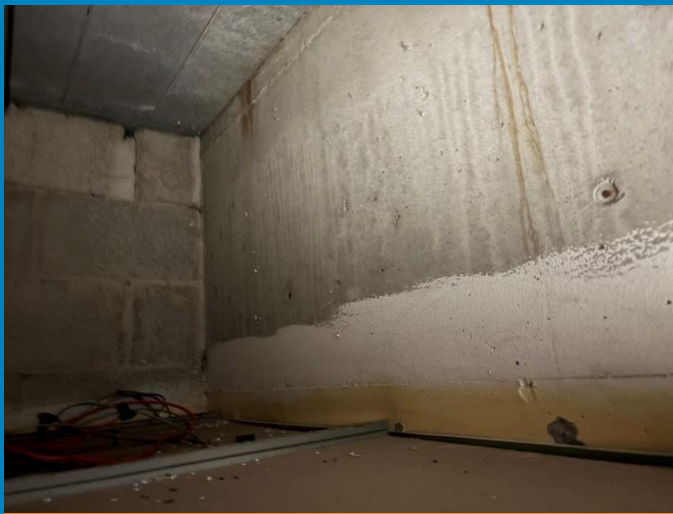
Photo 7: General view of the area above the ceiling tiles, where no suspect building materials were observed within the 2nd floor entrance vestibule (Loc# 48777).

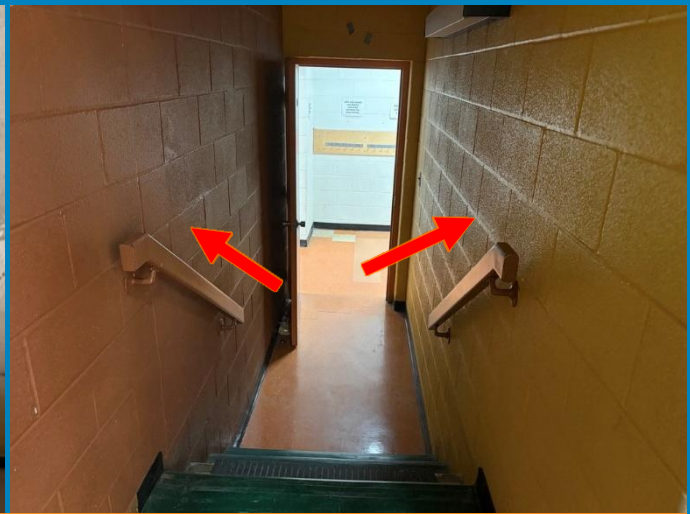
Photo 8: View of the red paint on the concrete wall (see left arrow) and yellow paint on concrete wall (see right arrow) within the basement stage area (Loc# 73832) that was determined to contain a lead concentration exceeding the 0.009% limit as outlined in the federal surface coating regulation.

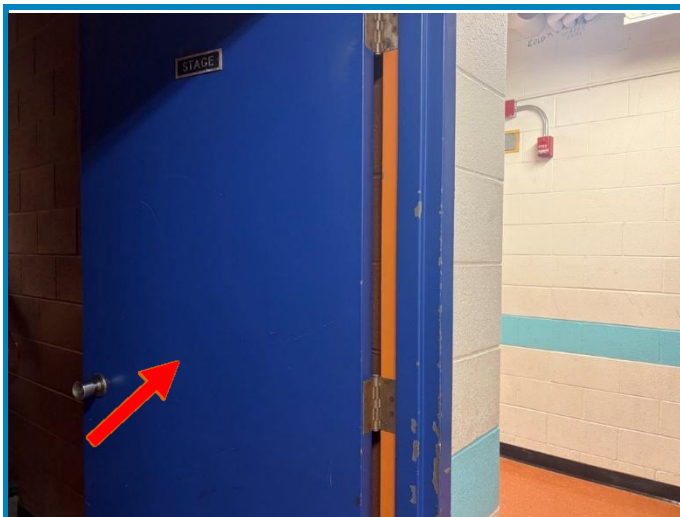
Photo 9: View of the blue paint on metal door within the basement stage area (Loc# 73832) that was determined to contain a lead concentration exceeding the 0.009% limit as outlined in the federal surface coating regulation. Paint of similar colour was also observed on doors in the basement storage room (Loc# 73834) and the 2nd floor entrance vestibule (Loc# 48777).

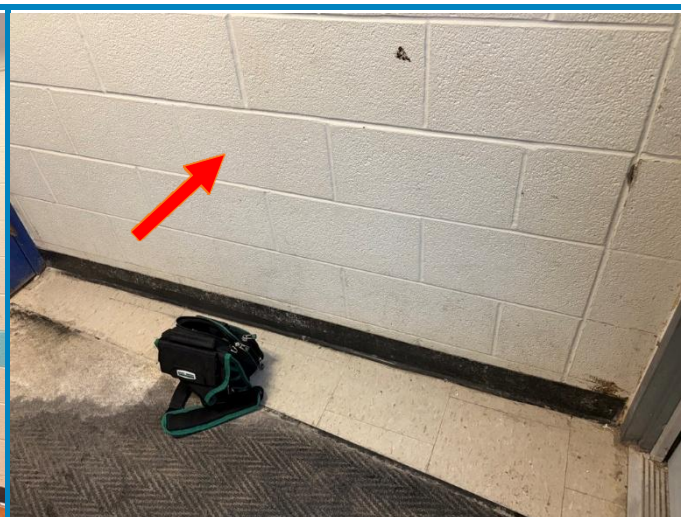
- White paint (Sample No. LS-04) on concrete wall in entrance vestibule (Loc# 48777) was determined to have a lead concentration exceeding the 0.009% limit as noted by the Federal Surface Coating Materials Regulation, SOR/2016-193 made under the Canada Consumer Product Safety Act; and
- Lead-acid batteries are presumed to be present in emergency light fixtures; and
- Lead may also be present in electronic components (e.g., wiring connections, wire bundles, etc.), and plumbing solder.

Photo 10: View of a concrete block (see arrow) with asbestos-containing white block sealant, along with white paint on the concrete wall that was determined to contain a lead concentration exceeding the 0.009% limit as outlined in the federal surface coating regulation, observed within the 2nd floor entrance vestibule (Loc# 48777).

- 5) It is recommended that asbestos containing white concrete block sealant be removed following Type 1 asbestos work procedures as per O. Reg. 278/05 (as amended) where the concrete block walls are to be disturbed or impacted by the planned accessibility project work.

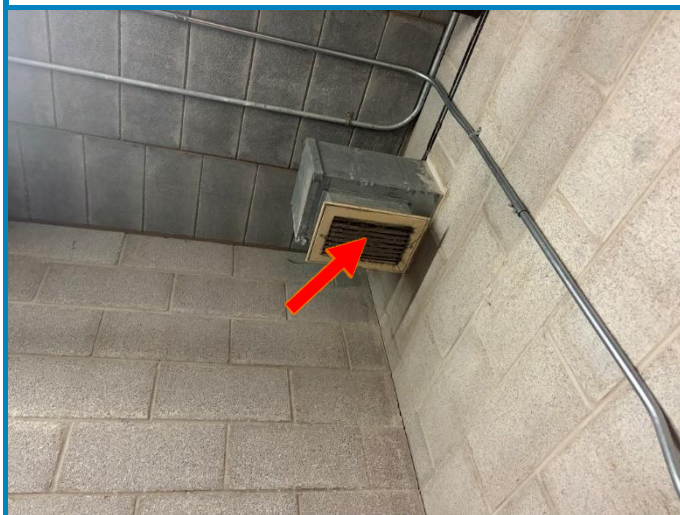
Photo 11: View of the existing exhaust ductwork (see arrow), which is planned to be relocated, appearing uninsulated with no caulking or tar observed in the basement storage room (Loc# 73834).

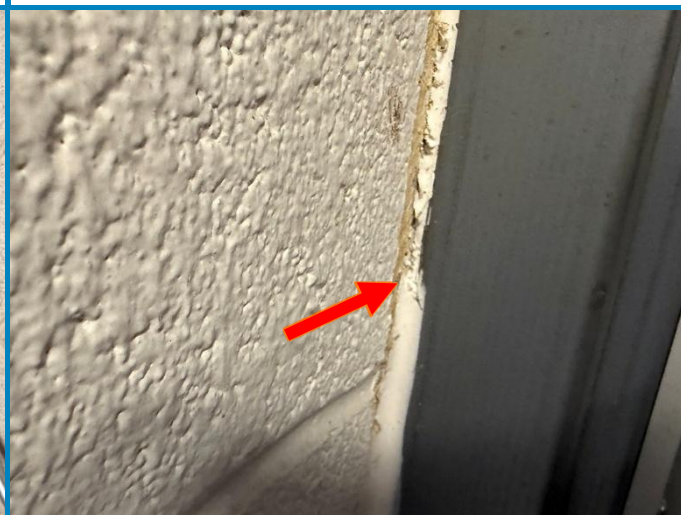
Photo 12: View of newly applied white caulking on the double door (see arrow), with no secondary layer observed beneath, observed within the 2nd floor entrance vestibule (Loc# 48777).

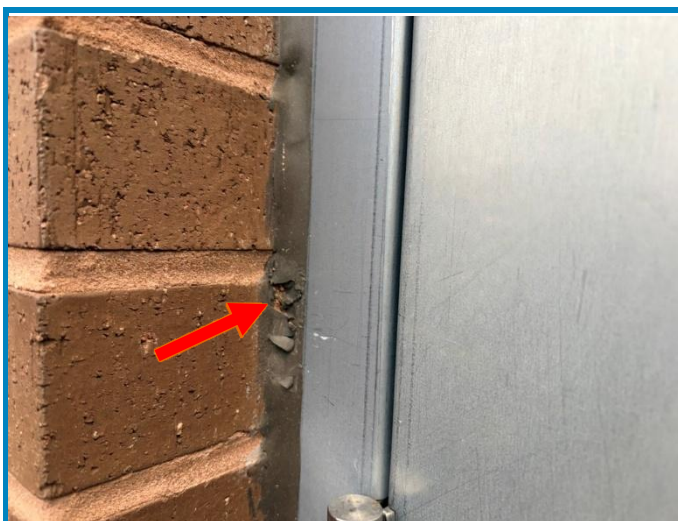
Photo 13: View of newly applied brown caulking on the double door (see arrow), with no secondary layer observed beneath, observed within the 2nd floor entrance vestibule (Loc# 48777).

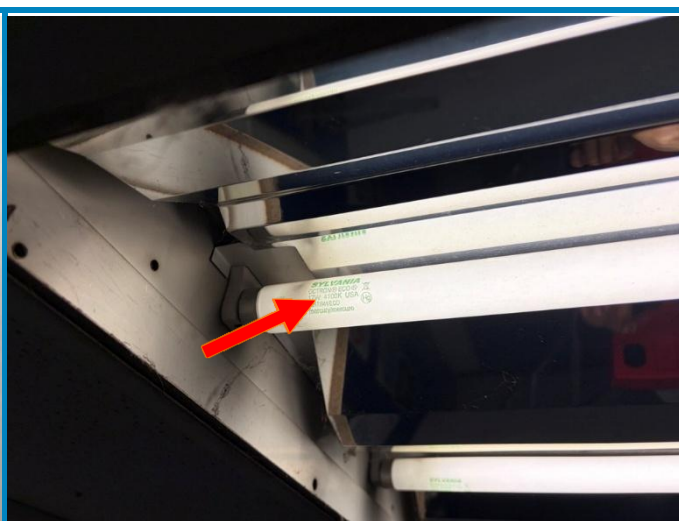
Mercury in the form of vapour may be present within the fluorescent light tubes throughout the accessibility project work locations. At the time of the site visit, fluorescent light tubes were noted to be intact.

Photo 14: View of the mercury containing light tubes observed in the basement storage room (Loc# 73834) and the 2nd floor entrance vestibule (Loc# 48777).

- 8) It is recommended that disposal of out-of-service fluorescent light tubes or any other mercury containing materials or equipment be completed in accordance with *General – Waste Management* Reg. 347 (as amended).
