Designated Substances Survey

SAP # 3679 – Parkdale Junior and Senior Public School
Accessibility Project Work Locations
78 Seaforth Avenue
Toronto, Ontario

April 17, 2026
Project No. 32460

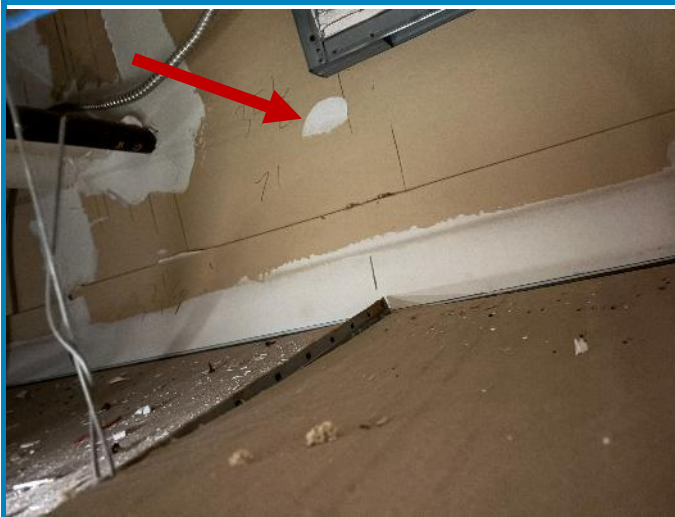
Photo 1: Partial view above ceiling showing drywall wall with non asbestos-containing joint compound (see arrow) that was observed within project work areas.

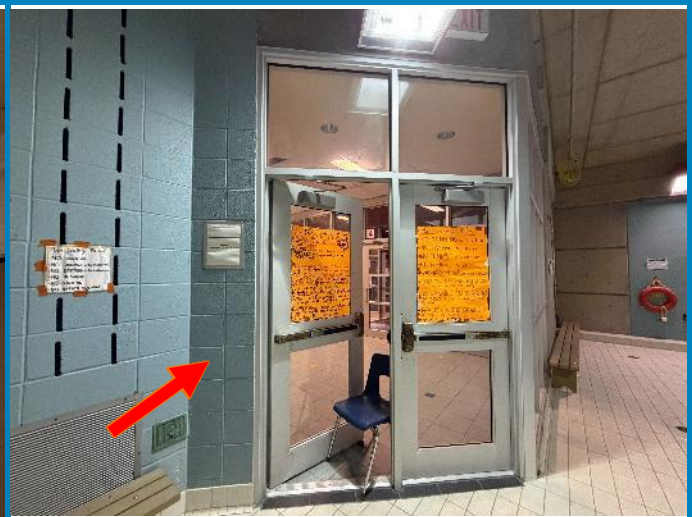
Photo 2: View of the non asbestos-containing blue/white paint compound/sealant (see arrow) observed on the concrete block walls within the Swimming Pool (Loc# 54477).

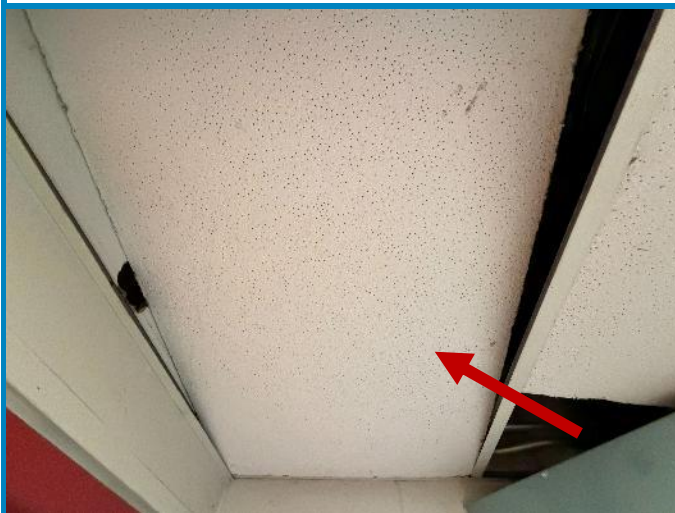
Photo 3: Typical view of the non-asbestos-containing 2'x4 textured pinholes acoustic ceiling tile (see arrow) observed in Corridor near Electrical Room 122 (Loc# 54465).

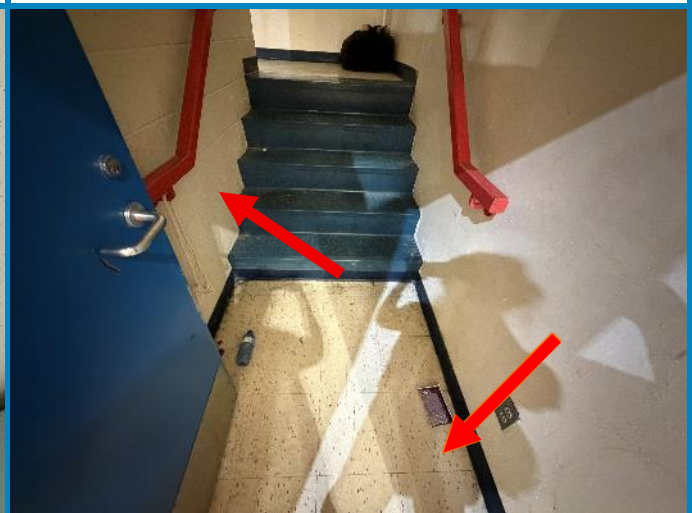
Photo 4: View of the non-asbestos containing 12"x12" white with red, blue, and yellow specks vinyl floor tiles (see right arrow) and non-asbestos containing concrete block mortar (see left arrow) observed within the stair of the stage (Loc# 54529) of the project work area.

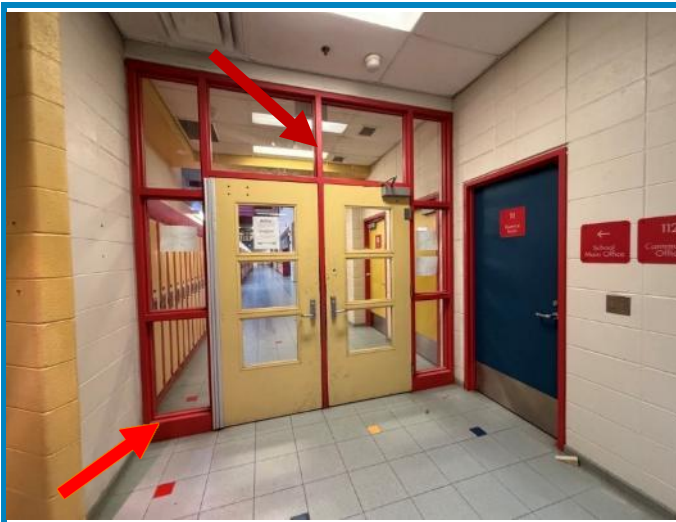
- Red and grey paint (Sample No. LS-02) on metal door frame in the 1st floor corridor (Loc# 54537 near Electrical Room (Loc# 104380), were determined to have a lead concentration exceeding the 0.009% limit as noted by the Federal Surface Coating Materials Regulation, SOR/2016-193 made under the Canada Consumer Product Safety Act;
- Lead-acid batteries are presumed to be present in emergency light fixtures; and
- Lead may also be present in electronic components (e.g., wiring connections, wire bundles, etc.) and plumbing solder.

Photo 5: Typical view of the red and grey (2nd layer) paint (see arrows) observed on metal door frame within the project work areas that was determined to contain a lead concentration exceeding the 0.009% limit as outlined in the federal surface coating regulation.

- 3) Appropriate worker protection (e.g., respiratory protection), as outlined in the Ontario Ministry of Labour *Guideline – Lead on Construction Projects*, April 2011, should be employed when conducting demolition or renovation work that will create lead dust.
- 4) It is recommended that disposal of out-of-service fluorescent light tubes or any other mercury containing materials or equipment be completed in accordance with *General – Waste Management* Reg. 347 (as amended).
- 5) Appropriate worker protection (e.g., respiratory protection), as outlined in the Ontario MOL *Guideline – Silica on Construction Projects*, April, 2011, should be utilized when conducting renovation/demolition activities that may disturb or create silica dust.

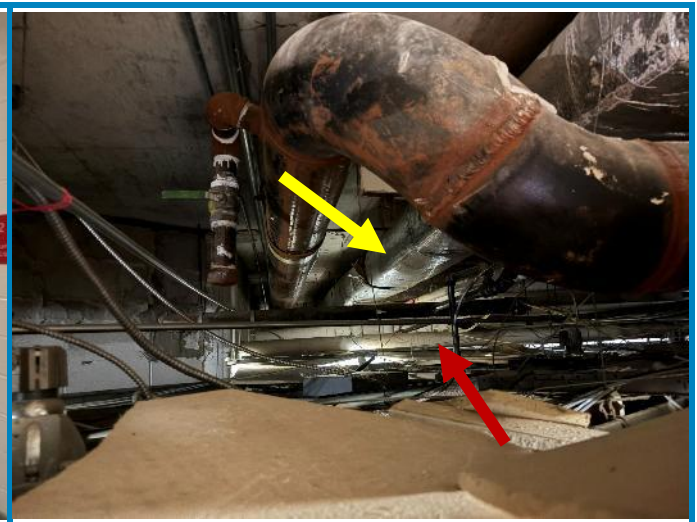
Photo 6: Partial view above ceiling showing the uninsulated pipe, insulated pipe with fibreglass (see red arrow), and duct work insulated fibreglass jacketed with foil (see yellow arrow).
