DESIGNATED SUBSTANCES AND HAZARDOUS BUILDING MATERIALS ASSESSMENT REPORT

**Roof Replacement & Window Rehabilitation Project
Eva Phoenix Transitional Housing
60 Brant Street
Toronto, Ontario**

Safetech Project Number: 1-3260479

**Date of Site Work: May 29, 2026
Date of Issue: June 8, 2026**

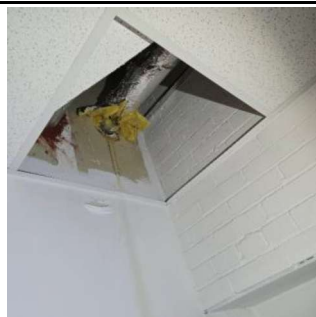
Sprayed Texture / Stucco Finishes	None identified in areas assessed.	
Plaster Finishes	None identified in areas assessed.	
Drywall Joint Compound	Drywall joint compound was observed in the areas assessed. Bulk samples were collected during the assessment and results of analysis confirmed that this building material is not asbestos-containing. Refer to sample set 13 in Table 2.

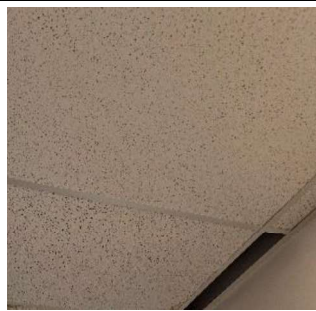
Ceiling Tiles	Location/Description	
Lay-in Acoustic Ceiling Tiles	2'x4' ceiling tile – small and medium pinholes were observed in the subject areas. Based on the date stamp observed on the back of the ceiling tiles, the material is expected to be not asbestos-containing.

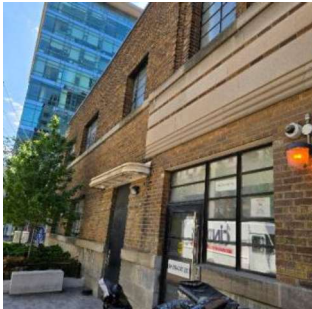
Brick Mortar	Brick Mortar was observed in the areas assessed. Bulk samples were collected during the assessment and results of analysis confirmed that this building material is not asbestos-containing. Refer to sample set 9 in Table 2.

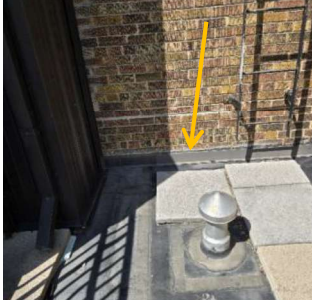
Caulking	Black remnant caulking above flashing was observed in the areas assessed. Bulk samples were collected during the assessment and results of analysis confirmed that this building material contains 2% chrysotile asbestos. Refer to sample set 12 in Table 2 and the location, condition, friability, and estimated quantity in Appendix I.

Caulking: The black remnant caulking above flashing is considered to be a non-friable ACM. As per O. Reg. 278/05, removal of non-friable ACM can be conducted following Type 1 operations; as long as the material can be removed without being broken, cut, drilled or otherwise similarly disturbed. If the material cannot be removed without it breaking or being similarly disturbed then the work should be conducted using non-powered hand tools and the material should be wetted to control the spread of dust. If the material cannot be wetted or if power tools attached to dust-collecting devices equipped with HEPA (high efficiency particulate aerosol) filters are used during removal or disturbance, then work should be performed following Type 2 operations. If non-friable materials are removed or disturbed using power tools that are not attached to dust-collecting devices that are equipped with HEPA filters then work should be conducted following Type 3 operations.

Removal or disturbance of identified asbestos-containing materials must be conducted in accordance with O.Reg. 278/05. Asbestos containing materials in Poor condition must be removed and/or repaired immediately following applicable asbestos abatement procedures. Asbestos-containing materials in Good condition can remain in place until major system upgrading, maintenance or demolition which could result in disturbance of this material.

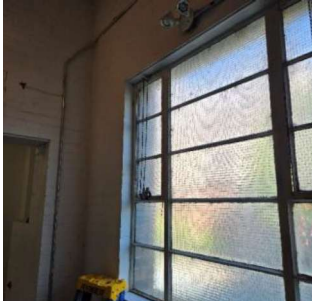
Hard window glazing was observed in the areas assessed. Bulk samples were collected during the assessment and results of analysis confirmed that this building material is not asbestos-containing. Refer to sample set 10 in Table 2.

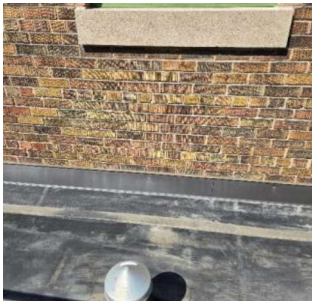
Brown caulking was observed in the areas assessed. Bulk samples were collected during the assessment and results of analysis confirmed that this building material is not asbestos-containing. Refer to sample set 11 in Table 2.

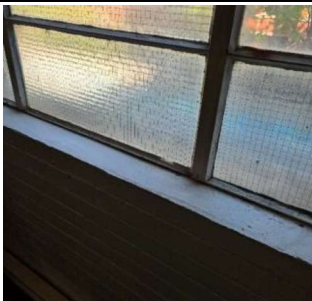
Soft White caulking was observed in the areas assessed. Bulk samples were collected during the assessment and results of analysis confirmed that this building material is not asbestos-containing. Refer to sample set 14 in Table 2.

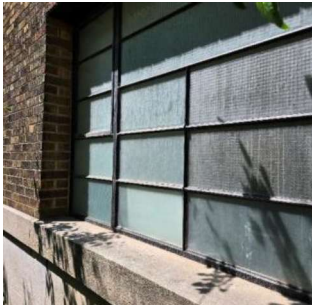
Caulking (Continued)	Window glass glazing was observed in the areas assessed. Bulk samples were collected during the assessment and results of analysis confirmed that this building material is not asbestos-containing. Refer to sample set 15 in Table 2.

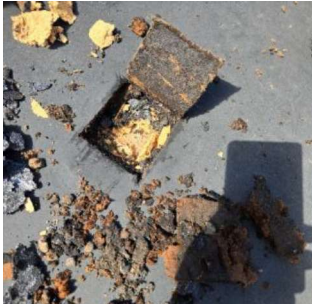
Roof Membrane	Roof Felt associated with the lower roof area was observed in the areas assessed. Bulk samples were collected during the assessment and results of analysis confirmed that this building material is not asbestos-containing. Refer to sample set 1 in Table 2.

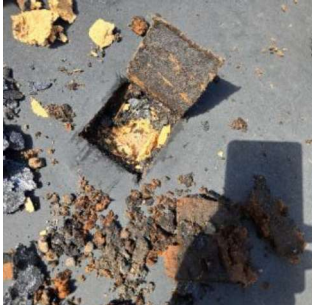
EPDM Membrane associated with the lower roof areas was observed in the areas assessed. Bulk samples were collected during the assessment and results of analysis confirmed that this building material is not asbestos-containing. Refer to sample set 2 in Table 2.

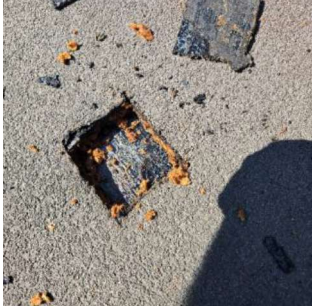
Capsheet associated with the roof area above the stairs was observed in the areas assessed. Bulk samples were collected during the assessment and results of analysis confirmed that this building material is not asbestos-containing. Refer to sample set 3 in Table 2.

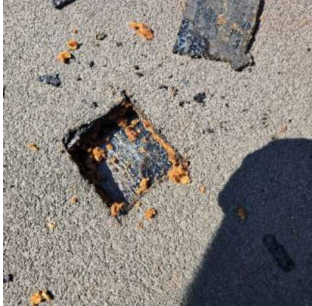
Vapour Barrier associated with the roof area above the stairs was observed in the areas assessed. Bulk samples were collected during the assessment and results of analysis confirmed that this building material is not asbestos-containing. Refer to sample set 4 in Table 2.

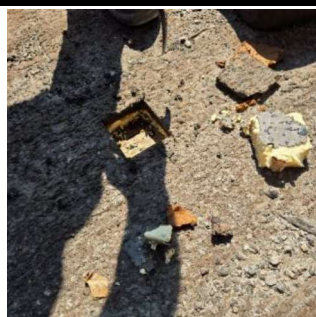
Roof Membrane (Continued)	Roof Felt associated with the upper roof was observed in the areas assessed. Bulk samples were collected during the assessment and results of analysis confirmed that this building material is not asbestos-containing. Refer to sample set 5 in Table 2.

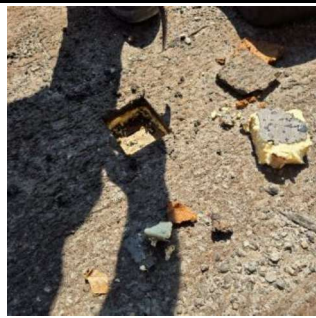
Vapour Barrier associated with the upper roof was observed in the areas assessed. Bulk samples were collected during the assessment and results of analysis confirmed that this building material is not asbestos-containing. Refer to sample set 6 in Table 2.

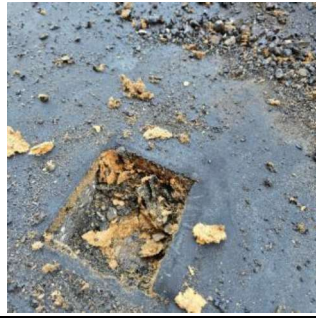
Old roof felt associated with the doghouse/ lower roof area observed in the areas assessed. Bulk samples were collected during the assessment and results of analysis confirmed that this building material is not asbestos-containing. Refer to sample set 7 in Table 2.

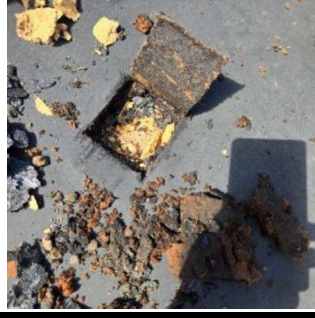
Vapour Barrier associated with the lower roof was observed in the areas assessed. Bulk samples were collected during the assessment and results of analysis confirmed that this building material is not asbestos-containing. Refer to sample set 8 in Table 2.

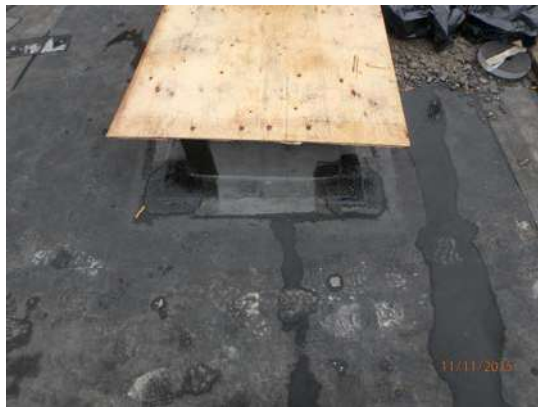
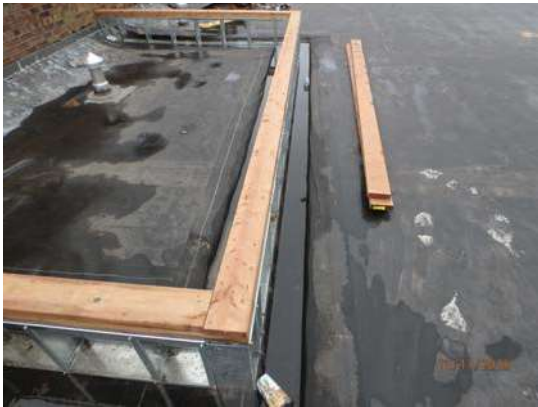
These bases have been flashed in with the appropriate materials; the work was acceptable.

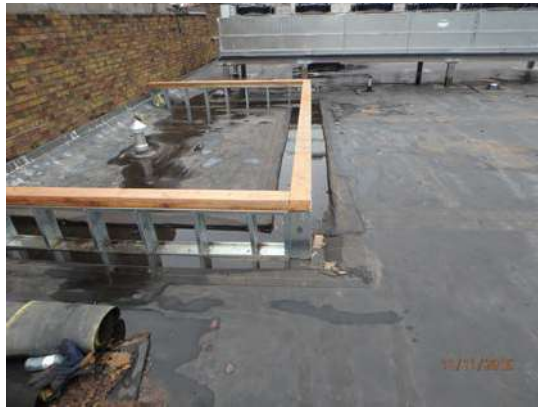
Picture 151

These two areas are stub walls to support later construction. Nortex used modified bituminous felt to line the cut through the old roof so the bottom track of the stud wall bears on the original wood. This is a dubious choice as EPDM and asphalt do not go well together.

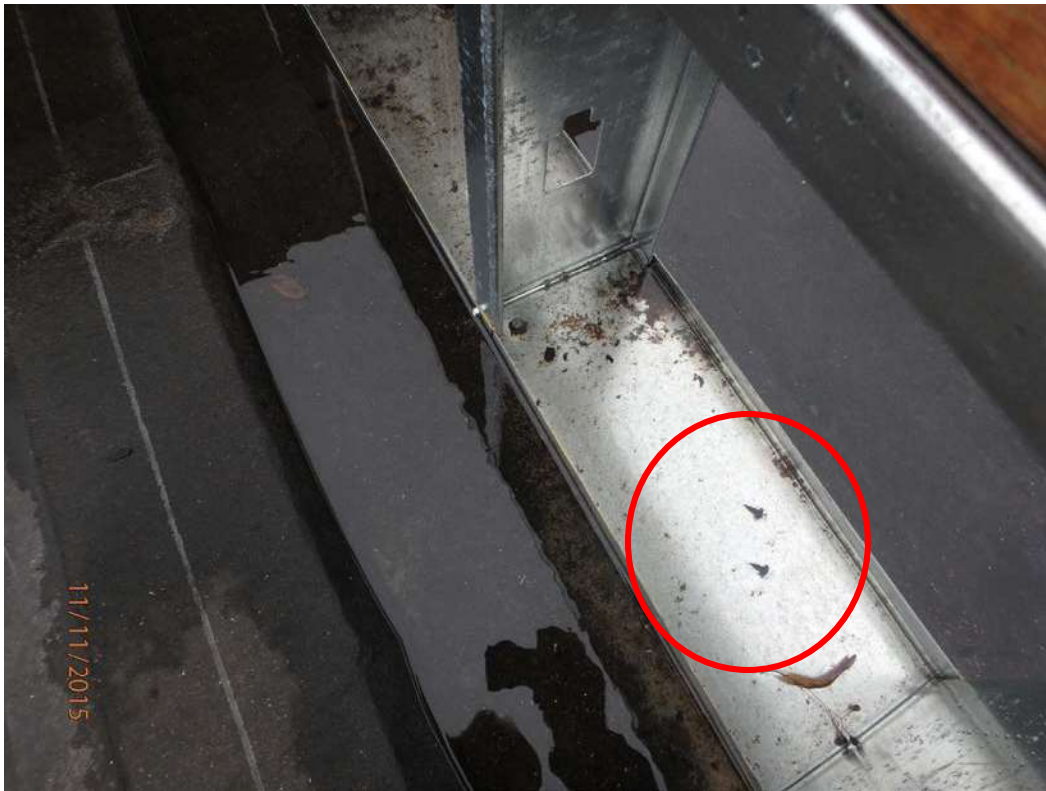
Picture 152

The recess has filled with rainwater and leaks are occurring. As the temporary roof is penetrated every few feet with screws holding the track leaks are inevitable. If the substrate can be dried a butyl sealant like Tremco TRS600 applied to each side of the track and all screw heads and track joints would lessen if not prevent leaking.

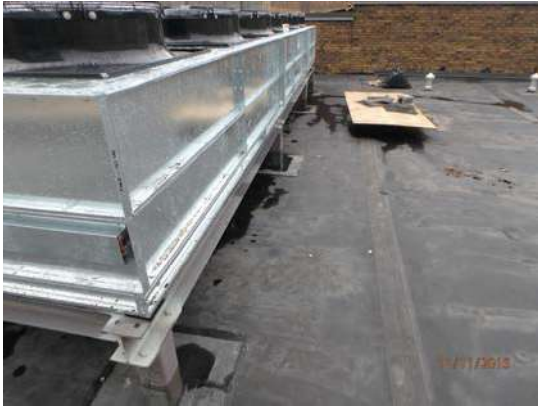
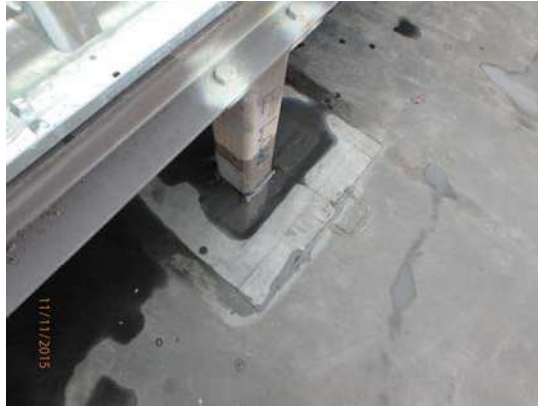
The chillers at the North side are flashed in, they are watertight but more work has to be done to complete the flashing.

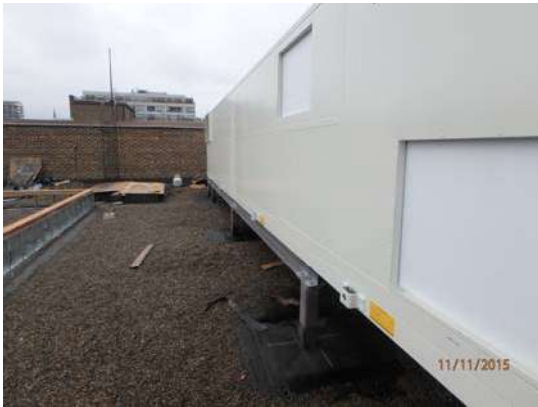
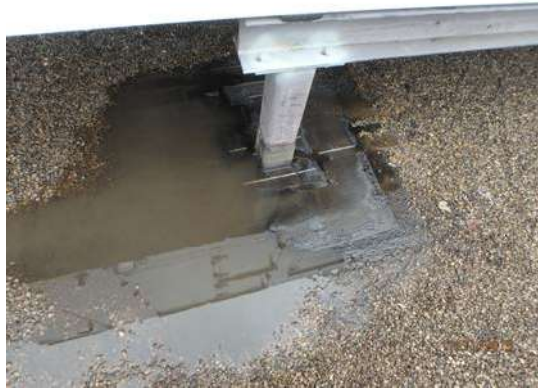
The large unit at the North end sits on structural posts. Re-roofing under the unit will be a challenge. The structural posts are sealed with a base ply and this will be strengthened when the new roof is installed.

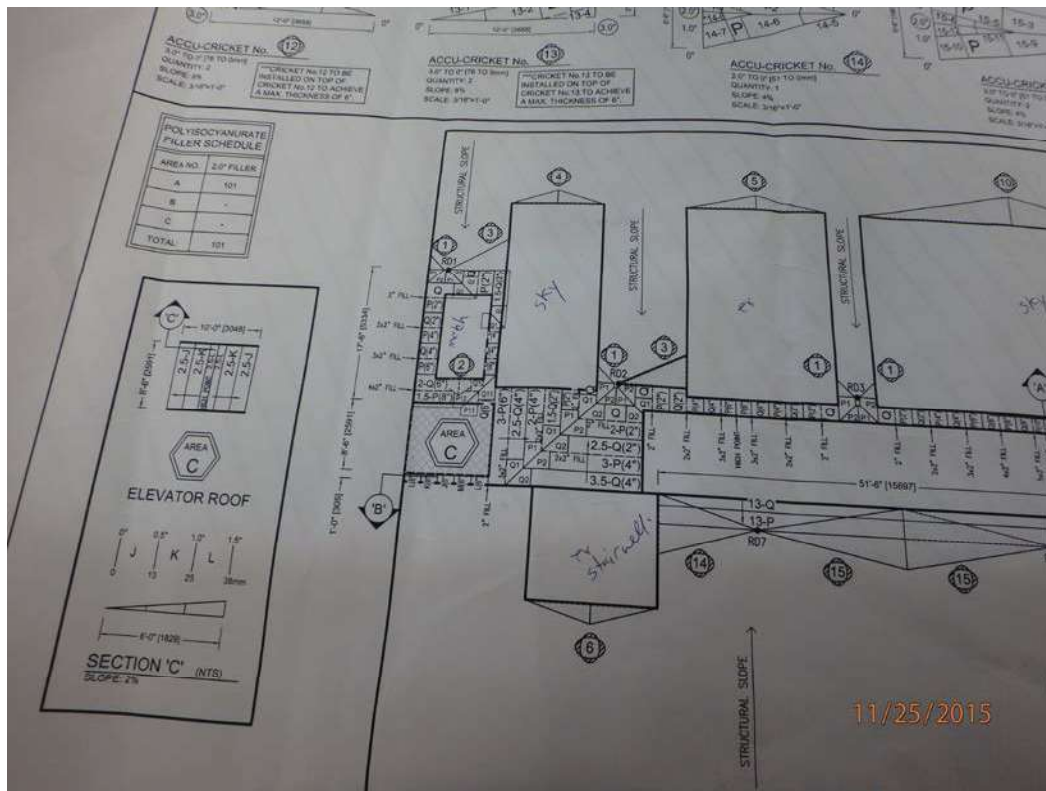
Picture 400

1. At the new elevator structure the tapered insulation [Section B on the tapered drawing] was not installed as there was some problem with the shaft. I advised the roofer to roof in open "end" of the tapered insulation as it may be days before this area is released.

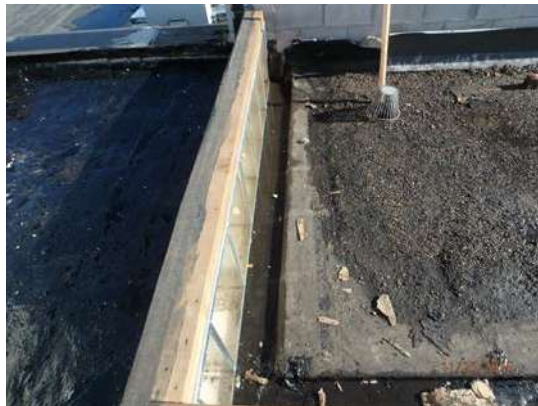
Picture 399

4. The cuts in the existing roofs to allow the steel track and studs to be installed are a potential problem. Rainwater can collect on the skylight side of the stub wall and then seep under the track and could wet the new roof. This was discussed on site and Somerville intends to dry out the recess and seal the track and the securing screws as soon as possible. Some of these openings could be uncovered until January I understand. Temporary roofs of tarps would be a more reliable cover as if a head of water develops the new roof may be compromised.

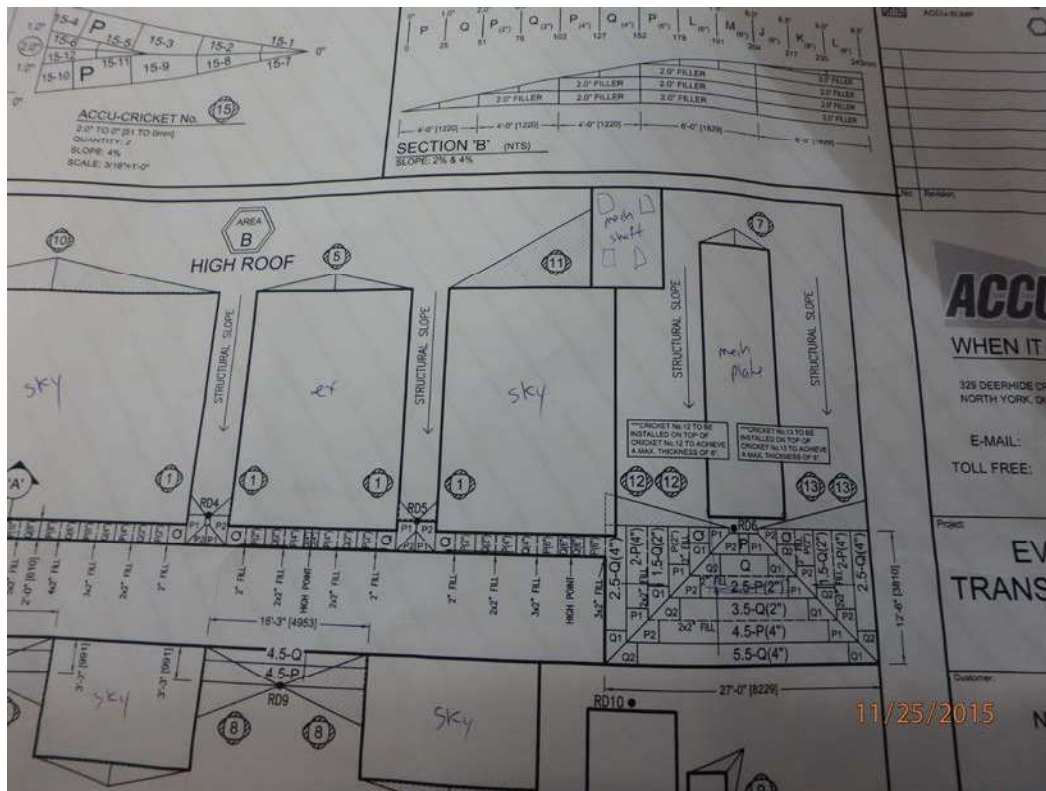
Picture 401

5. As the Northwest corner the change in the curbs has led to some changes to the tapered insulation. The crew is altering the details of the layout in response to these changes.

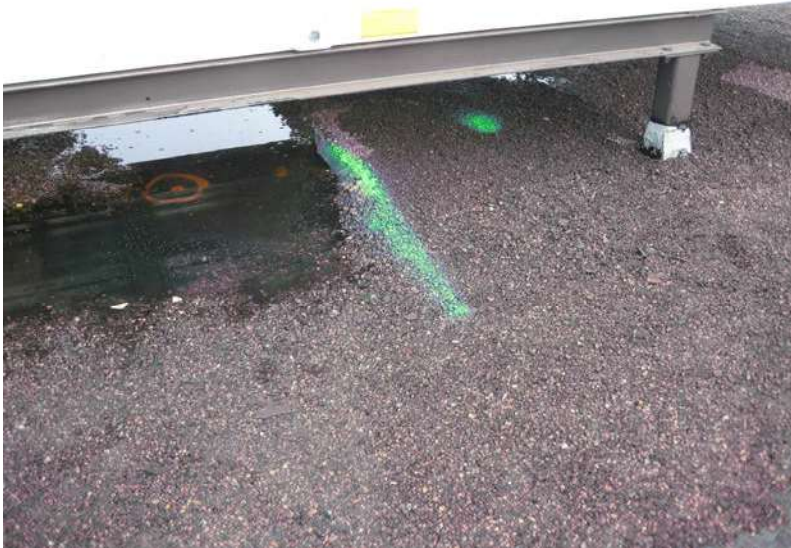
Picture 002

There has been an error in the layout of the North drain. In the picture the orange spot is where the roofer thought the drain was going, the green spot is nearer to the correct position.

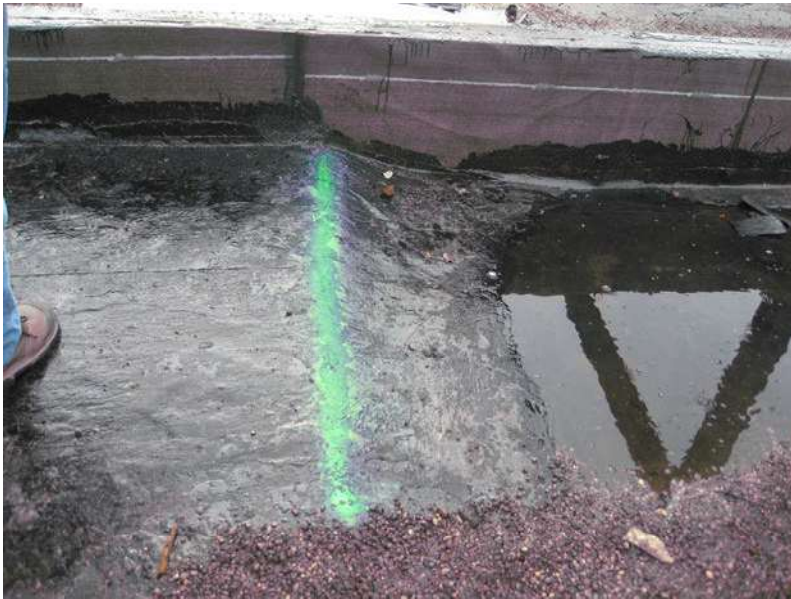
Picture 003

At the same area the tapered insulation is laid as per the drawing but it has resulted in an incorrect slope. Nortex are contracting Accuplane to find a way to smooth out the transition between the new slope and the existing roof.

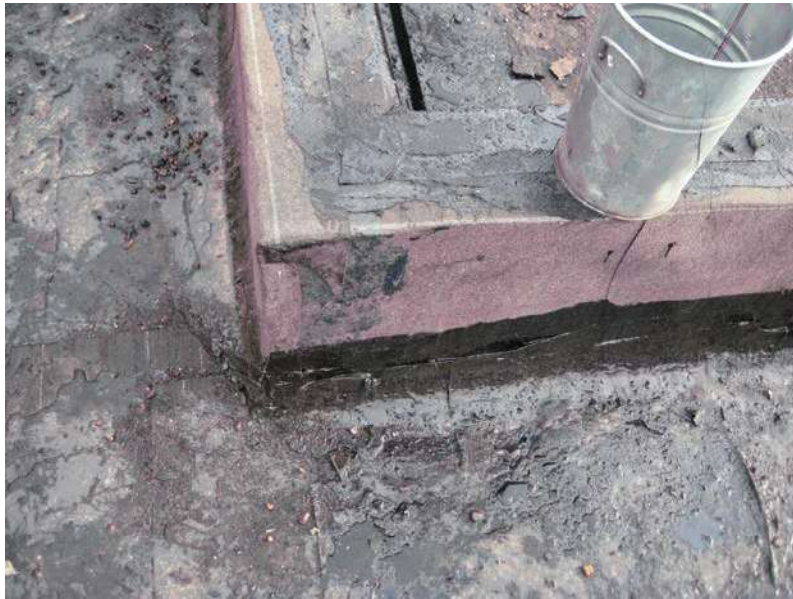
Picture 009

The crew have not sealed the top of the plies and leaks are occurring.

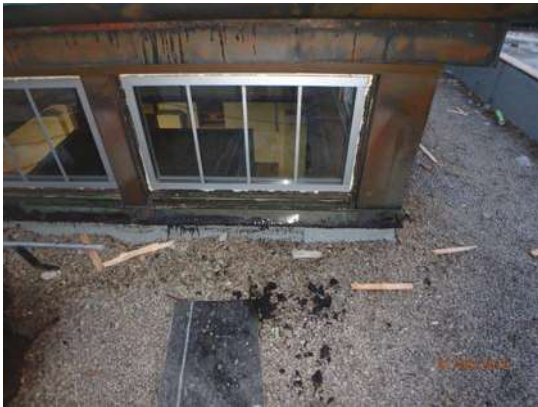
Picture 1080

4. The much discussed flashings at the West end of the monitor roofs turned out well with adequate flashing height. The original copper counter flashing must be cleaned of asphalt.

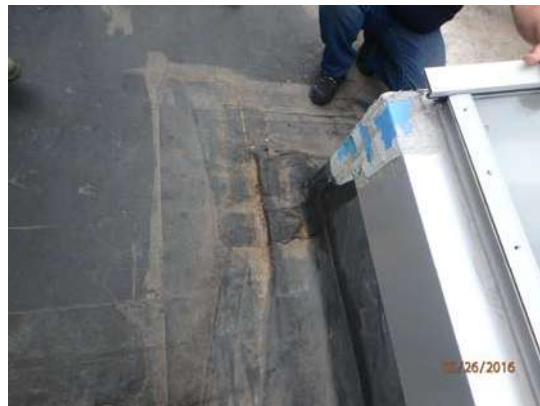
Picture 329

The Southeast corner of the skylight is irregular and Nortex will cut out the corner, insert a piece of tapered fibreboard and recover with E.P.D.M. sheet.

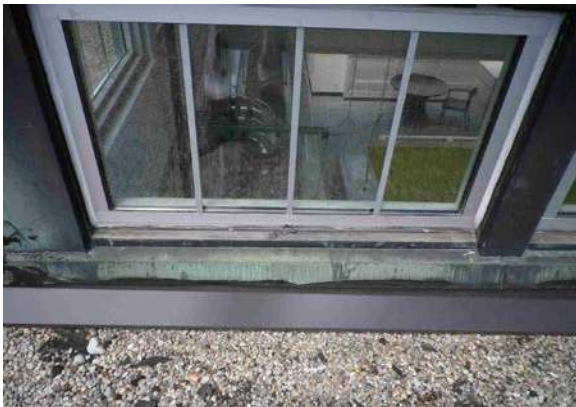
When water was sprayed on the north-east corner of the north wood/copper clad clearstory water leaked into the building at the same location as the reported leak during recent rains. On investigation, we found that there were unsealed screw holes on the top surface of the existing copper flashing that enabled water to enter the clearstory wall and into the building. West Metro subsequently caulked the open screw holes and seams on the top surface of the copper flashing.
