DESIGNATED SUBSTANCES AND HAZARDOUS MATERIALS REASSESSMENT REPORT

**Eva Phoenix Transitional Housing
60 Brant Street
Toronto, Ontario
M5V 3G9**

Date of Issue: November 19, 2025
Safetech Project # 1-3250872

RE: Designated Substances and Hazardous Materials Reassessment
Eva Phoenix Transitional Housing
60 Brant Street, Toronto, Ontario

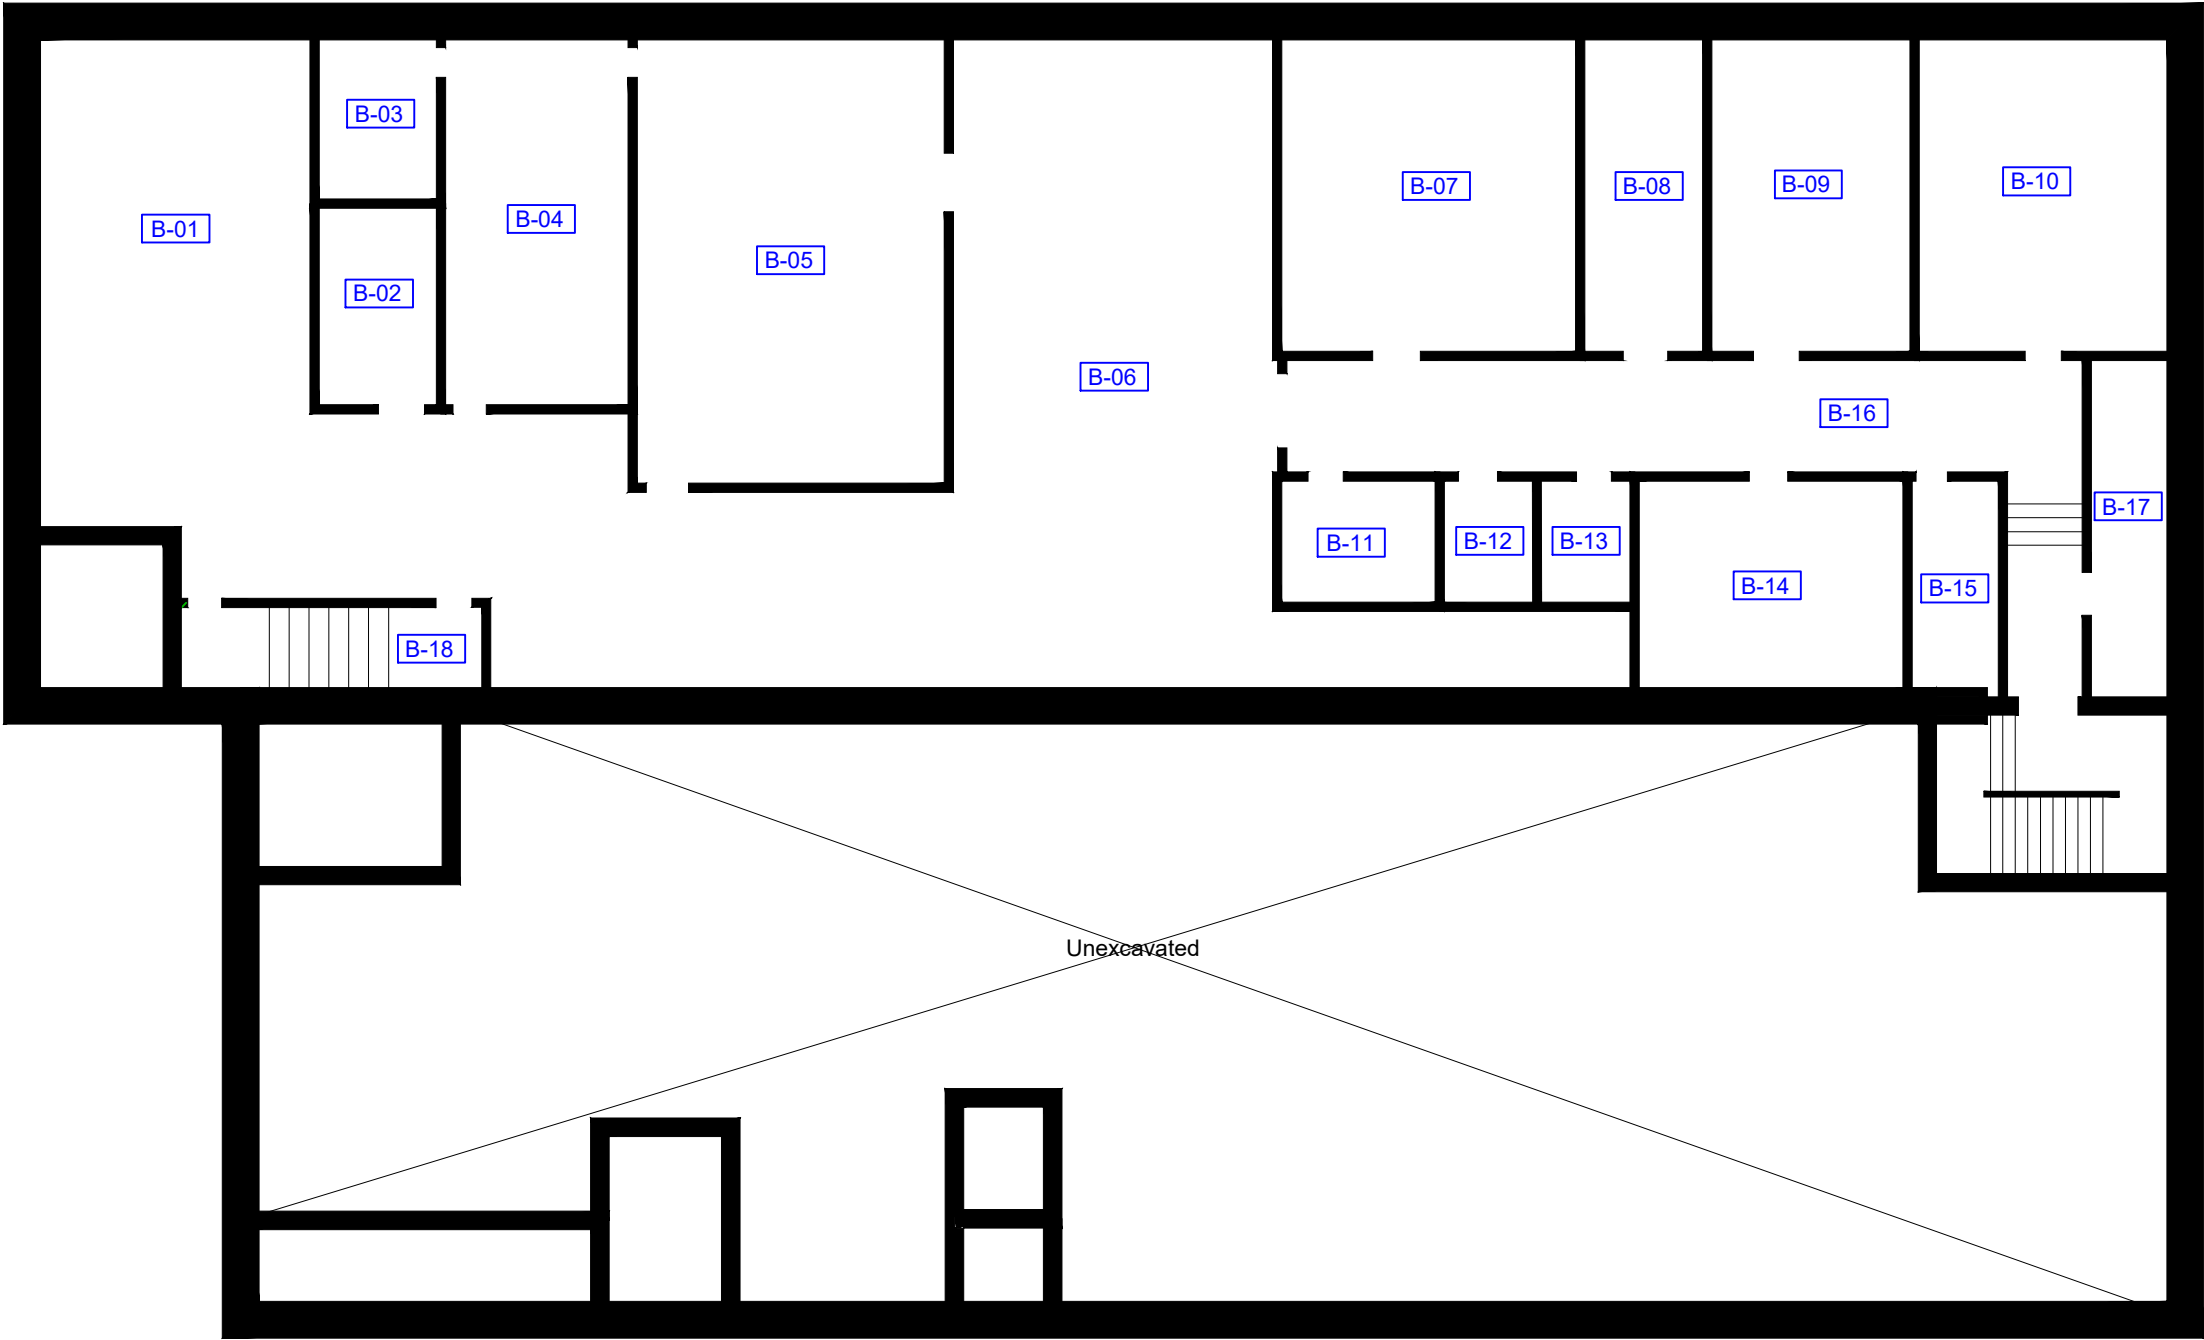
BASEMENT

Note: Mastic associated
with flooring is
suspected to be
asbestos-containing.

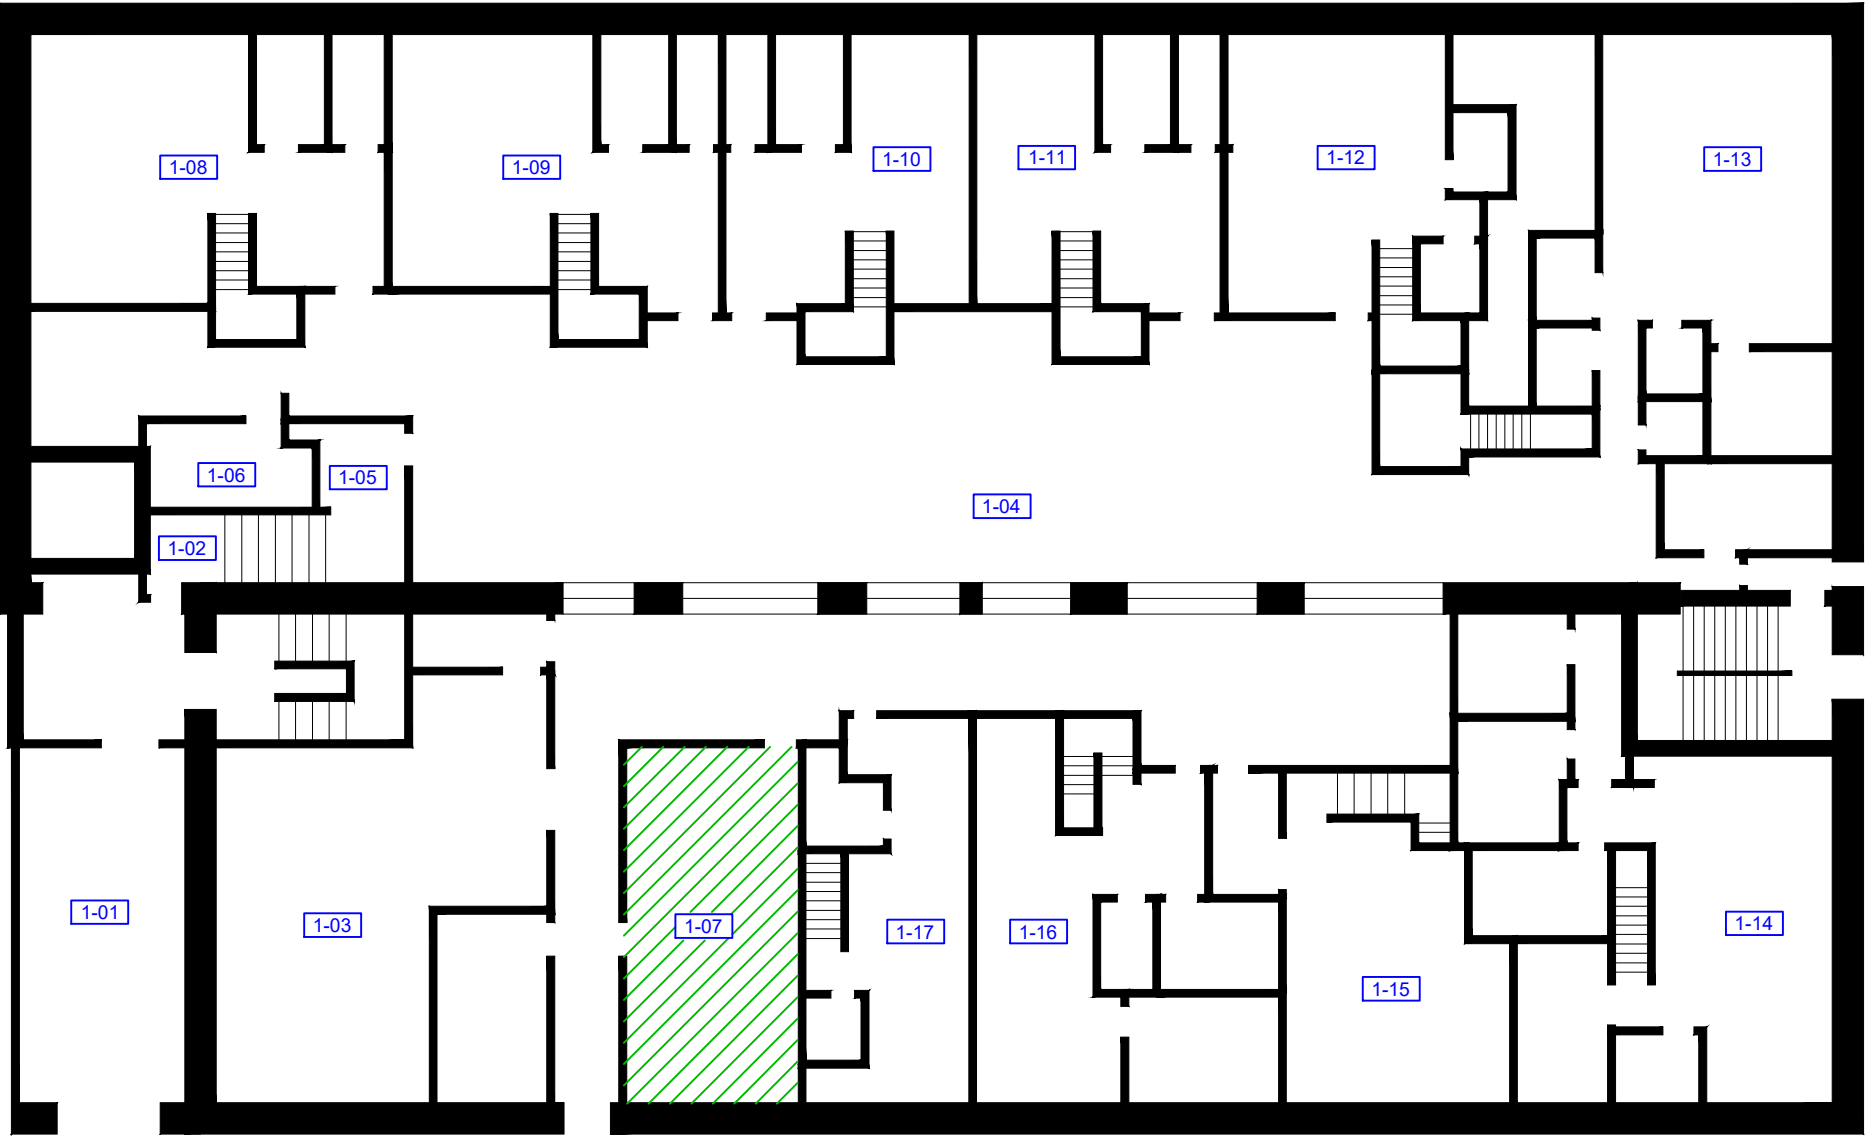
1ST FLOOR

Note: Mastic associated
with flooring is
suspected to be
asbestos-containing.

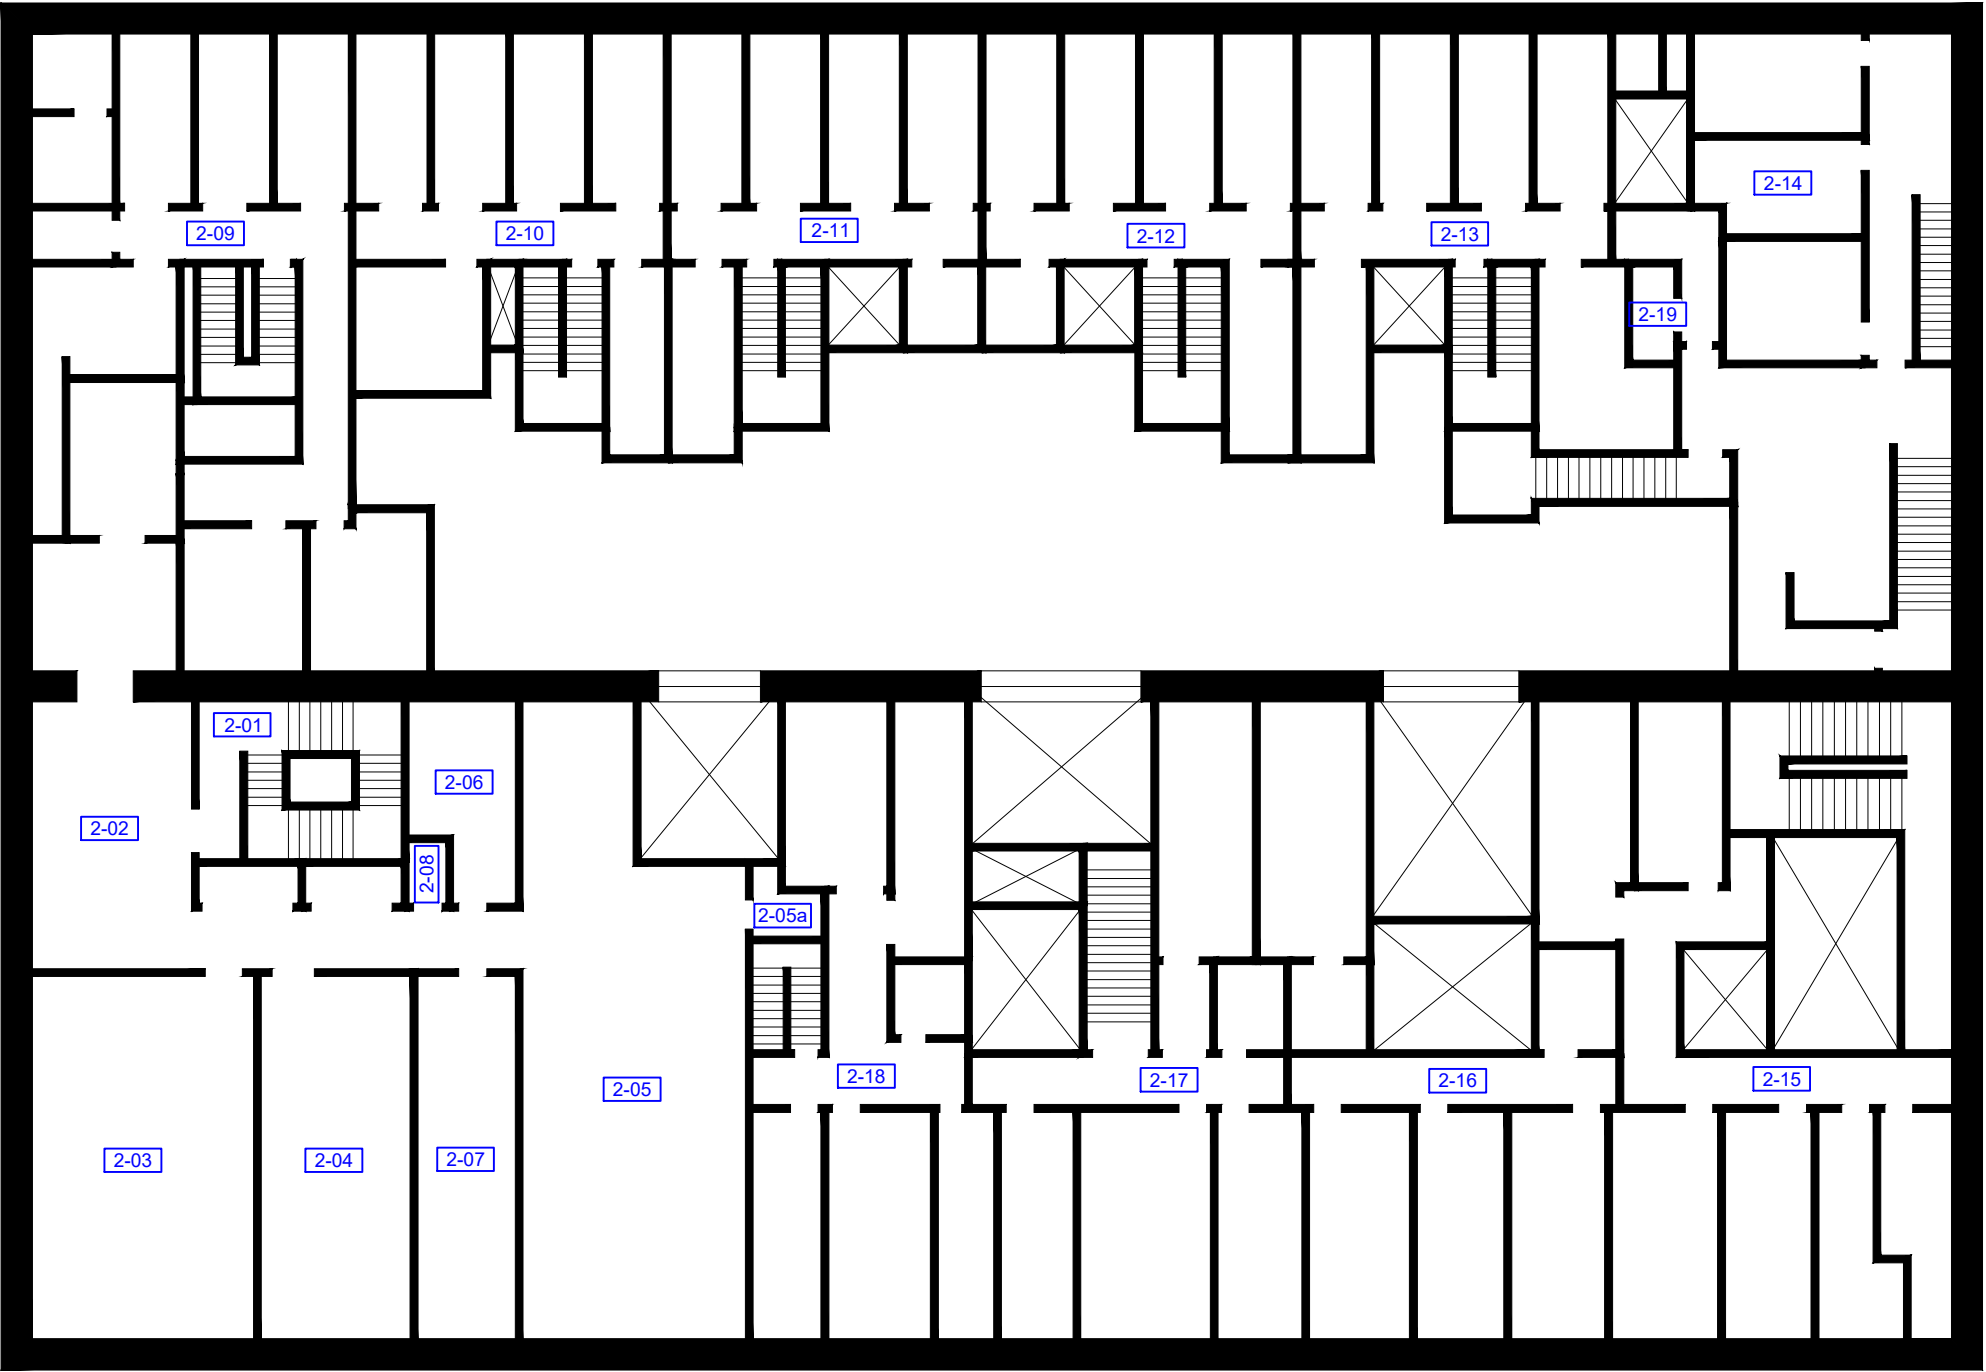
2ND FLOOR	DRAWING NO.
CoT SHELTERS - 2025 ANNUAL REASSESSMENTS	DS-3
60 BRANT STREET	DATE: OCTOBER 2025
	SAFETECH PROJECT NO. 1-3250872

Note: Mastic associated with flooring is suspected to be asbestos-containing.

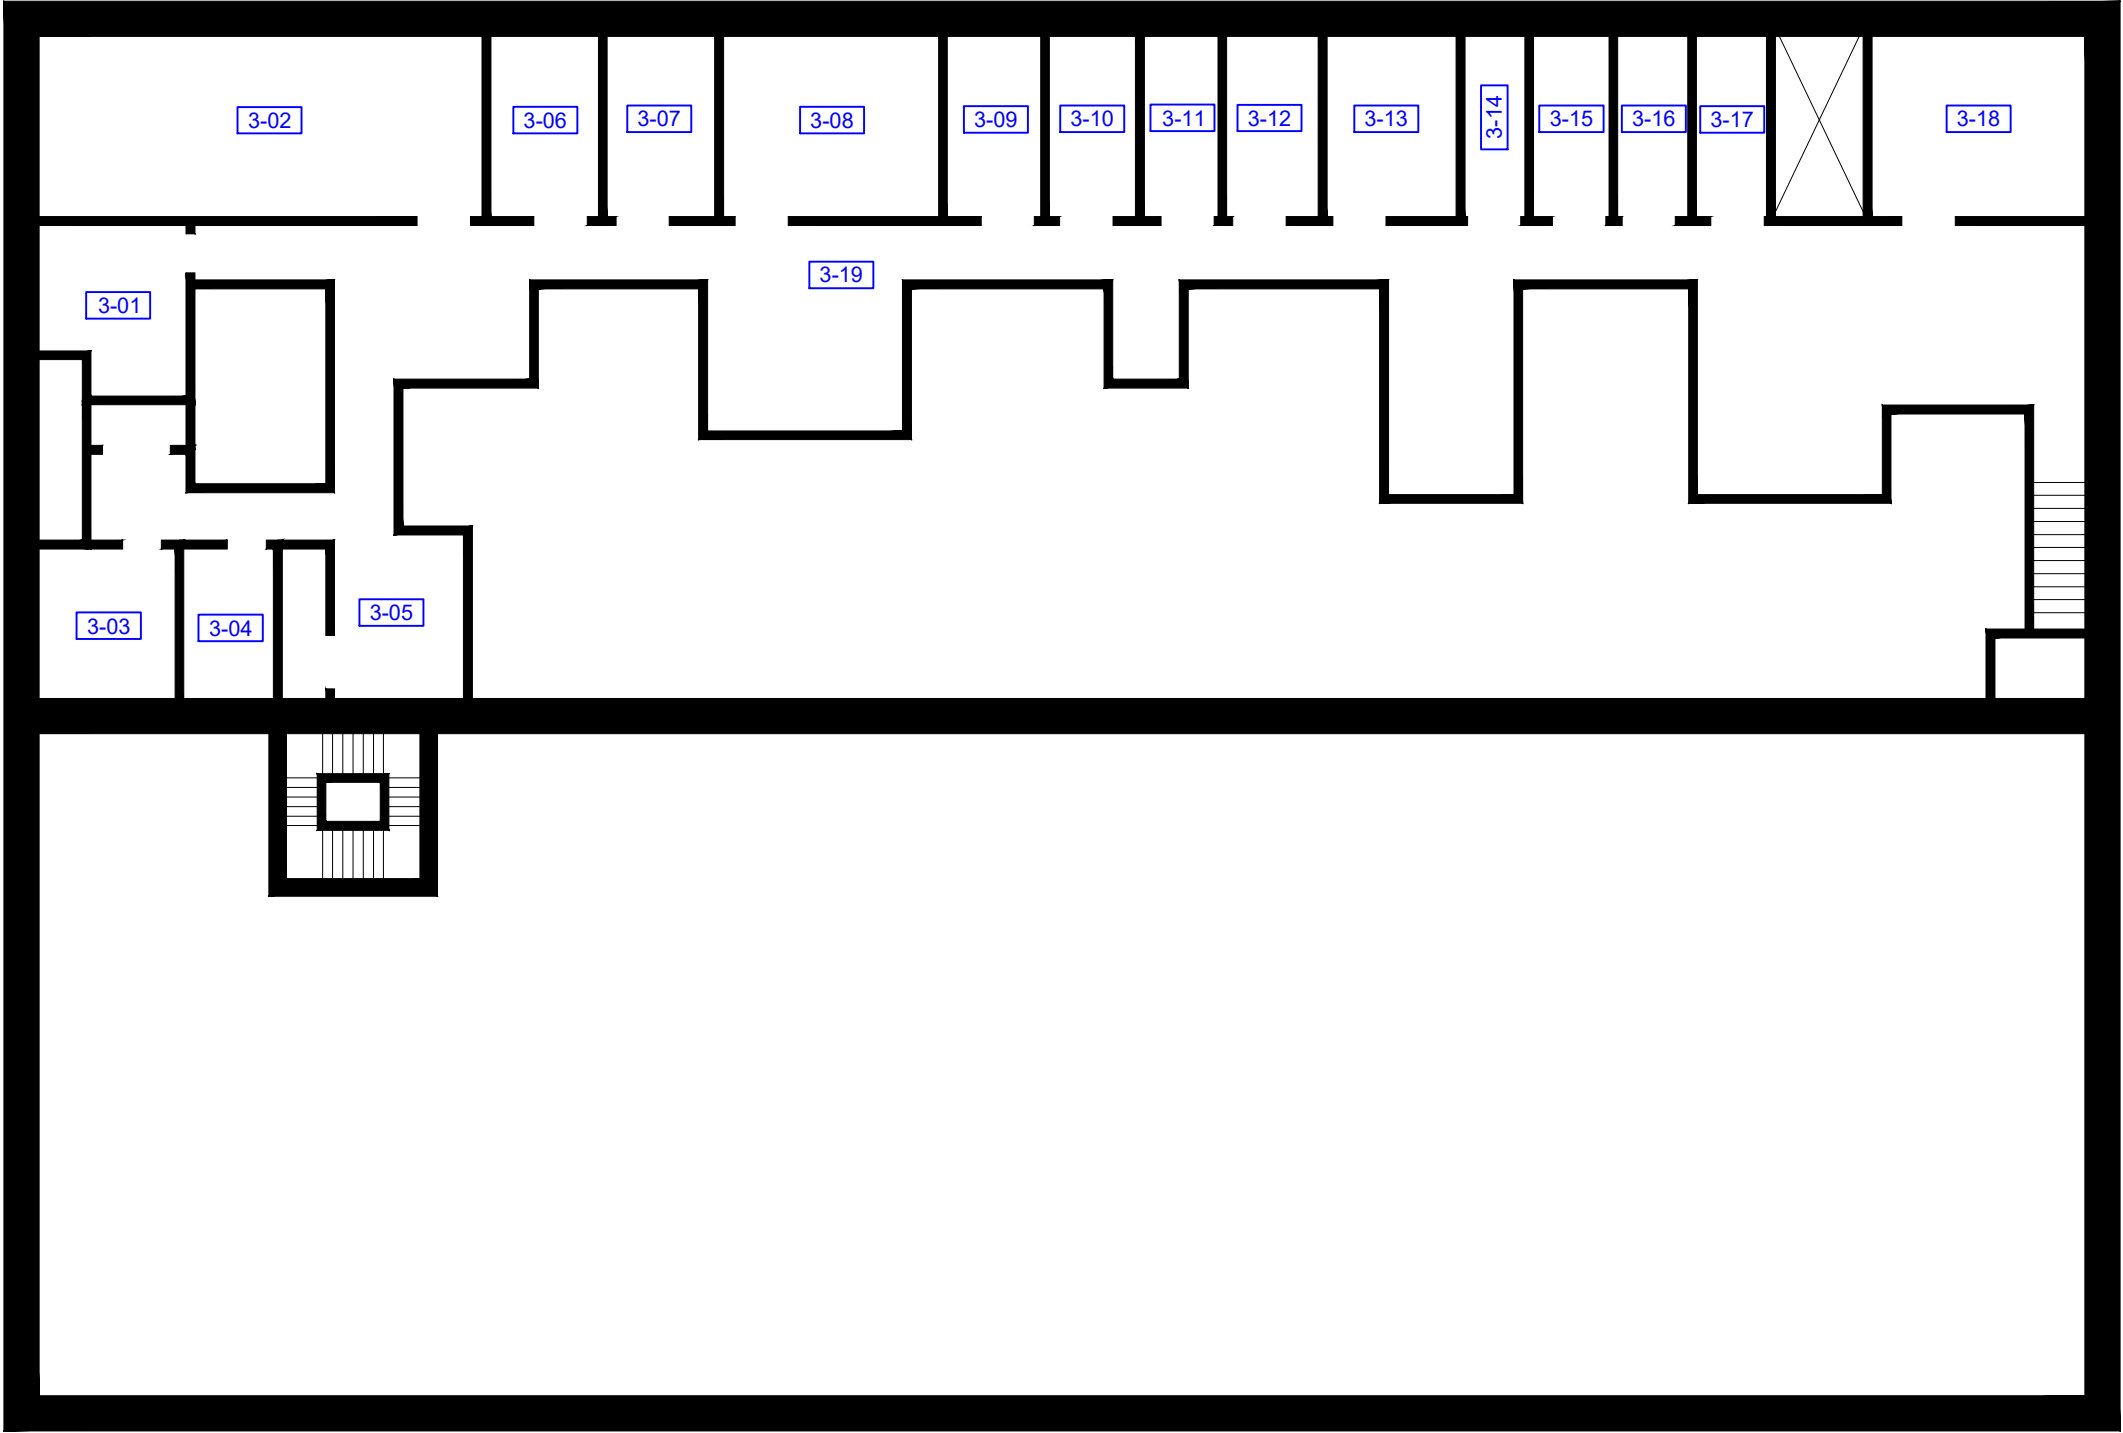
3RD FLOOR

Note: Mastic associated
with flooring is
suspected to be
asbestos-containing.

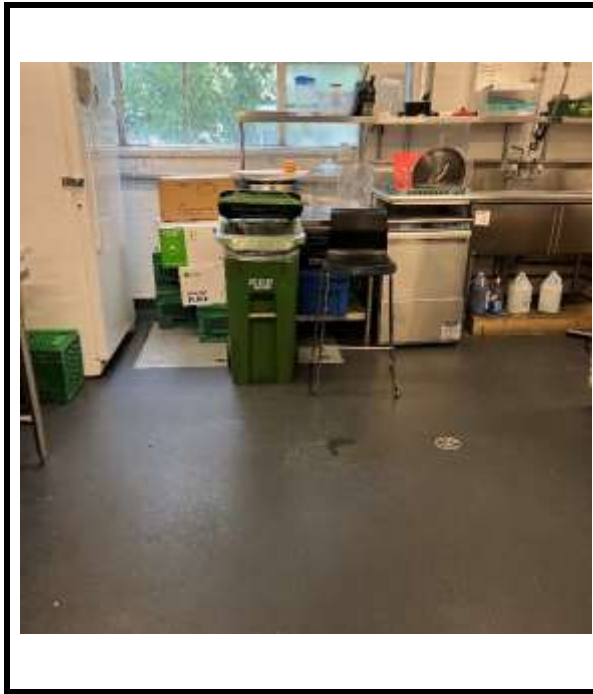
Photograph I

Mastic is assumed to be present underneath existing Vinyl Sheet Flooring throughout the facility. Complete sampling of mastic is recommended prior to any flooring renovations.

View of suspect vinyl sheet flooring identified in the Kitchen (1-07) suspected to contain asbestos content.
