# Designated Substances and Hazardous Materials Survey – Pre-Renovation

**City of Barrie, City Hall, Level 4, 70 Collier Street, Barrie, Ontario**

Updated June 2, 2026

Arcadis Project No. 30292342

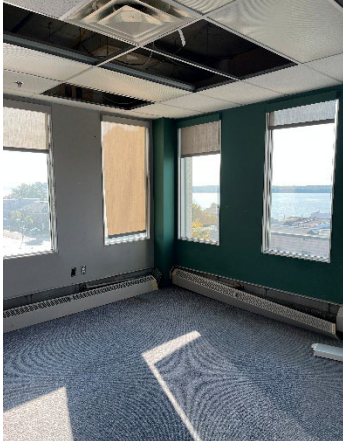
Drywall with drywall joint compound (DWJC) is present as a wall and ceiling finish throughout Level 4. The DWJC was sampled and determined to be asbestos-containing (Samples 1-A to 1-G). Drywall joint compound is considered to be non-friable and is in good condition. There are approximately 1,200 square metres of drywall with drywall joint compound.

Photograph 1 – Room 430 showing typical drywall walls with asbestos-containing drywall joint compound.

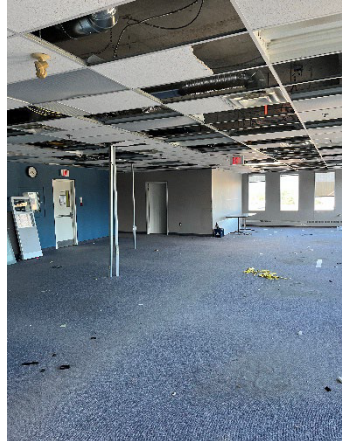
One type of vinyl floor tile (VFT) was observed below carpeting in Room 418. The tiles and mastic were sampled (Samples 6-A to 6-C). The tiles were determined to be asbestos-containing. There are approximately 12 square metres of vinyl floor tiles in Room 418. The tiles are installed over a cement substrate. The leveler was sampled and was determined to be non-asbestos. The vinyl floor tiles and mastic/leveler are non-friable and are in good condition.

Photograph 2 – North Open Area. Room 418 (at top of picture) has vinyl asbestos tiles below carpet.

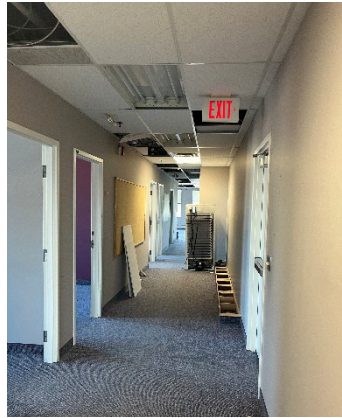
Halocarbon-Containing Equipment: A refrigerator was observed in the corridor near Room 416.

Photograph 4 – Corridor at Room 416 showing refrigerator.

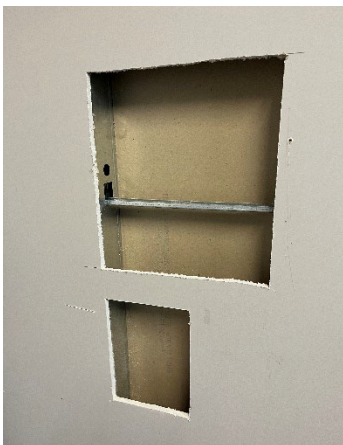
Photograph 5 – Typical space between drywall walls.

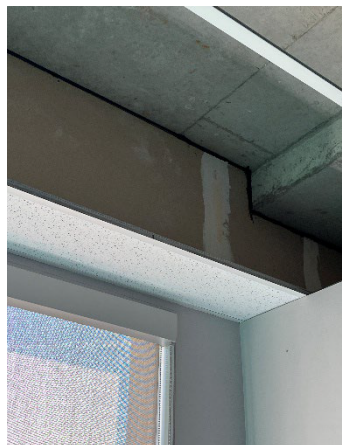
Black tar/caulking was observed along the upper perimeter of Level 4. The tar/caulking was sampled and determined to be asbestos-containing (Samples 4-A to 4-C). The tar/caulking is non-friable and is in good condition. There is approximately 120 linear metres of caulking present.

Photograph 6 – Asbestos-containing black tar/caulking.
