# DESIGNATED SUBSTANCES AND HAZARDOUS BUILDING MATERIALS ASSESSMENT REPORT

Pre-Renovation Project  
Kennedy House Youth Centre  
1076 Pape Avenue  
Toronto, Ontario  
M4K 3W5

Safetech Project Number: 1-3260614

Date of Site Work: June 24, 2026  
Date of Issue: July 13, 2026

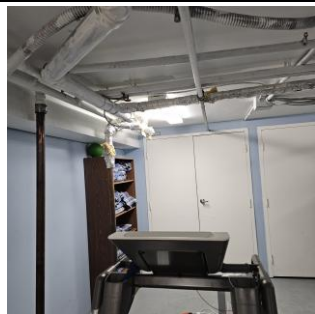
| Mechanical Pipe Insulation | Mechanical pipes were observed to be not insulated or insulated with fiberglass insulation and is therefore not suspect to be asbestos containing. | |

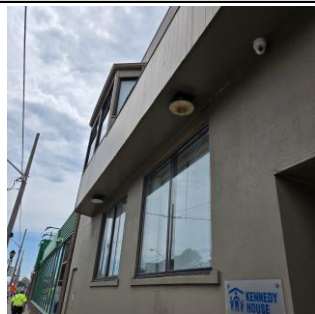
| Sprayed Texture / Stucco Finishes | Texture finish was observed in the subject areas. Bulk samples were collected during the assessment and results of analysis confirmed that this building material is not asbestos-containing. Refer to sample set 7 in Table 2. | |

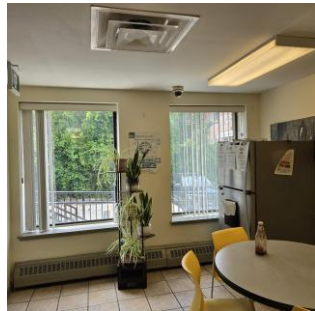
| Drywall Joint Compound | <p><b>Drywall joint compound</b> was observed in the subject areas. Based on the 2025 reassessment report by Safetech, this building material contains <b>2% chrysotile</b> asbestos. Refer to the location, condition, friability, and estimated quantity in Appendix I.</p> | |

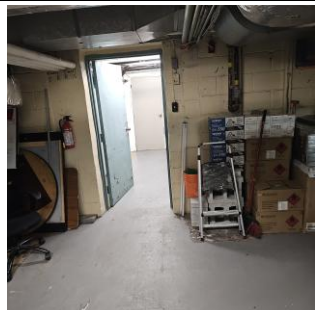
| Mastic | <p><b>Black mastic</b> was observed in the subject areas. Based on the 2025 reassessment report by Safetech, this building material contains <b>4.1% chrysotile</b> asbestos. Refer to the location, condition, friability, and estimated quantity in Appendix I.</p> <p>Although asbestos containing mastic associated with flooring was observed within B-01 and B-02, this material may be present beneath existing flooring in other areas of the subject building.</p> | |

**Mastic:** The black mastic associated with vinyl floor tiles is considered to be a non-friable ACM. As per O. Reg. 278/05, removal of non-friable ACM can be conducted following Type 1 operations; as long as the material can be removed without being broken, cut, drilled or otherwise similarly disturbed. If the material cannot be removed without it breaking or being similarly disturbed then the work should be conducted using non-powered hand tools and the material should be wetted to control the spread of dust. If the material cannot be wetted or if power tools attached to dust-collecting devices equipped with HEPA (high efficiency particulate aerosol) filters are used during removal or disturbance, then work should be performed following Type 2 operations. If non-friable materials are removed or disturbed using power tools that are not attached to dust-collecting devices that are equipped with HEPA filters then work should be conducted following Type 3 operations.

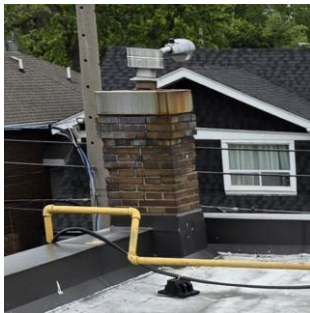
| Other Cement Products | Brick mortar was observed in the subject areas. Bulk samples were collected during the assessment and results of analysis confirmed that this building material is not asbestos-containing. Refer to sample set 8 in Table 2. | |

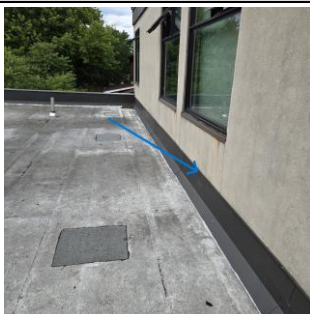
| Other Cement Products | Brick mortar was observed in the subject areas. Bulk samples were collected during the assessment and results of analysis confirmed that this building material is not asbestos-containing. Refer to sample set 8 in Table 2. | |
|---|---|---|
| Caulking | Brown caulking on flashing was observed in the subject areas. Bulk samples were collected during the assessment and results of analysis confirmed that this building material is not asbestos-containing. Refer to sample set 4 in Table 2. | |

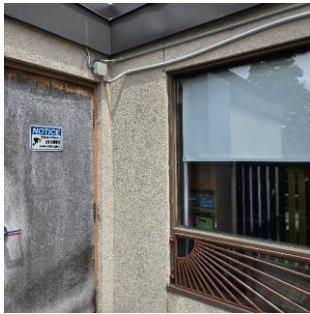
| Other Cement Products | Brick mortar was observed in the subject areas. Bulk samples were collected during the assessment and results of analysis confirmed that this building material is not asbestos-containing. Refer to sample set 8 in Table 2. | |
|---|---|---|
| | Window glass glazing was observed in the subject areas. Bulk samples were collected during the assessment and results of analysis confirmed that this building material is not asbestos-containing. Refer to sample set 5 in Table 2. | |

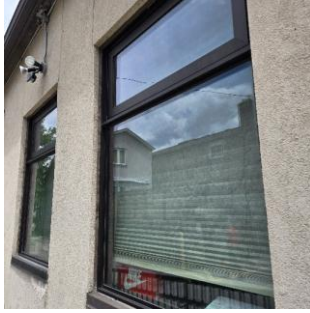
| Other Cement Products | Brick mortar was observed in the subject areas. Bulk samples were collected during the assessment and results of analysis confirmed that this building material is not asbestos-containing. Refer to sample set 8 in Table 2. | |
|---|---|---|
| | Brown window frame caulking was observed in the subject areas. Bulk samples were collected during the assessment and results of analysis confirmed that this building material is not asbestos-containing. Refer to sample set 6 in Table 2. | |

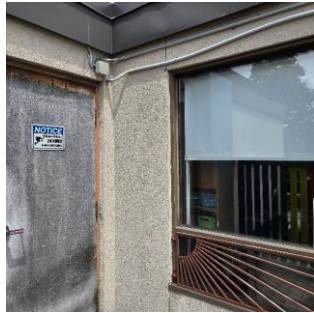
| | Black caulking on vent was observed in the subject areas. Bulk samples were collected during the assessment and results of analysis confirmed that this building material is not asbestos-containing. Refer to sample set 9 in Table 2. | |

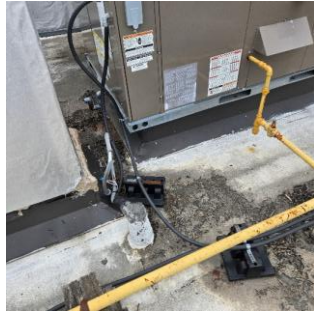
| Caulking<br>(Continued) | Black mastic on Pitch Pocket was observed in the subject areas. Bulk samples were collected during the assessment and results of analysis confirmed that this building material is not asbestos-containing. Refer to sample set 10 in Table 2. | |

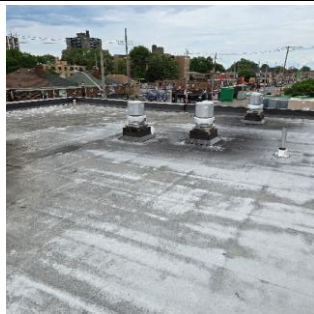
| Roof<br>Membrane | Capsheet were observed in the subject areas. Bulk samples were collected during the assessment and results of analysis confirmed that this building material is not asbestos-containing. Refer to sample set 1 in Table 2. | |

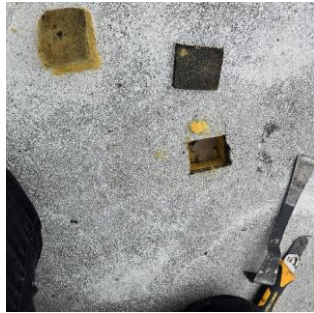
| | Roof Felt under Capsheet were observed in the subject areas. Bulk samples were collected during the assessment and results of analysis confirmed that this building material is not asbestos-containing. Refer to sample set 2 in Table 2. | |

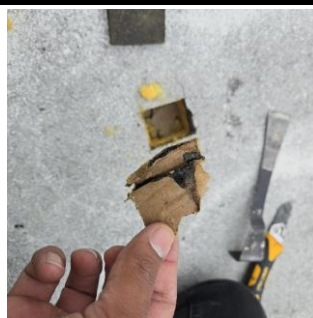
| | <p>Craft Paper were observed in the subject areas. Bulk samples were collected during the assessment and results of analysis confirmed that this building material is not asbestos-containing. Refer to sample set 3 in Table 2.</p> | |

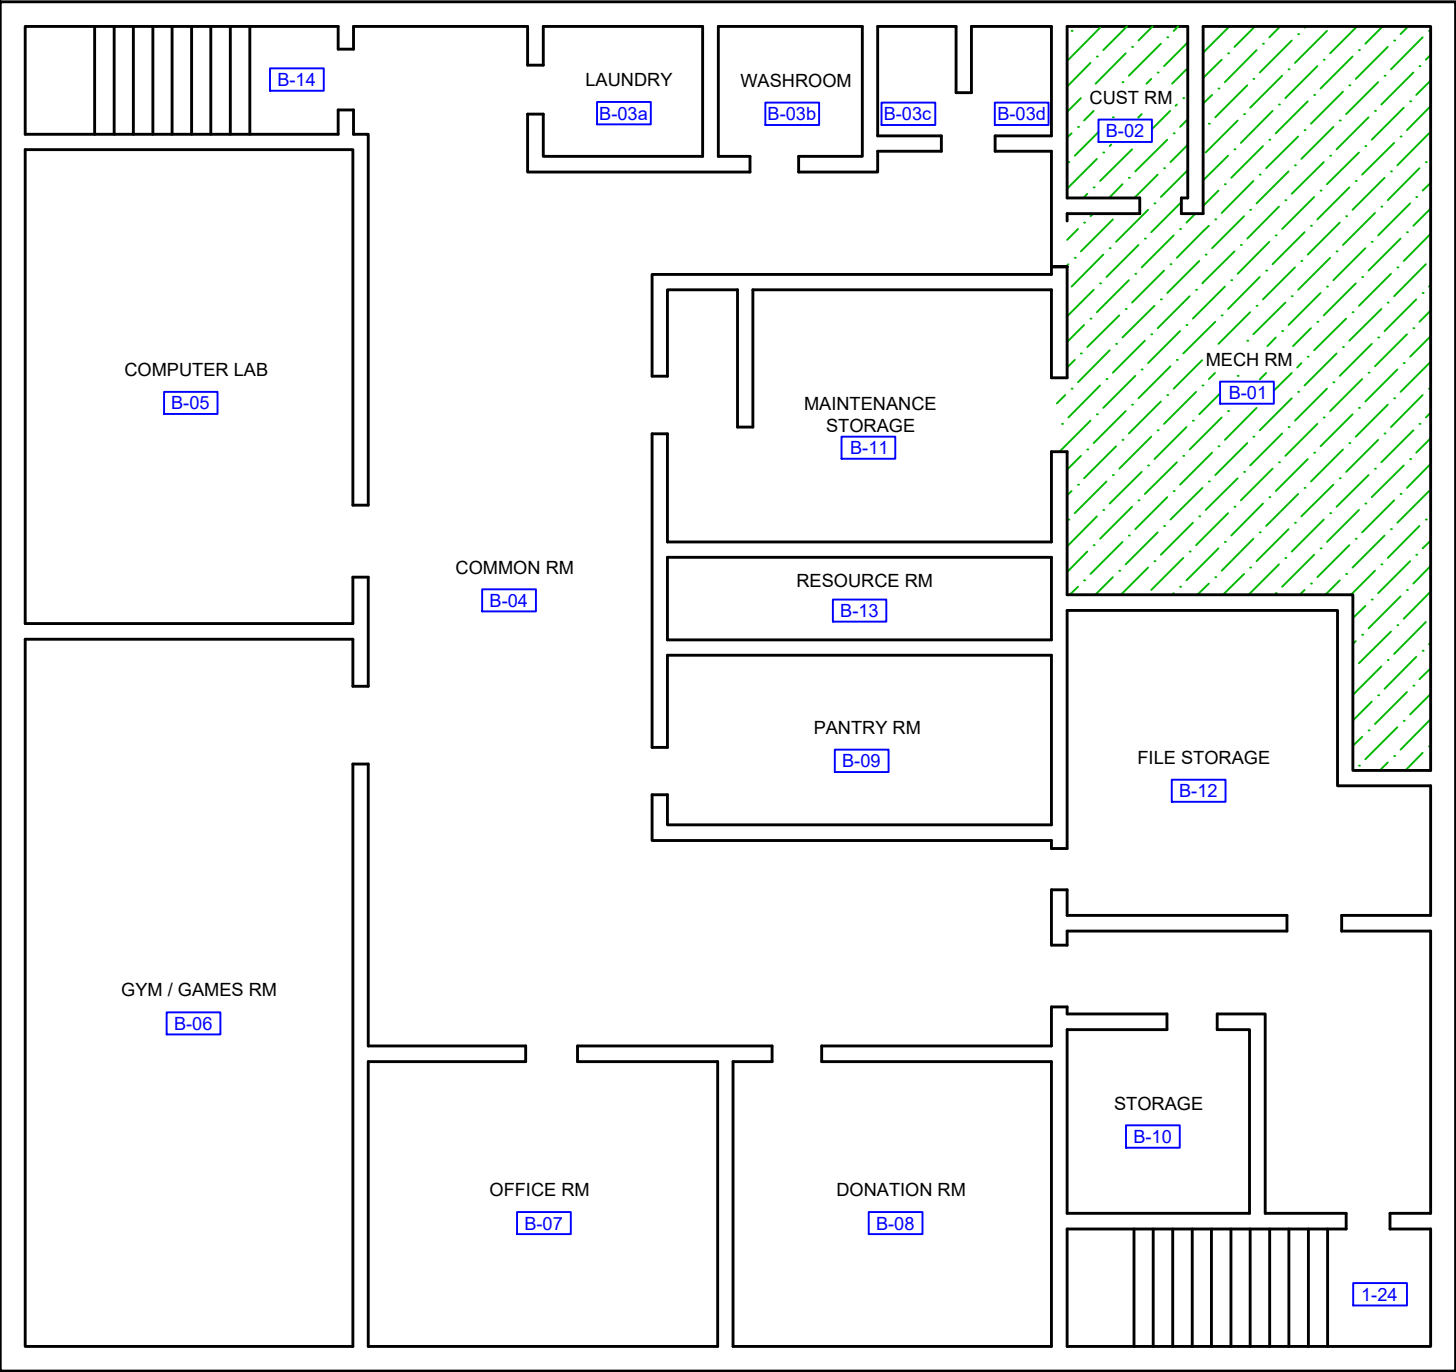
Note: 1) All drywall joint compound associated with wall and ceiling finishes has been found to be asbestos containing as per the Designated Substances and Hazardous Materials Report prepared, by ECOH. Project No.25715-B147, Dated November 27, 2020

2) Although asbestos containing black mastic was only observed within B-01 and B-02, this materials may be present beneath existing flooring.

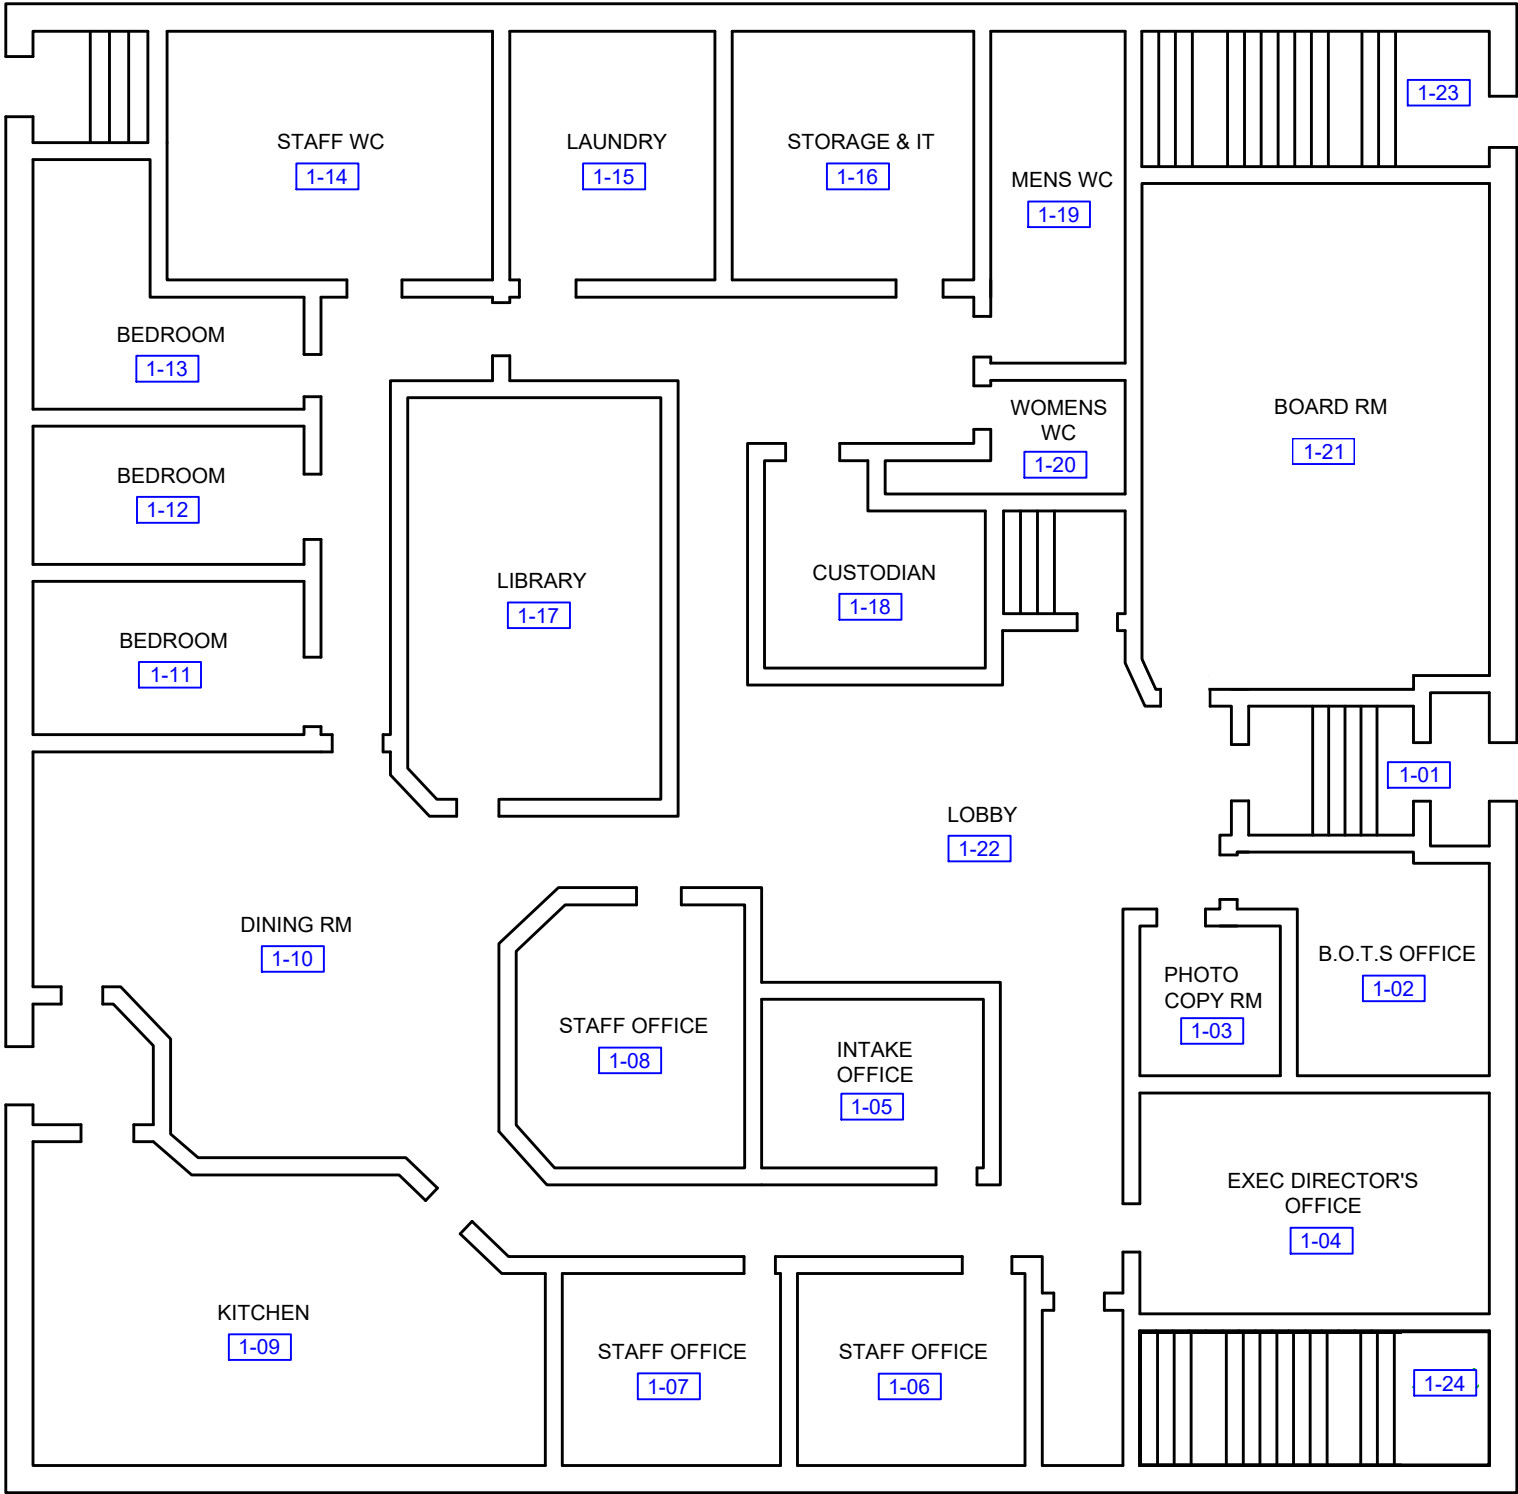
1ST FLOOR

Note: 1) All drywall joint compound associated with wall and ceiling finishes has been found to be asbestos containing as per the Designated Substances and Hazardous Materials Report prepared, by ECOH. Project No.25715-B147, Dated November 27, 2020  
2) Mastic associated with flooring is assumed to be asbestos-containing.

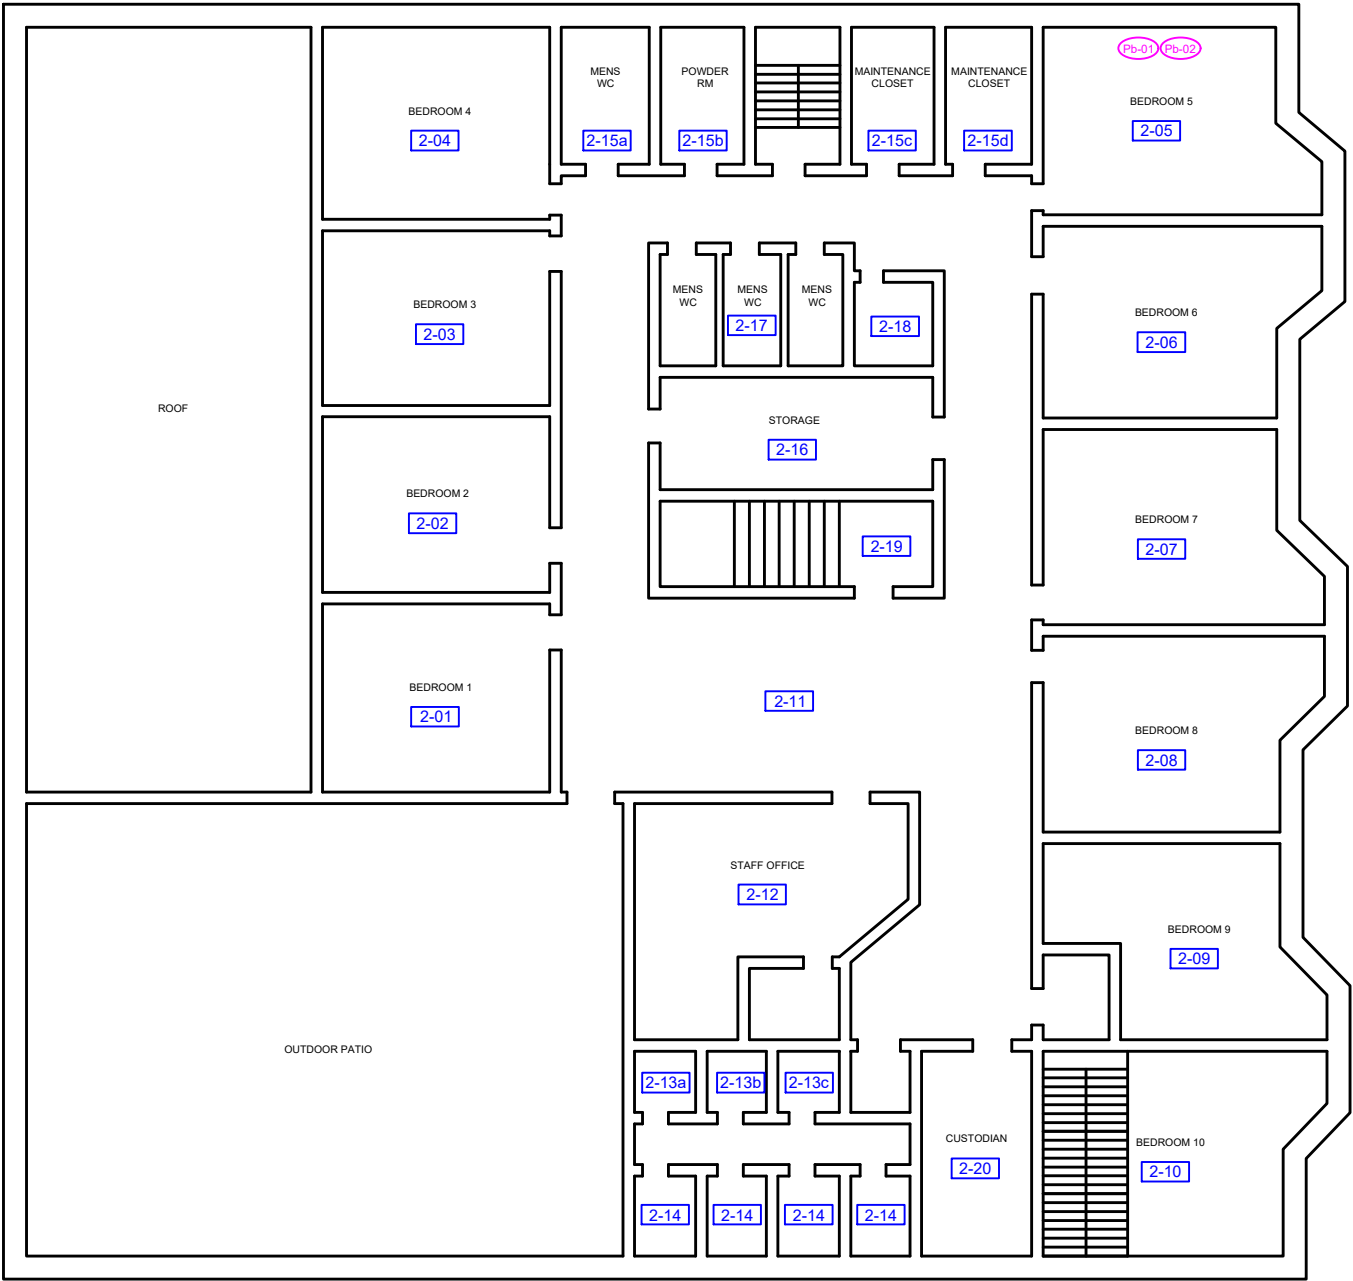
2ND FLOOR

Note: 1) All drywall joint compound associated with wall and ceiling finishes has been found to be asbestos containing as per the Designated Substances and Hazardous Materials Report prepared, by ECOH. Project No.25715-B147, Dated November 27, 2020  
2) Mastic associated with flooring is assumed to be asbestos-containing.
